## **Project**

**Project Name:** Arundel Gate BN18 9EX  
**Project Description:** General CCTV - Condition Check  
**Project Number:** JSD10246  
**Project Status:** Complete  
**Project Date:** 17/09/2026  
**Inspection Standard:** MSCC4 Sewers & Drainage GB (SRM4 Scoring)

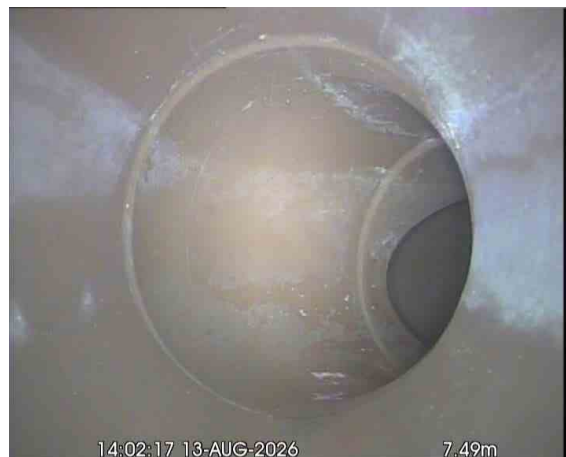
MH15X\_c3dfec66-6f70-4ed8-9596-f3f5208a5763\_20260917\_170323\_835.jpg, 00:01:26, 7.49 m  
Line deviates right

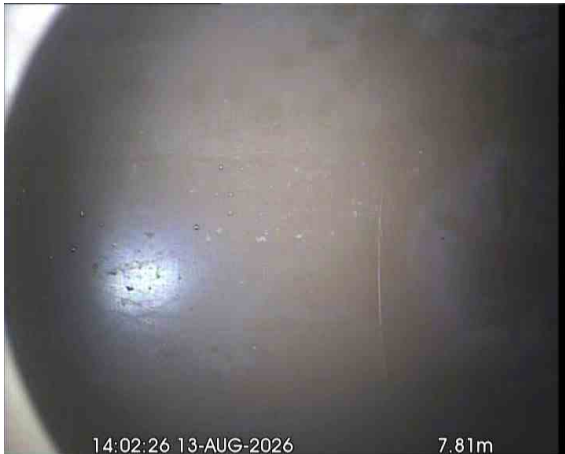
MH15X\_cd0fcec4-553b-492e-9b5f-feeb21337835\_20260917\_170351\_539.jpg, 00:01:35, 7.81 m  
Finish node, major connection without manhole, reference:  
BLIND JUNCTION - JOINS THE MAIN SEWER, \*\*IN THE ROAD\*\*

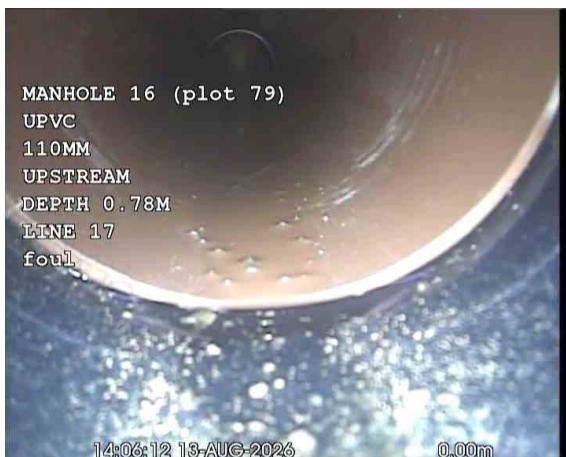
SVPX\_f04ced03-d09c-4ac6-97e2-8e53969a3199\_20260917\_170448\_268.jpg, 00:00:23, 0.00 m  
Start node, manhole, reference: MANHOLE 16 (MH16)

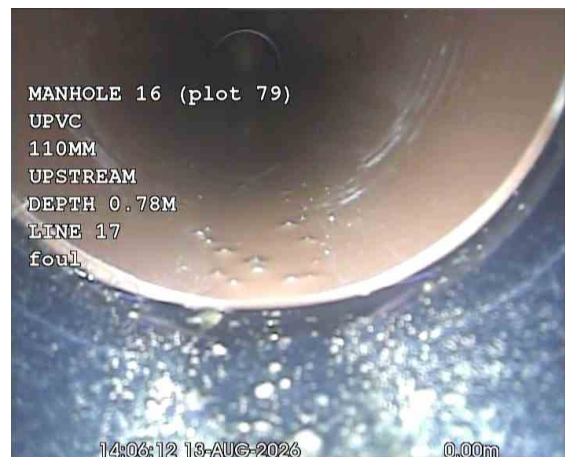
SVPX\_966f4f9e-989c-4148-854f-879d1f09f5f4\_20260917\_170453\_860.jpg, 00:00:23, 0.00 m  
Water level, 0% of the vertical dimension

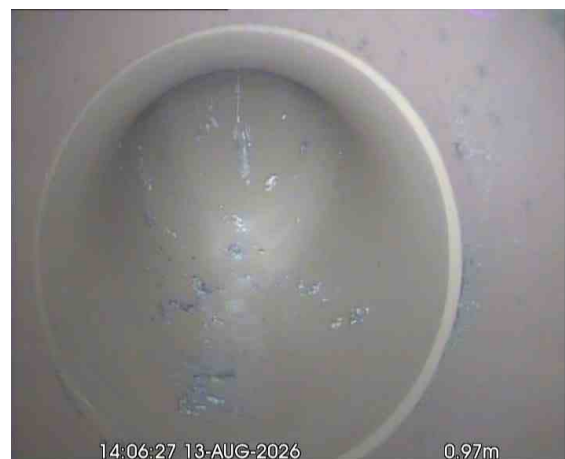
SVPX\_e743adae-db1d-4e84-8163-44e73515b26a\_20260917\_170529\_959.jpg, 00:00:38, 0.97 m  
Line deviates up, REST BEND

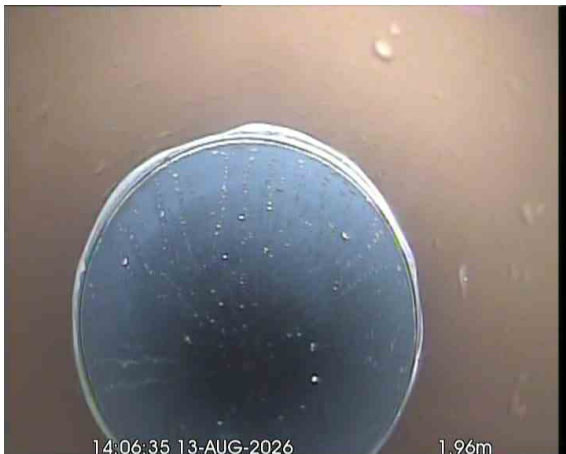
SVPX\_54201fc8-9a5b-4133-8569-6ca7bbfd02da\_20260917\_1  
70547\_467.jpg, 00:00:46, 1.96 m

Finish node, major connection without manhole, reference:  
SOIL VENT PIPE (SVP)

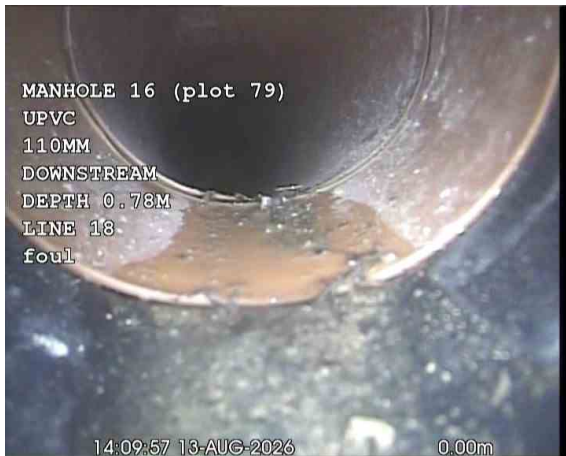
MH16X\_7ed15a63-7253-4d54-bc25-7c3c44105ce0\_20260917\_170643\_154.jpg, 00:00:22, 0.00 m  
Start node, manhole, reference: MANHOLE 16 (MH16)

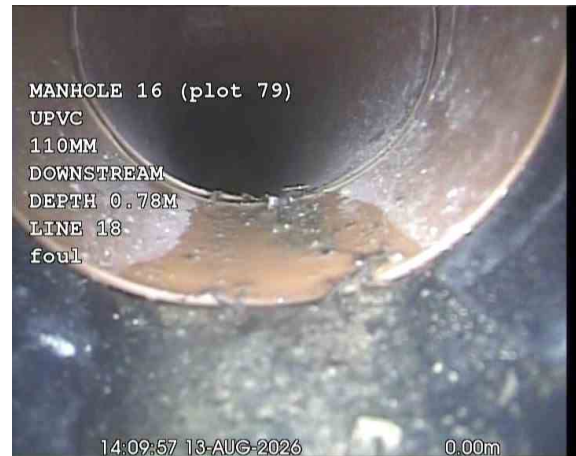
MH16X\_7ab5ae4a-1ab4-4d1b-bd75-725340569ee8\_20260917\_170649\_207.jpg, 00:00:22, 0.00 m  
Water level, 0% of the vertical dimension

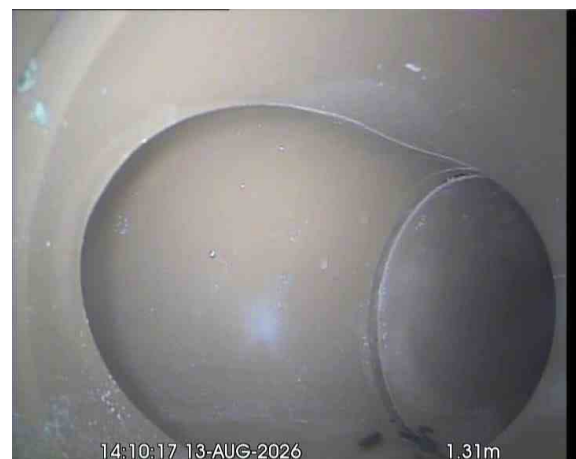
MH16X\_428f2b95-b001-412b-abc9-27e4679198db\_20260917\_170720\_699.jpg, 00:00:41, 1.31 m  
Finish node, major connection without manhole, reference: BLIND JUNCTION - JOINS SECTION 22 (S22)

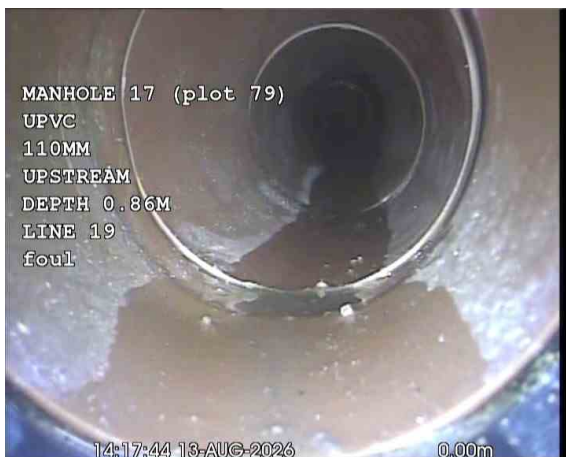
BASINX\_af5ce351-2921-4ba2-bdaf-ebc53474b9f7\_20260917\_170828\_084.jpg, 00:00:25, 0.00 m  
Start node, manhole, reference: MANHOLE 17 (MH17)

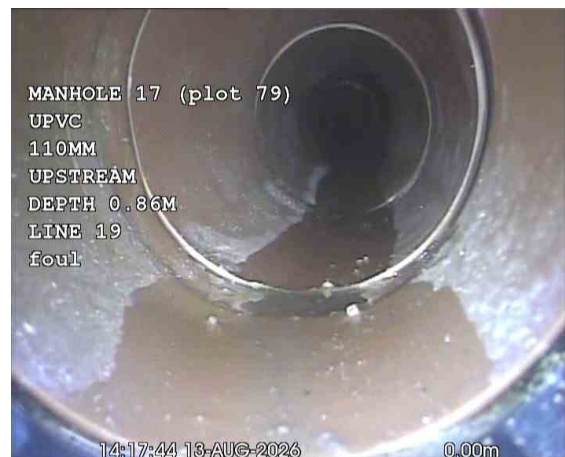
BASINX\_7ac3fc77-0303-42bc-8a62-a722d0f07bad\_20260917\_170834\_875.jpg, 00:00:25, 0.00 m  
Water level, 0% of the vertical dimension

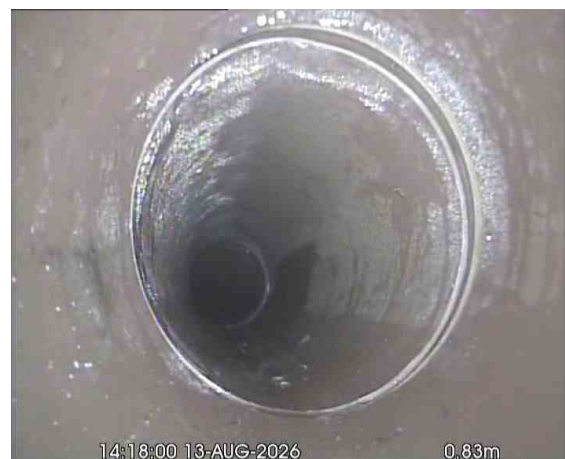
BASINX\_4352884e-0c3c-48e3-b304-1235cdef5f5c\_20260917\_170904\_555.jpg, 00:00:40, 0.83 m  
Line deviates left

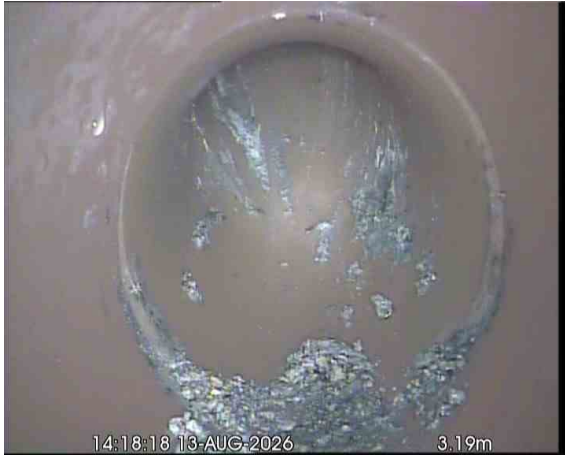
BASINX\_f79740ec-7974-48e7-9a37-fc3e2b8576cc\_20260917\_170920\_384.jpg, 00:00:58, 3.19 m  
Line deviates up, REST BEND

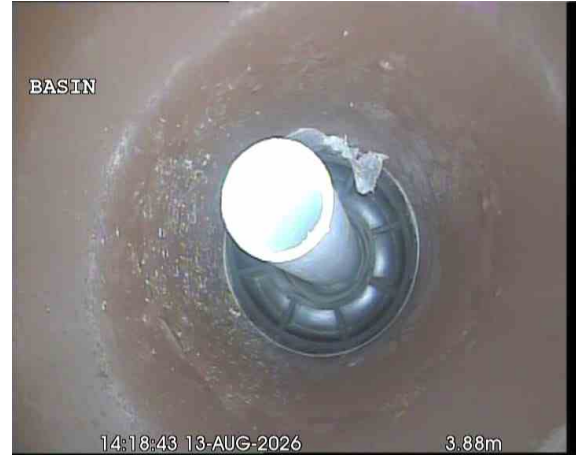
BASINX\_bfb68a32-918e-4b3d-bd2d-c11b1287306e\_20260917\_170930\_804.jpg, 00:01:14, 3.88 m  
Finish node, major connection without manhole, reference: BASIN

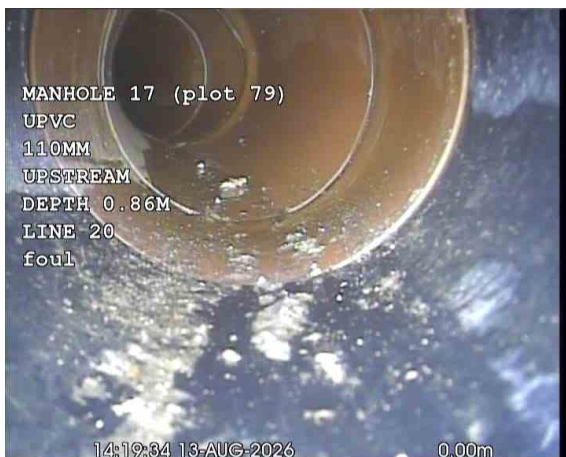
W\_CX\_1abf18ae-b3bd-411c-819f-99249c00b505\_20260917\_171020\_769.jpg, 00:00:19, 0.00 m  
Start node, manhole, reference: MANHOLE 17 (MH17)

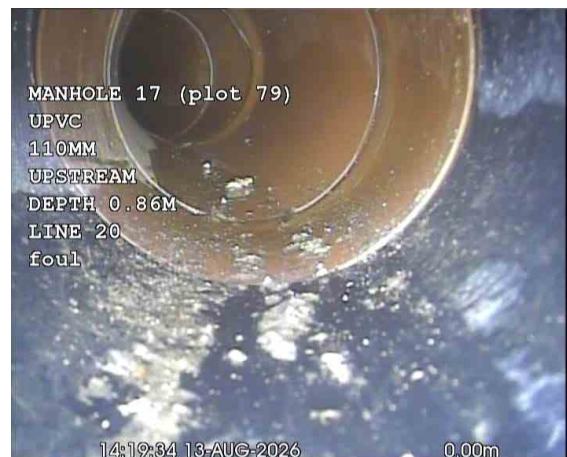
W\_CX\_a401950c-bc96-4dc5-b135-0128f70b779f\_20260917\_171026\_869.jpg, 00:00:19, 0.00 m  
Water level, 0% of the vertical dimension

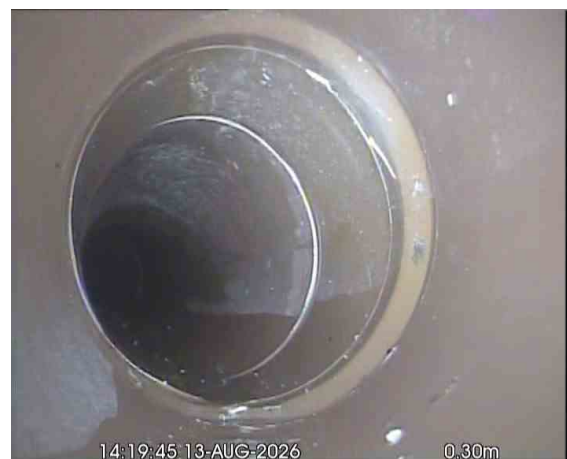
W\_CX\_a57f05f7-9d6c-4b65-8ab5-76ee476a6623\_20260917\_171049\_396.jpg, 00:00:29, 0.30 m  
Line deviates left

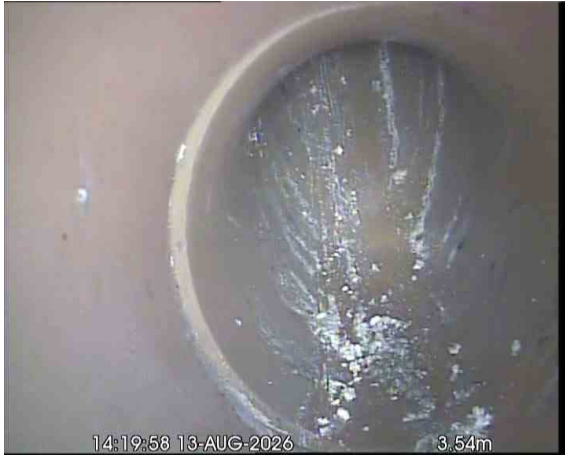
W\_CX\_b4296c61-451e-4780-b165-025cf86c2310\_20260917\_171113\_525.jpg, 00:00:42, 3.54 m  
Line deviates up, REST BEND

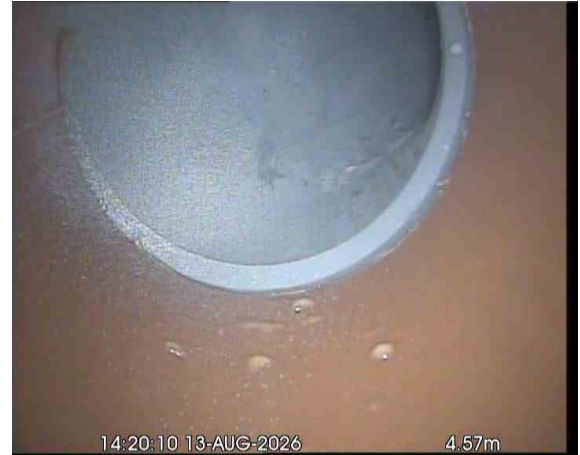
W\_CX\_6c84b869-0fbf-4491-b149-1df9dedb4af4\_20260917\_171124\_774.jpg, 00:00:54, 4.57 m  
Finish node, major connection without manhole, reference: W/C

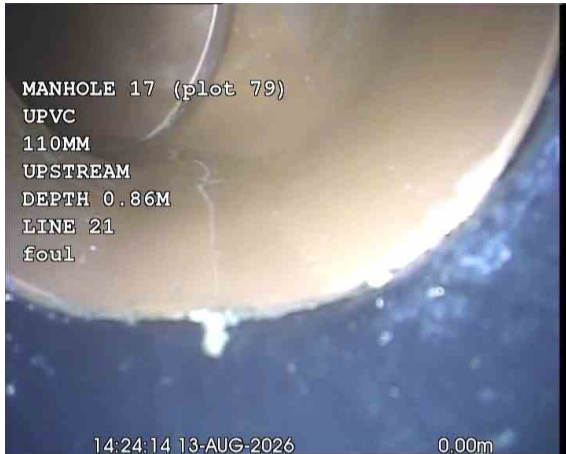
SVPX\_5a0120fe-2875-4ba6-92e4-71d64a493fda\_20260917\_171218\_915.jpg, 00:00:29, 0.00 m  
Start node, manhole, reference: MANHOLE 17 (MH17)

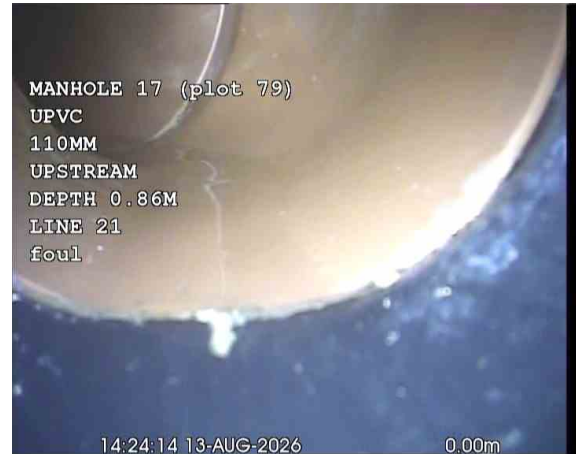
SVPX\_a6e8ca92-aad8-4f9f-b188-818883c408aa\_20260917\_171226\_021.jpg, 00:00:29, 0.00 m  
Water level, 0% of the vertical dimension

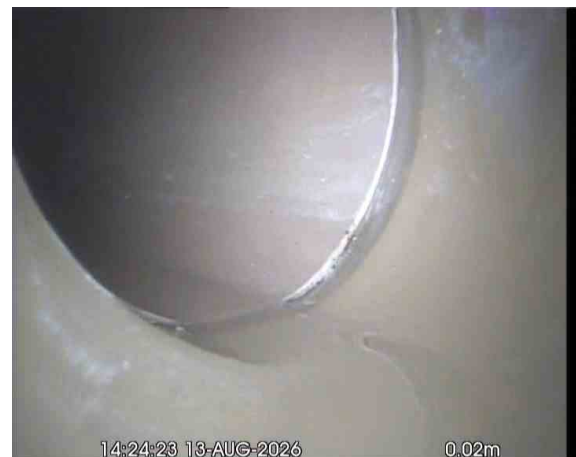
SVPX\_65cf9813-f4ed-4a7c-a7f3-61bf8bdc7fbf\_20260917\_171245\_884.jpg, 00:00:39, 0.02 m  
Line deviates left

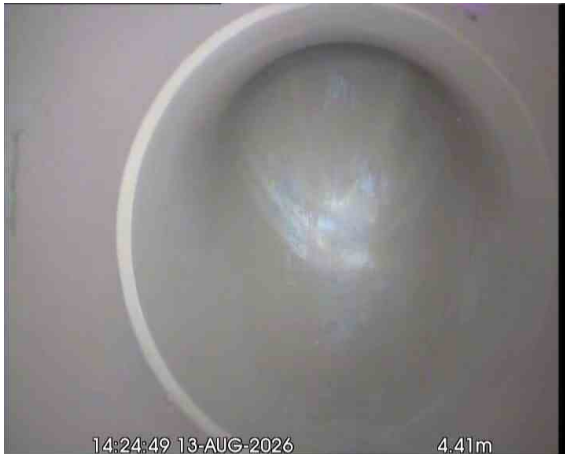
SVPX\_20acf176-d350-4499-b5e7-33c17b2036cd\_20260917\_171310\_629.jpg, 00:01:04, 4.41 m  
Line deviates up, REST BEND

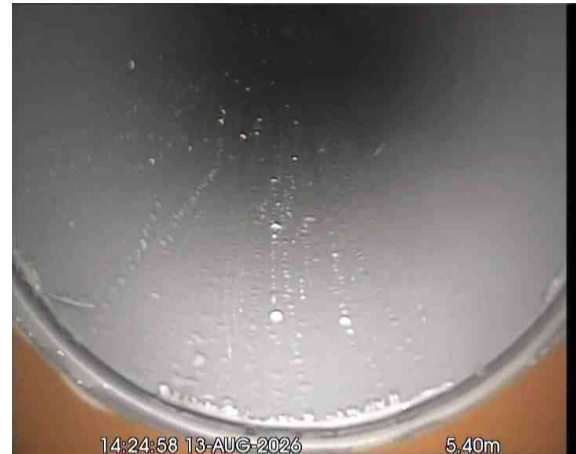
SVPX\_f5641a2a-3f0d-4dfb-9118-07a890dbf729\_20260917\_171329\_515.jpg, 00:01:13, 5.40 m  
Finish node, major connection without manhole, reference: SOIL VENT PIPE (SVP)

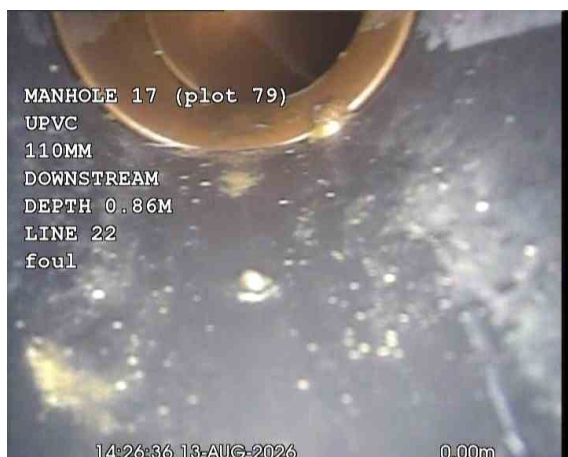
MH17X\_44199b25-50d9-4700-891f-b23154a8e130\_20260917\_171426\_034.jpg, 00:00:24, 0.00 m  
Start node, manhole, reference: MANHOLE 17 (MH17)

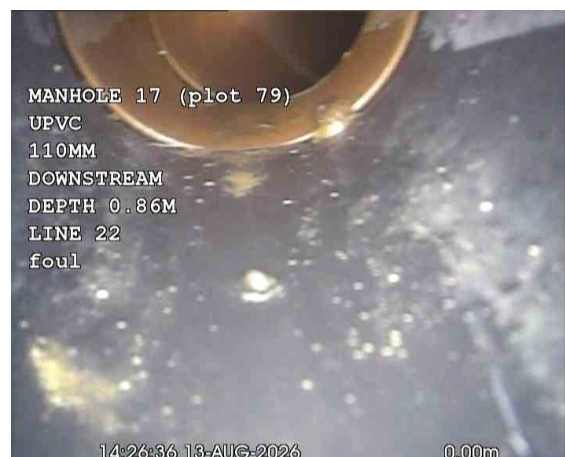
MH17X\_e71f2f2f-3a22-413e-9c81-0c17864832ac\_20260917\_171431\_235.jpg, 00:00:24, 0.00 m  
Water level, 0% of the vertical dimension

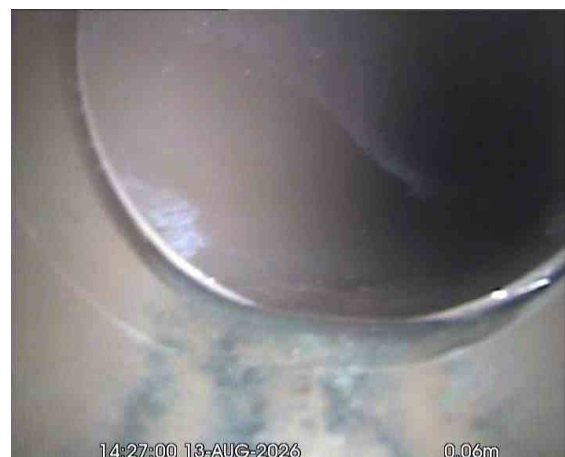
MH17X\_4519127e-9da7-4b69-a54e-91df8a42085a\_20260917\_171504\_237.jpg, 00:00:48, 0.06 m  
Line deviates right

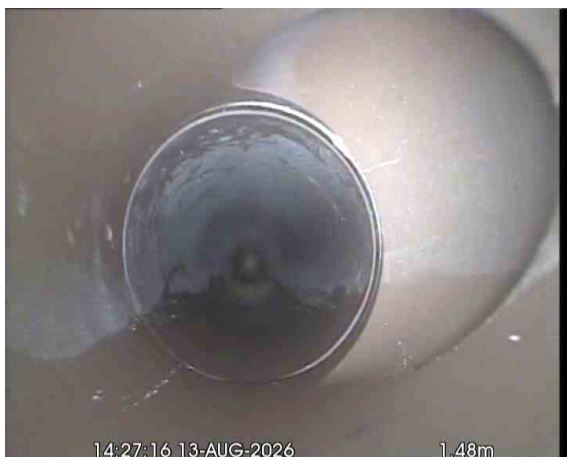
MH17X\_29239583-7e43-4c4c-8f21-8b2c144d30ed\_20260917\_171521\_414.jpg, 00:01:04, 1.48 m  
Junction at 3 o'clock, diameter: 110mm, SECTION 18 (S18)

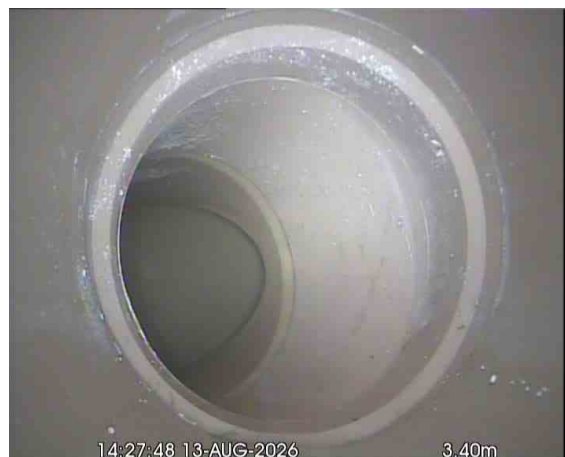
MH17X\_1142224a-fbc7-4b73-ae62-4d6160c99412\_20260917\_171541\_910.jpg, 00:01:36, 3.40 m  
Line deviates left

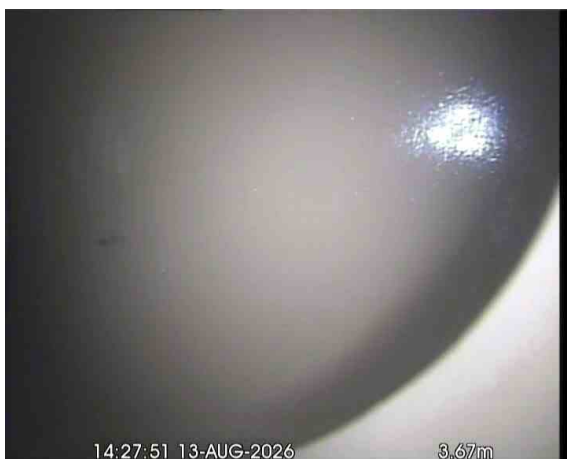
MH17X\_63e6a9da-b00e-4df3-bf8a-768f73311e2a\_20260917\_171604\_159.jpg, 00:01:39, 3.67 m  
Finish node, major connection without manhole, reference:  
BLIND JUNCTION - JOINS SECTION 16 (S16)

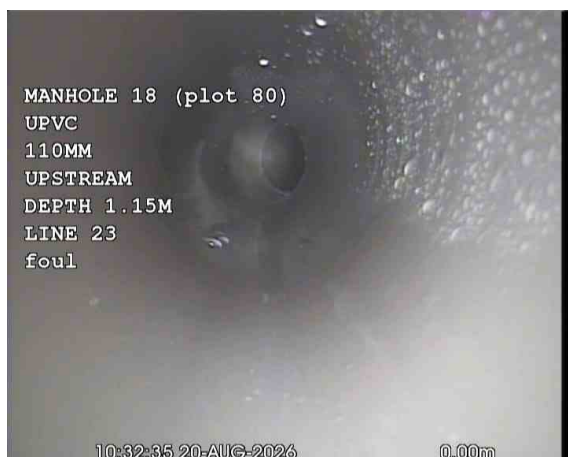
KIT.  
SINKX\_127a114f-22b0-4eed-beac-47838286044a\_20260917\_172027\_464.jpg, 00:00:29, 0.00 m  
Start node, manhole, reference: MANHOLE 18 (MH18)

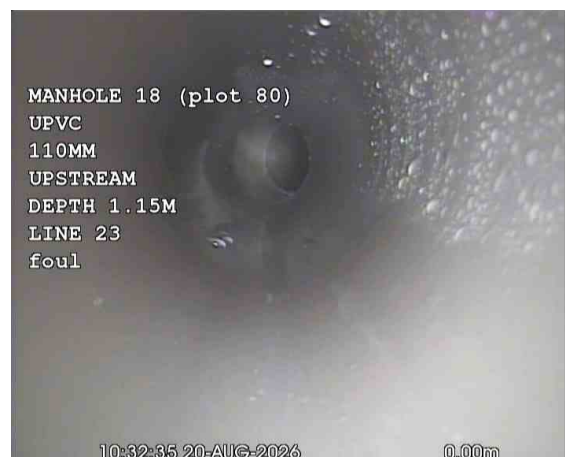
KIT.  
SINKX\_d18719db-c4a0-4ef5-ba72-ec72938a6f7b\_20260917\_172033\_755.jpg, 00:00:29, 0.00 m  
Water level, 0% of the vertical dimension

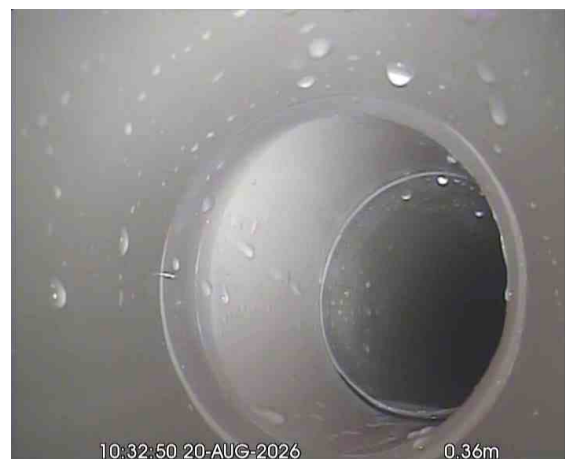
KIT.  
SINKX\_7f6a78dd-bf72-4feb-9690-3e8ee3f130d6\_20260917\_172051\_549.jpg, 00:00:44, 0.36 m  
Line deviates right

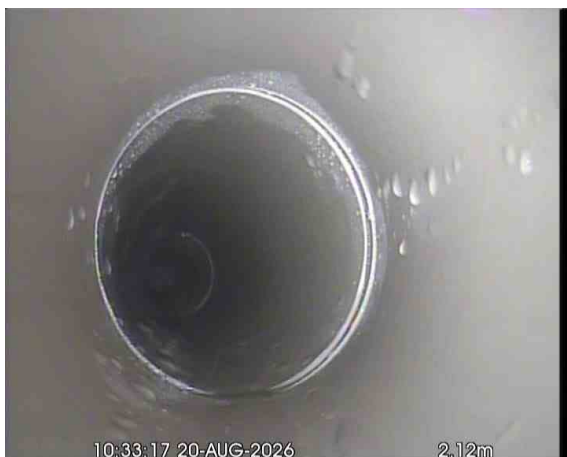
KIT.  
SINKX\_4c4615d5-8afe-46fe-abfa-9437e60ddb6a\_20260917\_172106\_901.jpg, 00:01:12, 2.12 m  
Line deviates left

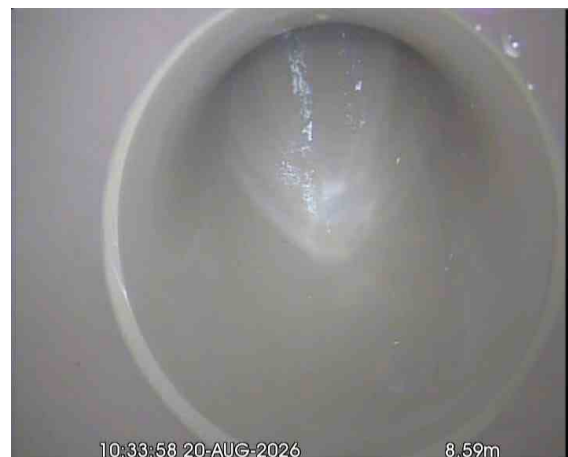
KIT.  
SINKX\_ef349aab-60ba-42da-a7c8-8815dd824d1a\_20260917\_172122\_502.jpg, 00:01:52, 8.59 m  
Line deviates up, REST BEND

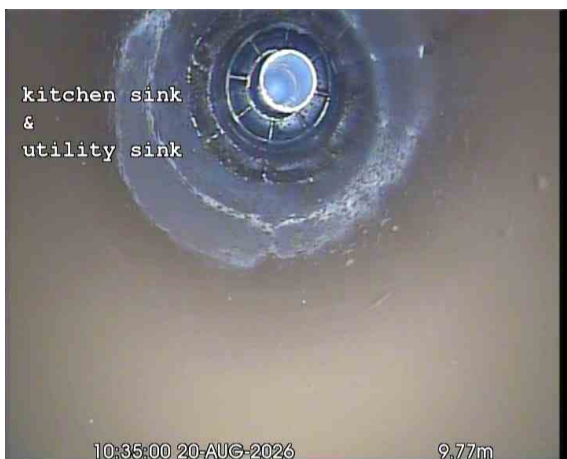
KIT.  
SINKX\_922ef9a8-3312-49c9-a29f-98dec6e21b2e\_20260917\_172141\_099.jpg, 00:02:14, 9.77 m  
Finish node, major connection without manhole, reference:  
KITCHEN & UTILITY SINK

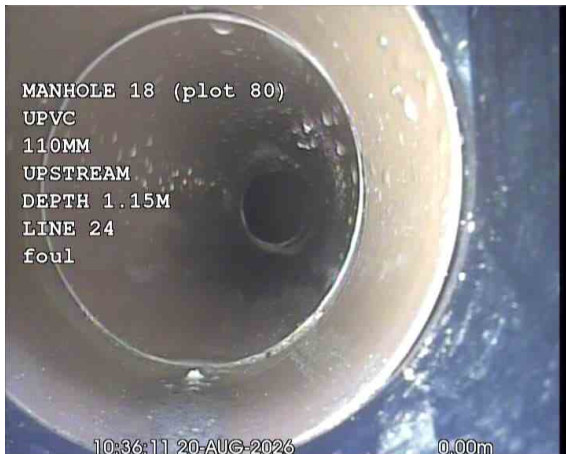
SVPX\_e468887e-16f8-418e-80c7-2ed563686ce8\_20260917\_172235\_349.jpg, 00:00:19, 0.00 m  
Start node, manhole, reference: MANHOLE 18 (MH18)

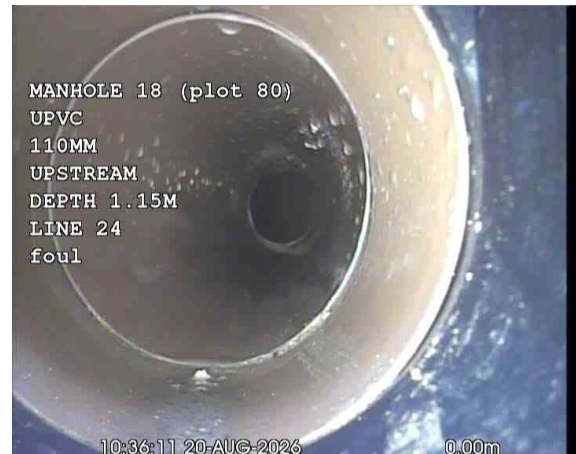
SVPX\_c651a3df-8f10-4d18-9e79-4cfe3e3c62d9\_20260917\_172240\_669.jpg, 00:00:19, 0.00 m  
Water level, 0% of the vertical dimension

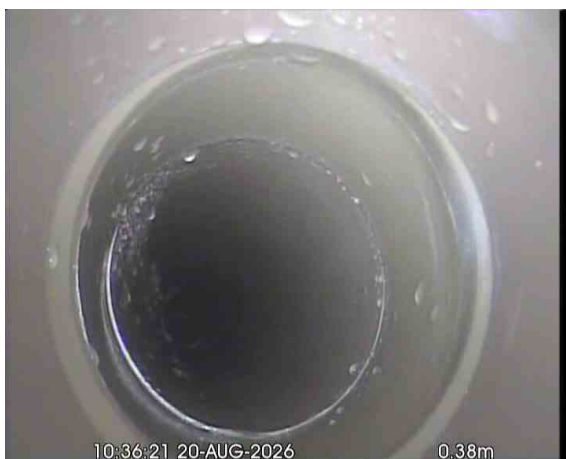
SVPX\_fdd0e0d6-8e91-4ef3-b778-3b0a6ac22db0\_20260917\_172300\_699.jpg, 00:00:29, 0.38 m  
Line deviates left

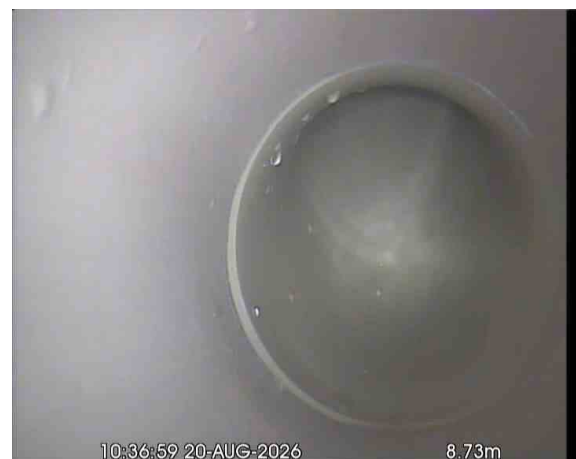
SVPX\_b62ef229-8eab-40e3-aeda-763403b412c2\_20260917\_172320\_991.jpg, 00:01:07, 8.73 m  
Line deviates up, REST BEND

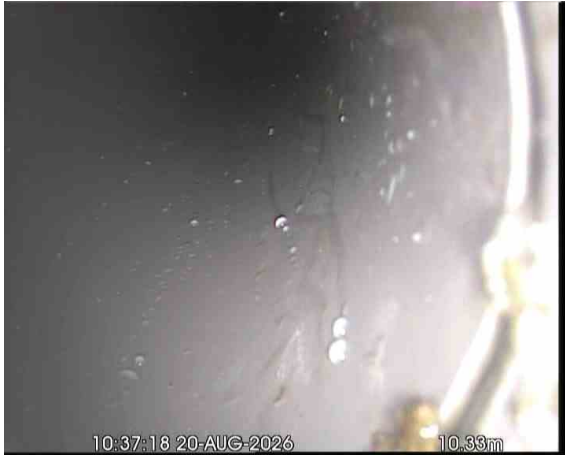
SVPX\_eb06b1a6-3291-4a15-9a22-e94d428a1896\_20260917\_172349\_566.jpg, 00:01:26, 10.33 m

Finish node, major connection without manhole, reference:  
SOIL VENT PIPE (SVP)

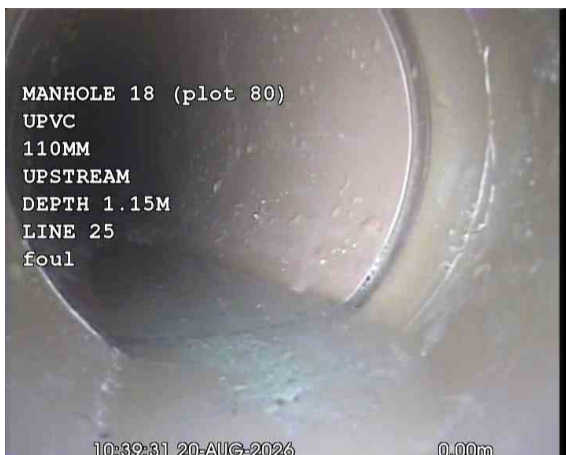
SVPX\_db27abdd-764f-48a2-8db6-5257bb3fac5f\_20260917\_172439\_531.jpg, 00:00:32, 0.00 m  
Start node, manhole, reference: MANHOLE 18 (MH18)

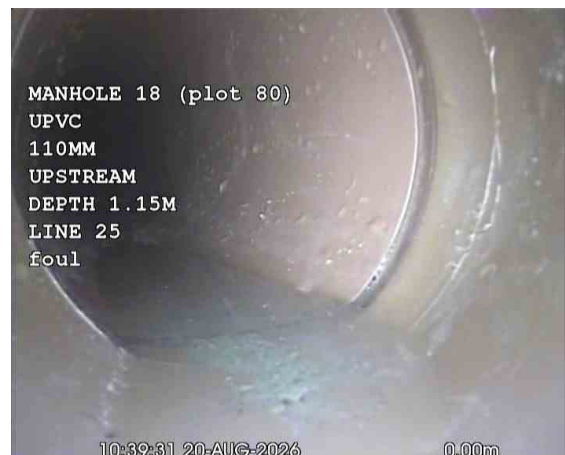
SVPX\_1010f633-5b94-4482-a847-6c9750f4c8f0\_20260917\_172445\_869.jpg, 00:00:32, 0.00 m  
Water level, 0% of the vertical dimension

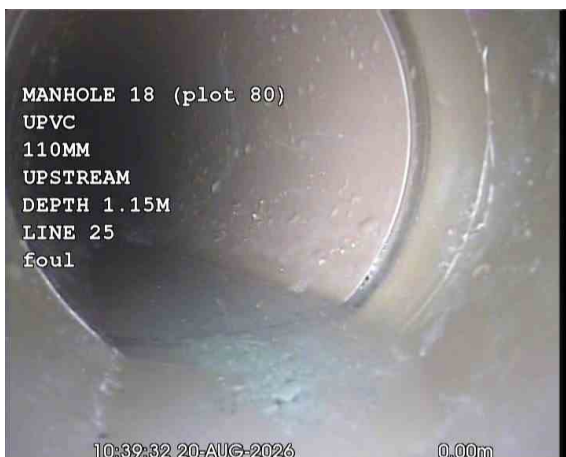
SVPX\_0b274464-3330-45b2-9a17-49441895e9ff\_20260917\_172453\_434.jpg, 00:00:33, 0.02 m  
Line deviates left

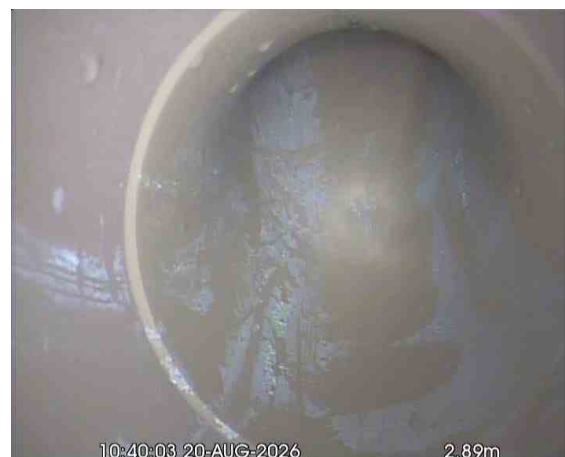
SVPX\_6b41b416-6a39-4cfe-a2c1-4a535335776f\_20260917\_172508\_036.jpg, 00:01:04, 2.89 m  
Line deviates up, REST BEND

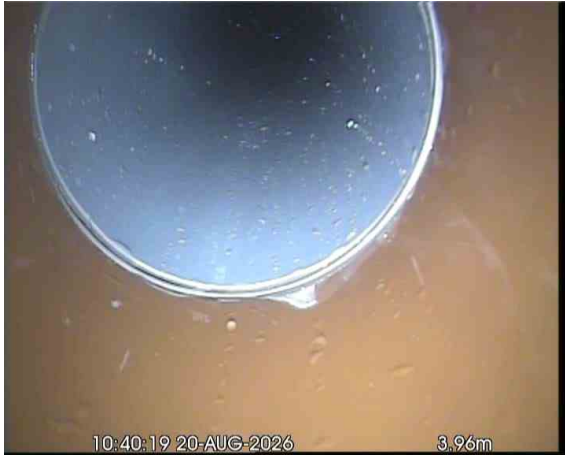
SVPX\_e178cb8a-edfc-41af-8bcf-52008b78a9cb\_20260917\_1  
72523\_518.jpg, 00:01:20, 3.96 m  
Finish node, major connection without manhole, reference:  
SOIL VENT PIPE (SVP)

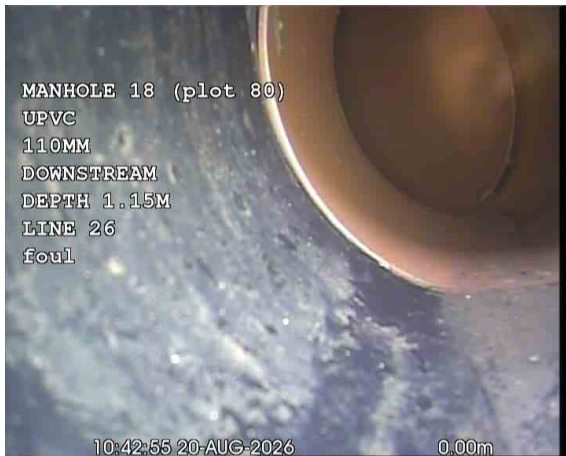
MH18X\_99746b94-685d-4e1b-b362-86349ff1a78e\_20260917\_172625\_060.jpg, 00:00:21, 0.00 m  
Start node, manhole, reference: MANHOLE 18 (MH18)

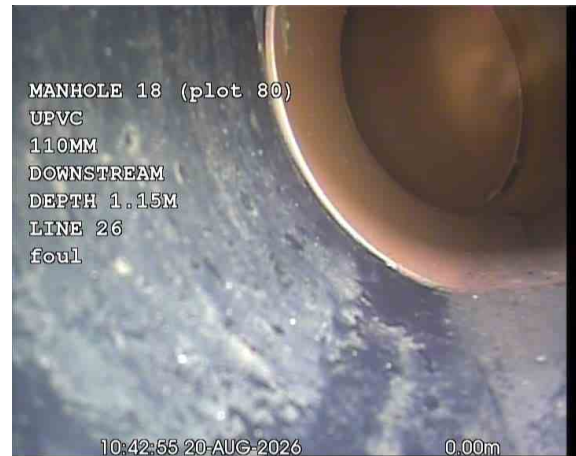
MH18X\_d190bcd2-5cb7-42a8-a38a-37c5f93c884b\_20260917\_172630\_110.jpg, 00:00:21, 0.00 m  
Water level, 0% of the vertical dimension

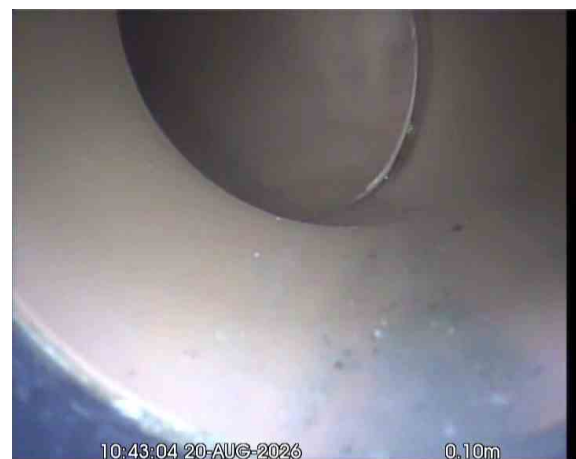
MH18X\_fc59def7-a7fe-4719-bfc2-ec6431eecb40\_20260917\_172649\_229.jpg, 00:00:30, 0.10 m  
Line deviates left

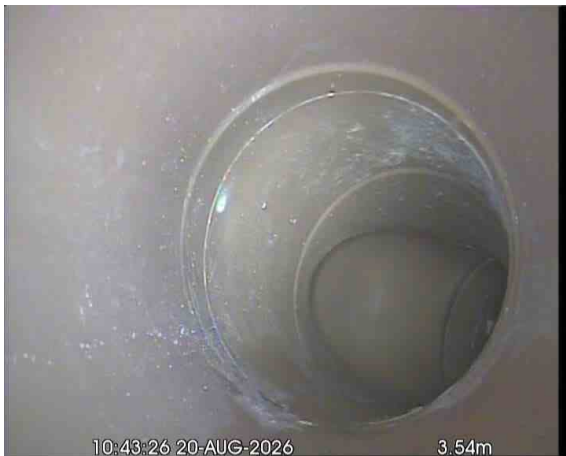
MH18X\_268b6589-d669-4bfe-9c9b-40feec28391f\_20260917\_172703\_203.jpg, 00:00:53, 3.54 m  
Line deviates right

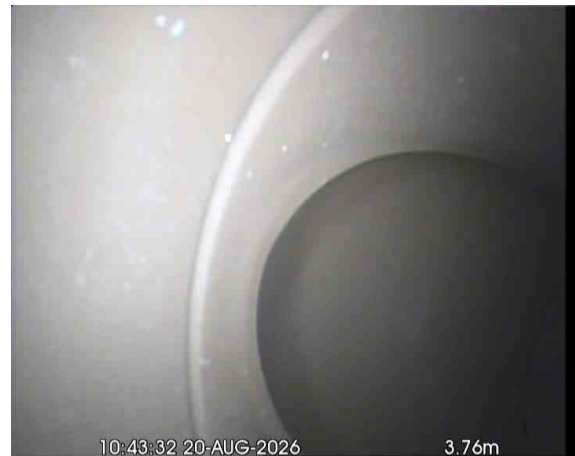
MH18X\_a928e2e4-2da2-4094-816f-51954ca8c04c\_20260917\_172749\_269.jpg, 00:00:59, 3.76 m  
Finish node, major connection without manhole, reference:  
BLIND JUNCTION - JOINS SECTION 29 (S29)

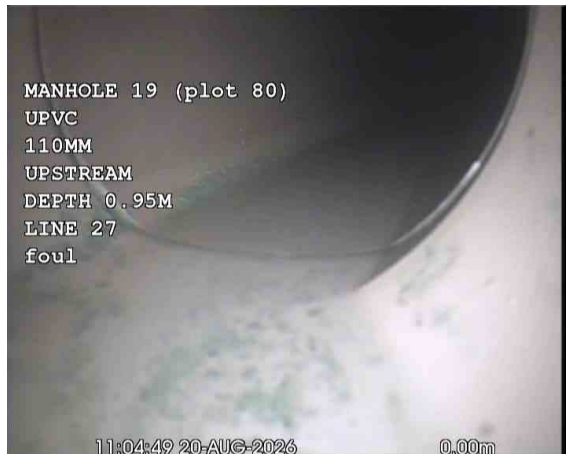
BASINX\_7d255818-8980-4b5b-9301-0e50d3741451\_20260917\_172918\_690.jpg, 00:00:54, 0.00 m  
Start node, manhole, reference: MANHOLE 19 (MH19)

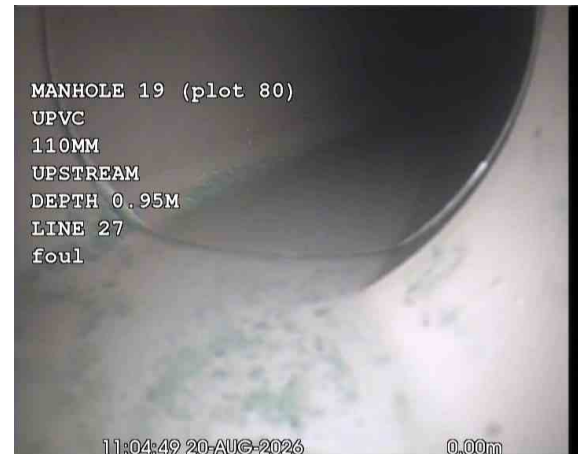
BASINX\_294ffa5-56f5-428c-a005-439469a1bef5\_20260917\_172924\_739.jpg, 00:00:55, 0.00 m  
Water level, 5% of the vertical dimension

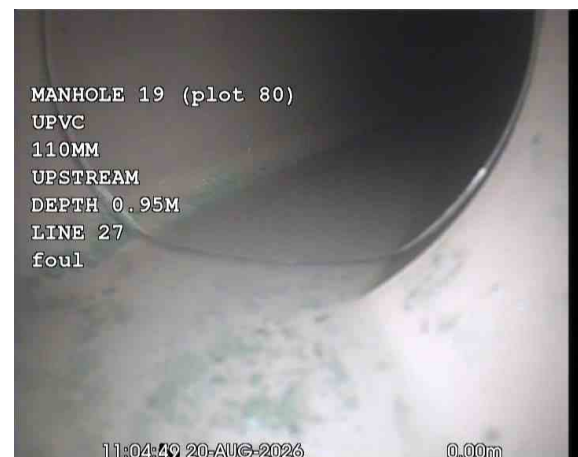
BASINX\_68b4a55a-693d-4c87-8654-4240521c9e41\_20260917\_172940\_995.jpg, 00:00:56, 0.02 m  
Line deviates right

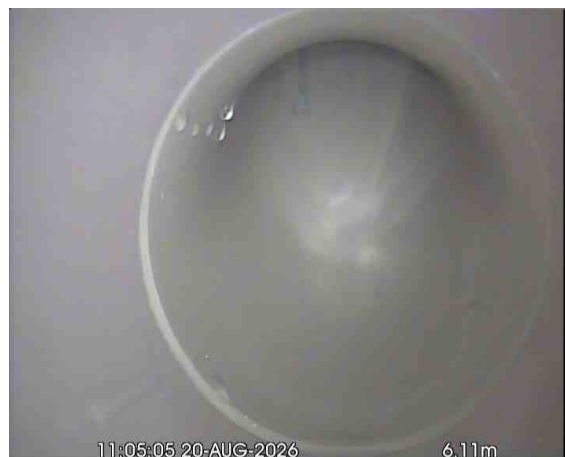
BASINX\_3850f504-a288-4bef-9a1a-a2ea1de32231\_20260917\_173012\_306.jpg, 00:01:12, 6.11 m  
Line deviates up, REST BEND

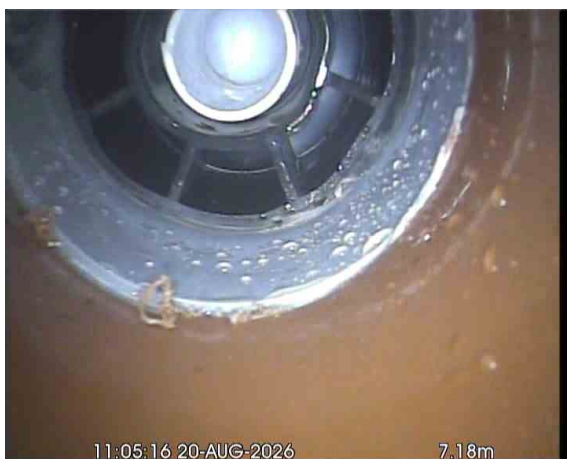
BASINX\_de3d61d1-393a-4a94-8d68-8ebe88da30a0\_20260917\_173026\_581.jpg, 00:01:22, 7.18 m  
Finish node, major connection without manhole, reference: BASIN

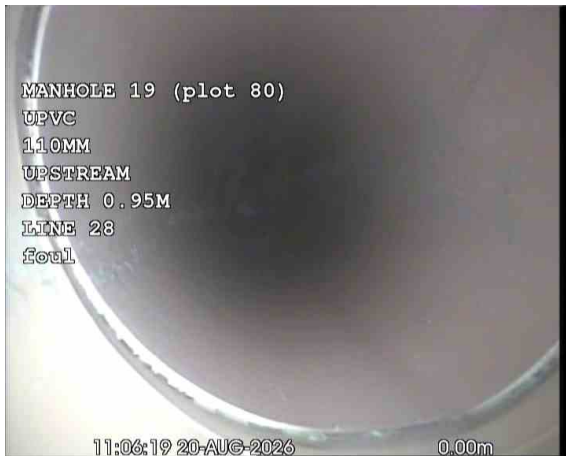
W\_CX\_114763e0-15fc-4e1f-885e-ab74307a7e63\_20260917\_173236\_658.jpg, 00:00:14, 0.00 m  
Start node, manhole, reference: MANHOLE 19 (MH19)

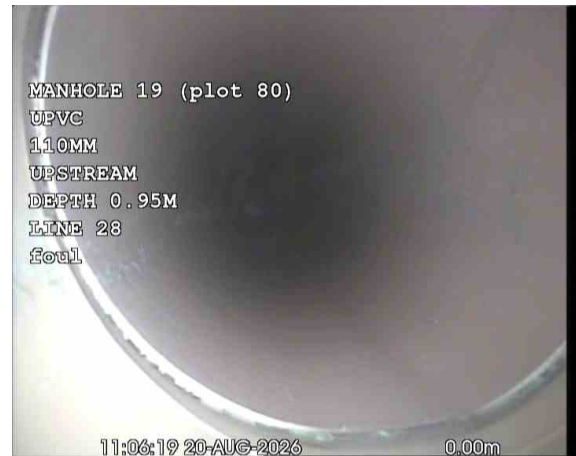
W\_CX\_e79d9ecf-1e93-4095-96e0-de79c73465f6\_20260917\_173242\_989.jpg, 00:00:14, 0.00 m  
Water level, 0% of the vertical dimension

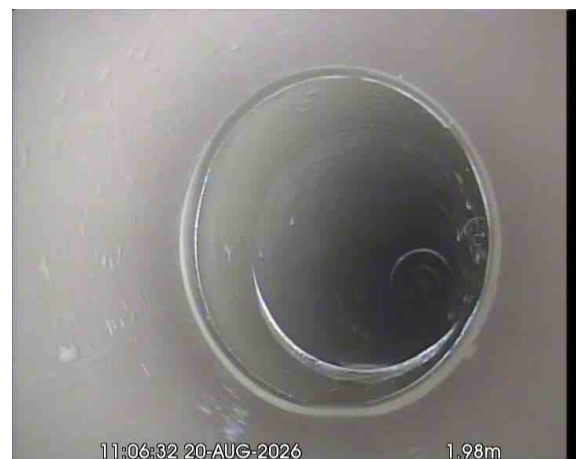
W\_CX\_bf7f41d6-6092-4f26-b0fa-a86bc298efb0\_20260917\_173307\_462.jpg, 00:00:28, 1.98 m  
Line deviates right

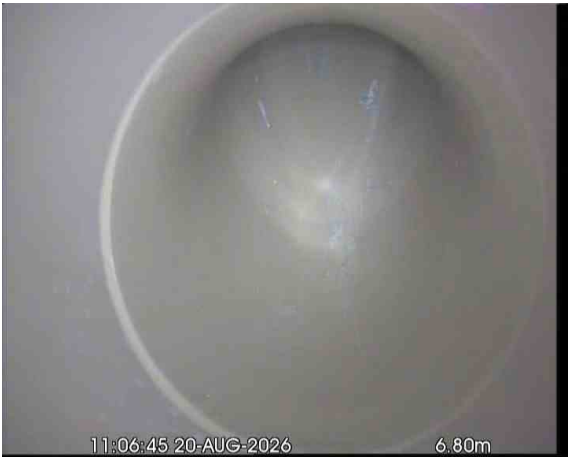
W\_CX\_e89d96ab-1287-4ddc-8592-fe09755ff76c\_20260917\_173328\_060.jpg, 00:00:40, 6.80 m  
Line deviates up, REST BEND

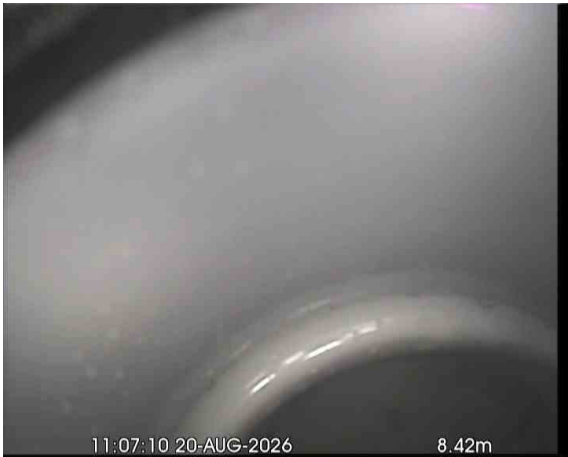
W\_CX\_409388aa-d100-4396-b8a9-0fc85fbb24d7\_20260917\_173350\_054.jpg, 00:01:05, 8.42 m  
Finish node, major connection without manhole, reference: W/C

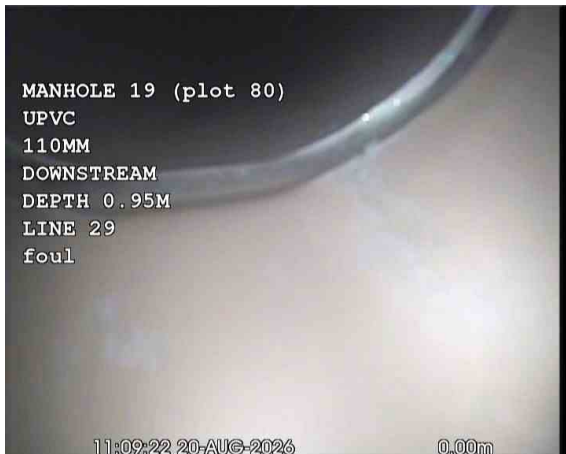
MH19X\_39b1171e-fc43-48b7-acbd-f285a79238fb\_20260917\_173450\_637.jpg, 00:00:23, 0.00 m  
Start node, manhole, reference: MANHOLE 19 (MH19)

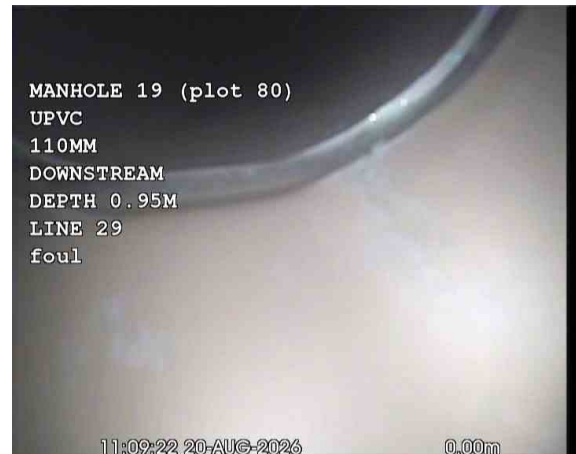
MH19X\_4c81dade-bbaa-422a-a8e6-f72ab22431fd\_20260917\_173456\_756.jpg, 00:00:23, 0.00 m  
Water level, 0% of the vertical dimension

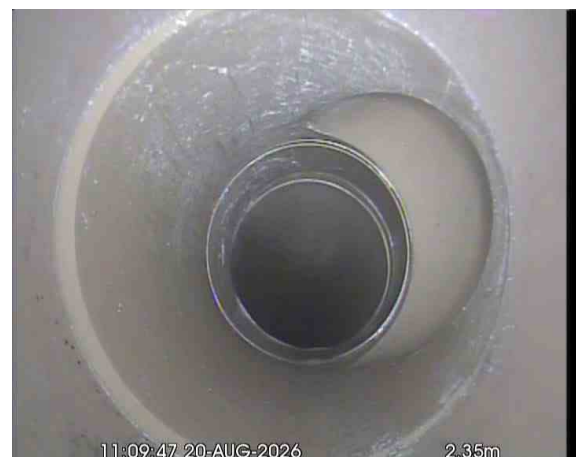
MH19X\_51f7dcac-fc35-4f2e-b122-b16cd6f3f567\_20260917\_173523\_814.jpg, 00:00:48, 2.35 m  
Junction at 3 o'clock, diameter: 110mm, SECTION 26 (S26)

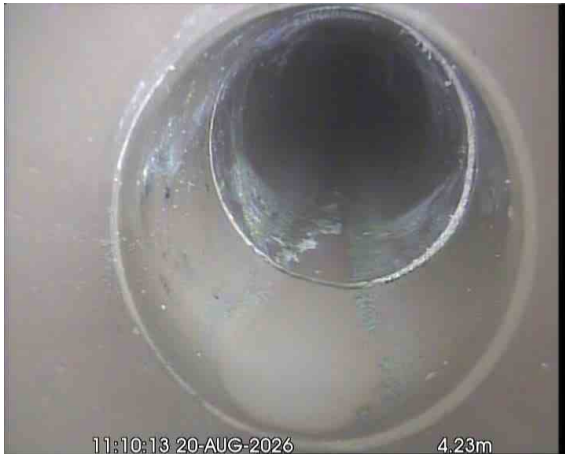
MH19X\_d9462d28-2e68-4964-8066-9cb3c1f9aded\_20260917\_173541\_582.jpg, 00:01:14, 4.23 m  
Line deviates up

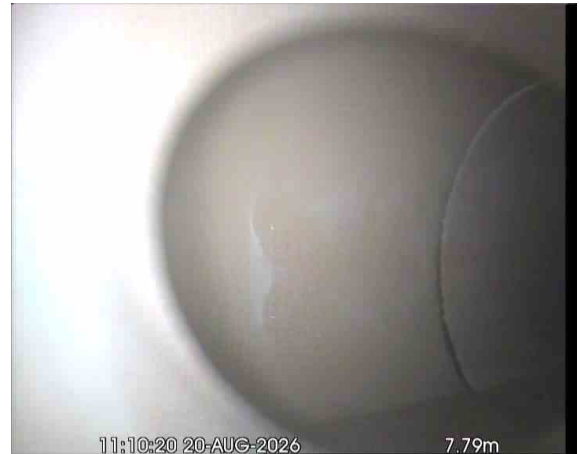
MH19X\_87352554-c3a2-4c3d-886e-ea60928cbe1a\_20260917\_173707\_311.jpg, 00:01:21, 7.79 m  
Finish node, major connection without manhole, reference:  
BLIND JUNCTION - JOINS THE MAIN SEWER, \*\*IN THE ROAD\*\*

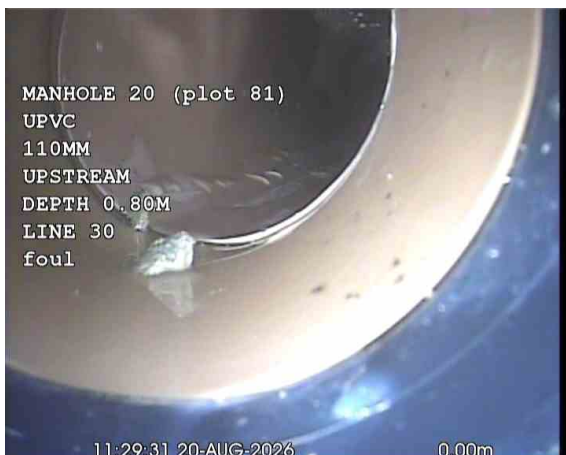
KIT.  
SINKX\_528fc05f-cfd7-4f01-8447-395349a6ec3c\_20260917\_174823\_422.jpg, 00:00:29, 0.00 m  
Start node, manhole, reference: MANHOLE 20 (MH20)

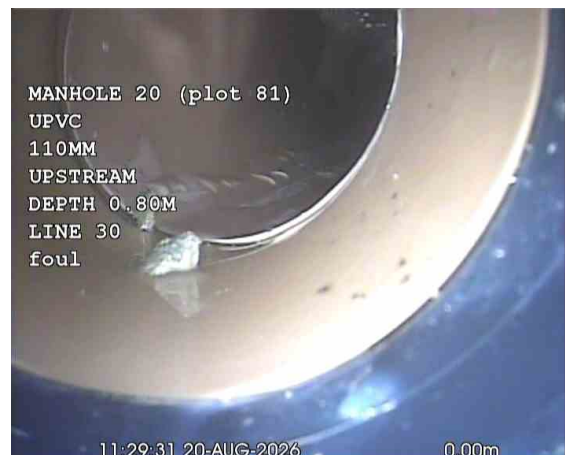
KIT.  
SINKX\_5ecf6fc2-22eb-4db7-b0a2-8486791c2cea\_20260917\_174828\_946.jpg, 00:00:29, 0.00 m  
Water level, 0% of the vertical dimension

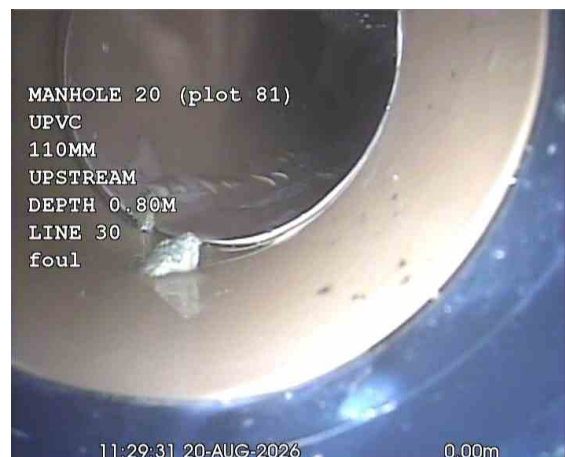
KIT.  
SINKX\_a24192a0-7b26-4fed-8ce3-1a6fc3fda468\_20260917\_174849\_550.jpg, 00:00:29, 0.04 m  
Line deviates right

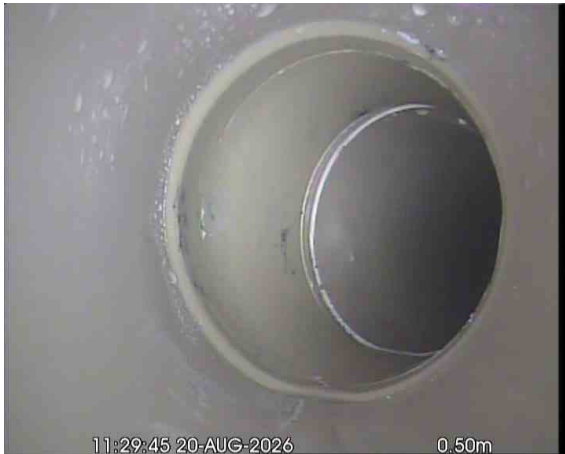
KIT.  
SINKX\_c2e0c532-d8b6-4860-86cf-757afc9b706e\_20260917\_174902\_799.jpg, 00:00:43, 0.50 m  
Line deviates right

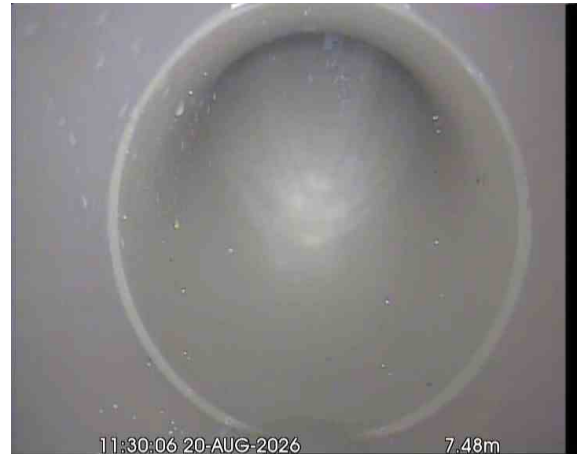
KIT.  
SINKX\_430aaf13-ac28-47e6-9827-aef3607b2ee8\_20260917\_174920\_910.jpg, 00:01:04, 7.48 m  
Line deviates up, REST BEND

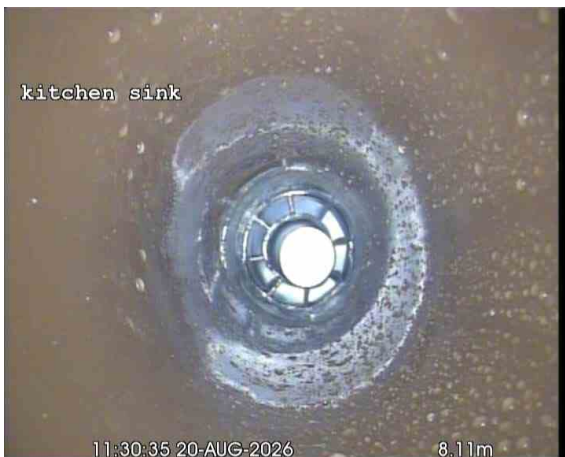
KIT.  
SINKX\_a991a2f0-69f1-4353-b84d-bd3e5162529b\_20260917\_174934\_935.jpg, 00:01:20, 8.11 m  
Finish node, major connection without manhole, reference:  
KITCHEN SINK

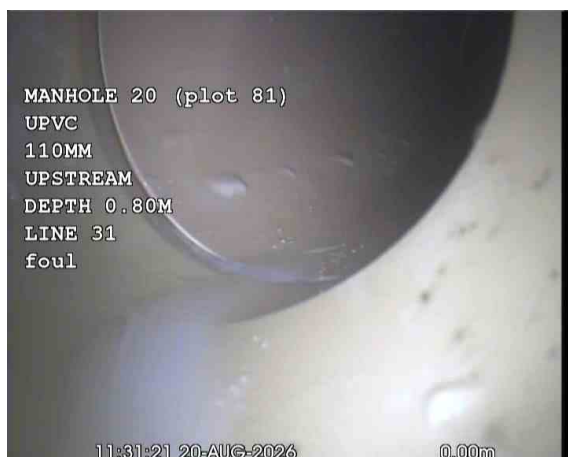
UTIL.  
SINKX\_578b374c-c4ed-4317-960c-69d16578a319\_20260917\_175029\_804.jpg, 00:00:17, 0.00 m  
Start node, manhole, reference: MANHOLE 20 (MH20)

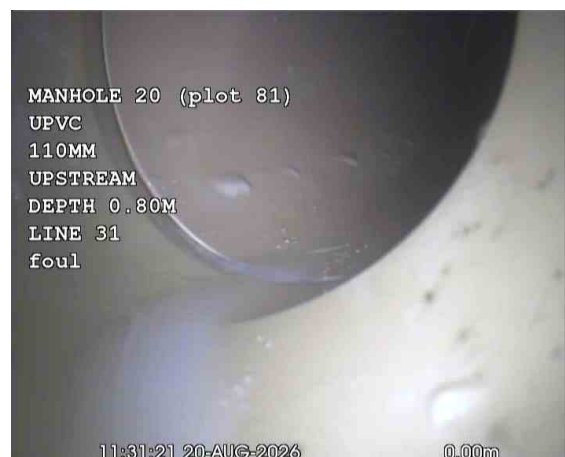
UTIL.  
SINKX\_351ccc9b-b17e-4e52-9f02-1badffc71fc8\_20260917\_175035\_614.jpg, 00:00:17, 0.00 m  
Water level, 0% of the vertical dimension

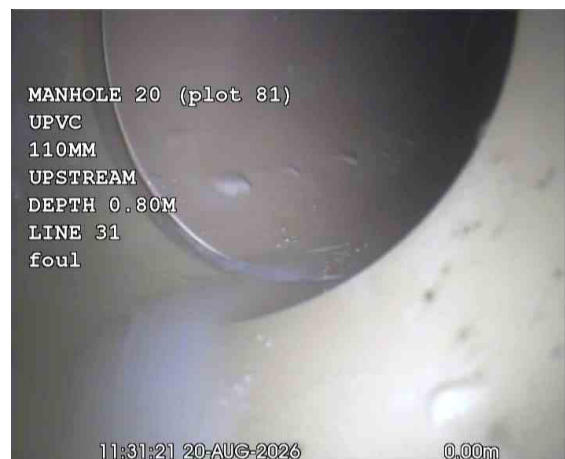
UTIL.  
SINKX\_a89ab534-07bd-46f6-8914-35476aec4773\_20260917\_175051\_502.jpg, 00:00:17, 0.02 m  
Line deviates right

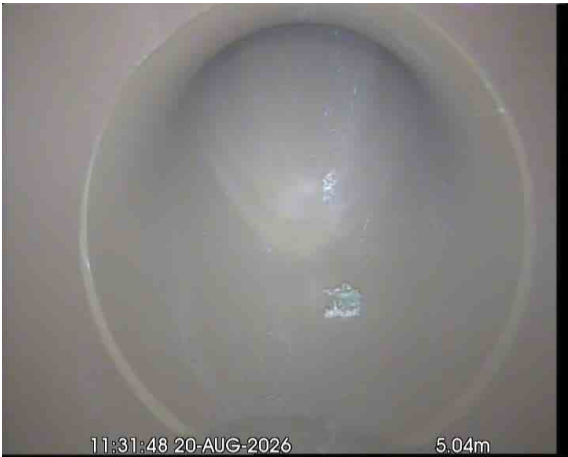
UTIL.  
SINKX\_fb20255c-8285-4bca-80fd-bfd51da69a61\_20260917\_175107\_919.jpg, 00:00:45, 5.04 m  
Line deviates up, REST BEND

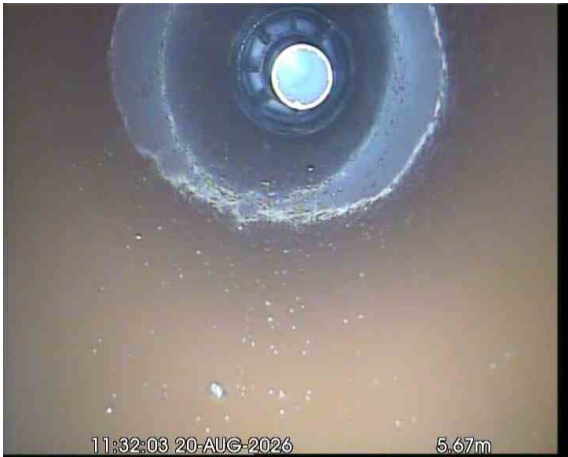
UTIL.  
SINKX\_909ac16d-6327-4b52-9e95-248ba5637d24\_20260917\_175133\_486.jpg, 00:00:59, 5.67 m  
Finish node, major connection without manhole, reference:  
UTILITY SINK
