## **Project**

**Project Name:** Arundel Gate BN18 9EX  
**Project Description:** General CCTV - Condition Check  
**Project Number:** JSD10246  
**Project Status:** Complete  
**Project Date:** 17/09/2026  
**Inspection Standard:** MSCC4 Sewers & Drainage GB (SRM4 Scoring)

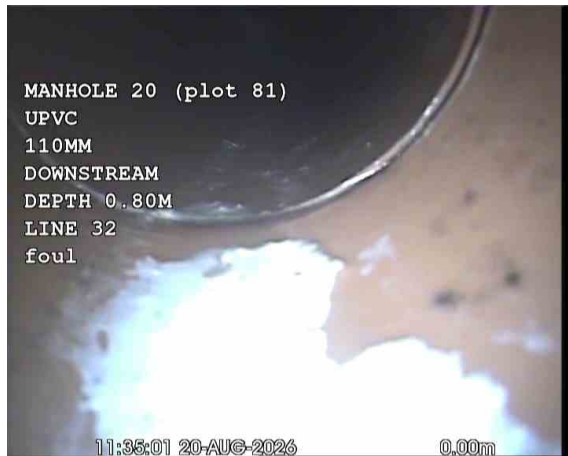
MH20X\_482556e8-18fb-44d2-851f-46a30a011ab4\_20260917\_175228\_858.jpg, 00:00:30, 0.00 m  
Start node, manhole, reference: MANHOLE 20 (MH20)

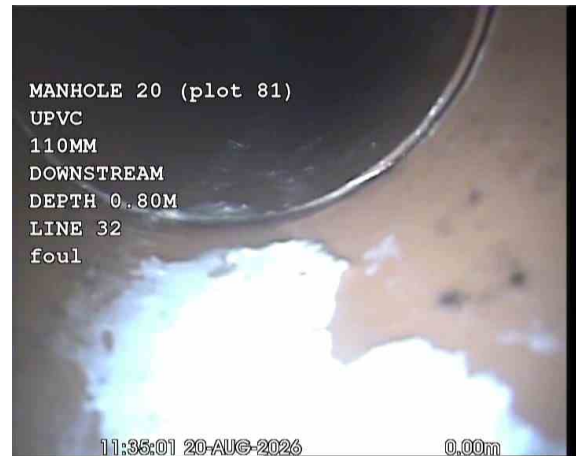
MH20X\_096673fe-1158-46fa-b502-18065a805ed1\_20260917\_175235\_014.jpg, 00:00:30, 0.00 m  
Water level, 0% of the vertical dimension

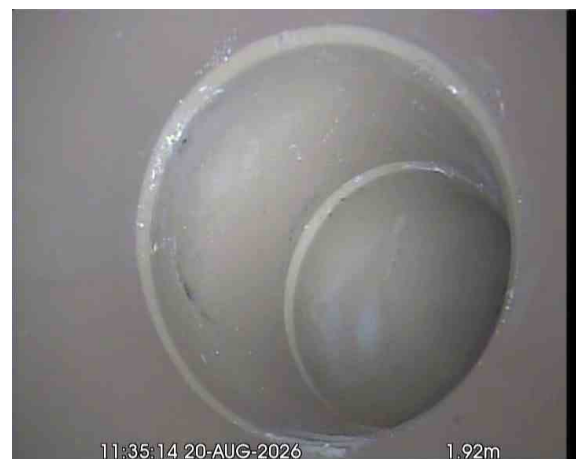
MH20X\_6593b2f0-fa2f-4709-a780-fbc6a0b13676\_20260917\_175258\_119.jpg, 00:00:42, 1.92 m  
Line deviates right

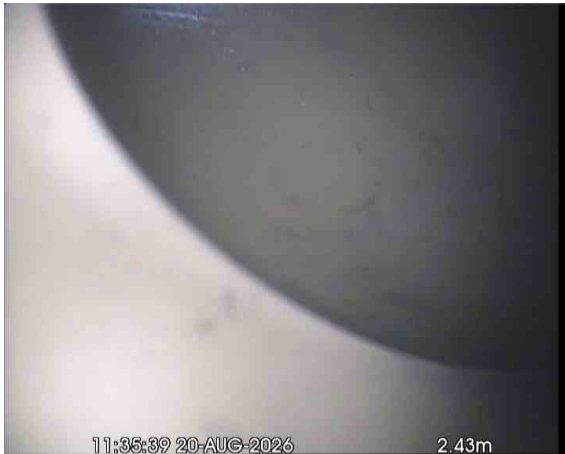
MH20X\_22fc2e3c-949b-437e-b636-60e5af7902cd\_20260917\_175334\_941.jpg, 00:01:07, 2.43 m  
Finish node, major connection without manhole, reference:  
BLIND JUNCTION - JOINS SECTION 36 (S36)

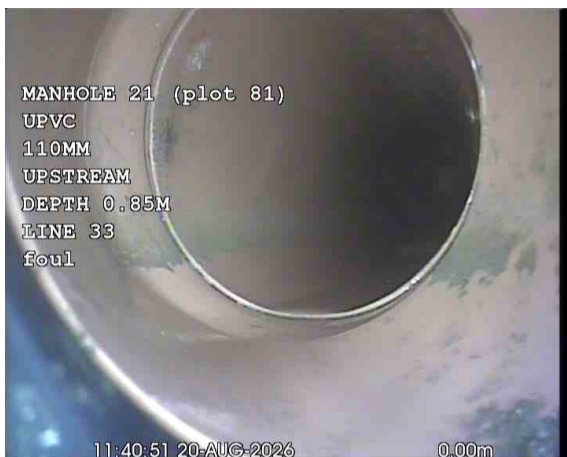
SVPX\_f2157d9c-c9bd-431d-9665-e0a8a52972c7\_20260917\_175442\_091.jpg, 00:00:40, 0.00 m  
Start node, manhole, reference: MANHOLE 21 (MH21)

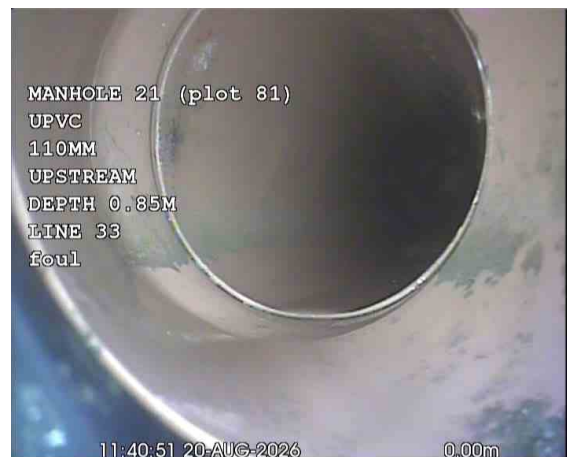
SVPX\_51731c94-efdb-402b-8a96-1aad33777d14\_20260917\_175448\_204.jpg, 00:00:40, 0.00 m  
Water level, 0% of the vertical dimension

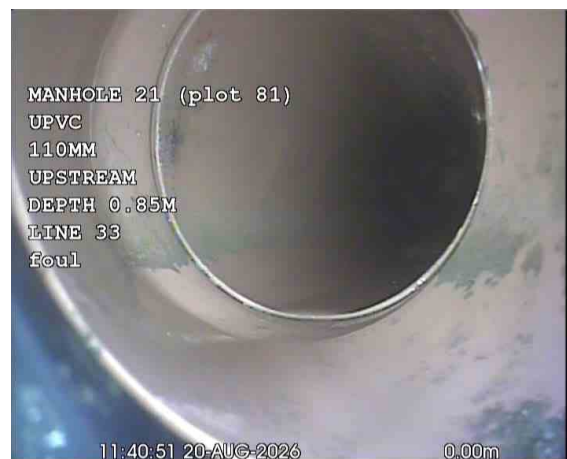
SVPX\_57041f86-0a0d-4010-9a17-935acd425bad\_20260917\_175504\_301.jpg, 00:00:40, 0.04 m  
Line deviates right

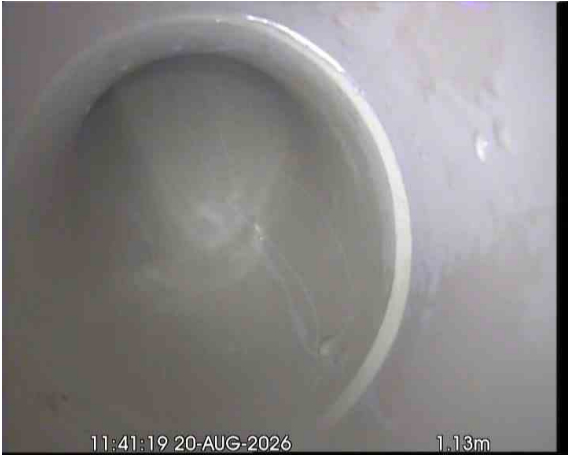
SVPX\_e427ca2a-107a-4ea9-a0da-e44bbd509246\_20260917\_175526\_581.jpg, 00:01:08, 1.13 m  
Line deviates up, REST BEND

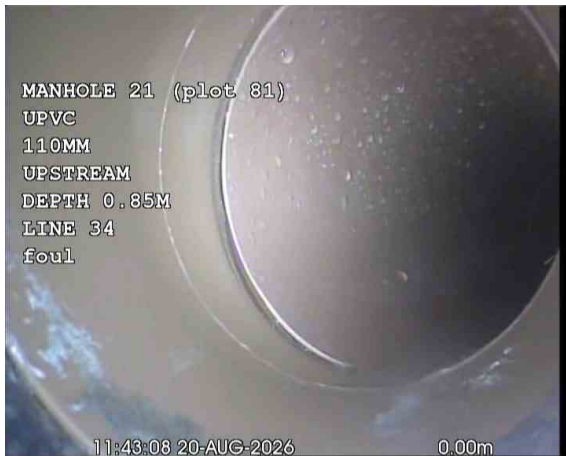
BASINX\_3ce3f895-d02d-466c-8391-f9e368b19190\_20260917\_175733\_165.jpg, 00:00:22, 0.00 m  
Start node, manhole, reference: MANHOLE 21 (MH21)

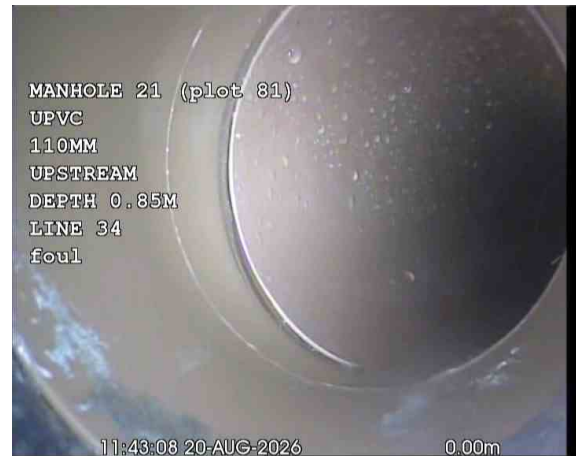
BASINX\_2e006caf-2029-45e4-9114-5515bd78bad2\_20260917\_175739\_095.jpg, 00:00:22, 0.00 m  
Water level, 0% of the vertical dimension

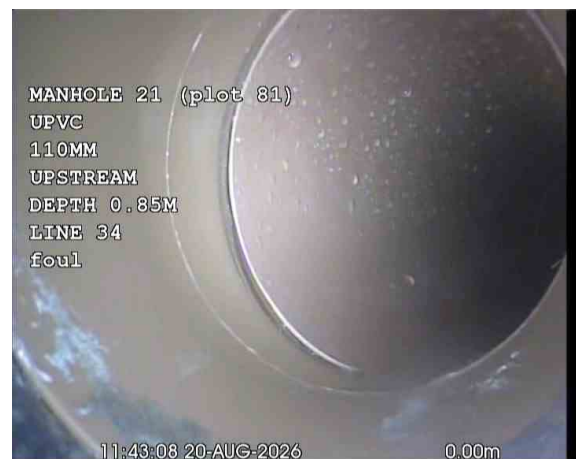
BASINX\_174c6773-1f98-49d0-8a46-bf51393b0f07\_20260917\_175755\_367.jpg, 00:00:22, 0.02 m  
Line deviates right

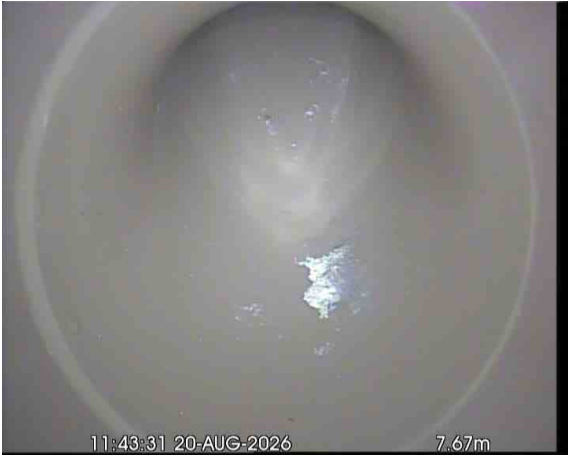
BASINX\_f196327a-540f-41ef-960d-920cd33a2aef\_20260917\_175813\_068.jpg, 00:00:46, 7.67 m  
Line deviates up, REST BEND

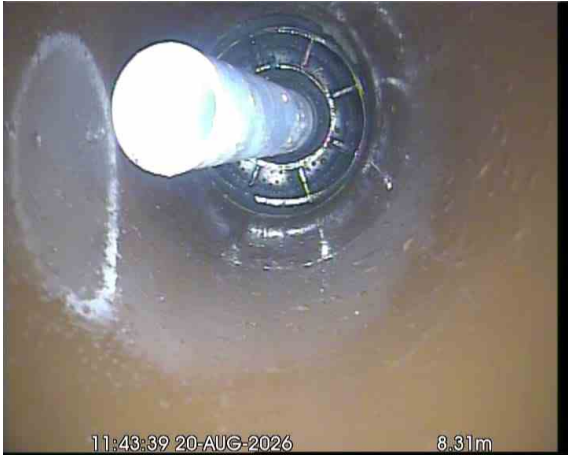
BASINX\_d5c22b29-dda7-4334-9cbb-2a31b3a5bf66\_20260917\_175832\_110.jpg, 00:00:54, 8.31 m  
Finish node, major connection without manhole, reference: BASIN

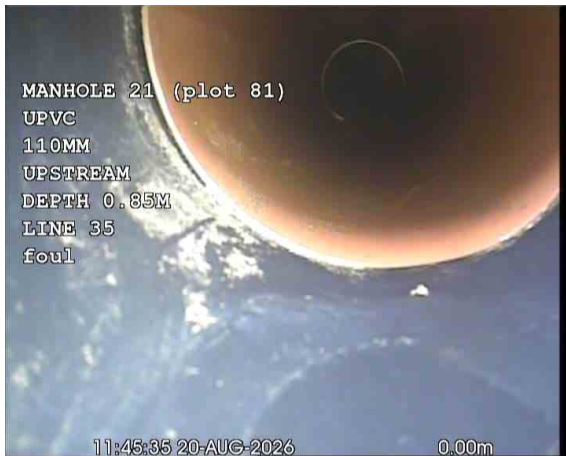
W\_CX\_be5123c8-25b0-4dcb-8499-8a13e69a35a2\_20260917\_181507\_926.jpg, 00:00:20, 0.00 m  
Start node, manhole, reference: MANHOLE 21 (MH21)

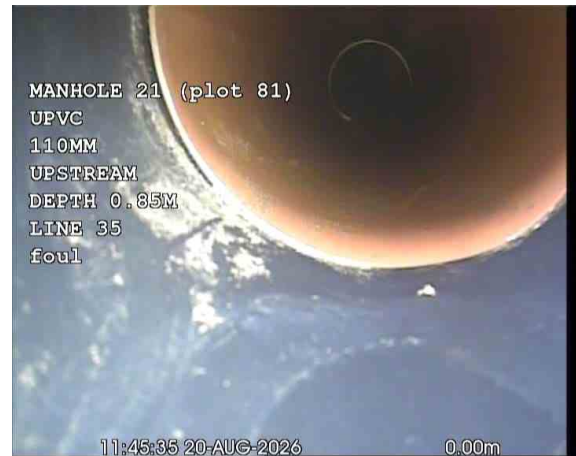
W\_CX\_f8fd93a6-088e-4223-b8ee-2afa1c5f9248\_20260917\_181514\_598.jpg, 00:00:20, 0.00 m  
Water level, 0% of the vertical dimension

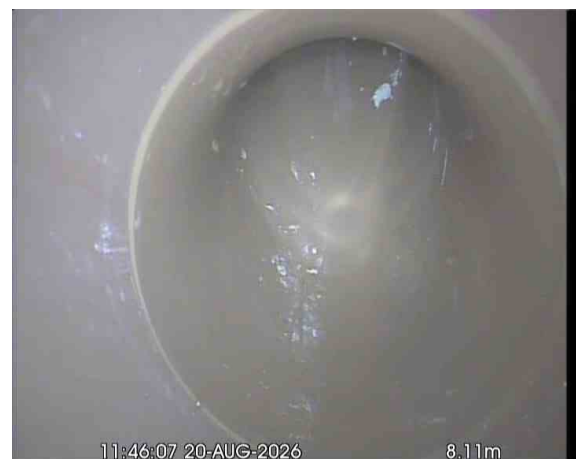
W\_CX\_ce8484da-cb17-481c-b19e-21035f4049d8\_20260917\_181545\_839.jpg, 00:00:51, 8.11 m  
Line deviates up, REST BEND

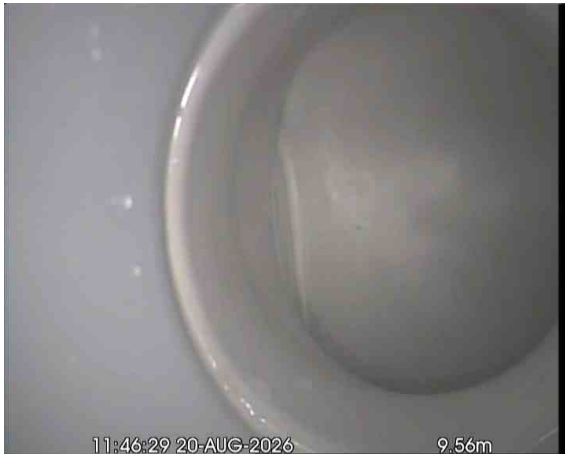
W\_CX\_8a3f1b22-2a49-4017-8aba-8ae3714f2f4b\_20260917\_181939\_173.jpg, 00:01:13, 9.56 m  
Finish node, major connection without manhole, reference:  
W/C

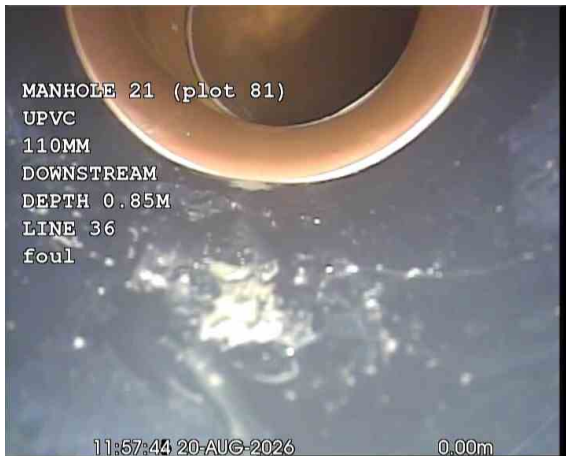
MH21X\_0b6eb6b2-ca5c-4298-8a11-b38a610af9e8\_20260917\_182047\_434.jpg, 00:00:19, 0.00 m  
Start node, manhole, reference: MANHOLE 21 (MH21)

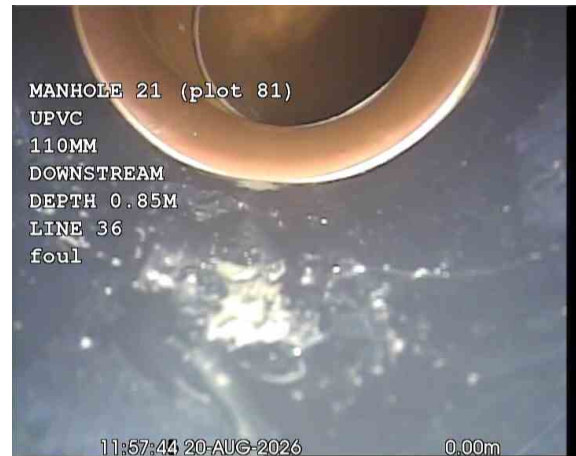
MH21X\_73c4addb-e92a-4a3d-822b-dc93bbd5de51\_20260917\_182053\_350.jpg, 00:00:19, 0.00 m  
Water level, 0% of the vertical dimension

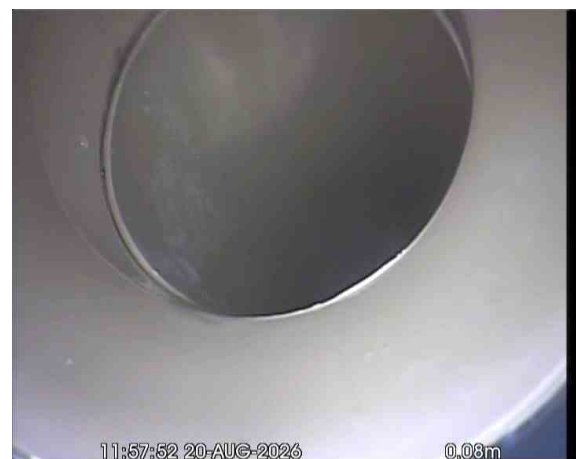
MH21X\_2fe4941a-fc44-4b64-8983-a82f4c9ab2ab\_20260917\_182114\_094.jpg, 00:00:27, 0.08 m  
Line deviates right

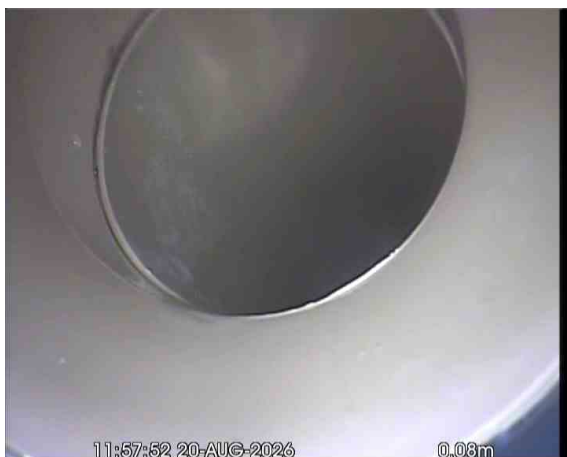
MH21X\_bfb0d036-24df-40eb-af21-87cb0f3fa57b\_20260917\_182120\_268.jpg, 00:00:27, 0.08 m  
Line deviates down

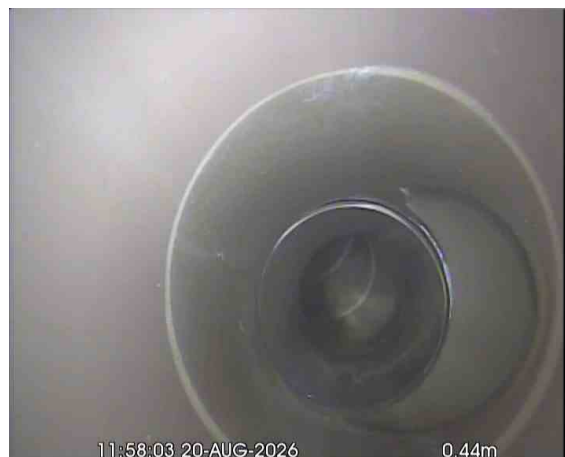
MH21X\_cebf1ea1-56be-48ab-b0b2-7dd4ed90976c\_20260917\_182138\_613.jpg, 00:00:38, 0.44 m  
Junction at 3 o'clock, diameter: 110mm, SECTION 32 (S32)

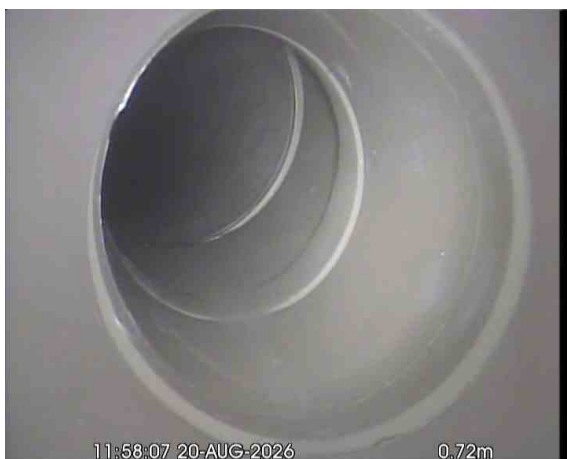
MH21X\_ce07fb07-ef41-4933-8686-be1d1c120c07\_20260917\_182149\_746.jpg, 00:00:42, 0.72 m  
Line deviates left

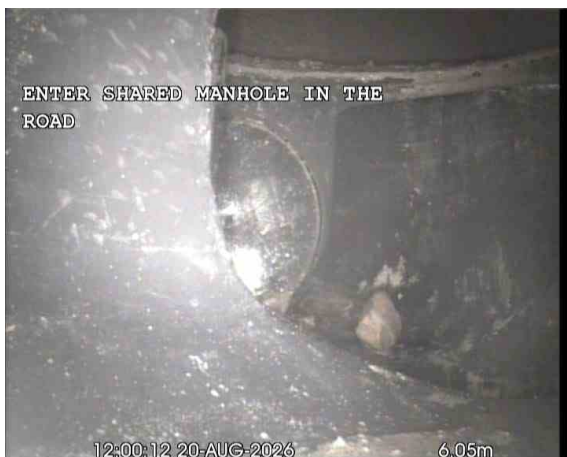
MH21X\_c0bd32aa-588a-4742-b5bb-a079044af88d\_20260917\_182236\_740.jpg, 00:01:16, 6.05 m  
Finish node, manhole, reference: SHARED MANHOLE IN THE ROAD, (F5)

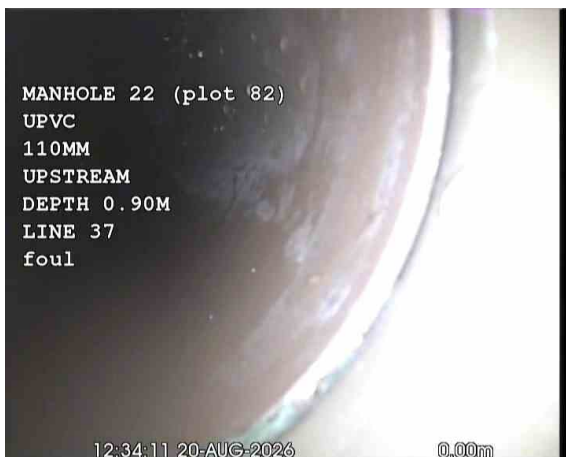
SVPX\_329580d6-76e8-42e0-b84f-8c142b0f265b\_20260917\_182810\_838.jpg, 00:00:37, 0.00 m  
Start node, manhole, reference: MANHOLE 22 (MH22)

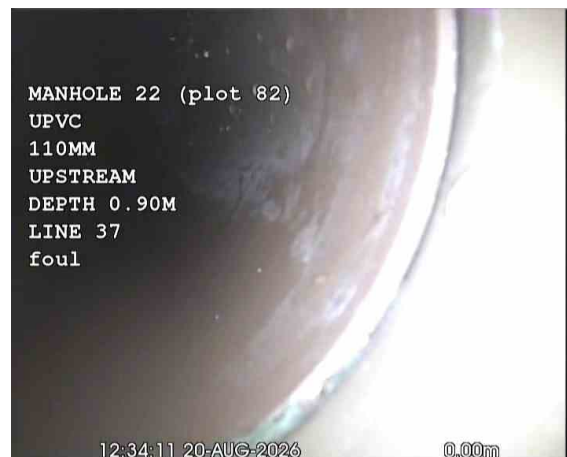
SVPX\_5dea739b-2eb7-4fc6-bfec-fad8ede82eae\_20260917\_182817\_103.jpg, 00:00:37, 0.00 m  
Water level, 0% of the vertical dimension

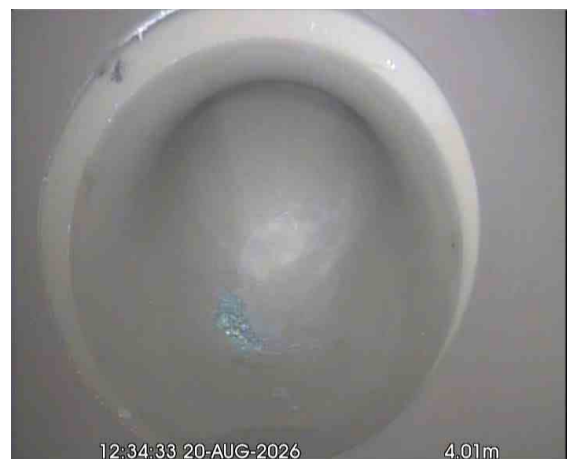
SVPX\_12d30369-315d-4c96-89d5-d91a2ed2c29e\_20260917\_182841\_615.jpg, 00:00:59, 4.01 m  
Line deviates up, REST BEND

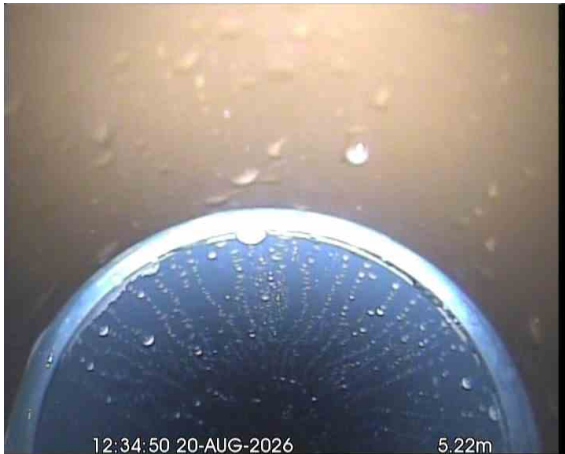
SVPX\_46319a34-a3a0-409f-907d-0f52cc14f5f9\_20260917\_18  
2858\_904.jpg, 00:01:16, 5.22 m  
Finish node, major connection without manhole, reference:  
SOIL VENT PIPE (SVP)

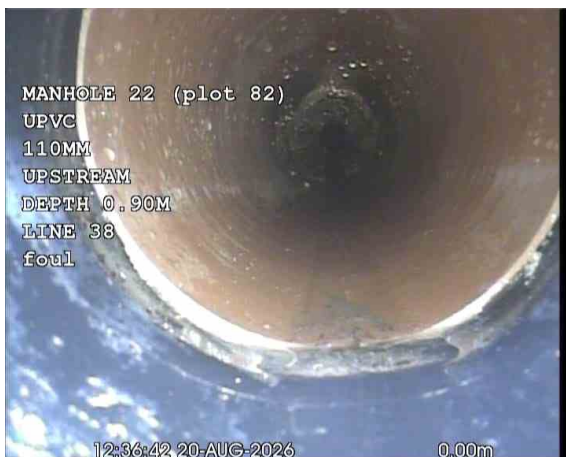
SVPX\_dcb35af0-f88e-4edc-8a4a-27670d7f09f6\_20260917\_182951\_340.jpg, 00:00:15, 0.00 m  
Start node, manhole, reference: MANHOLE 22 (MH22)

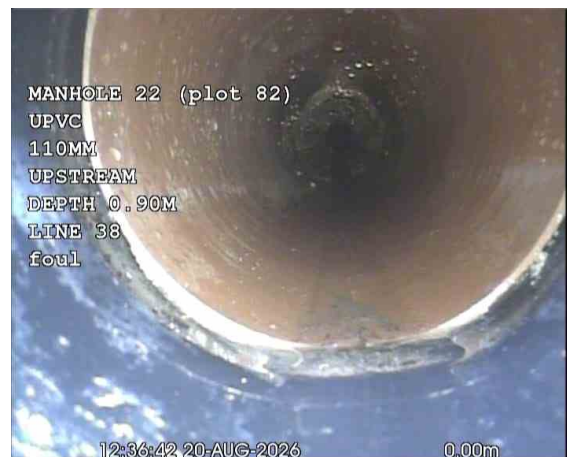
SVPX\_42910abf-b3e8-4d00-8c7a-8bd7cd52181b\_20260917\_182957\_373.jpg, 00:00:15, 0.00 m  
Water level, 0% of the vertical dimension

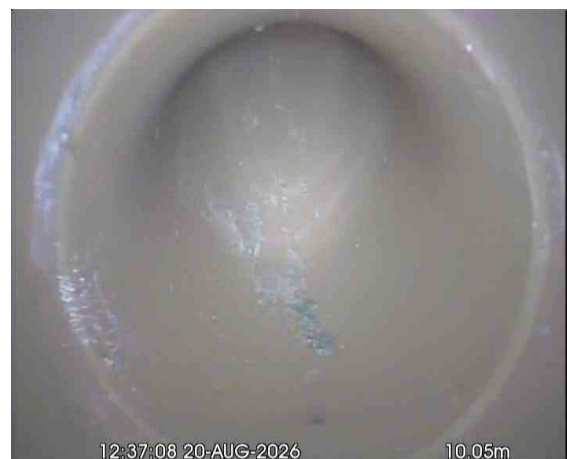
SVPX\_ef59d4fd-517b-400d-a653-1d437e89bdcd\_20260917\_183028\_478.jpg, 00:00:41, 10.05 m  
Line deviates up, REST BEND

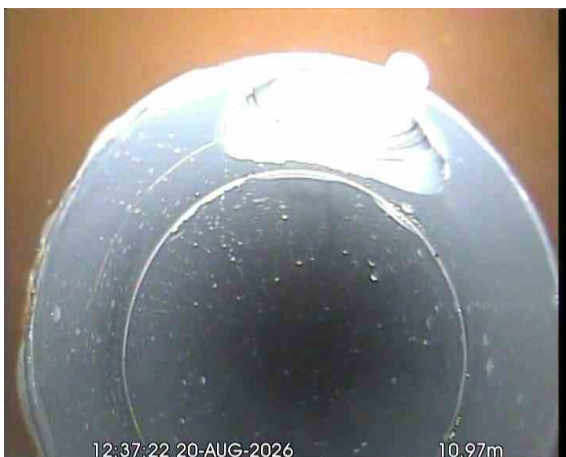
SVPX\_b6792ff5-d783-440f-8d3e-0b9a229c4107\_20260917\_1  
83047\_654.jpg, 00:00:56, 10.97 m  
Finish node, major connection without manhole, reference:  
SOIL VENT PIPE (SVP) & KITCHEN SINK

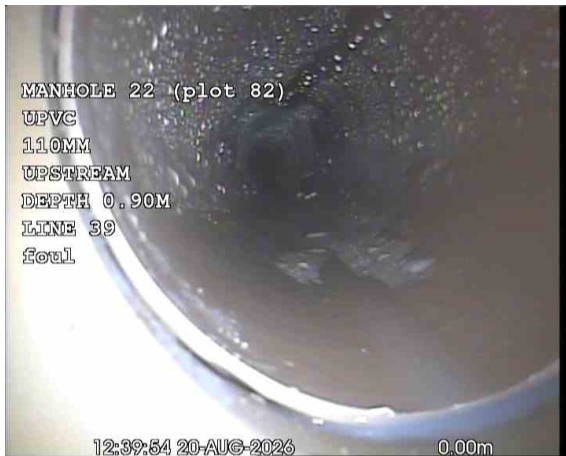
OFFX\_20e8ba16-9d9c-4d8b-ba17-63bde864a98d\_20260917\_183137\_059.jpg, 00:00:26, 0.00 m  
Start node, manhole, reference: MANHOLE 22 (MH22)

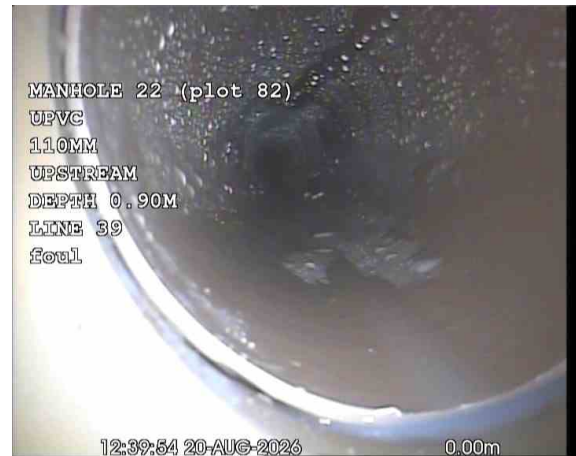
OFFX\_2db4d5c6-3898-4e45-b25e-ff1e09936923\_20260917\_183143\_655.jpg, 00:00:26, 0.00 m  
Water level, 0% of the vertical dimension

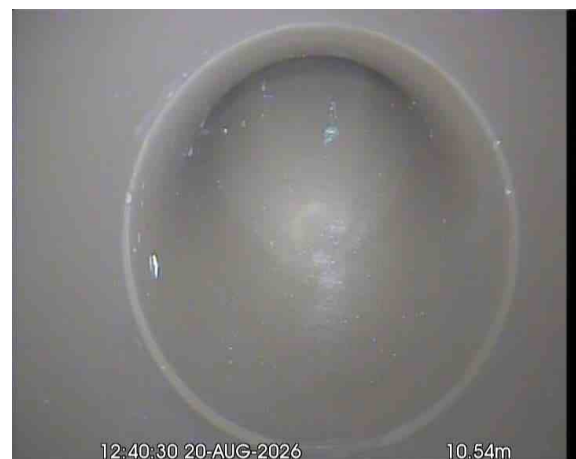
OFFX\_930dcd95-2313-4427-ba33-1913847b7a7c\_20260917\_183210\_005.jpg, 00:01:02, 10.54 m  
Line deviates up, REST BEND

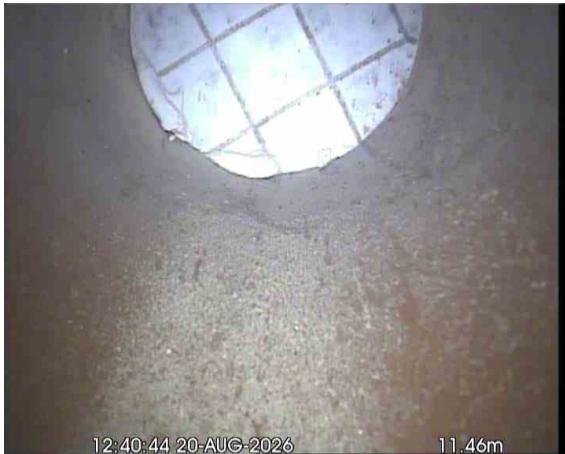
CAPPED  
OFFX\_255ad10c-a065-4f7c-8bd6-a084082c8849\_20260917\_  
183236\_568.jpg, 00:01:15, 11.46 m  
Survey abandoned, S/A - CAPPED OFF (WET ROOM)

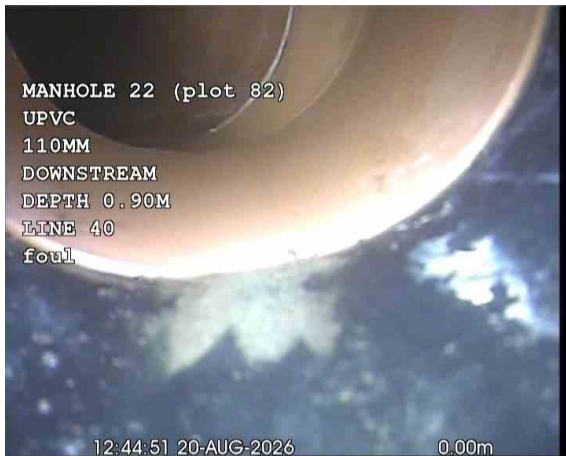
MH22X\_06481b2a-6201-4c44-bc15-0ddffc2c6d1e\_20260917\_183341\_955.jpg, 00:00:21, 0.00 m  
Start node, manhole, reference: MANHOLE 22 (MH22)

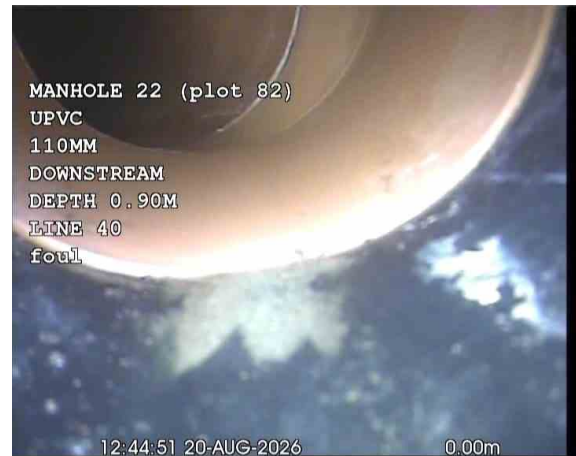
MH22X\_a1089d2b-631c-4adb-bb2a-21b3685dcbae\_20260917\_183348\_003.jpg, 00:00:21, 0.00 m  
Water level, 0% of the vertical dimension

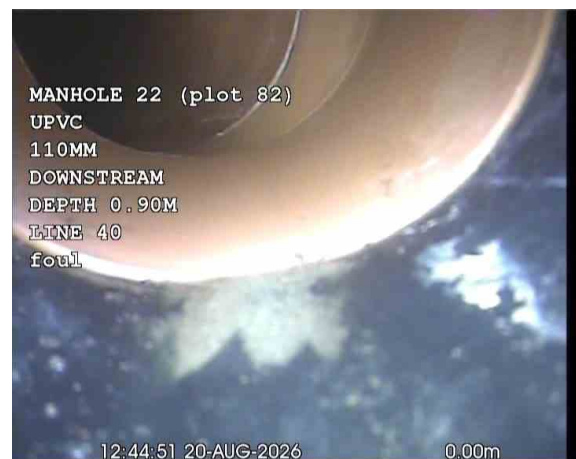
MH22X\_f5ae5fa1-ae77-4747-8222-07acbb627a25\_20260917\_183402\_166.jpg, 00:00:21, 0.02 m  
Line deviates left

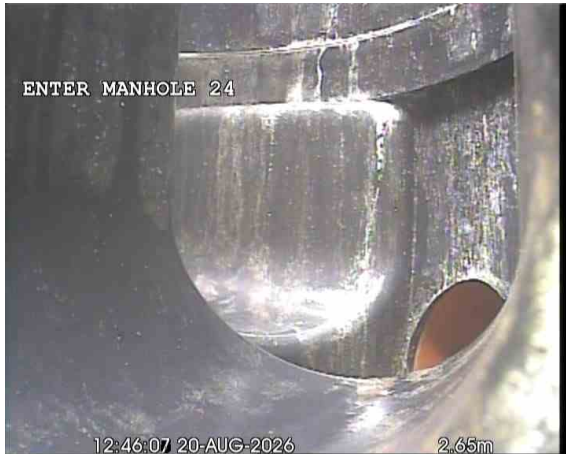
MH22X\_8cd74f19-8277-4e4d-83bd-138bf5822d97\_20260917  
\_183423\_899.jpg, 00:00:53, 2.65 m  
Finish node, manhole, reference: MANHOLE 24 (MH24)

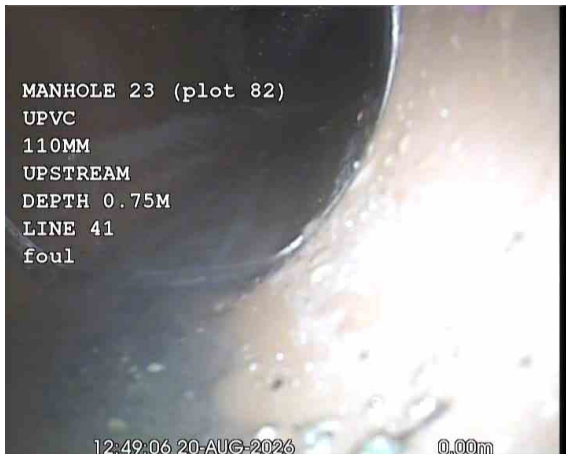
UTIL.  
SINKX\_a1e3df06-70ba-4eaf-a188-2cd1ce9911b1\_20260917\_183529\_173.jpg, 00:00:24, 0.00 m  
Start node, manhole, reference: MANHOLE 23 (MH23)

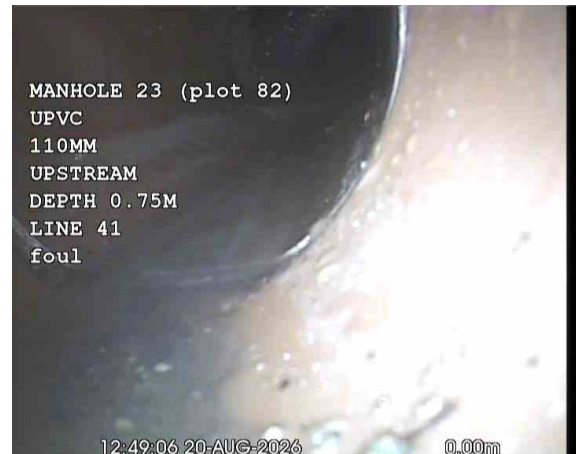
UTIL.  
SINKX\_483d4967-86d1-467b-ac14-0623c15e0530\_20260917\_183535\_295.jpg, 00:00:24, 0.00 m  
Water level, 0% of the vertical dimension

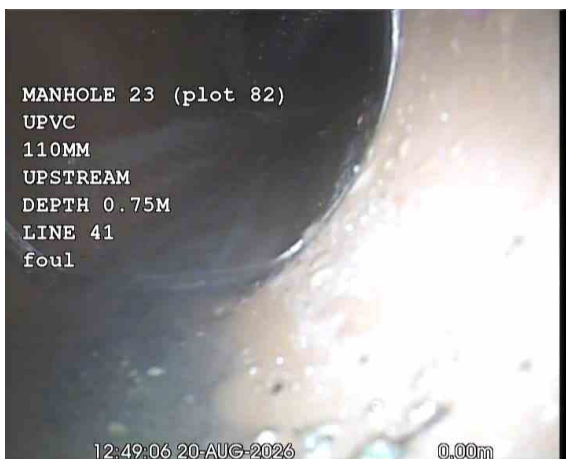
UTIL.  
SINKX\_1c582c71-aebc-4209-a128-abc77785e6b8\_20260917\_183540\_981.jpg, 00:00:24, 0.02 m  
Line deviates right

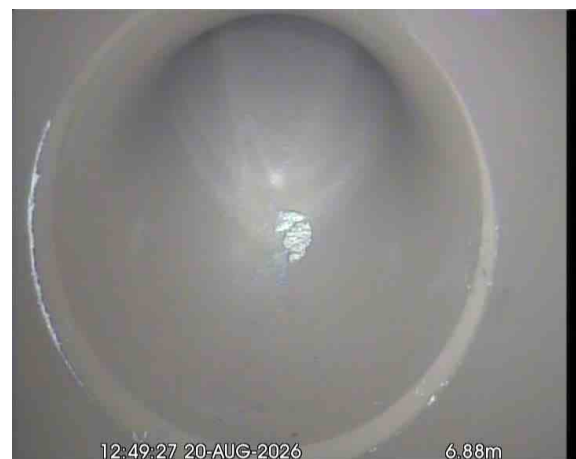
UTIL.  
SINKX\_394e542c-b4db-432c-b100-f1df7faa1ed8\_20260917\_183603\_212.jpg, 00:00:45, 6.88 m  
Line deviates up, REST BEND

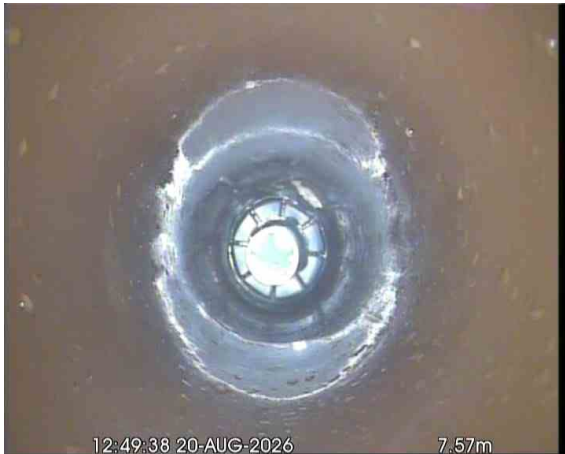
UTIL.  
SINKX\_5eb17ff4-8e15-430f-99b7-09ab9bb8bff4\_20260917\_1  
83617\_367.jpg, 00:00:56, 7.57 m  
Finish node, major connection without manhole, reference:  
UTILITY SINK

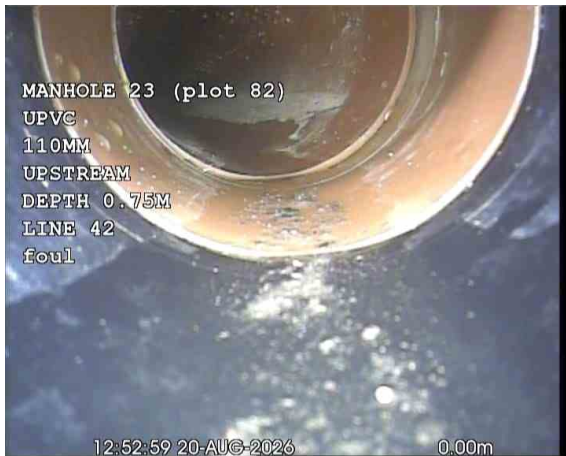
SVPX\_158096e1-881e-4ce5-9f80-a11f19a6f17d\_20260917\_183711\_515.jpg, 00:00:29, 0.00 m  
Start node, manhole, reference: MANHOLE 23 (MH23)

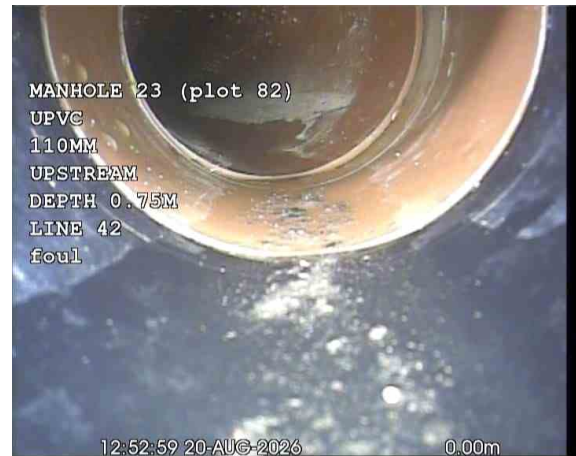
SVPX\_ea48cf4c-2d03-450d-9455-21e902552caa\_20260917\_183717\_262.jpg, 00:00:29, 0.00 m  
Water level, 0% of the vertical dimension

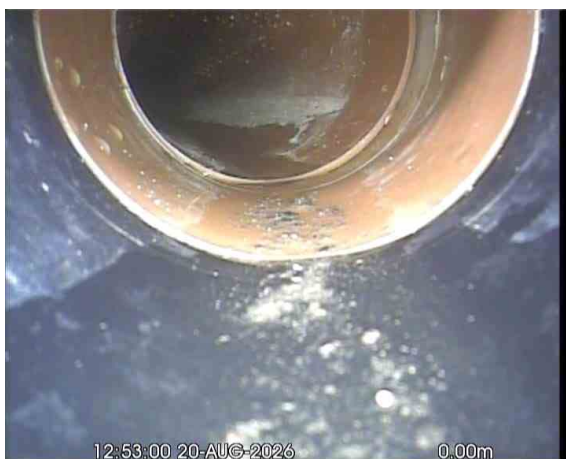
SVPX\_17640d32-d379-4e05-baac-137395ff5db9\_20260917\_183733\_366.jpg, 00:00:30, 0.02 m  
Line deviates left

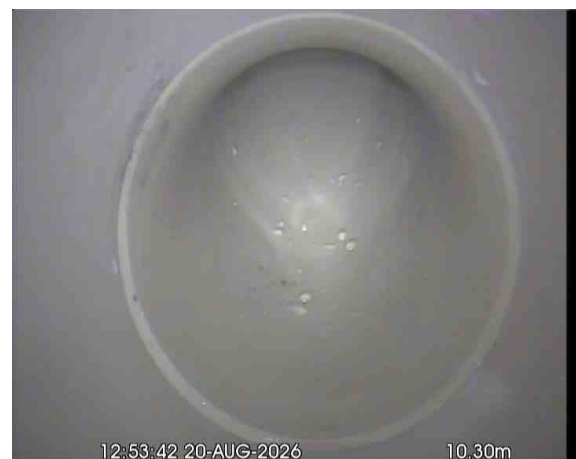
SVPX\_c6a3b36b-720f-453a-9592-58dc0503e30a\_20260917\_183749\_790.jpg, 00:01:13, 10.30 m  
Line deviates up, REST BEND

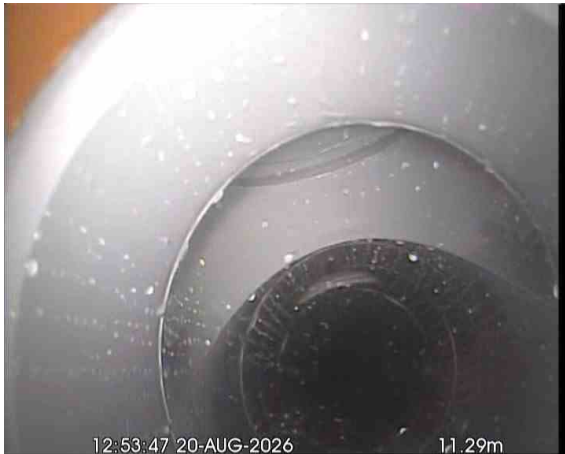
SVPX\_8739bc12-8db7-4748-9f13-90ce074fef2f\_20260917\_18  
3807\_923.jpg, 00:01:17, 11.29 m

Finish node, major connection without manhole, reference:  
SOIL VENT PIPE (SVP) & DOWNSTAIRS W/C

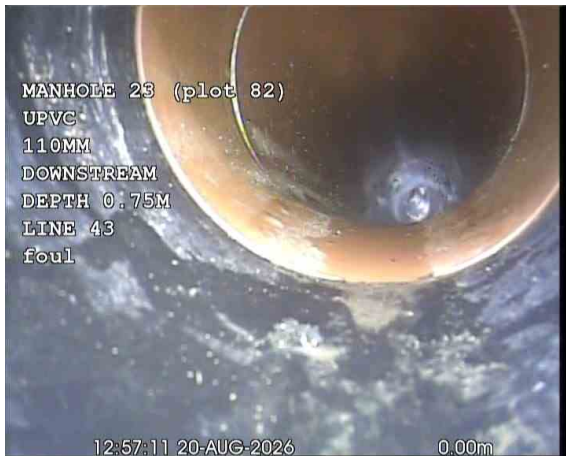
MH23X\_2e07efe7-02fa-4850-b759-3bf05391faf\_20260917\_183910\_280.jpg, 00:00:18, 0.00 m  
Start node, manhole, reference: MANHOLE 23 (MH23)

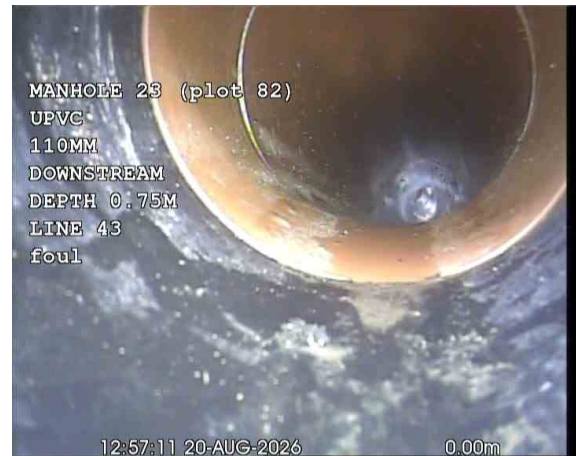
MH23X\_a67011ff-f958-4f51-9321-722ac6d27860\_20260917\_183916\_123.jpg, 00:00:18, 0.00 m  
Water level, 0% of the vertical dimension

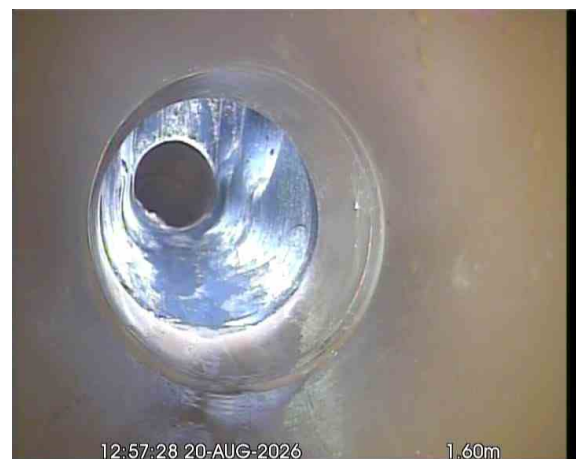
MH23X\_c7c7f22a-c364-419f-9ab4-912108abca88\_20260917\_183936\_624.jpg, 00:00:35, 1.60 m  
Line deviates left

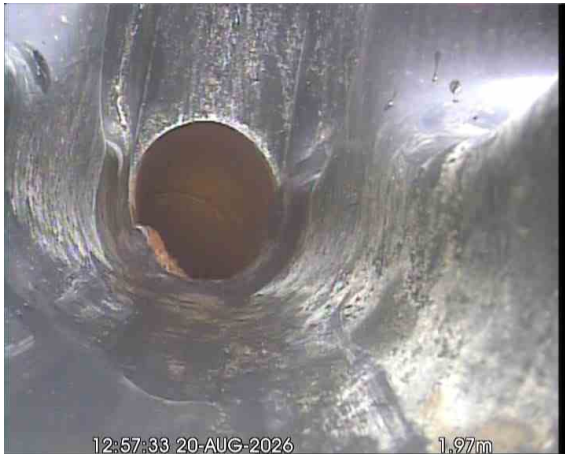
MH23X\_baf5f801-a90a-40e8-86f9-ae2985d85f30\_20260917\_183955\_093.jpg, 00:00:41, 1.97 m  
Finish node, manhole, reference: MANHOLE 24 (MH24)

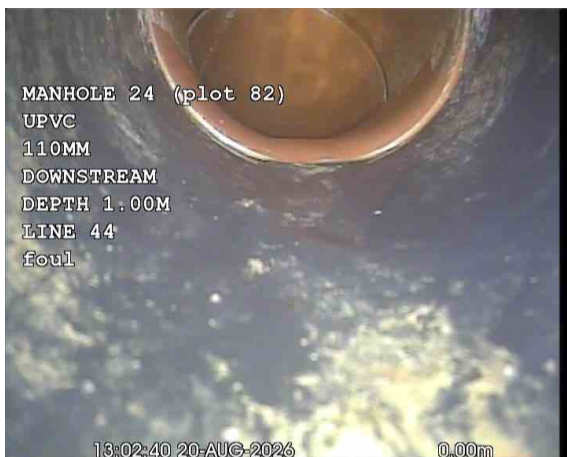
MH24X\_74176b70-0352-48b6-8c17-b7cb16e8dd27\_20260917\_184100\_499.jpg, 00:00:18, 0.00 m  
Start node, manhole, reference: MANHOLE 24 (MH24)

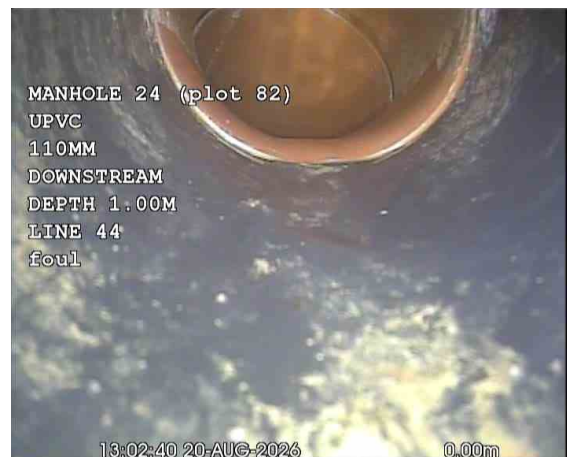
MH24X\_bf3dfde6-f6f3-45f9-9d91-0c7447c9717e\_20260917\_184106\_030.jpg, 00:00:18, 0.00 m  
Water level, 0% of the vertical dimension

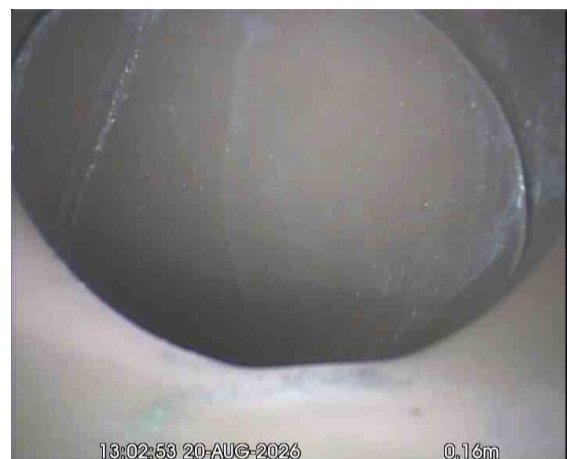
MH24X\_ae460999-0313-493a-80ae-bbafb8359510\_20260917\_184123\_673.jpg, 00:00:30, 0.16 m  
Line deviates down

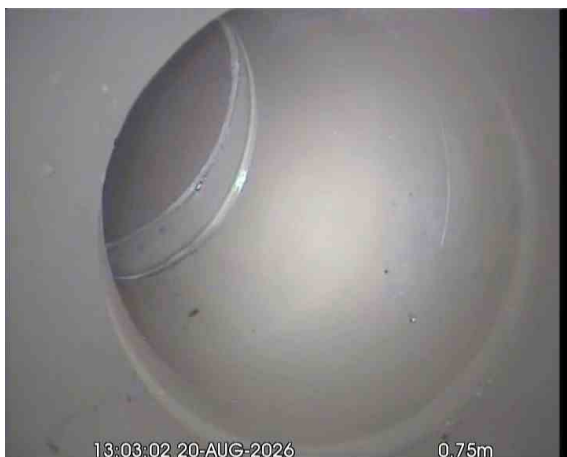
MH24X\_e51a6242-5226-4a44-904b-1452dcda3dea\_20260917\_184139\_287.jpg, 00:00:39, 0.75 m  
Line deviates left

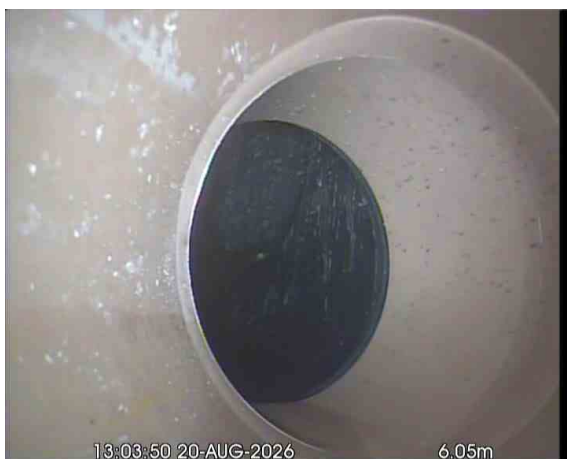
MH24X\_05513c93-b7d8-4673-ac1b-77e9709ec39b\_20260917\_184206\_762.jpg, 00:01:22, 6.05 m  
Line deviates left

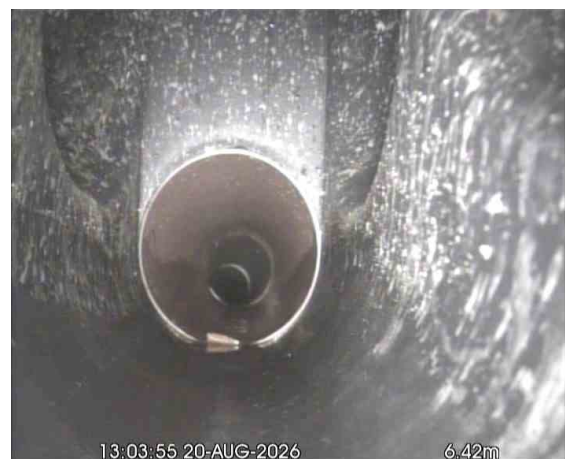
MH24X\_9b2ca61f-d6e0-4dee-b5b2-998733174fa9\_20260917\_184230\_765.jpg, 00:01:28, 6.42 m  
Finish node, manhole, reference: MANHOLE 9 (MH9), (F32)

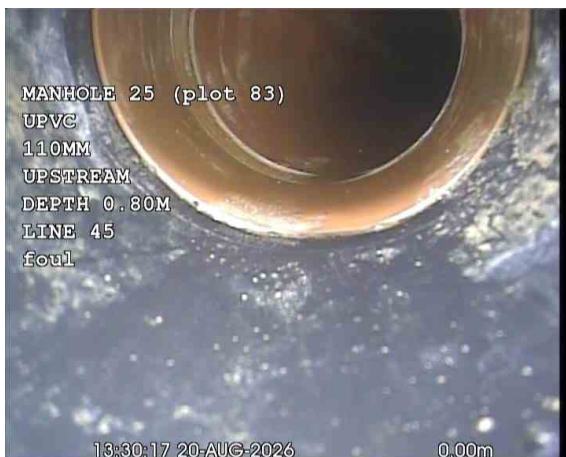
SVPX\_36deb4c8-1776-4594-b344-04a343cba3c0\_20260917\_184559\_771.jpg, 00:00:30, 0.00 m  
Start node, manhole, reference: MANHOLE 25 (MH25)

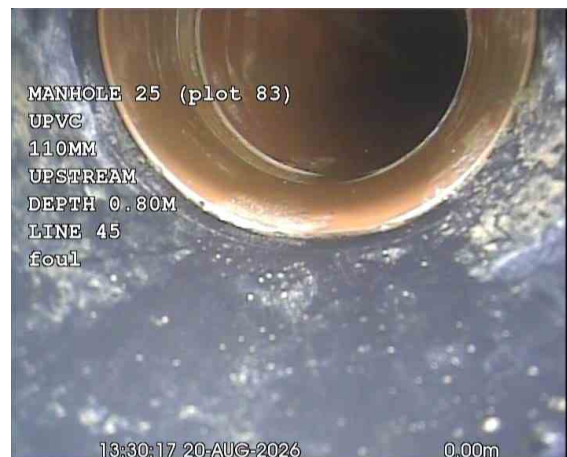
SVPX\_bd56442d-907a-414e-9b62-72023c73e00d\_20260917\_184605\_661.jpg, 00:00:30, 0.00 m  
Water level, 0% of the vertical dimension

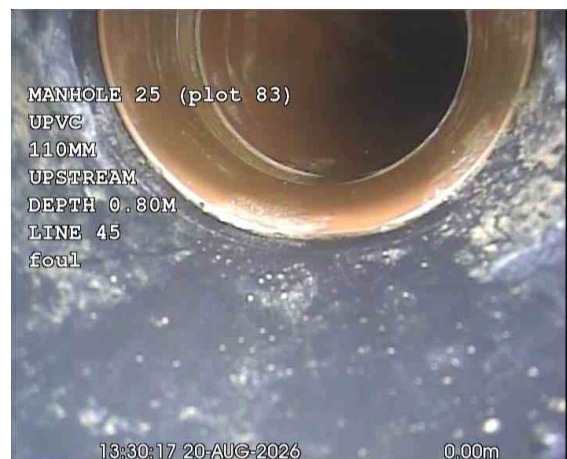
SVPX\_2a61e4e4-b748-43a6-859b-07c19e03c5cd\_20260917\_184618\_523.jpg, 00:00:30, 0.02 m  
Line deviates right

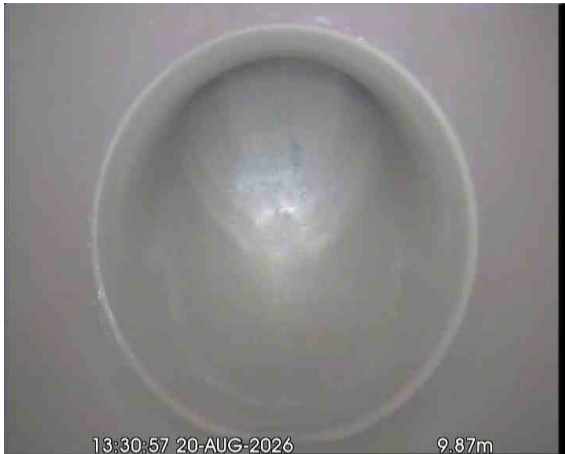
SVPX\_756a6aed-3973-4003-ae3d-e4813c50bb8d\_20260917\_184639\_991.jpg, 00:01:10, 9.87 m  
Line deviates up, REST BEND

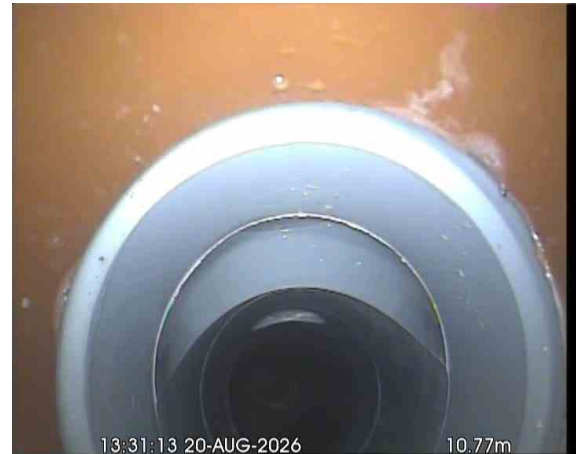
SVPX\_06741d48-459e-47d2-b25c-0dd297d9ba21\_20260917\_184703\_127.jpg, 00:01:27, 10.77 m  
Finish node, major connection without manhole, reference: SOIL VENT PIPE (SVP) & DOWNSTAIRS W/C

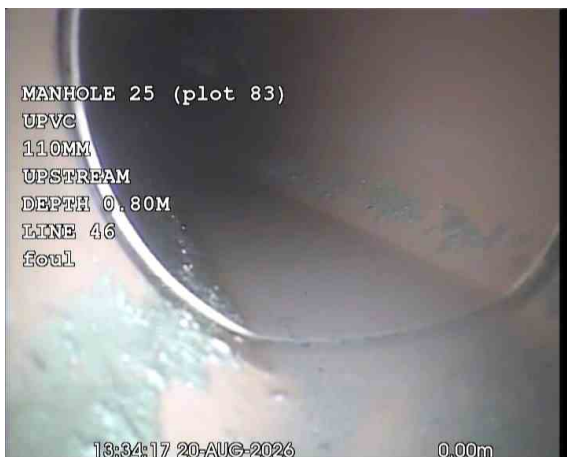
UTIL.

SINKX\_fd529d31-0512-4d0d-bae0-29b0a360c8f5\_20260917\_184754\_694.jpg, 00:00:18, 0.00 m  
Start node, manhole, reference: MANHOLE 25 (MH25)

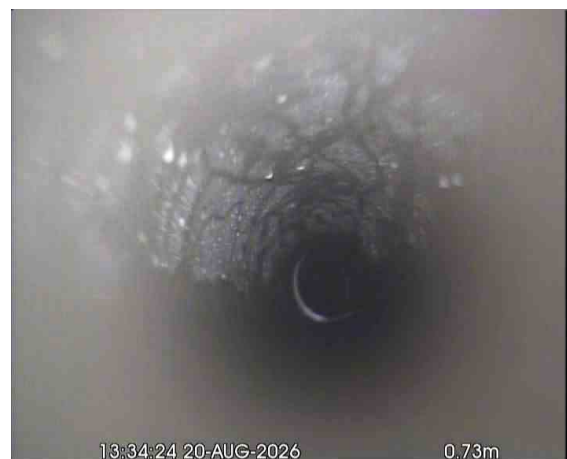
UTIL.

SINKX\_296475b1-2423-4c63-86a9-c1fda327500d\_20260917\_184823\_974.jpg, 00:00:25, 0.73 m  
Water level, 0% of the vertical dimension

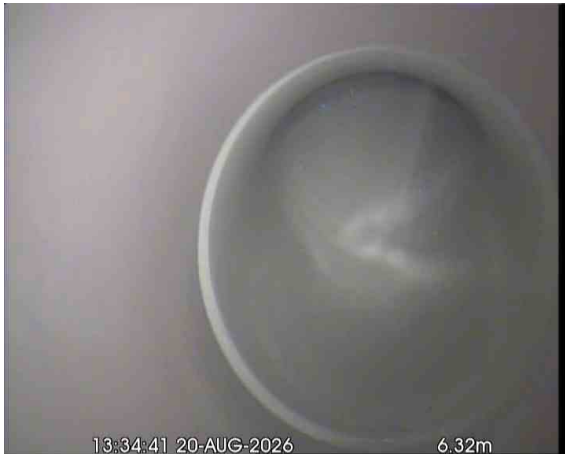
UTIL.  
SINKX\_a5ffe22-e254-4a21-9083-55167c9d769c\_20260917\_184857\_865.jpg, 00:00:42, 6.32 m  
Line deviates up, REST BEND

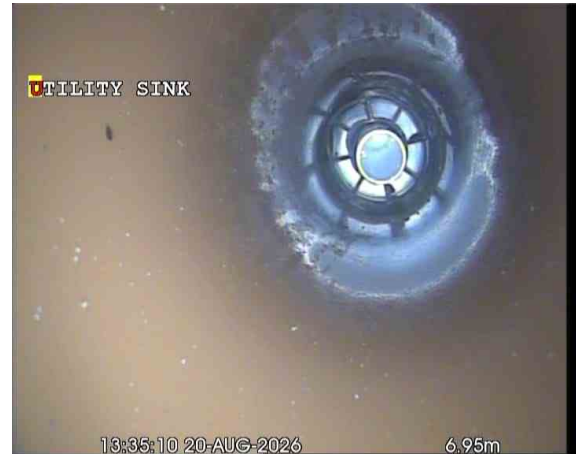
UTIL.  
SINKX\_807faf6-cd62-4a82-90a6-a00f5bb74c68\_20260917\_184837\_968.jpg, 00:00:58, 6.95 m  
Finish node, major connection without manhole, reference:  
UTILITY SINK

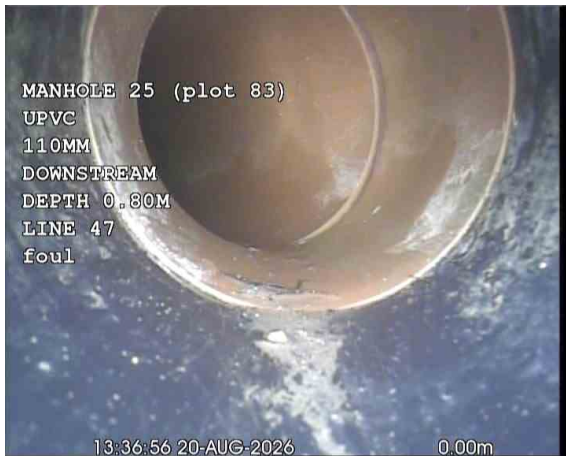
MH25X\_ad981f67-90cc-45bc-a8a3-6a0eda50f06e\_20260917\_184954\_605.jpg, 00:00:18, 0.00 m  
Start node, manhole, reference: MANHOLE 25 (MH25)

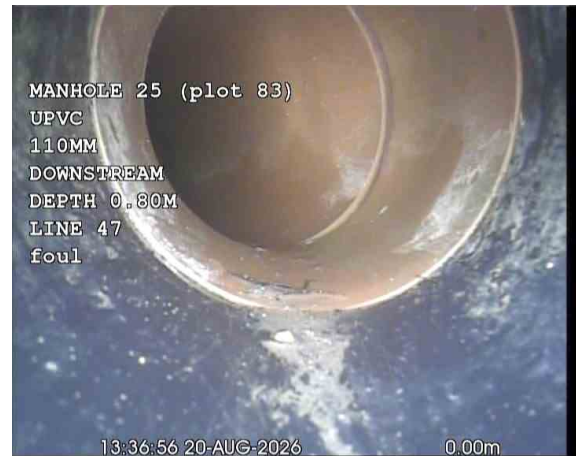
MH25X\_750e8ebd-6274-4fdd-9e72-59e255fd5b7b\_20260917\_185000\_927.jpg, 00:00:18, 0.00 m  
Water level, 0% of the vertical dimension

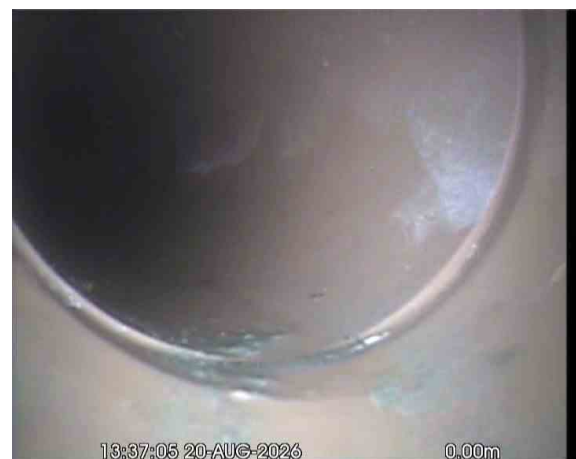
MH25X\_bb028413-274f-412d-8ed7-1395f1435ce7\_20260917\_185029\_539.jpg, 00:00:27, 0.04 m  
Line deviates left

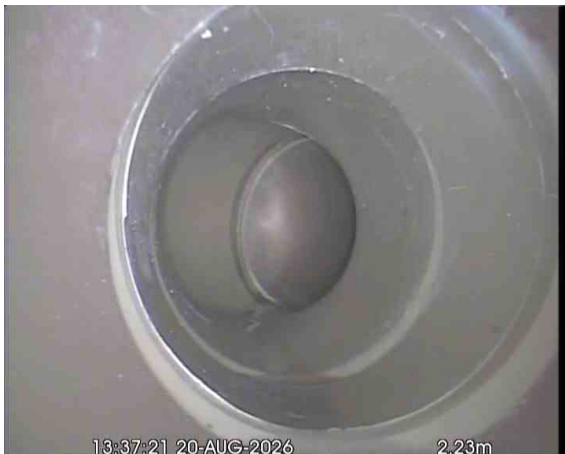
MH25X\_0633491a-78ff-4ad8-9e9c-8e7e21fadc38\_20260917\_185042\_809.jpg, 00:00:43, 2.23 m  
Line deviates left

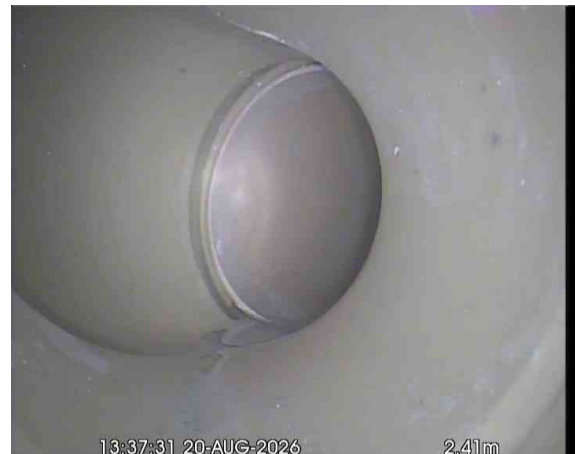
MH25X\_5cc29811-30cf-4776-b1e2-48c33b9716a4\_20260917\_185118\_701.jpg, 00:00:52, 2.41 m  
Finish node, major connection without manhole, reference:  
BLIND JUNCTION - JOINS SECTION 50 (S50)

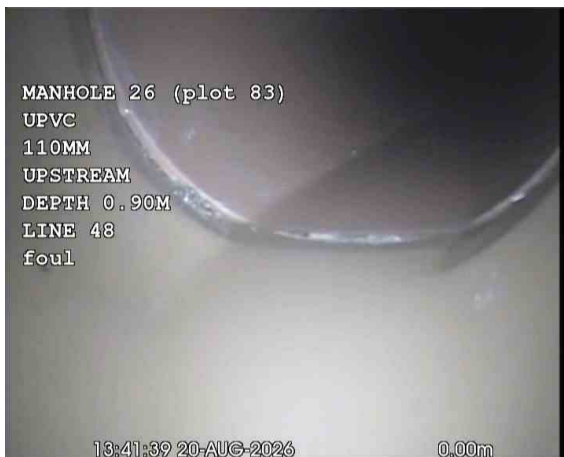
OFFX\_d01597d4-3749-4766-a0ba-44fe3ca45844\_20260917\_185232\_727.jpg, 00:00:30, 0.00 m  
Water level, 0% of the vertical dimension

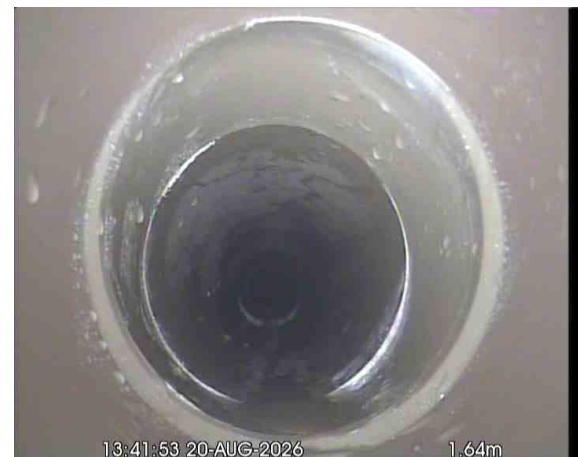
OFFX\_7a74dc5c-1d23-45ea-bc28-7b8b0f892491\_20260917\_185239\_349.jpg, 00:00:30, 0.00 m  
General remark, \*\*PLOT 83\*\*

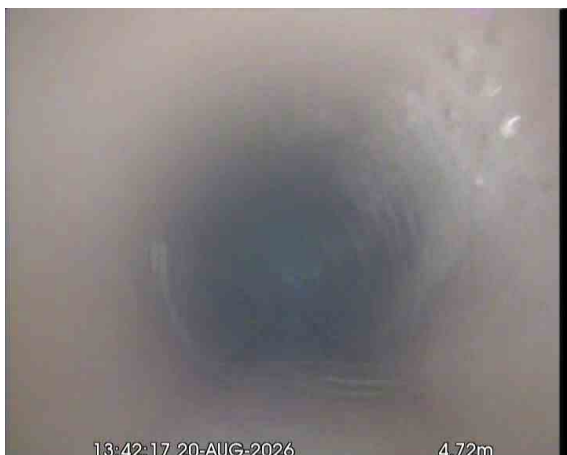
CAPPED  
OFFX\_5d280b9b-a668-4d42-b7ac-e4069e697619\_20260917\_185316\_268.jpg, 00:01:07, 4.72 m  
Water level, 5% of the vertical dimension
