## **Project**

**Project Name:** Arundel Gate BN18 9EX  
**Project Description:** General CCTV - Condition Check  
**Project Number:** JSD10246  
**Project Status:** Complete  
**Project Date:** 17/09/2026  
**Inspection Standard:** MSCC4 Sewers & Drainage GB (SRM4 Scoring)

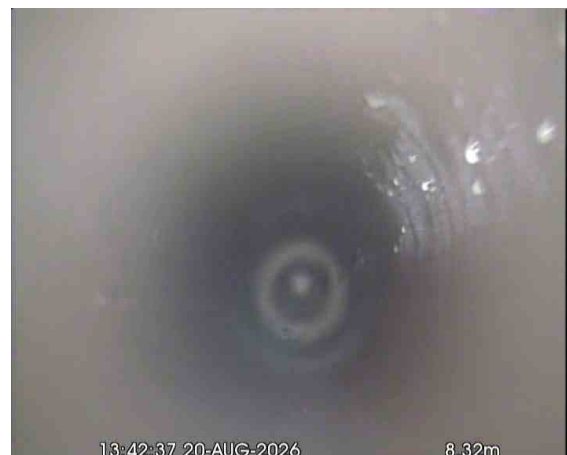
CAPPED  
OFFX\_806f7018-b1ae-4e8c-bd13-b77898bdce52\_20260917\_185330\_673.jpg, 00:01:28, 8.32 m  
Water level, 0% of the vertical dimension

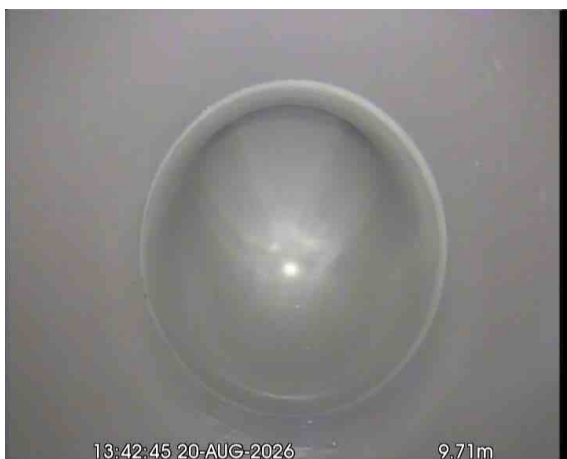
CAPPED  
OFFX\_9f5d1a94-85fc-4e28-803a-5e62180bdc04\_20260917\_185346\_439.jpg, 00:01:35, 9.71 m  
Line deviates up, REST BEND

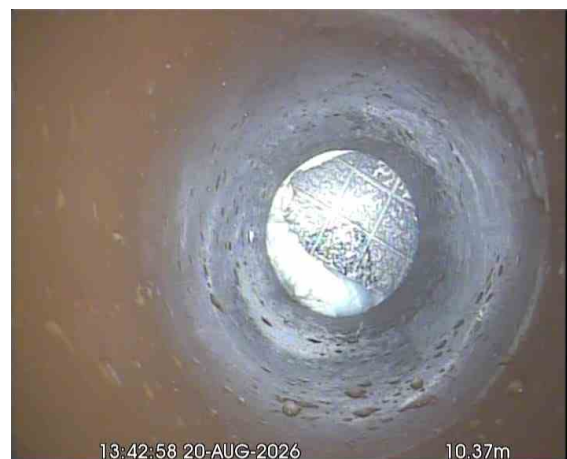
CAPPED  
OFFX\_d02015fa-c904-4857-9e1b-08e97a9685ac\_20260917\_185409\_523.jpg, 00:01:49, 10.37 m  
Survey abandoned, S/A - CAPPED OFF (WET ROOM)

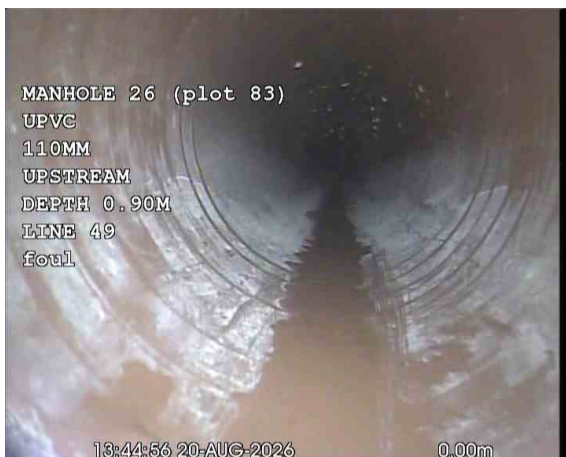
SVPX\_cff1c84-fc60-40cd-a8a3-08646aed5a47\_20260917\_185501\_819.jpg, 00:00:20, 0.00 m  
Start node, manhole, reference: MANHOLE 26 (MH26)

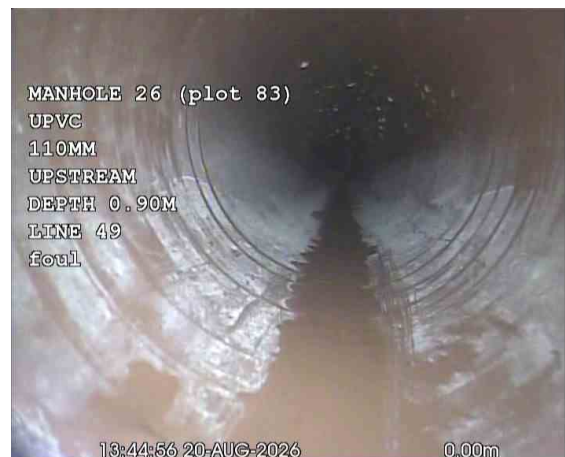
SVPX\_104ee36d-93b1-420d-a30e-f4f8289e6012\_20260917\_185507\_515.jpg, 00:00:20, 0.00 m  
Water level, 0% of the vertical dimension

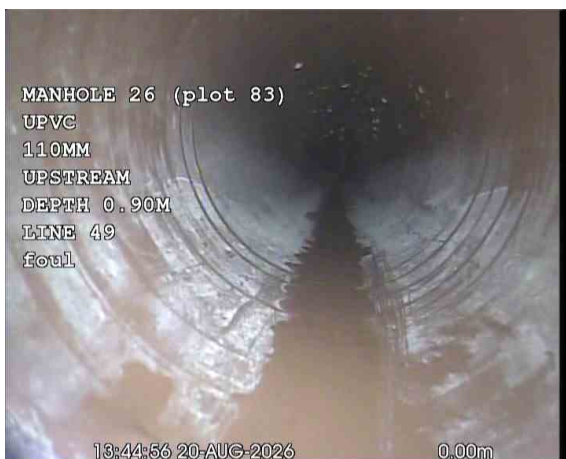
SVPX\_8ac80e10-c65e-42aa-834b-d7b0fcb88076\_20260917\_185514\_314.jpg, 00:00:20, 0.00 m  
General remark, \*\*PLOT 83\*\*

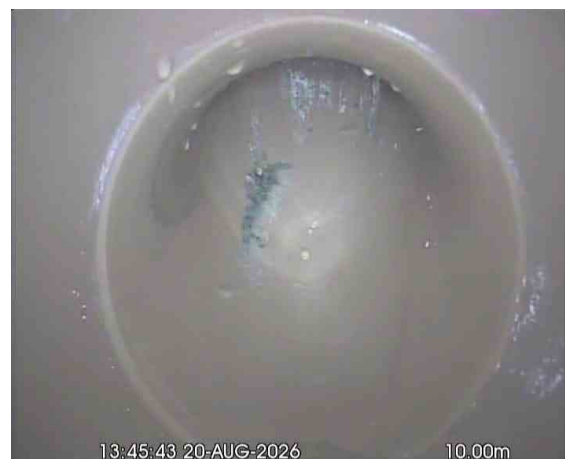
SVPX\_1f7c8f2b-79d4-4b84-8986-45f786409ac9\_20260917\_185533\_394.jpg, 00:01:07, 10.00 m  
Line deviates up, REST BEND

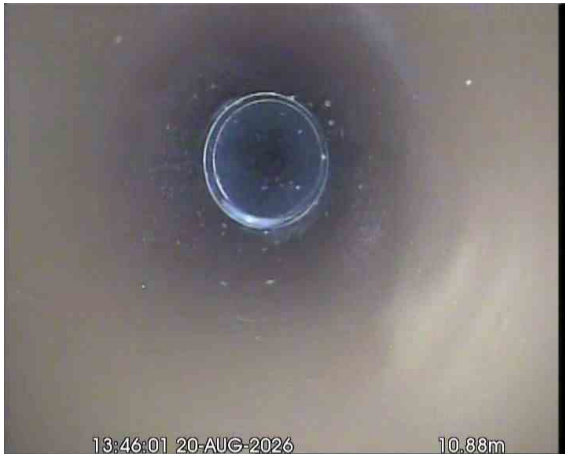
SVPX\_99f82d2b-10b9-4ca3-9b33-09774c3d1359\_20260917\_185555\_528.jpg, 00:01:25, 10.88 m  
Finish node, major connection without manhole, reference:  
SOIL VENT PIPE (SVP) & KITCHEN SINK

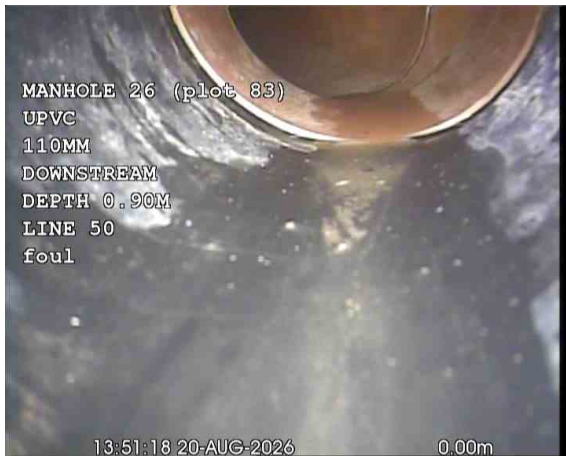
MH26X\_df3942ec-aca3-4573-a697-11e0494948f6\_20260917\_185658\_828.jpg, 00:00:24, 0.00 m  
Start node, manhole, reference: MANHOLE 26 (MH26)

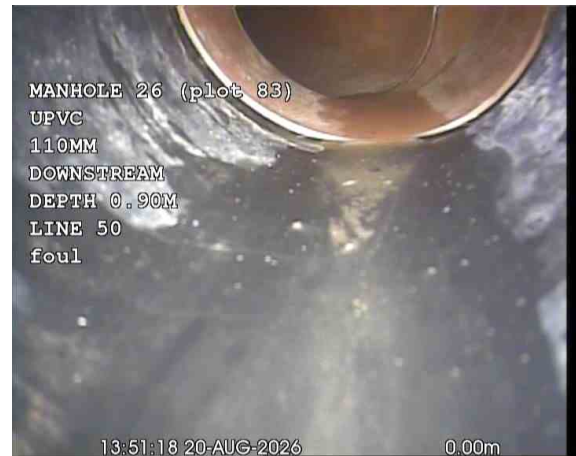
MH26X\_7a2816d4-1012-4d75-a582-b0a5868e1053\_20260917\_185704\_712.jpg, 00:00:24, 0.00 m  
Water level, 0% of the vertical dimension

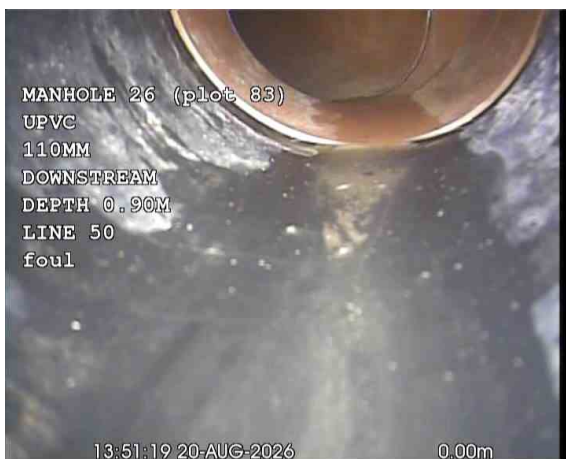
MH26X\_59552982-1336-4718-95e9-3ddc4d27903c\_20260917\_185713\_486.jpg, 00:00:25, 0.00 m  
General remark, \*\*PLOT 83\*\*

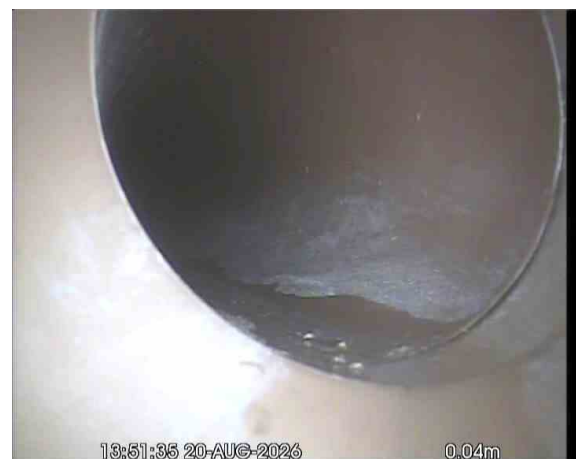
MH26X\_e532ab15-eb3a-42da-84df-3b3f30bbe6c7\_20260917\_185727\_439.jpg, 00:00:41, 0.04 m  
Line deviates left

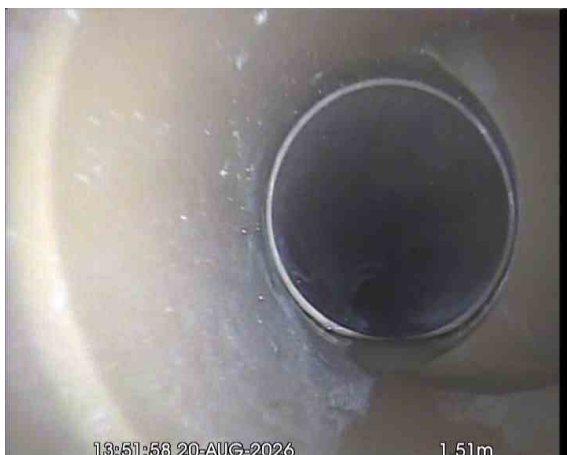
MH26X\_e0202715-f291-445b-b406-8e3a656578b7\_20260917\_185750\_378.jpg, 00:01:04, 1.51 m  
Junction at 3 o'clock, diameter: 110mm, SECTION 47 (S47)

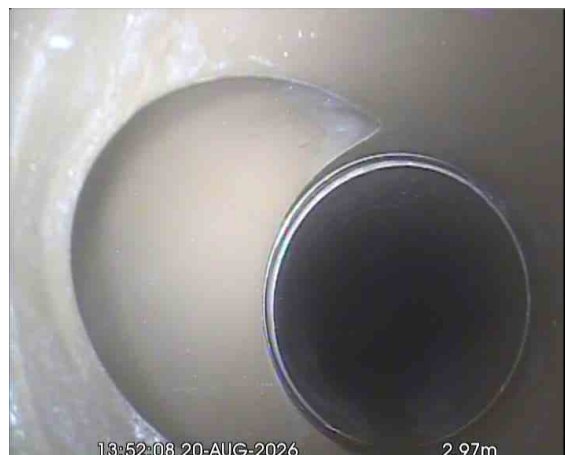
MH26X\_fa2cfba1-3b82-4303-a741-1397692fa505\_20260917\_185813\_273.jpg, 00:01:15, 2.97 m  
Junction at 9 o'clock, diameter: 110mm, SECTION 52 (S52)

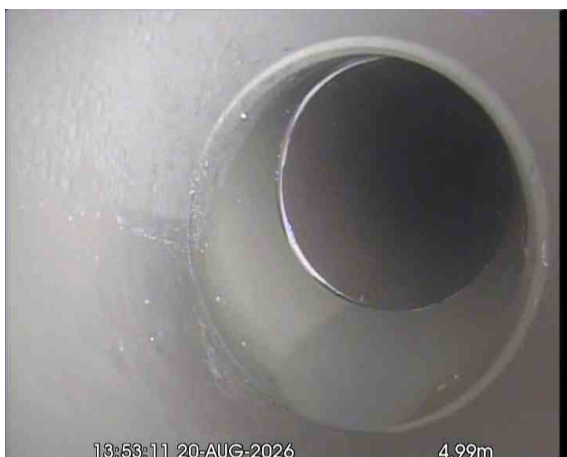
MH26X\_8d16dd87-7703-4d23-96b7-7e473cd8e2cc\_20260917\_185826\_415.jpg, 00:01:33, 4.99 m  
Line deviates right

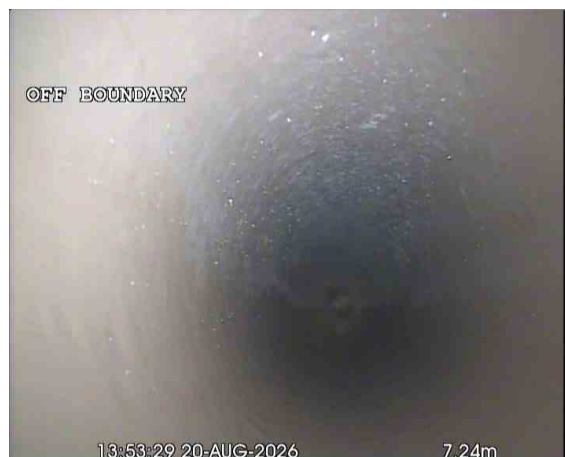
MH26X\_f241e131-e784-466b-9d94-6af77b7cf11d\_20260917\_185848\_786.jpg, 00:01:46, 7.24 m  
General remark, \*\*BOUNDARY POINT\*\*

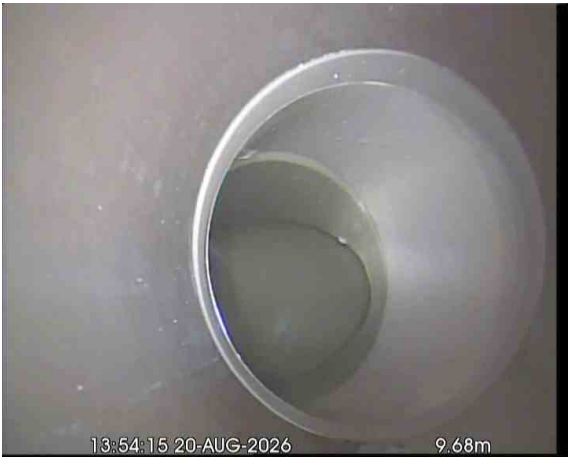
MH26X\_8d97f965-42f0-4b65-abe9-5d5c172e9719\_20260917\_185907\_550.jpg, 00:02:07, 9.68 m  
Line deviates left

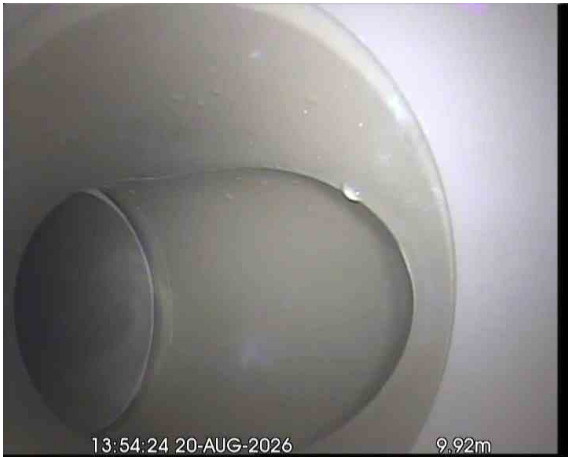
MH26X\_3f77b62a-d4bf-4e03-9595-01586d9bcbe4\_20260917\_185934\_254.jpg, 00:02:16, 9.92 m  
Finish node, major connection without manhole, reference:  
BLIND JUNCTION - JOINS SECTION 9 (S9)

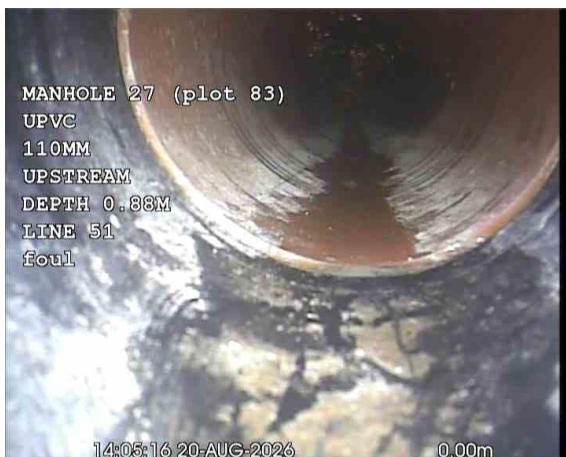
SVPX\_e3fe6dbd-809f-442a-9bbd-239b3fc9dbe0\_20260917\_190034\_222.jpg, 00:00:21, 0.00 m  
Start node, manhole, reference: MANHOLE 27 (MH27)

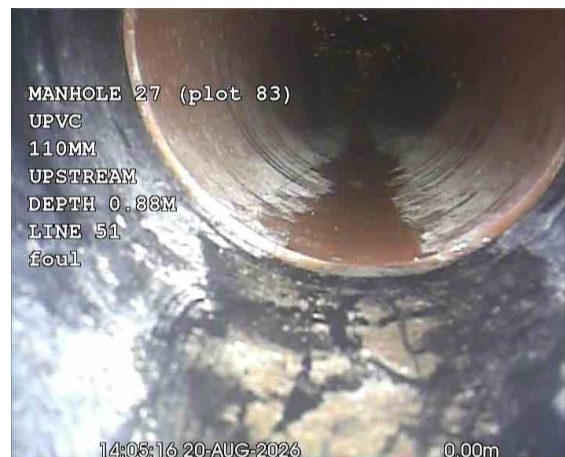
SVPX\_cba2bc36-c747-48d0-ad60-788ba6cef83e\_20260917\_190040\_046.jpg, 00:00:21, 0.00 m  
Water level, 0% of the vertical dimension

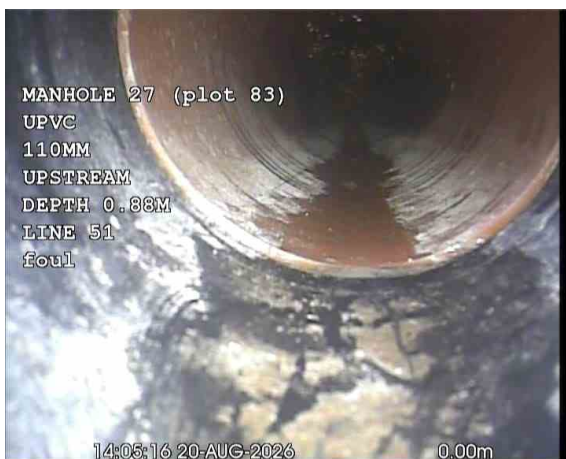
SVPX\_bc34866e-5d12-4620-b310-7064977611bb\_20260917\_190049\_694.jpg, 00:00:21, 0.00 m  
General remark, \*\*PLOT 83\*\*

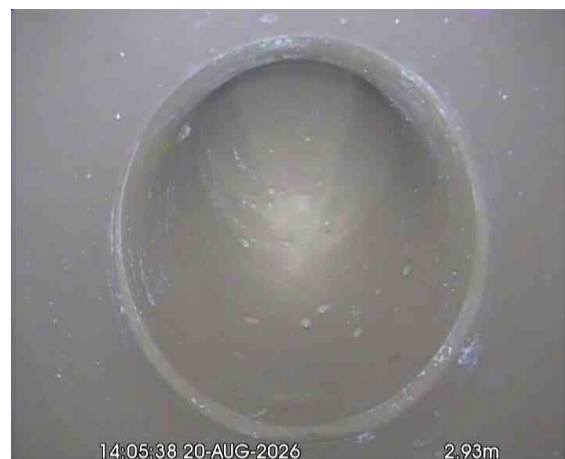
SVPX\_4137f733-8701-4420-a8a6-eda23250ee5a\_20260917\_190105\_466.jpg, 00:00:43, 2.93 m  
Line deviates up, REST BEND

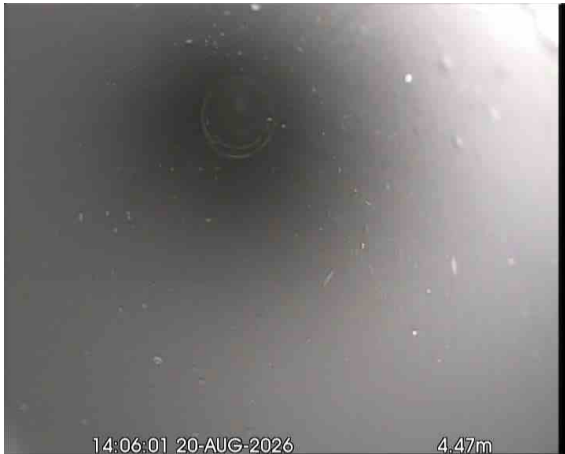
SVPX\_1b1a2d61-9ee0-44e1-a910-8a26f5290a24\_20260917\_190130\_646.jpg, 00:01:06, 4.47 m  
Finish node, major connection without manhole, reference:  
SOIL VENT PIPE (SVP)

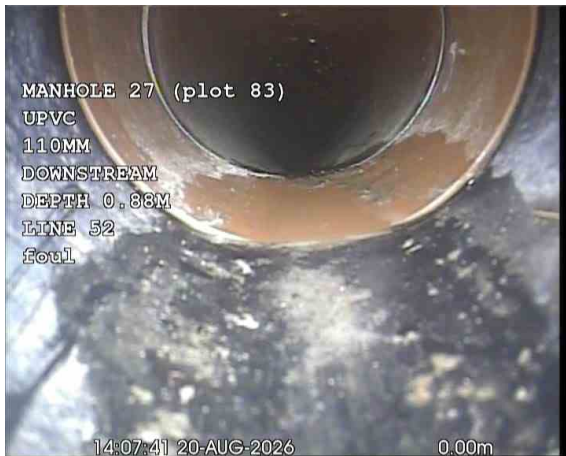
MH27X\_b8072987-1f9e-42d7-9b53-a5a8ae555f10\_20260917\_190322\_868.jpg, 00:00:25, 0.00 m  
Start node, manhole, reference: MANHOLE 27 (MH27)

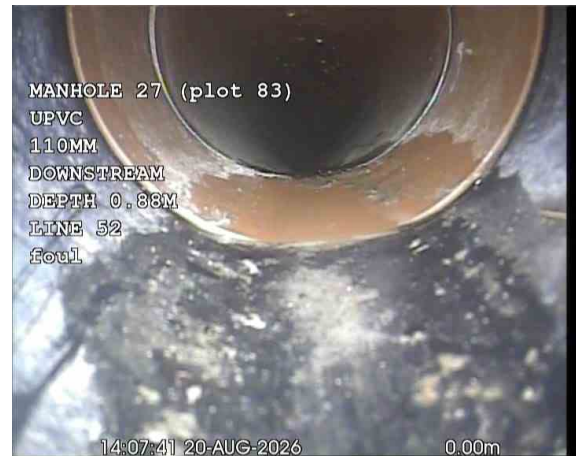
MH27X\_1740ab5d-364d-4cf1-964c-22a4517c6894\_20260917\_190329\_101.jpg, 00:00:25, 0.00 m  
Water level, 0% of the vertical dimension

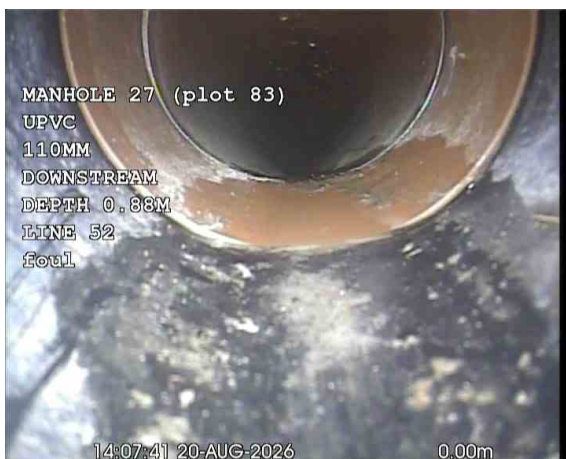
MH27X\_c5b5fc60-e0a1-4b74-a31c-ffdac6701955\_20260917\_190336\_213.jpg, 00:00:25, 0.00 m  
General remark, \*\*PLOT 83\*\*

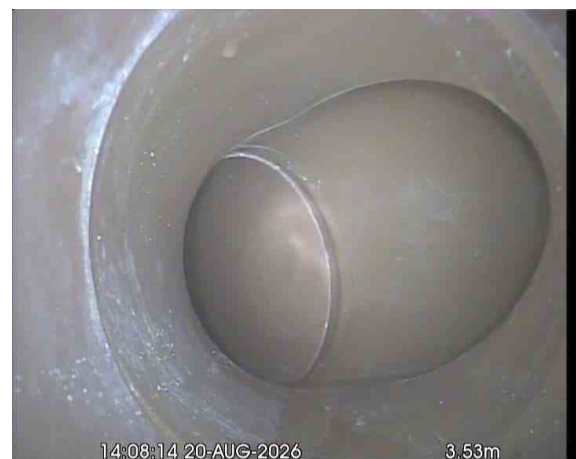
MH27X\_e1fb74e4-a880-4f38-96f8-fdb0901240fd\_20260917\_190405\_482.jpg, 00:00:58, 3.53 m  
Finish node, major connection without manhole, reference: BLIND JUNCTION - JOINS SECTION 50 (S50)

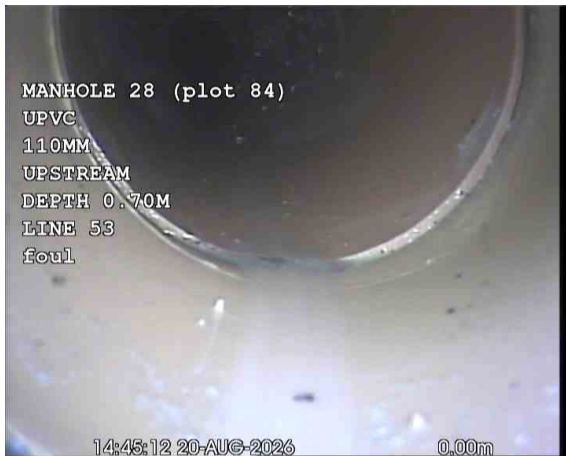
CAPPED  
OFFX\_750fa9a6-73ff-401b-9c07-3590f6c37903\_20260918\_09  
0618\_818.jpg, 00:00:30, 0.00 m  
Start node, manhole, reference: MANHOLE 28 (MH28)

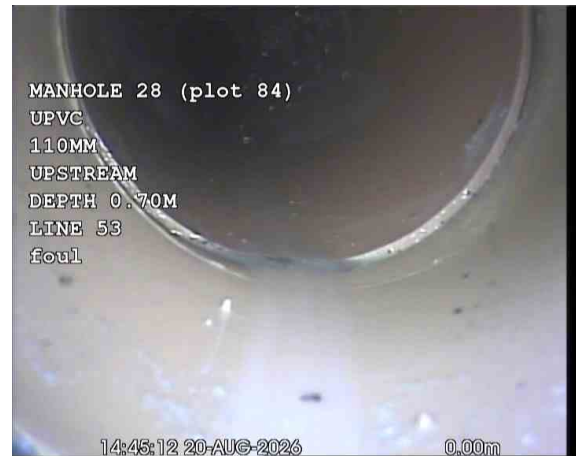
CAPPED  
OFFX\_338b7339-8fc5-47ef-8607-58f75723d100\_20260918\_0  
90625\_104.jpg, 00:00:30, 0.00 m  
Water level, 0% of the vertical dimension

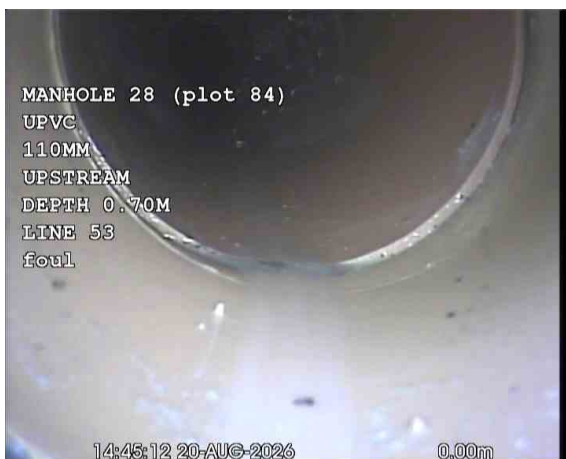
CAPPED  
OFFX\_a23de7c5-61ee-474a-a664-a6384c6b6dc5\_20260918\_  
090634\_494.jpg, 00:00:30, 0.00 m  
General remark, \*\*PLOT 84\*\*

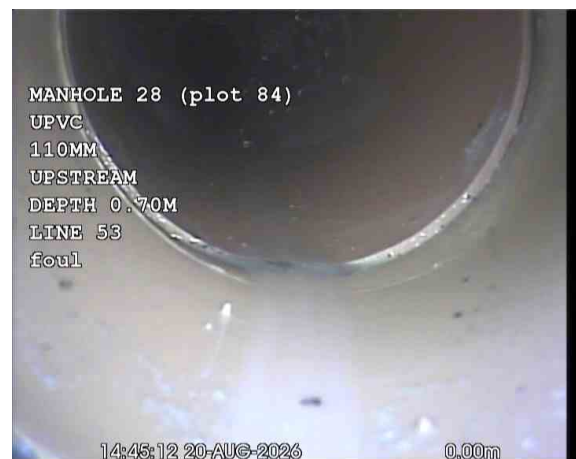
CAPPED  
OFFX\_6a3eb29f-20be-462c-9acd-e750ac4ced1a\_20260918\_  
090640\_574.jpg, 00:00:30, 0.02 m  
Line deviates left

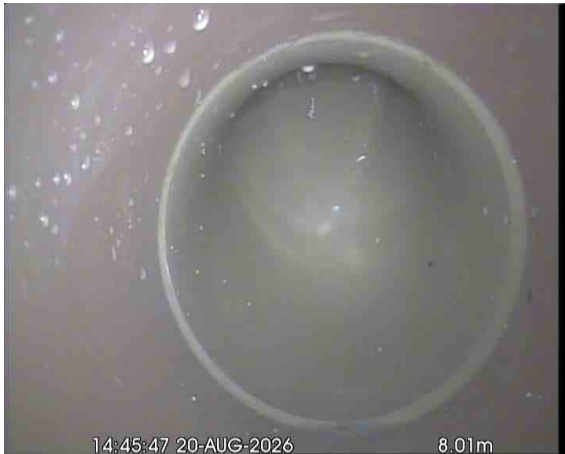
CAPPED  
OFFX\_7f4e235e-2145-42ce-9168-67b113218515\_20260918\_090712\_645.jpg, 00:01:05, 8.01 m  
Line deviates up, REST BEND

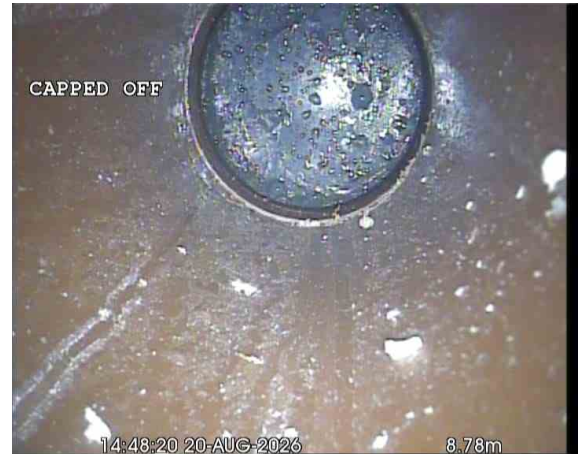
CAPPED  
OFFX\_1bbbbbf9-df29-4d90-86ab-ff12e9751df9\_20260918\_090734\_766.jpg, 00:01:21, 8.78 m  
Survey abandoned, S/A - CAPPED OFF (WET ROOM)

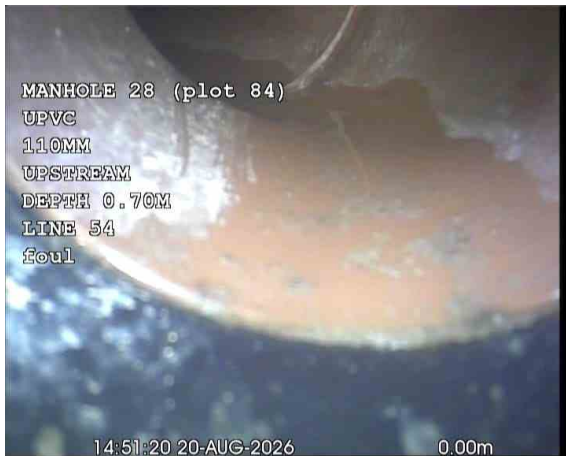
SVPX\_02082cc5-32a1-4dc0-b2f7-d6bec0ddbcb2\_20260918\_090826\_115.jpg, 00:00:27, 0.00 m  
Start node, manhole, reference: MANHOLE 28 (MH28)

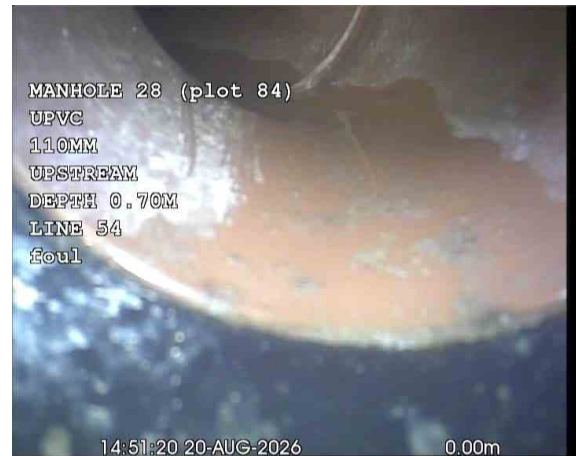
SVPX\_51c63463-7daf-4e40-99a2-dbef2f5737bc\_20260918\_090831\_905.jpg, 00:00:27, 0.00 m  
Water level, 0% of the vertical dimension

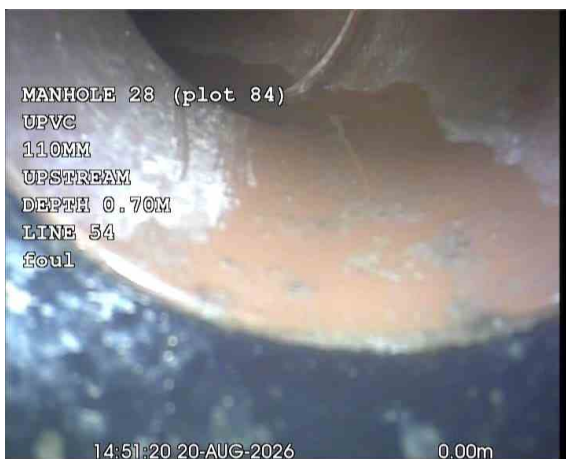
SVPX\_c637f6ee-025b-47f1-ab16-847e281a1c24\_20260918\_090838\_856.jpg, 00:00:27, 0.00 m  
General remark, \*\*PLOT 84\*\*

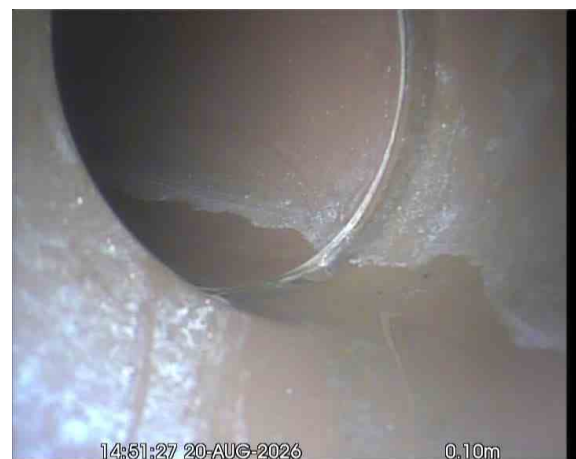
SVPX\_ac7e61a2-c9ab-445d-b6f4-5a7d93b10f49\_20260918\_090851\_753.jpg, 00:00:34, 0.10 m  
Line deviates left

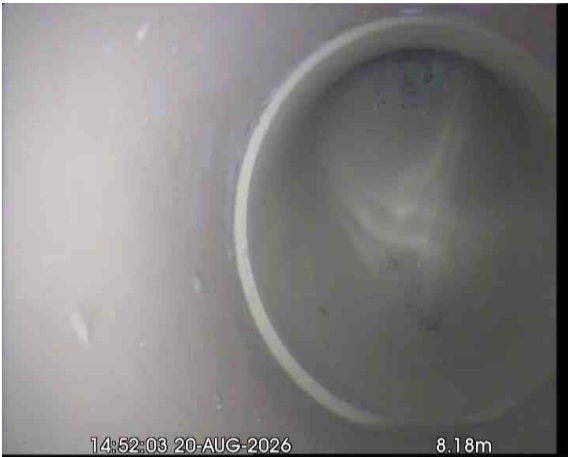
SVPX\_8a9fe533-3cad-4b89-8ecf-f4aa226d6638\_20260918\_090909\_460.jpg, 00:01:09, 8.18 m  
Line deviates up, REST BEND

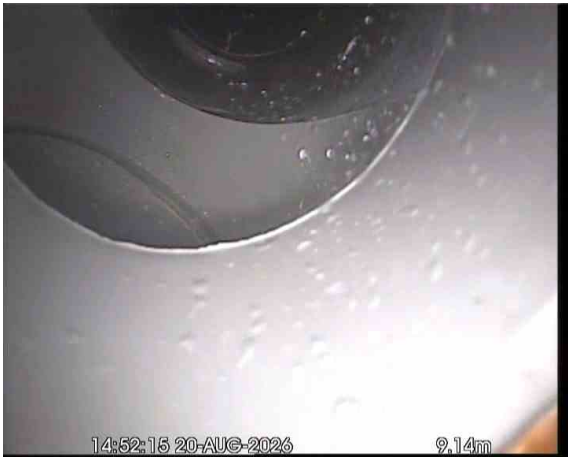
SVPX\_9ea43e84-82a3-437b-893d-5aa136d075fe\_20260918\_090939\_640.jpg, 00:01:21, 9.14 m  
Finish node, major connection without manhole, reference: SOIL VENT PIPE (SVP) & DOWNSTAIRS W/C

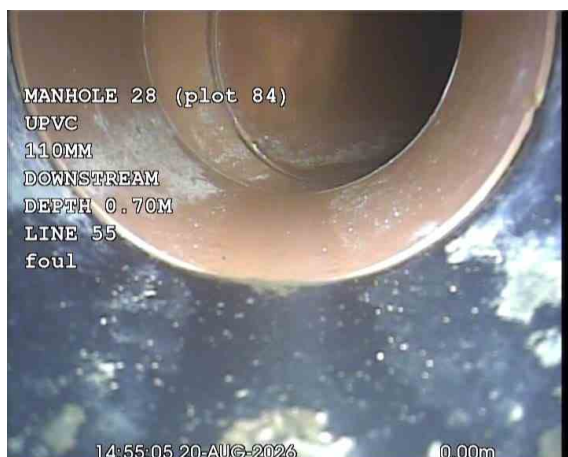
MH28X\_b06b7e3b-e5d9-4086-85d1-04627a22dca0\_20260918\_091126\_429.jpg, 00:00:20, 0.00 m  
Start node, manhole, reference: MANHOLE 28 (MH28)

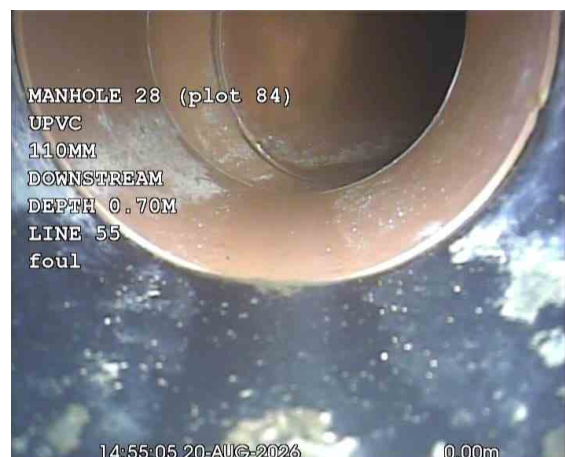
MH28X\_7f7e4a1b-de76-471e-baeb-a7caacd85dcf\_20260918\_091132\_166.jpg, 00:00:20, 0.00 m  
Water level, 0% of the vertical dimension

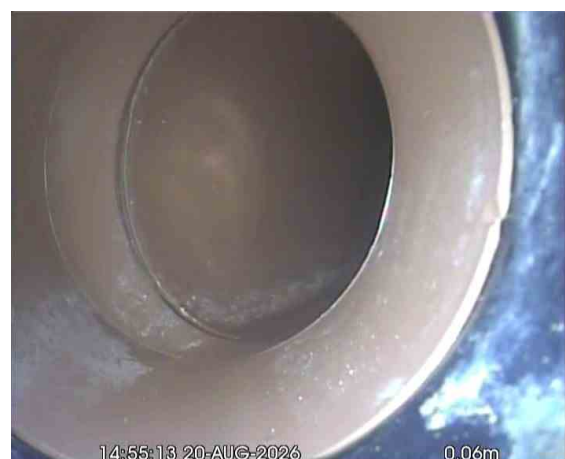
MH28X\_dceb120e-1642-4f0e-b11c-9d226030ae20\_20260918\_091155\_748.jpg, 00:00:27, 0.06 m  
Line deviates right

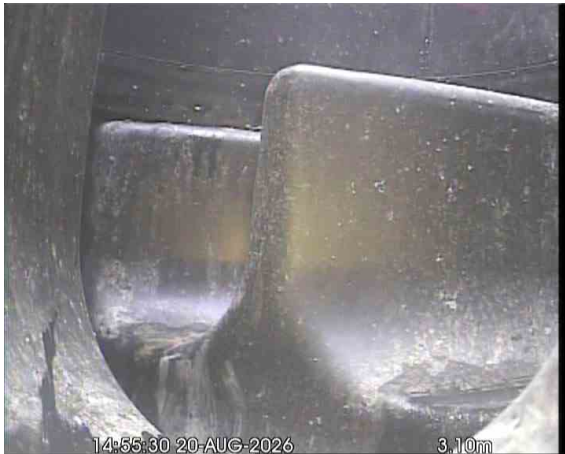
MH28X\_446a6055-ee40-4539-a617-3c7add82d712\_20260918\_091215\_446.jpg, 00:00:44, 3.10 m  
Finish node, manhole, reference: MANHOLE 29 (MH29)

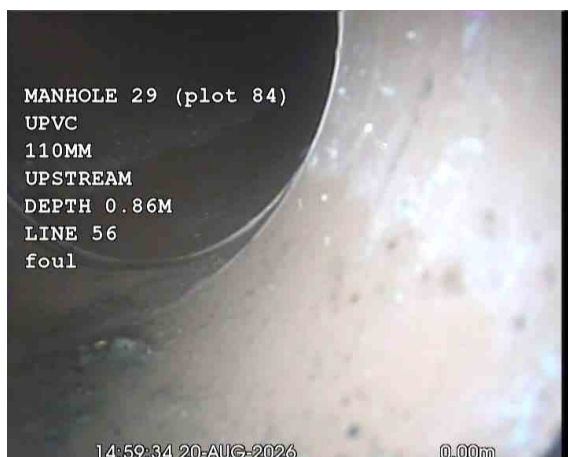
KIT.  
SINKX\_38226131-854a-4229-8172-206b4c21a6a4\_20260918\_091323\_039.jpg, 00:00:19, 0.00 m  
Start node, manhole, reference: MANHOLE 29 (MH29)

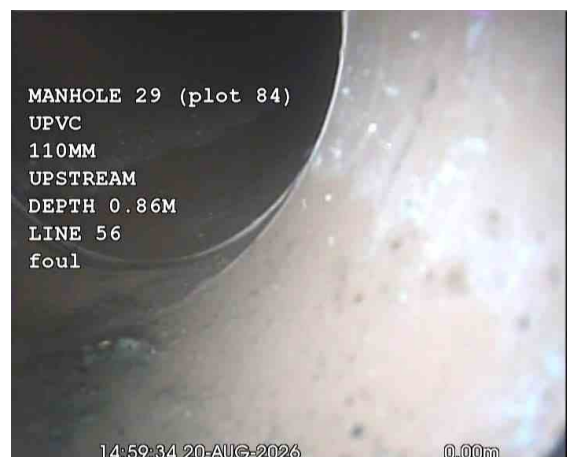
KIT.  
SINKX\_eb8816c6-1492-447e-80c8-0eb68124cb9f\_20260918\_091330\_028.jpg, 00:00:19, 0.00 m  
Water level, 0% of the vertical dimension

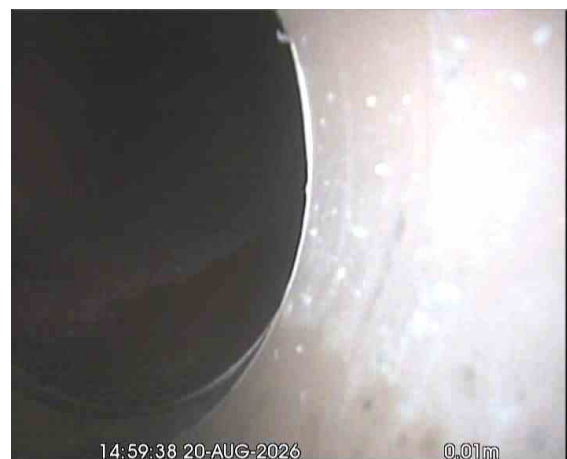
KIT.  
SINKX\_0e666ae3-1ea5-4e19-80c1-67ada34d2ad5\_20260918\_091358\_940.jpg, 00:00:23, 0.02 m  
Line deviates right

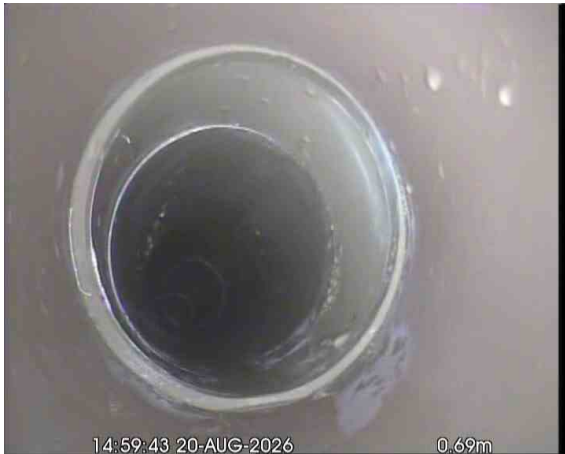
KIT.  
 SINKX\_cacbad40-2203-4c44-901a-1d7539de821b\_20260918\_091411\_860.jpg, 00:00:28, 0.69 m  
 Line deviates left

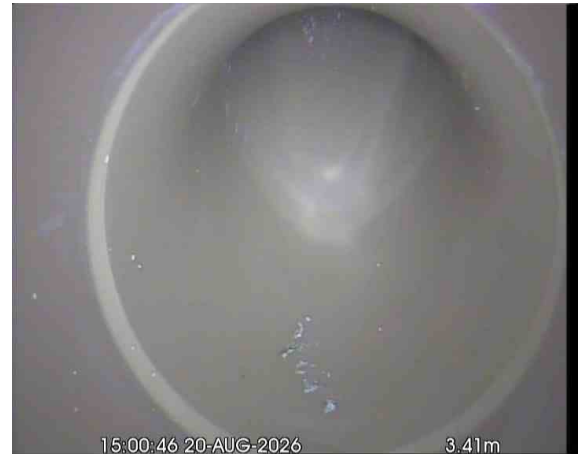
KIT.  
 SINKX\_62ebc3ac-0d35-4160-b030-966308e9e49c\_20260918\_091441\_704.jpg, 00:00:36, 3.41 m  
 Line deviates up, REST BEND

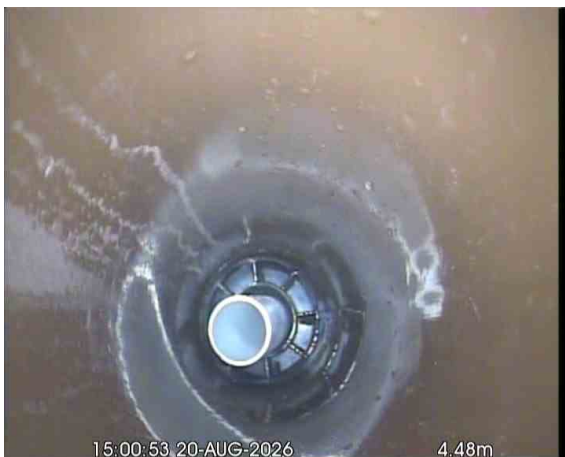
KIT.  
 SINKX\_96ce1cab-bc52-4324-bb3b-a90347d29259\_20260918\_091501\_155.jpg, 00:00:53, 4.48 m  
 Finish node, major connection without manhole, reference:  
 KITCHEN SINK

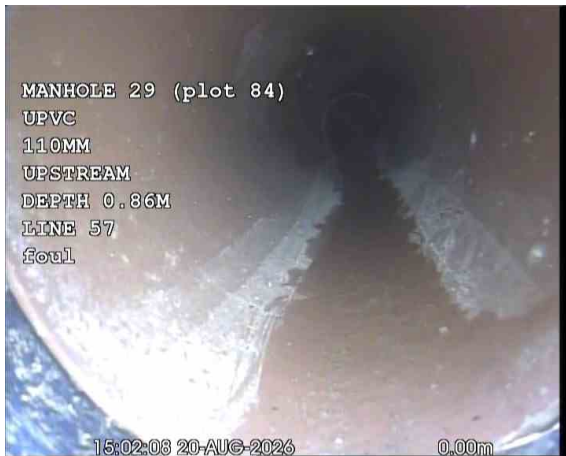
SVPX\_37573cdb-8ec3-4616-a0a4-d3f7198a9f2c\_20260918\_091555\_516.jpg, 00:00:20, 0.00 m  
Start node, manhole, reference: MANHOLE 29 (MH29)

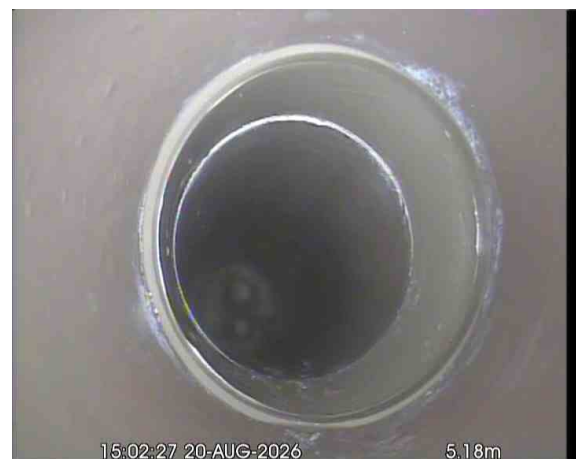
SVPX\_7899bd78-7d08-4328-aeec-14e2c43b2580\_20260918\_091802\_470.jpg, 00:00:39, 5.18 m  
Line deviates left

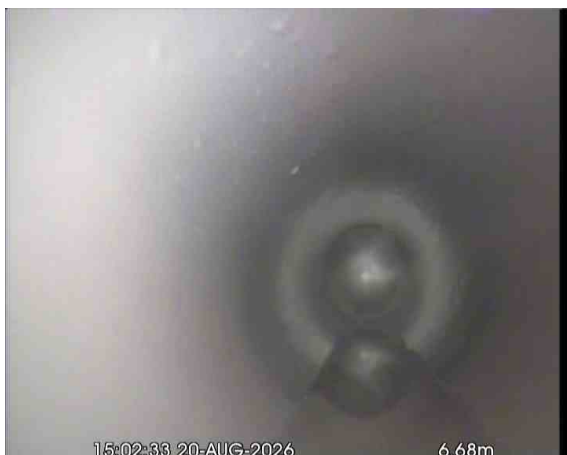
SVPX\_6bdf8b70-a074-44a7-bbc5-7abdbdda4dc4\_20260918\_092059\_604.jpg, 00:00:45, 6.68 m  
Water level, 5% of the vertical dimension

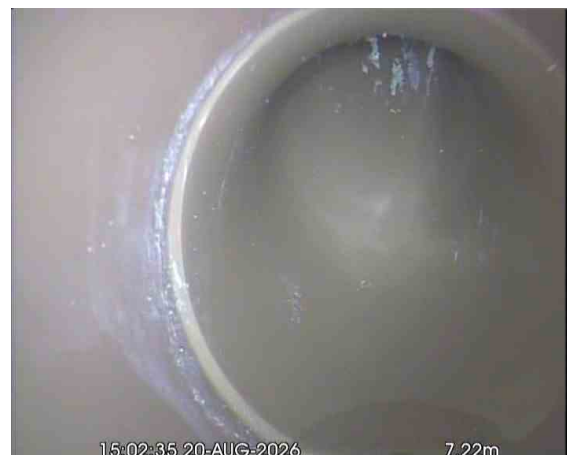
SVPX\_28b784ac-d56d-4867-80d0-49573f454542\_20260918\_092115\_855.jpg, 00:00:47, 7.22 m  
Line deviates up, REST BEND

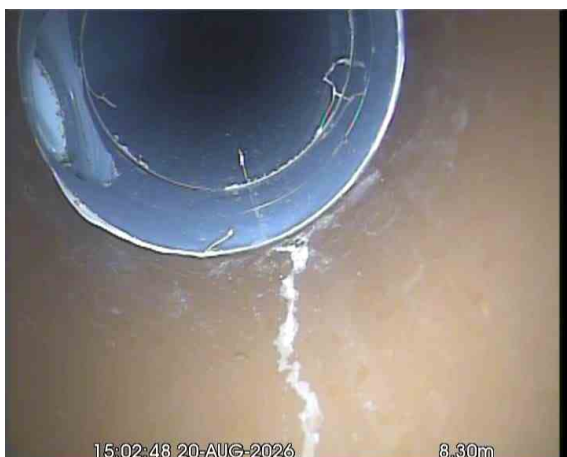
SVPX\_e8fae199-0d18-40df-852d-9152b1a3257f\_20260918\_092144\_539.jpg, 00:01:00, 8.30 m  
Finish node, major connection without manhole, reference:  
SOIL VENT PIPE (SVP) & UTILITY SINK

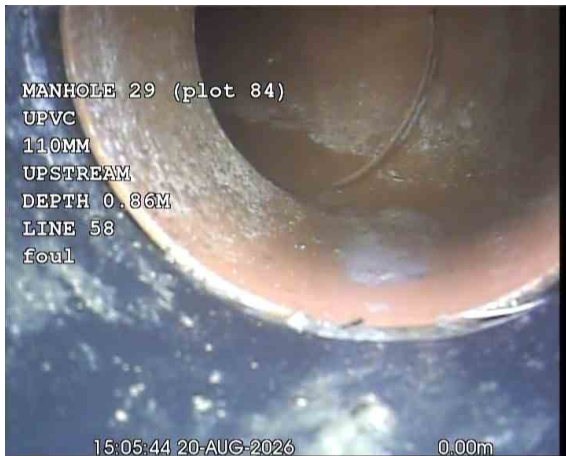
SVPX\_6bddfa59-6e48-495d-ad33-15f4c2e595df\_20260918\_092242\_050.jpg, 00:00:17, 0.00 m  
Start node, manhole, reference: MANHOLE 29 (MH29)

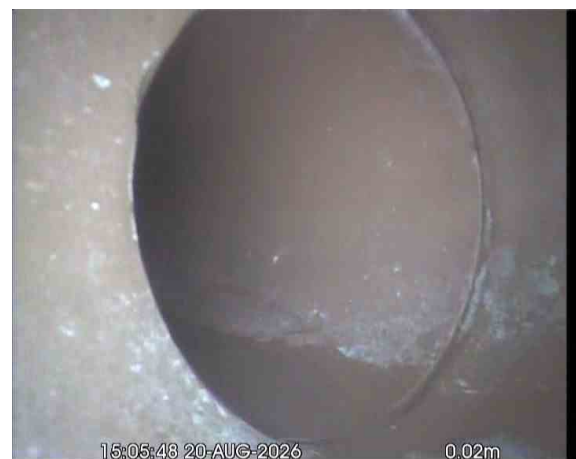
SVPX\_ddfad58a-0b6c-4283-a492-8677f958758b\_20260918\_092316\_775.jpg, 00:00:21, 0.02 m  
Line deviates left

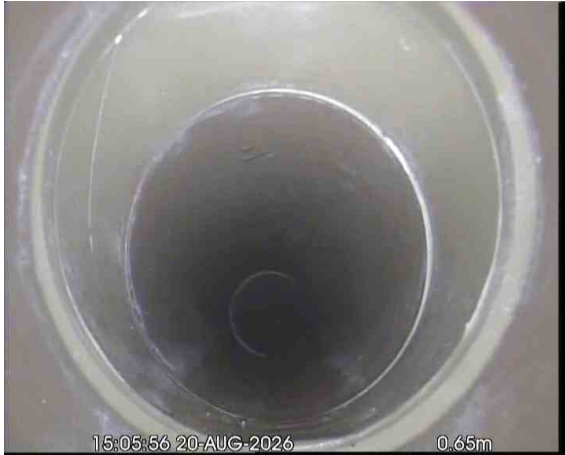
SVPX\_6d52c3d2-25f5-451d-96f2-1c7d6744fab8\_20260918\_092336\_423.jpg, 00:00:30, 0.65 m  
Line deviates down

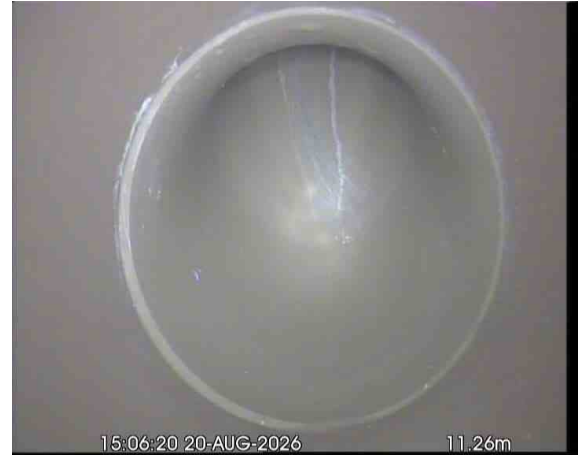
SVPX\_823520d6-ebad-4206-bf54-7e7e307a5059\_20260918\_092357\_476.jpg, 00:00:54, 11.26 m  
Line deviates up, REST BEND

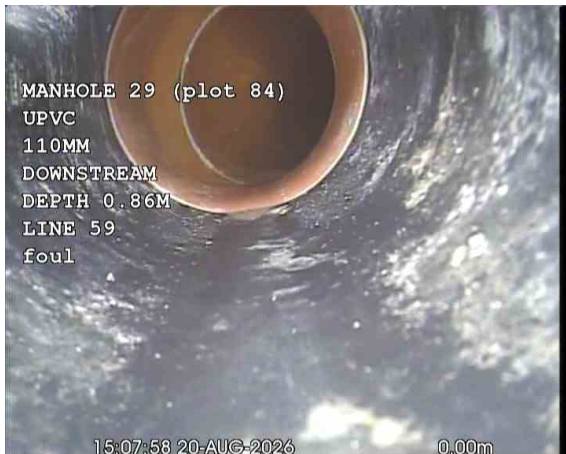
MH29X\_915e2cf9-5035-452c-b7bc-f39c08b0d4a7\_20260918\_092704\_584.jpg, 00:00:18, 0.00 m  
Start node, manhole, reference: MANHOLE 29 (MH29)

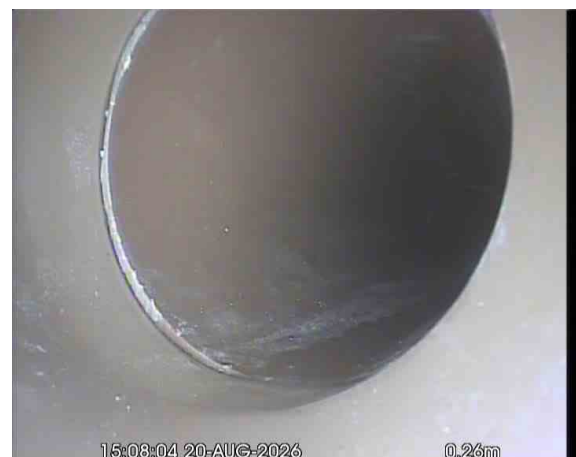
MH29X\_dc951e00-981c-4e32-b78b-abbe7293dcb5\_20260918\_092732\_216.jpg, 00:00:25, 0.26 m  
Line deviates right

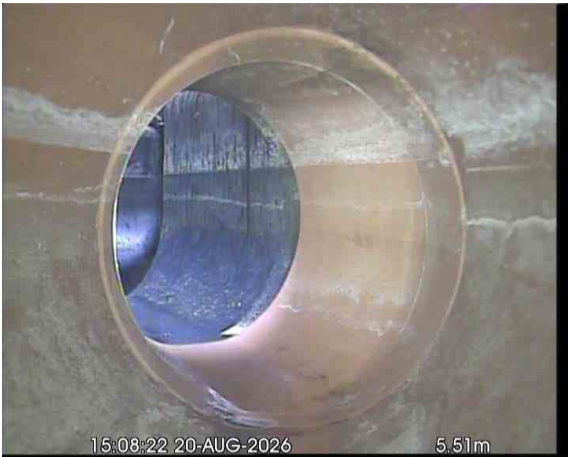
MH29X\_b1b87763-5835-4bce-891d-8157de740b19\_20260918\_092750\_310.jpg, 00:00:42, 5.51 m  
Line deviates left

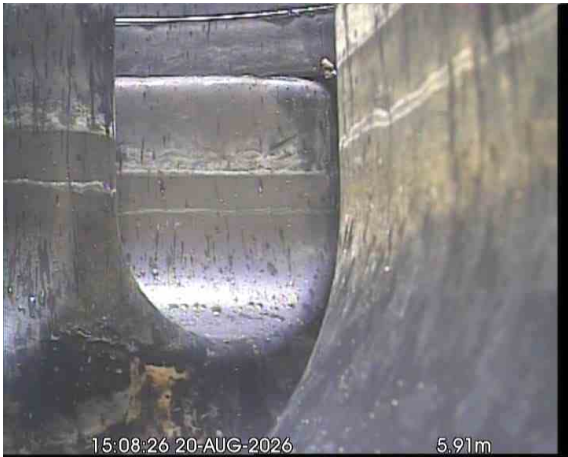
MH29X\_90cc19f5-3069-4695-88a9-8e6927d34d75\_20260918\_092811\_843.jpg, 00:00:46, 5.91 m  
Finish node, manhole, reference: MANHOLE 33 (MH33)

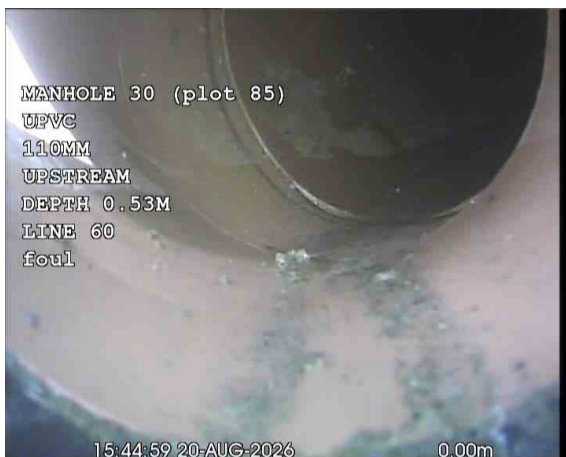
SINKX\_bdce23a3-d630-4aea-8220-df6b103140f0\_20260918\_093246\_023.jpg, 00:00:29, 0.00 m  
Start node, manhole, reference: MANHOLE 30 (MH30)

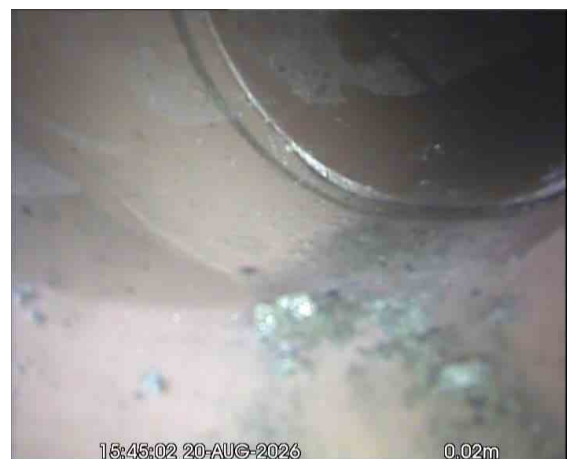
SINKX\_f812606d-9657-4e74-be40-d72f45f656f9\_20260918\_093259\_388.jpg, 00:00:29, 0.00 m  
General remark, \*\*PLOT 85\*\*

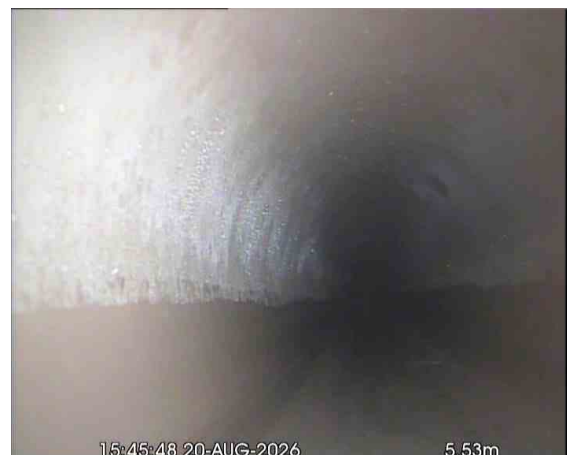
UTIL.  
SINKX\_7a5c597b-7542-4429-bbf0-6048260c1ef1\_20260918\_093340\_678.jpg, 00:01:18, 5.53 m  
Water level, 5% of the vertical dimension

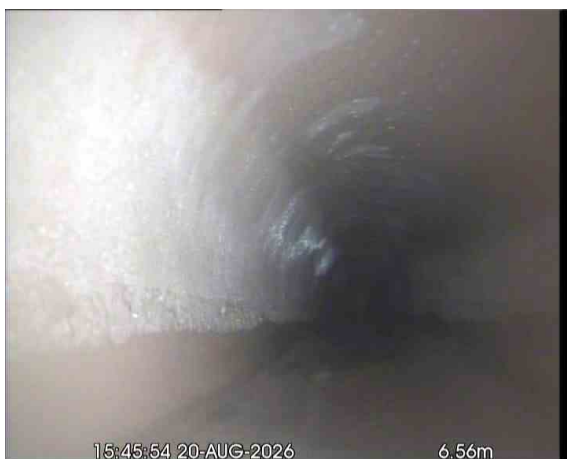
UTIL.  
SINKX\_a729455a-41df-4ff1-8b30-236bad8511af\_20260918\_093357\_871.jpg, 00:01:24, 6.56 m  
Water level, 10% of the vertical dimension

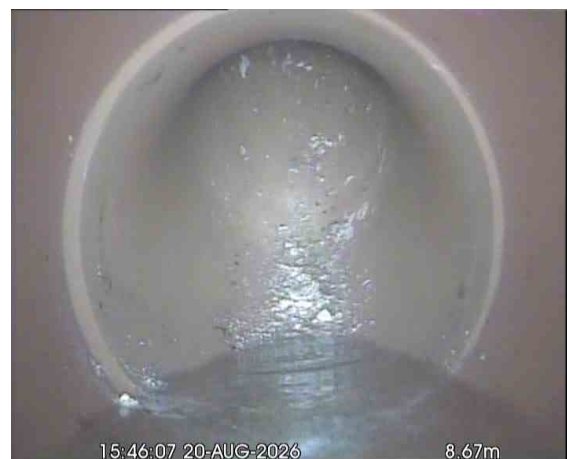
UTIL.  
SINKX\_b7ee2398-778b-4f67-8334-e8b9281de2ef\_20260918\_093422\_014.jpg, 00:01:37, 8.67 m  
Line deviates up, REST BEND

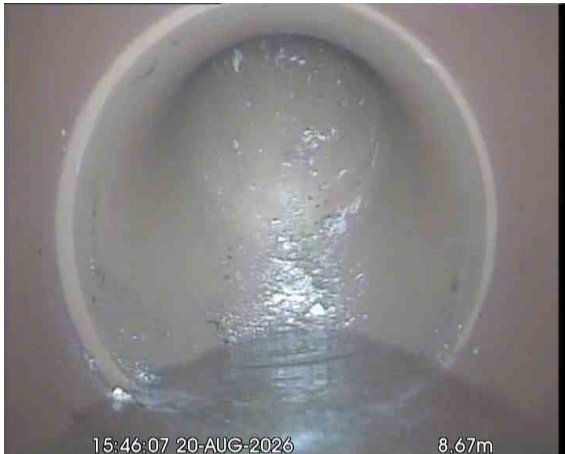
UTIL.  
SINKX\_1084a421-f083-4ae1-b810-c7a12b0fe103\_20260918\_093430\_630.jpg, 00:01:37, 8.67 m  
Water level, 5% of the vertical dimension

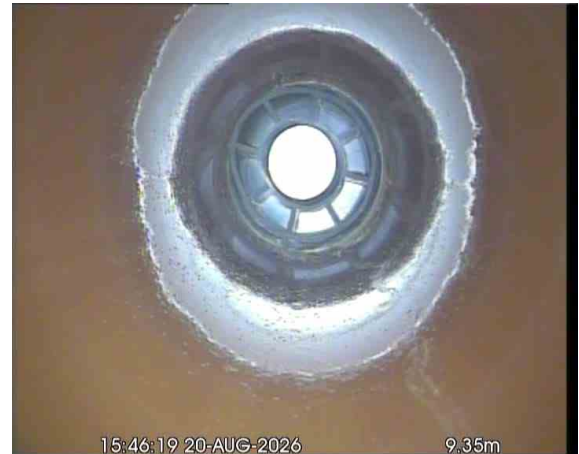
UTIL.  
SINKX\_0b6f4c81-eb59-4d86-9fd9-726035d62662\_20260918\_093448\_186.jpg, 00:01:49, 9.35 m  
Finish node, major connection without manhole, reference:  
UTILITY SINK

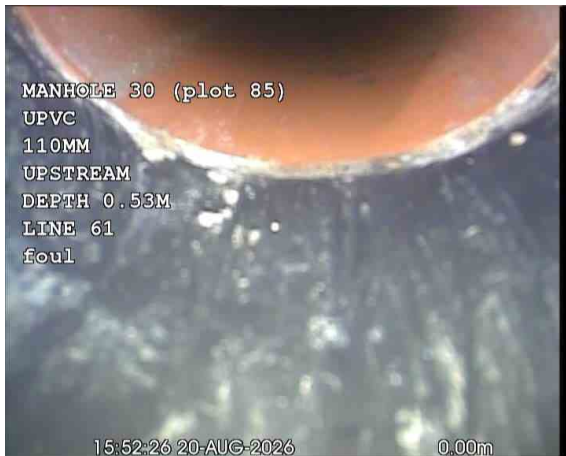
BASINX\_b32eb044-732f-424e-85ef-fc1e748c28bb\_20260918\_093544\_204.jpg, 00:00:17, 0.00 m  
Start node, manhole, reference: MANHOLE 30 (MH30)

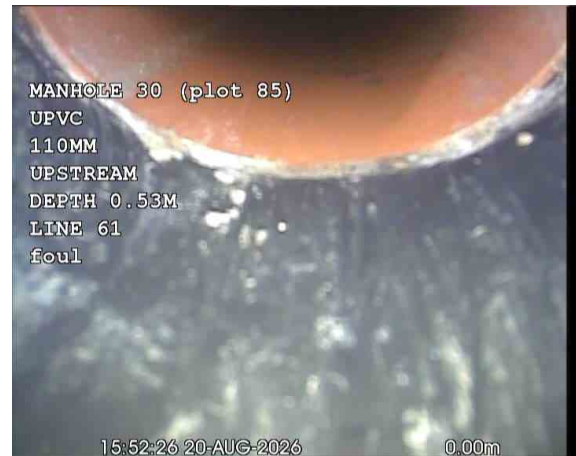
BASINX\_af489863-a3b1-4a70-8abf-ed89ee6cae3f\_20260918\_093550\_188.jpg, 00:00:17, 0.00 m  
Water level, 0% of the vertical dimension

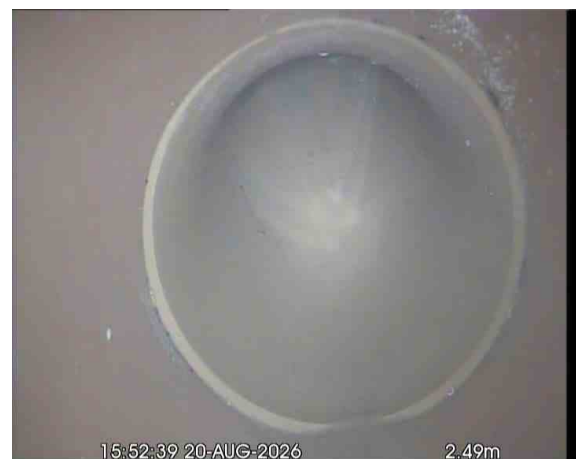
BASINX\_af4bf942-a14d-4ed3-81e3-fa4dacbd8225\_20260918\_093726\_384.jpg, 00:00:30, 2.49 m  
Line deviates up, REST BEND

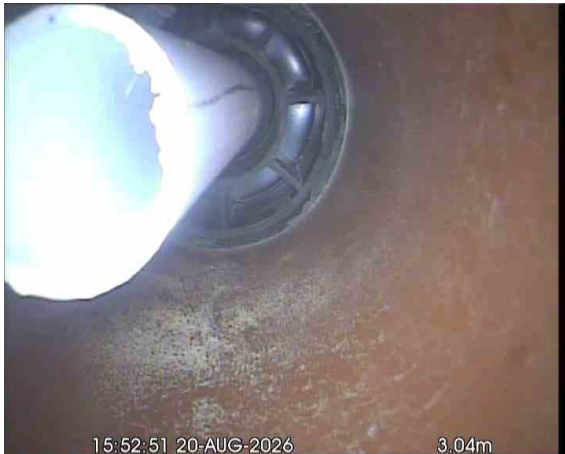
BASINX\_65a49bcf-2c6b-4c65-afb6-133386f0c5ef\_20260918\_093743\_250.jpg, 00:00:41, 3.04 m  
Finish node, major connection without manhole, reference:  
BASIN

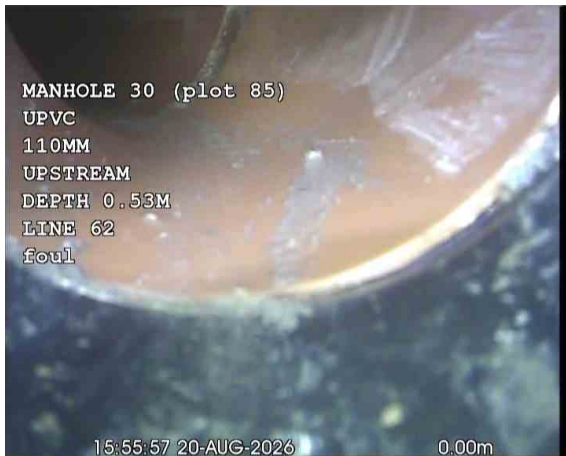
SVPX\_0d1ca588-7d4d-4e9b-9296-3c992dfe303f\_20260918\_093842\_294.jpg, 00:00:16, 0.00 m  
Start node, manhole, reference: MANHOLE 30 (MH30)

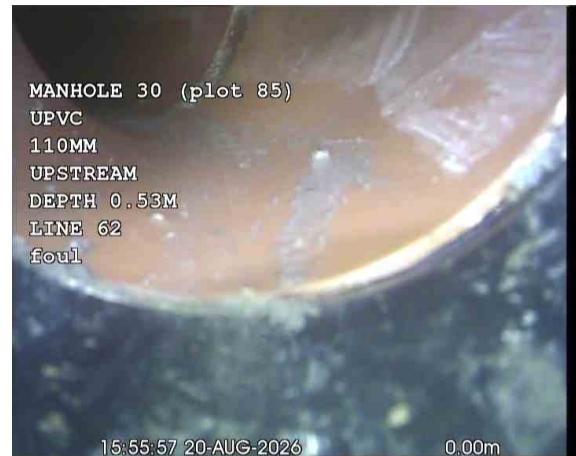
SVPX\_e9c41930-17e1-4e29-903c-bfe8eabb029d\_20260918\_093848\_670.jpg, 00:00:16, 0.00 m  
Water level, 0% of the vertical dimension

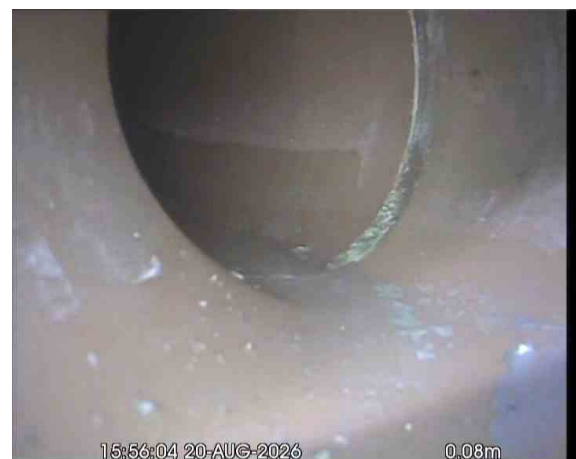
SVPX\_3c8cd955-9b13-4dbc-8055-8037fb39841c\_20260918\_093910\_496.jpg, 00:00:22, 0.08 m  
Line deviates left

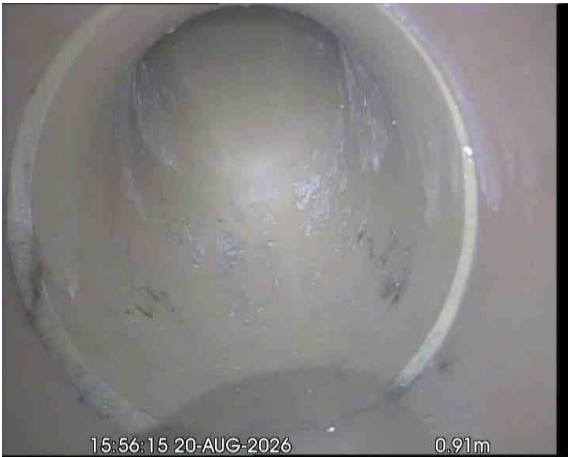
SVPX\_dc1d9c19-7e35-43b5-9efa-c37a1a9c5eeb\_20260918\_093926\_890.jpg, 00:00:33, 0.91 m  
Line deviates up, REST BEND
