## **Project**

**Project Name:** Arundel Gate BN18 9EX  
**Project Description:** General CCTV - Condition Check  
**Project Number:** JSD10246  
**Project Status:** Complete  
**Project Date:** 17/09/2026  
**Inspection Standard:** MSCC4 Sewers & Drainage GB (SRM4 Scoring)

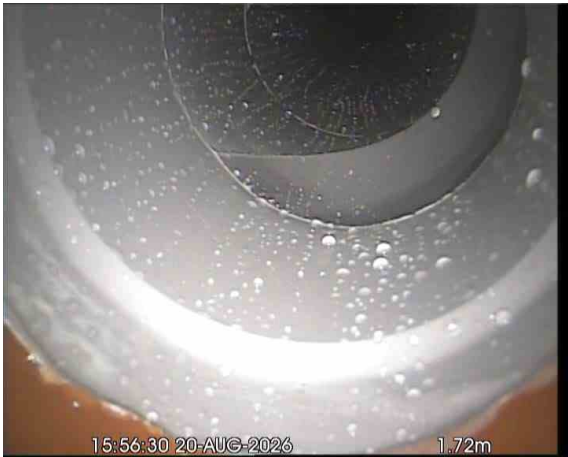
SVPX\_6dcee700-b0e5-4bd0-b866-ffd0f022fe8e\_20260918\_093952\_502.jpg, 00:00:48, 1.72 m  
Finish node, major connection without manhole, reference: SOIL VENT PIPE (SVP) & DOWNSTAIRS W/C

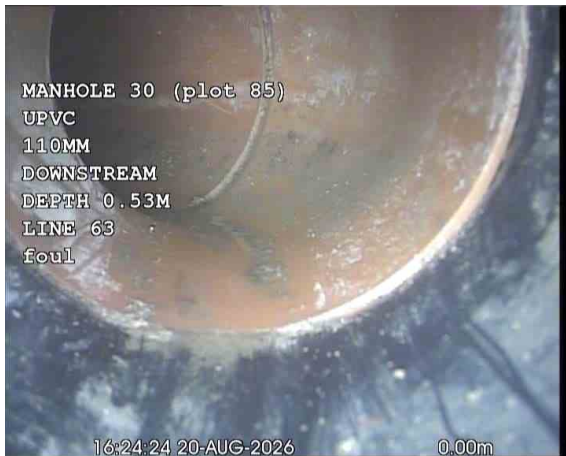
MH30X\_2d32c39e-2488-4136-8f1e-d84b379d3cdd\_20260918\_094053\_039.jpg, 00:00:17, 0.00 m  
Start node, manhole, reference: MANHOLE 30 (MH30)

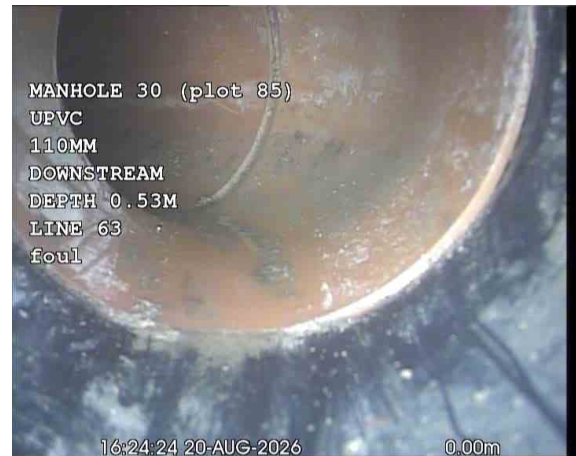
MH30X\_30ab6182-7487-46b1-a56a-3642f9d452b0\_20260918\_094059\_655.jpg, 00:00:17, 0.00 m  
Water level, 0% of the vertical dimension

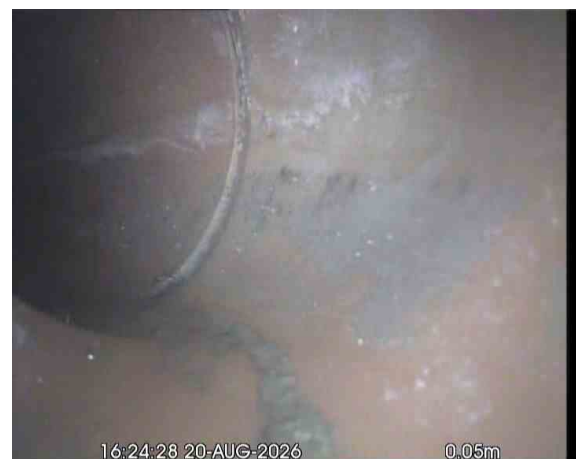
MH30X\_e592d5ce-48ca-48f3-b79f-d5a45f793627\_20260918\_094122\_115.jpg, 00:00:20, 0.05 m  
Line deviates left

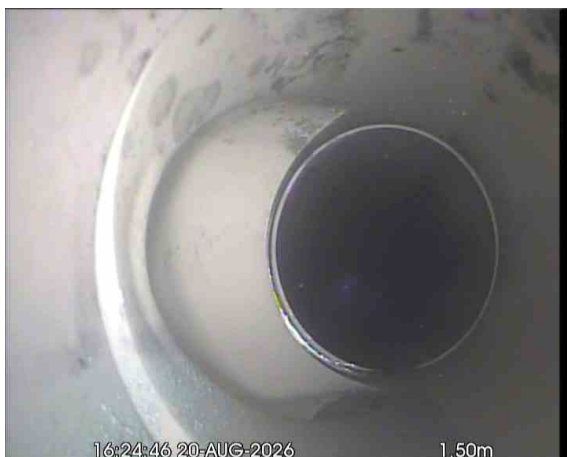
MH30X\_62136e09-344c-4480-8a78-2025aa5a2cbb\_20260918\_094142\_630.jpg, 00:00:38, 1.50 m  
Junction at 9 o'clock, diameter: 110mm, SECTION 65 (S65)

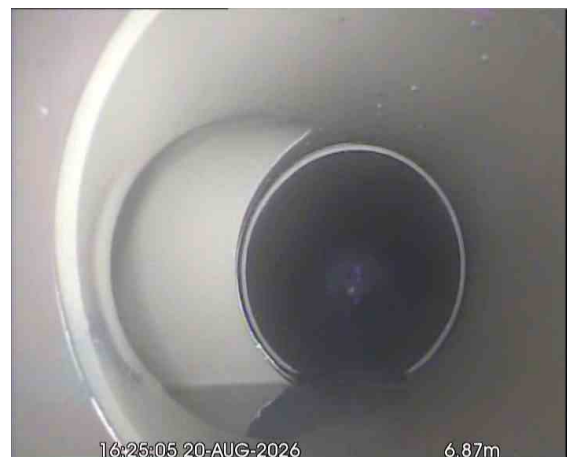
MH30X\_a5361829-394f-4579-8f6f-27fc6aebf915\_20260918\_094208\_103.jpg, 00:00:57, 6.87 m  
Junction at 9 o'clock, diameter: 110mm, SECTION 67 (S67)

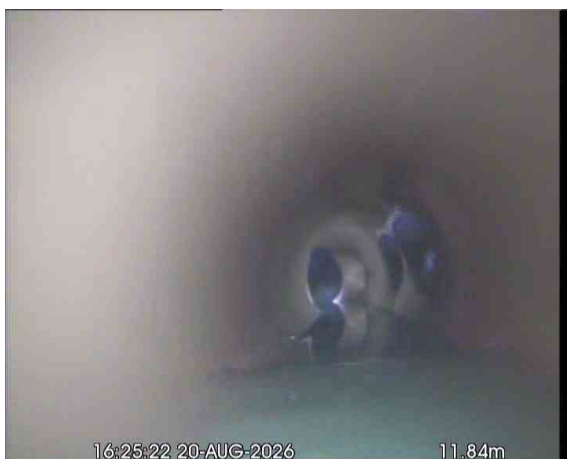
MH30X\_61764177-fc76-4130-be68-195b4df073a9\_20260918\_094226\_335.jpg, 00:01:14, 11.84 m  
Water level, 10% of the vertical dimension

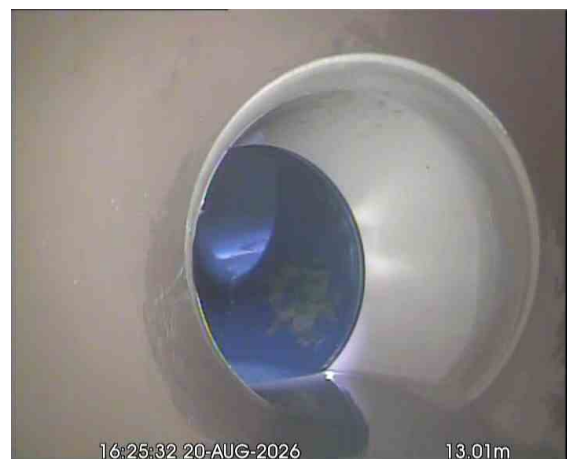
MH30X\_e6dd477d-844e-49bb-8fa4-aae3ab251036\_20260918\_094245\_330.jpg, 00:01:24, 13.01 m  
Line deviates left

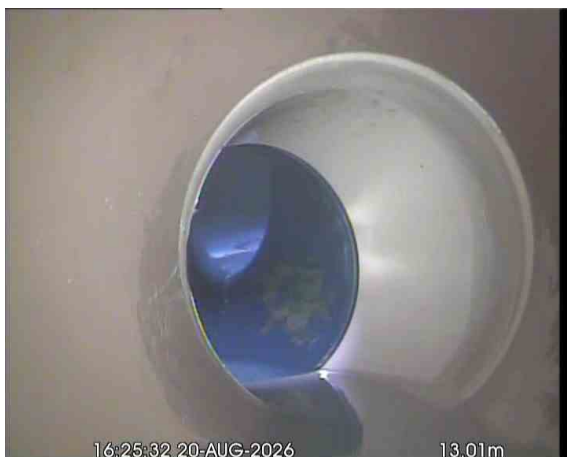
MH30X\_ea0d3238-24e0-43f3-8271-fe2026c42c16\_20260918\_094253\_438.jpg, 00:01:24, 13.01 m  
Water level, 5% of the vertical dimension

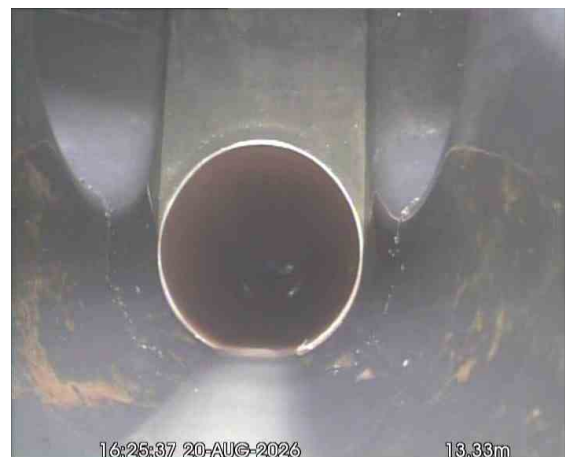
MH30X\_de6d7b5e-1df0-4526-8621-0321ea6a95d2\_20260918\_094311\_999.jpg, 00:01:29, 13.33 m  
Finish node, manhole, reference: MANHOLE 33 (MH33)

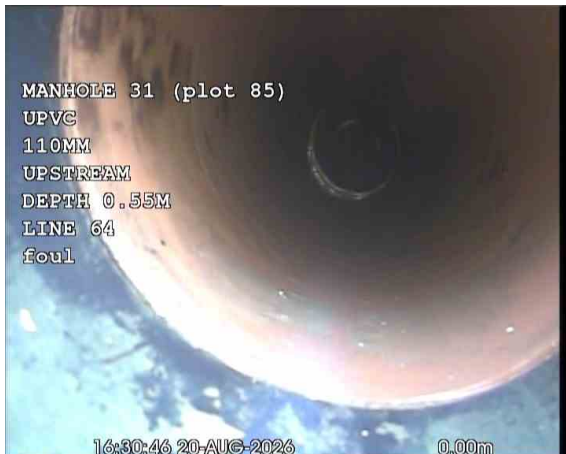
SVPX\_d8ca7d10-eb8b-4d85-a6c4-8f013f9c7bcd\_20260918\_094423\_397.jpg, 00:00:49, 0.00 m  
Start node, manhole, reference: MANHOLE 31 (MH31)

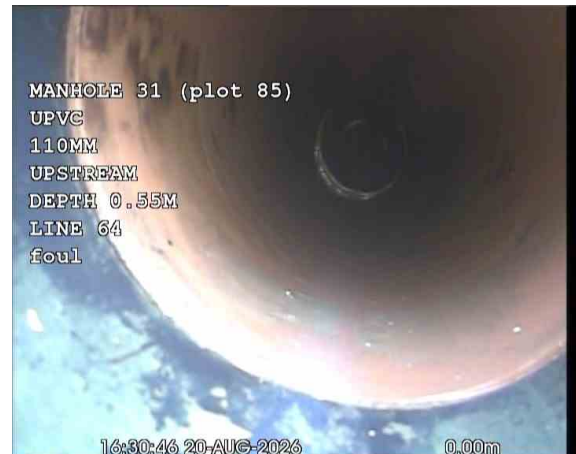
SVPX\_ae2b33a7-4a10-4adc-8487-6ef84f86d939\_20260918\_094429\_820.jpg, 00:00:49, 0.00 m  
Water level, 0% of the vertical dimension

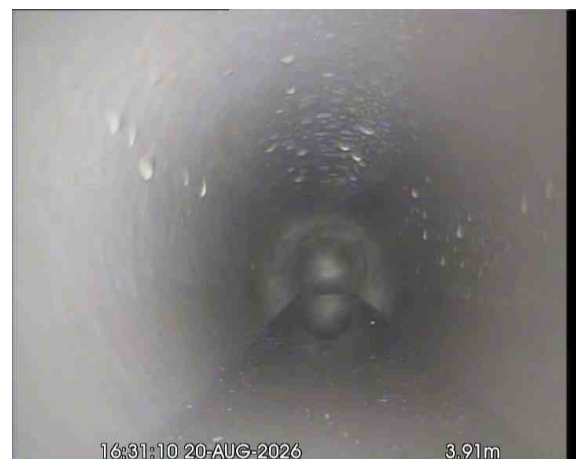
SVPX\_bc697c7c-1b60-4529-9309-0248e86da1ea\_20260918\_094451\_739.jpg, 00:01:14, 3.91 m  
Water level, 10% of the vertical dimension

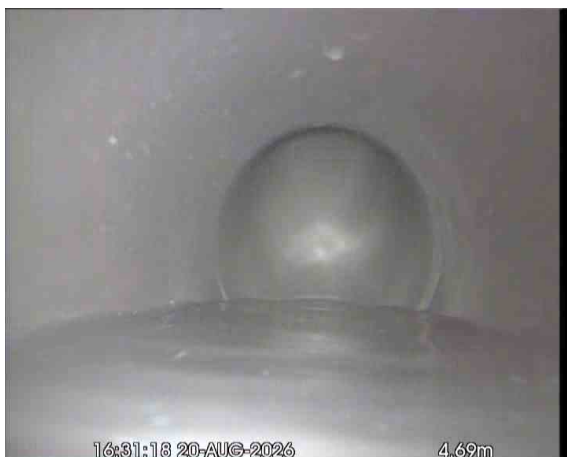
SVPX\_c6ebe67c-cb53-4259-b9f6-362d6ffde17f\_20260918\_094512\_423.jpg, 00:01:22, 4.69 m  
Water level, 15% of the vertical dimension

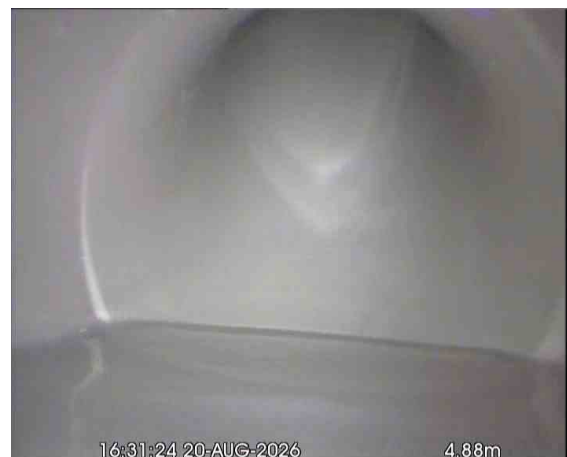
SVPX\_649224af-f3da-49ce-90a6-0e9e9bcac291\_20260918\_094533\_662.jpg, 00:01:27, 4.88 m  
Line deviates up, REST BEND

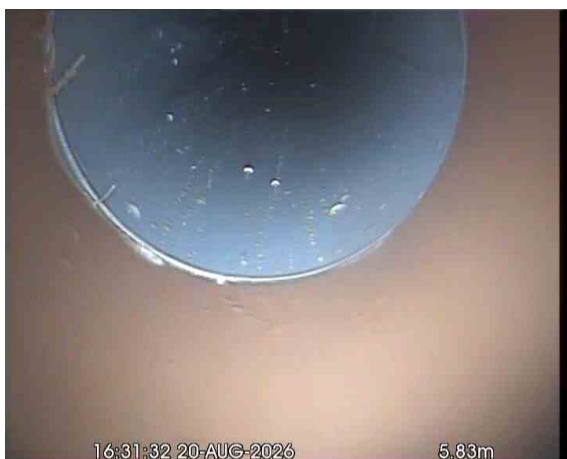
SVPX\_338a2e6e-6e3d-45c7-8b63-0cd4e1440a49\_20260918\_094551\_984.jpg, 00:01:36, 5.83 m  
Finish node, major connection without manhole, reference:  
SOIL VENT PIPE (SVP)

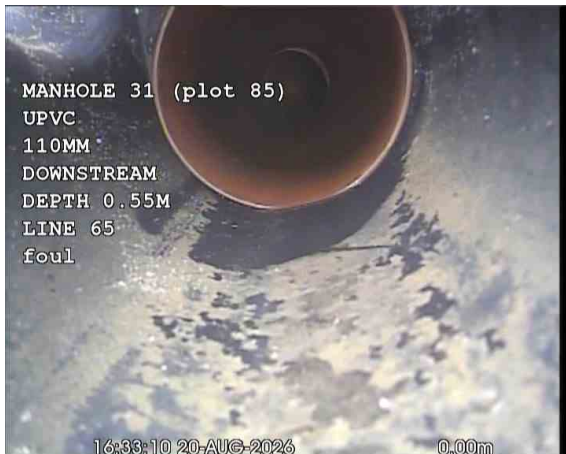
MH31X\_7acb1600-036b-4443-83cc-c4d7daa298e3\_20260918\_094652\_704.jpg, 00:00:13, 0.00 m  
Start node, manhole, reference: MANHOLE 31 (MH31)

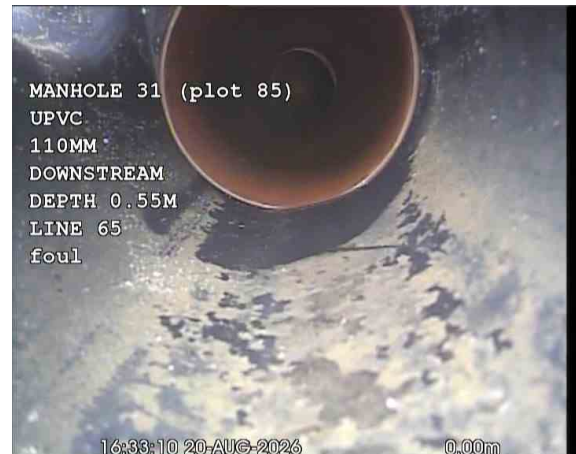
MH31X\_3d47006e-bc9c-4278-bec7-90b4ee73a435\_20260918\_094658\_258.jpg, 00:00:13, 0.00 m  
Water level, 0% of the vertical dimension

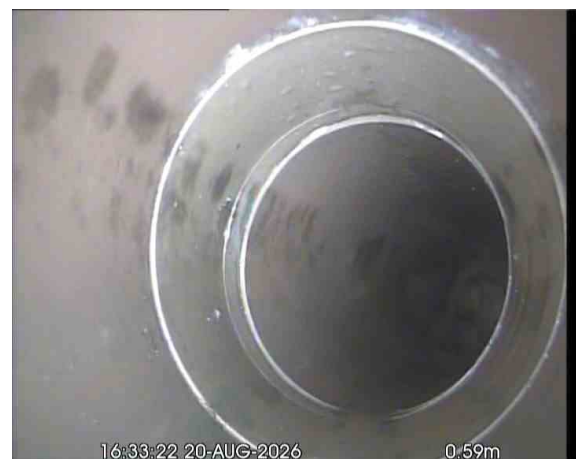
MH31X\_d7c9df2d-077d-4a44-8e79-5a2920e7fa12\_20260918\_094722\_462.jpg, 00:00:25, 0.59 m  
Line deviates right

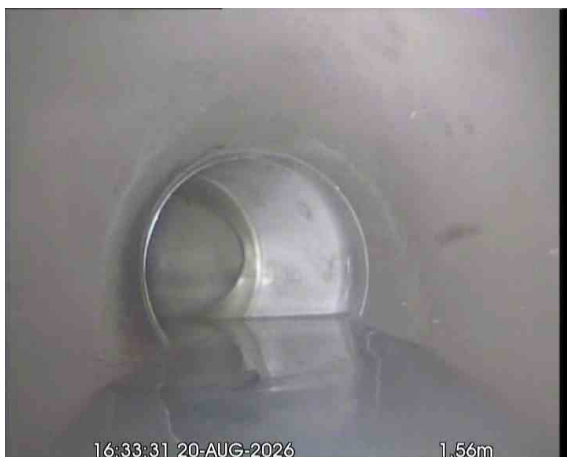
MH31X\_886aa7a1-9acc-4338-9464-57e2dbb4c92f\_20260918\_094737\_144.jpg, 00:00:34, 1.56 m  
Water level, 10% of the vertical dimension

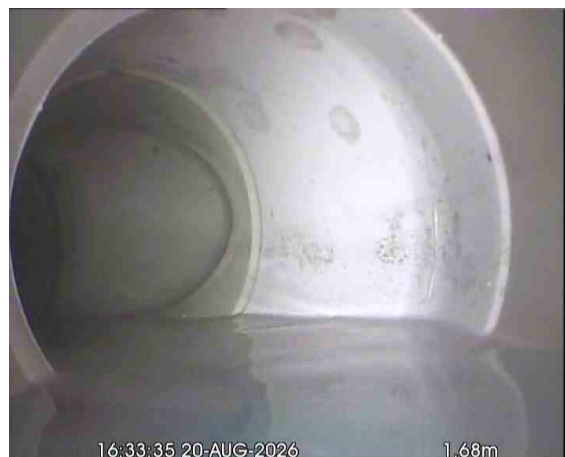
MH31X\_115ecd48-0f7e-4833-8da0-a25af0dfec4b\_20260918\_094749\_553.jpg, 00:00:38, 1.68 m  
Line deviates left

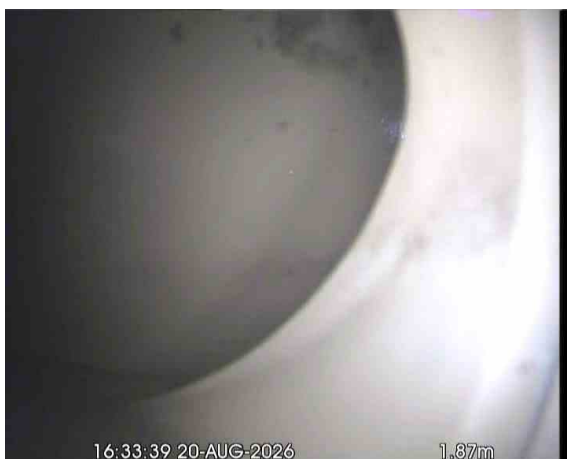
MH31X\_572c7c30-c072-400f-bbda-de16bf5a7652\_20260918\_094817\_536.jpg, 00:00:42, 1.87 m  
Finish node, major connection without manhole, reference:  
BLIND JUNCTION - JOINS SECTION 63 (S63)

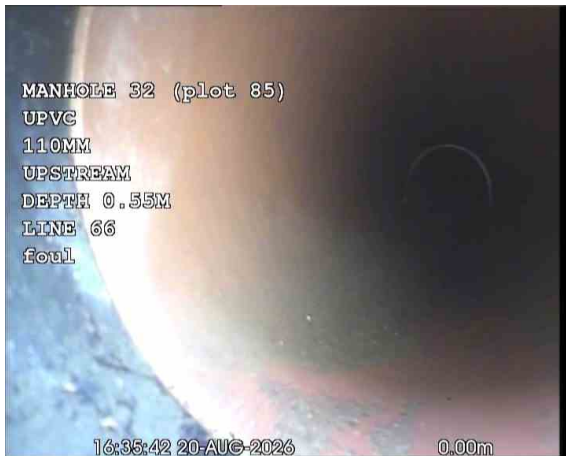
KIT.  
SINKX\_6a6819dd-8a78-48b7-ae54-d48514df1eb1\_20260918\_094923\_844.jpg, 00:00:17, 0.00 m  
Start node, manhole, reference: MANHOLE 32 (MH32)

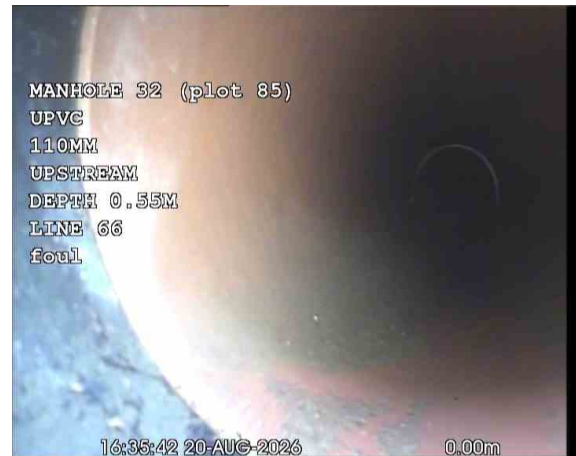
KIT.  
SINKX\_c1f7b5c9-1417-422d-9791-c5f2d74a728e\_20260918\_094929\_744.jpg, 00:00:17, 0.00 m  
Water level, 0% of the vertical dimension

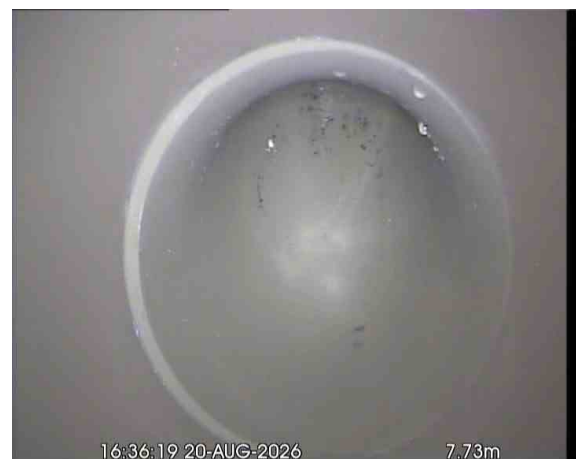
KIT.  
SINKX\_53c6a723-d0be-44a0-a4fc-4ace263d018c\_20260918\_095002\_070.jpg, 00:00:53, 7.73 m  
Line deviates up, REST BEND

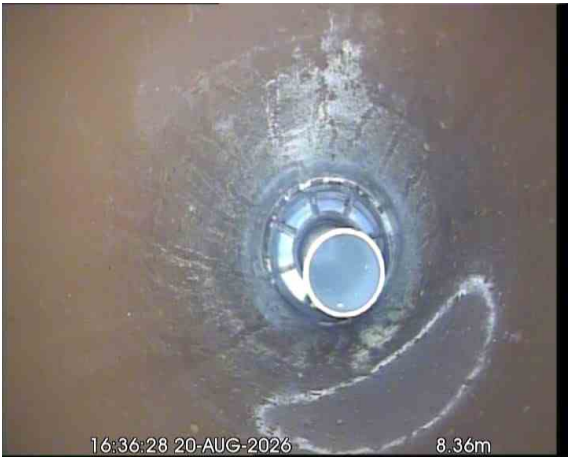
KIT.  
SINKX\_3b50ca90-67ec-4a5c-b67b-d2a1fed15622\_20260918\_095015\_783.jpg, 00:01:03, 8.36 m  
Finish node, major connection without manhole, reference:  
KITCHEN SINK

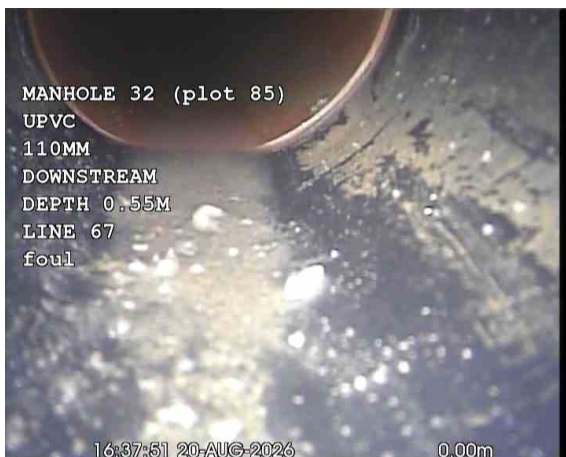
MH32X\_a749461f-2d39-4856-aaf8-75adc7fa6e60\_20260918\_095112\_484.jpg, 00:00:18, 0.00 m  
Start node, manhole, reference: MANHOLE 32 (MH32)

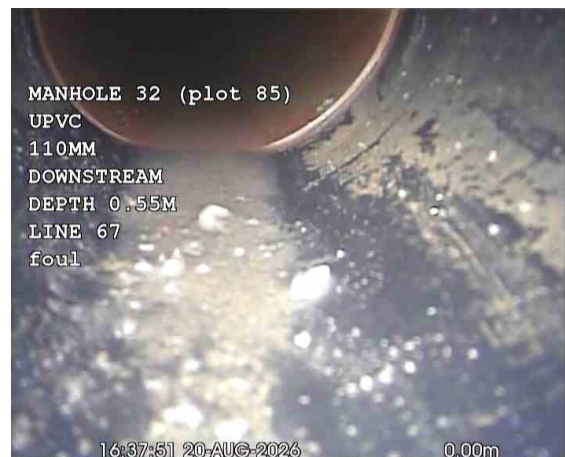
MH32X\_50522d39-e740-4cb5-a22b-7af5cbf29901\_20260918\_095118\_541.jpg, 00:00:18, 0.00 m  
Water level, 0% of the vertical dimension

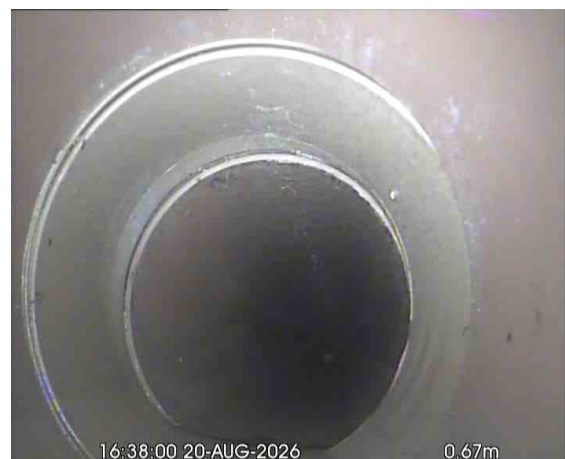
MH32X\_5e0910aa-3f6e-4157-b4b1-465c047b25e9\_20260918\_095139\_344.jpg, 00:00:28, 0.67 m  
Line deviates right

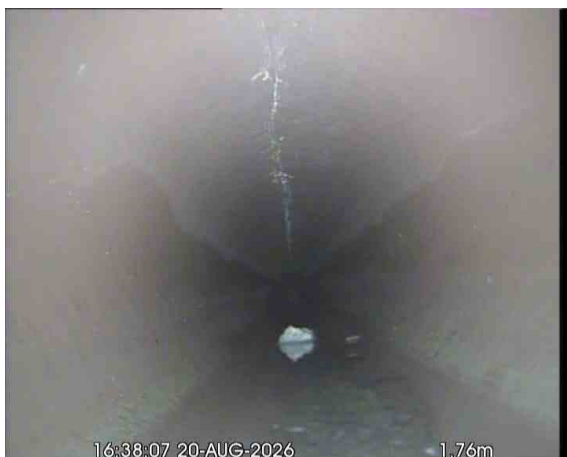
MH32X\_8387c9db-cf90-4561-a64e-93d17577154f\_20260918\_095158\_589.jpg, 00:00:34, 1.76 m  
Water level, 10% of the vertical dimension

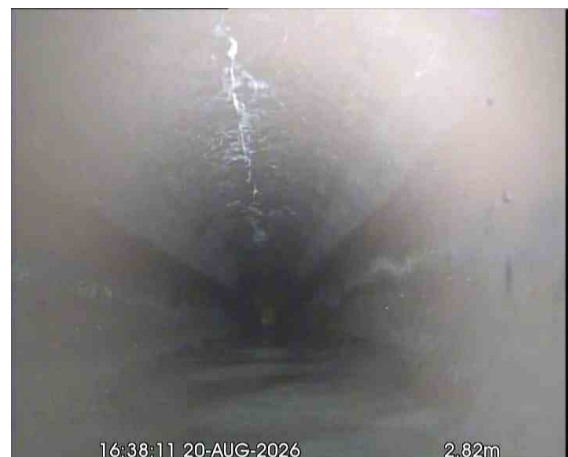
MH32X\_f05a7949-5f1b-43ac-a906-2a5c79c411e9\_20260918\_095215\_718.jpg, 00:00:38, 2.82 m  
Water level, 10% of the vertical dimension

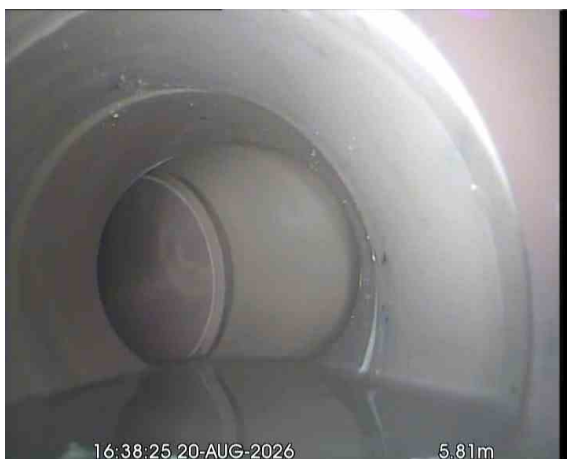
MH32X\_dfc88d4f-44ce-4566-b4c4-49e10635f7a6\_20260918\_095245\_591.jpg, 00:00:52, 5.81 m  
Water level, 10% of the vertical dimension

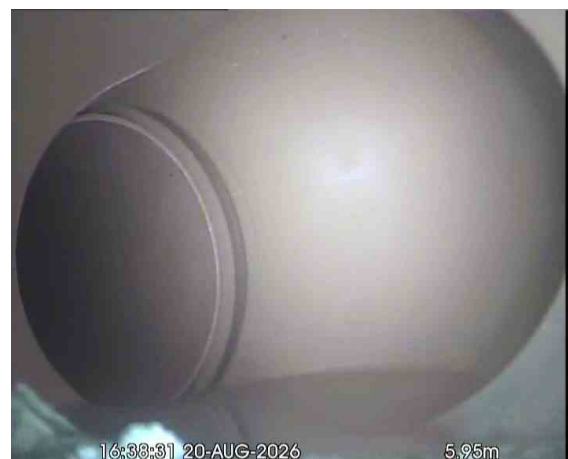
MH32X\_3caed786-831d-4c98-978c-eb59492bdba9\_20260918\_095311\_456.jpg, 00:00:58, 5.95 m  
Finish node, major connection without manhole, reference:  
BLIND JUNCTION - JOINS SECTION 63 (S63)

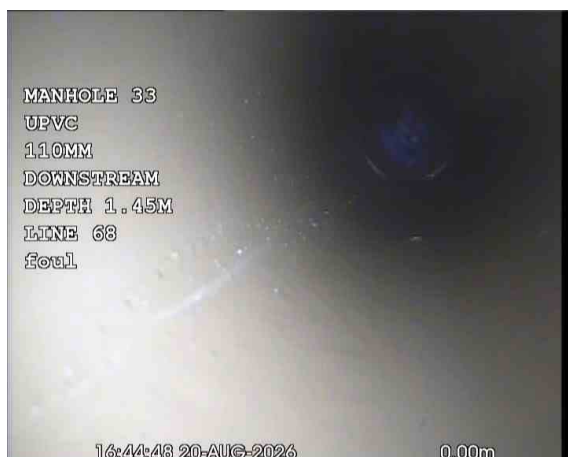
MH33X\_42e53fca-b86e-4afe-b49b-3d8e4b965fed\_20260918\_095450\_404.jpg, 00:00:25, 0.00 m  
Start node, manhole, reference: MANHOLE 33 (MH33)

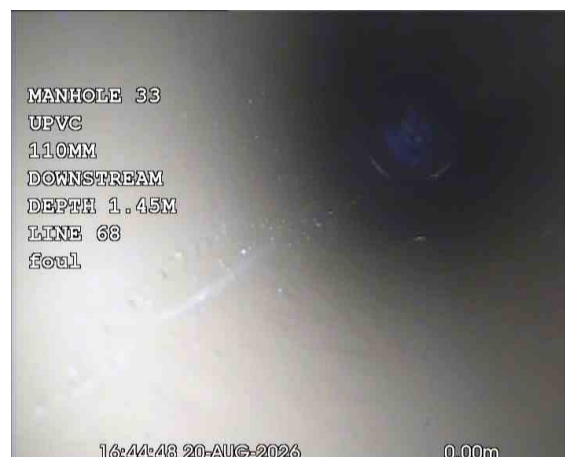
MH33X\_7e40d295-b96c-4b4d-aae4-fdb9dc3b0372\_20260918\_095456\_010.jpg, 00:00:25, 0.00 m  
Water level, 0% of the vertical dimension

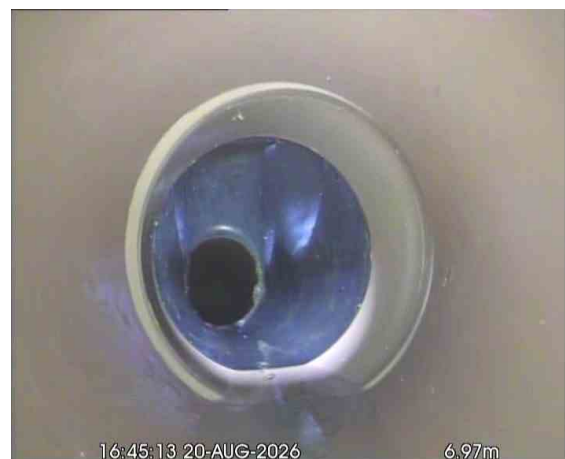
MH33X\_7969662a-4f60-406a-8183-673844b0759d\_20260918\_095704\_584.jpg, 00:00:50, 6.97 m  
Line deviates left

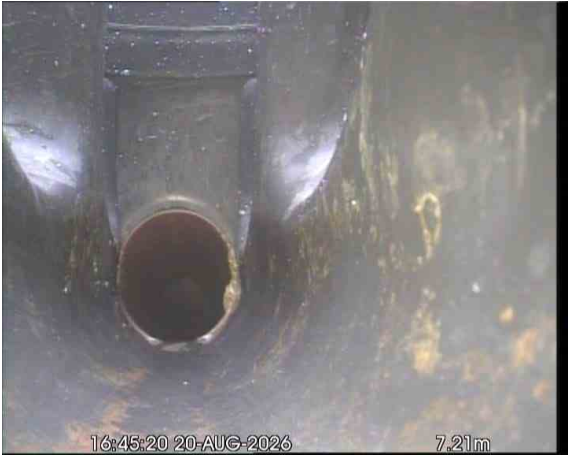
MH33X\_05ca6e2c-e1cb-44b5-a9f9-6d6e8b4bc\_20260918\_095725\_479.jpg, 00:00:57, 7.21 m  
Finish node, manhole, reference: MANHOLE 34 (MH34)

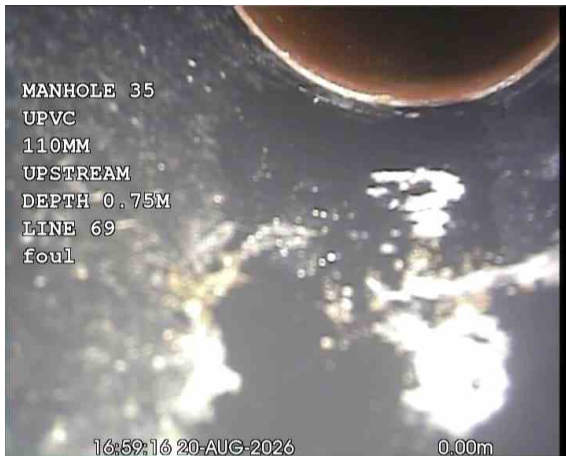
SVPX\_f8700f50-d548-4357-a56b-f88df7a17ce4\_20260918\_100855\_526.jpg, 00:00:29, 0.00 m  
Start node, manhole, reference: MANHOLE 35 (MH35)

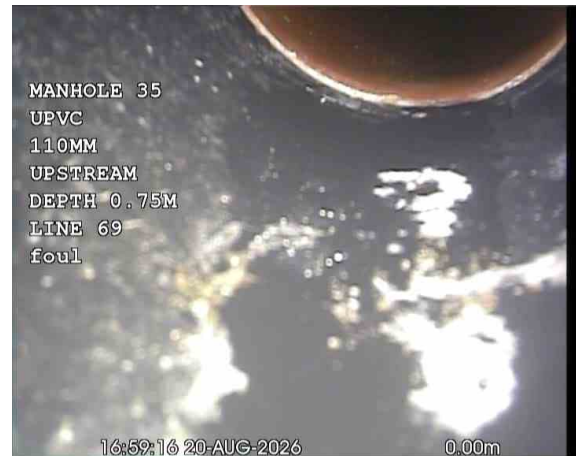
SVPX\_736e7c03-119a-40f7-8979-e1b3106d80d4\_20260918\_100902\_447.jpg, 00:00:29, 0.00 m  
Water level, 0% of the vertical dimension

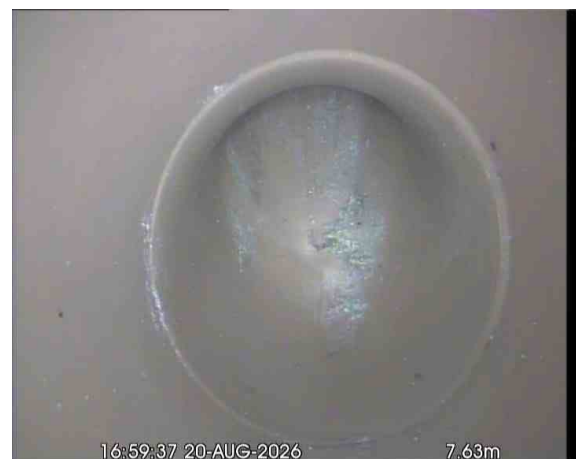
SVPX\_897eb8ea-979f-4907-96d5-132e957b8e94\_20260918\_100927\_359.jpg, 00:00:50, 7.63 m  
Line deviates up, REST BEND

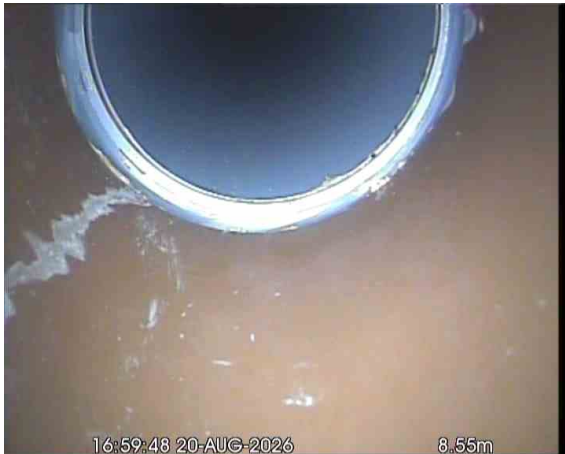
SVPX\_cde95fd1-ba9e-4ff6-af4e-189e7af11492\_20260918\_10  
0944\_959.jpg, 00:01:01, 8.55 m  
Finish node, major connection without manhole, reference:  
SOIL VENT PIPE (SVP)

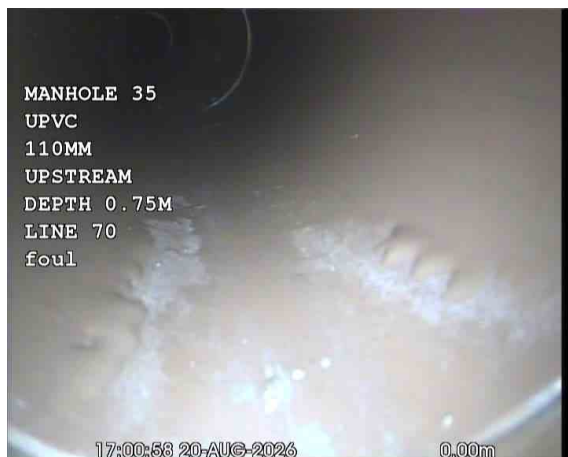
CAPPED  
OFFX\_d53374e7-919c-4a41-9204-07a9a2f8a2ef\_20260918\_101042\_084.jpg, 00:00:15, 0.00 m  
Start node, manhole, reference: MANHOLE 35 (MH35)

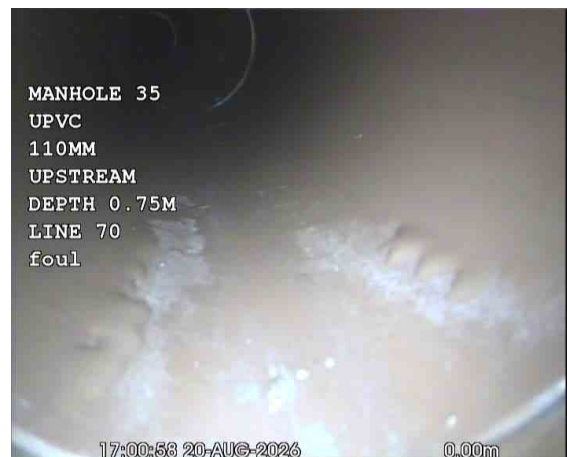
CAPPED  
OFFX\_caaa712e-a44e-4f0d-aeca-96b7998676b9\_20260918\_101049\_519.jpg, 00:00:15, 0.00 m  
Water level, 0% of the vertical dimension

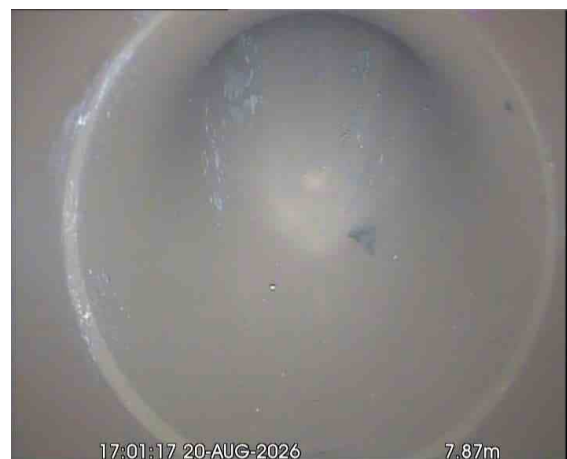
CAPPED  
OFFX\_54005148-d235-4a76-8058-409ad506c306\_20260918\_101122\_544.jpg, 00:00:34, 7.87 m  
Line deviates up, REST BEND

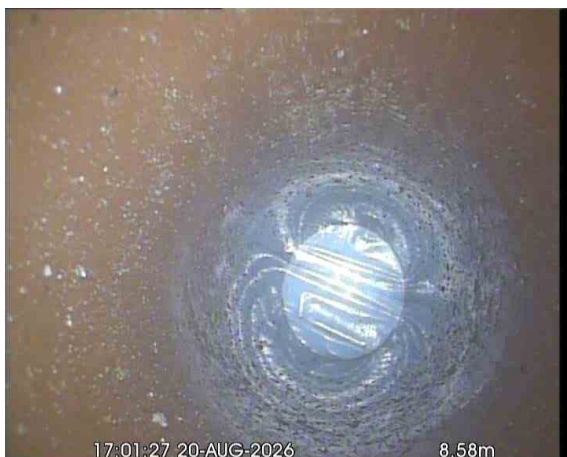
CAPPED

OFFX\_31938335-3fd4-45dd-9343-0b0b62044e47\_20260918\_101145\_528.jpg, 00:00:43, 8.58 m  
Survey abandoned, S/A - CAPPED OFF (WET ROOM)

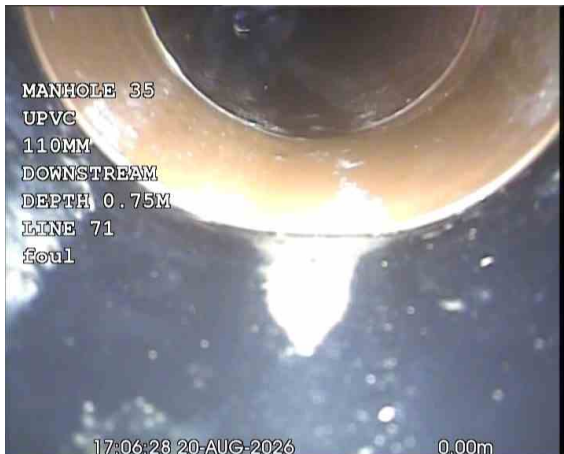
MH35X\_4c7770df-1197-4553-b7e1-d152173171aa\_20260918\_101257\_039.jpg, 00:00:16, 0.00 m  
Start node, manhole, reference: MANHOLE 35 (MH35)

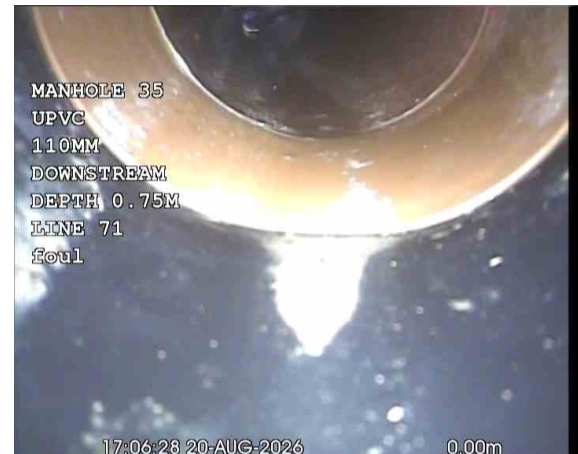
MH35X\_722e6e35-b57e-4225-b6a8-86de97a23128\_20260918\_101303\_551.jpg, 00:00:16, 0.00 m  
Water level, 0% of the vertical dimension

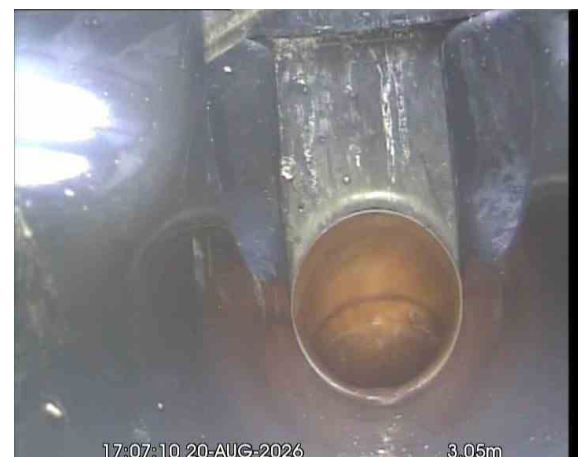
MH35X\_ee4fe31a-49f5-4de4-b501-2b71efe3fd7b\_20260918\_101336\_578.jpg, 00:00:36, 3.05 m  
Finish node, manhole, reference: MANHOLE 39 (MH39)

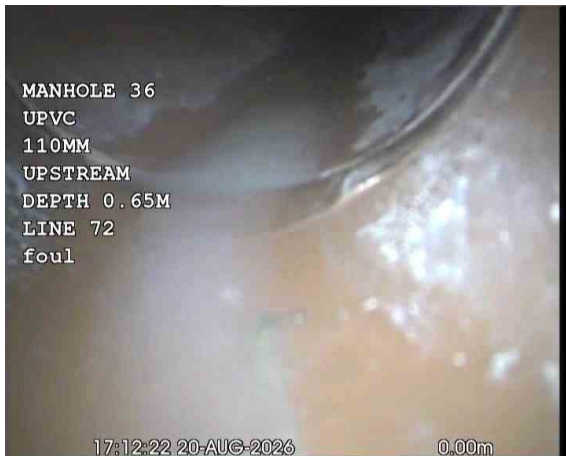
SVPX\_e944b52e-348b-4bb0-bb42-e3366dd31f44\_20260918\_101443\_234.jpg, 00:00:19, 0.00 m  
Start node, manhole, reference: MANHOLE 36 (MH36)

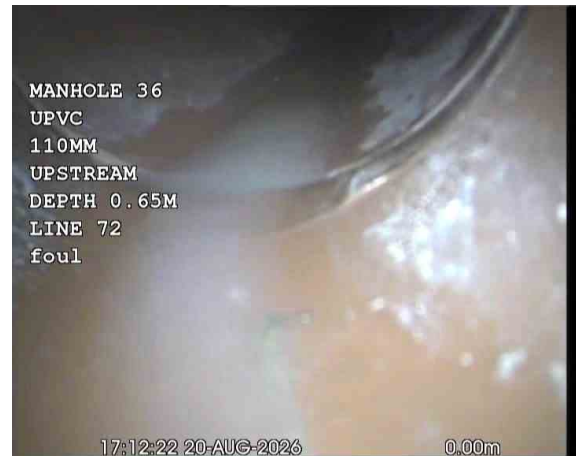
SVPX\_1711e918-e268-4741-9580-f351867aead1\_20260918\_101449\_309.jpg, 00:00:19, 0.00 m  
Water level, 0% of the vertical dimension

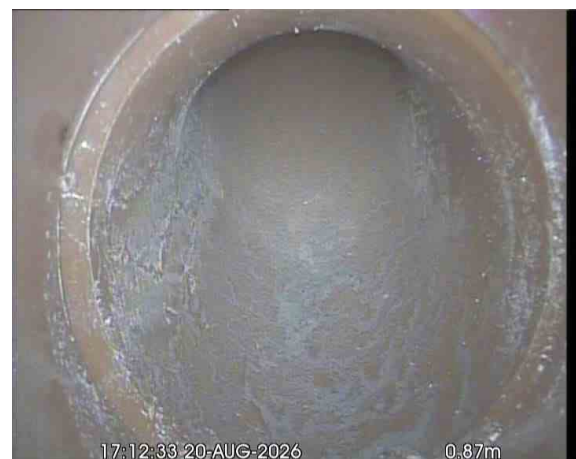
SVPX\_953880e6-8502-4fde-9845-3e6edcb53494\_20260918\_101514\_364.jpg, 00:00:30, 0.87 m  
Line deviates up, REST BEND

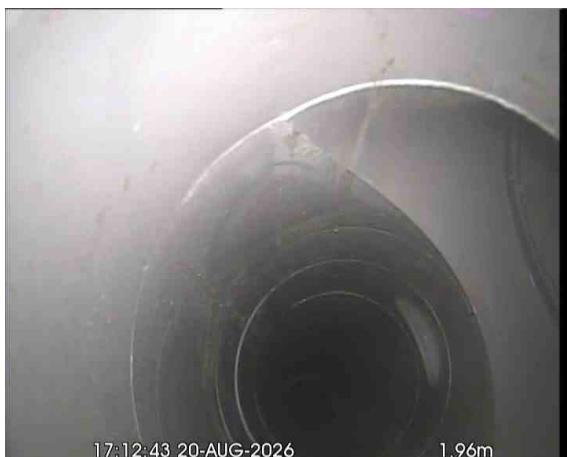
SVPX\_71b5f244-6272-4f6d-b256-c4087bf6dd6f\_20260918\_1  
01535\_865.jpg, 00:00:39, 1.96 m

Finish node, major connection without manhole, reference:  
SOIL VENT PIPE (SVP) & DOWNSTAIRS W/C

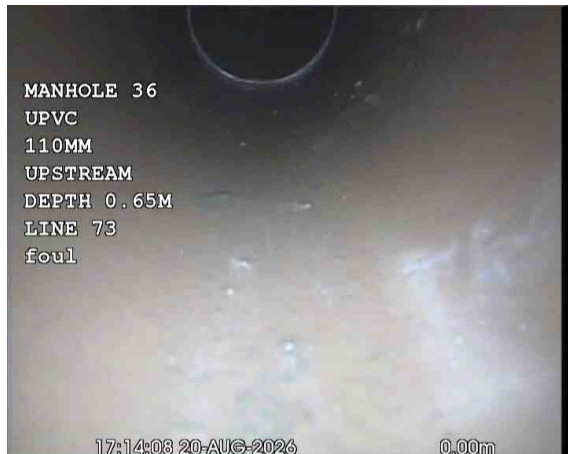
CAPPED  
OFFX\_c9cd19b9-49db-441b-9723-6cf9d343a64c\_20260918\_101637\_110.jpg, 00:00:11, 0.00 m  
Start node, manhole, reference: MANHOLE 36 (MH36)

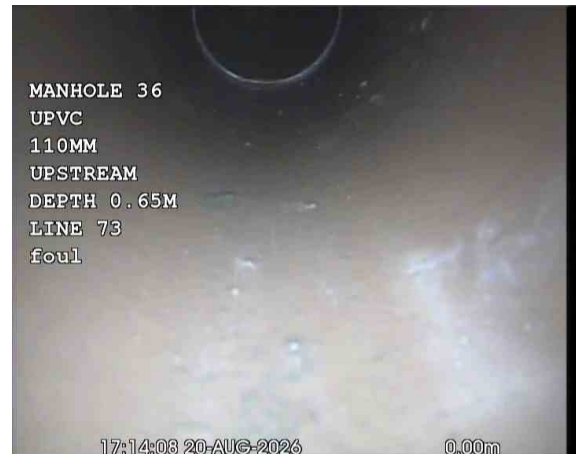
CAPPED  
OFFX\_e6c949f3-364b-4e0d-9c79-17786187e698\_20260918\_101643\_361.jpg, 00:00:11, 0.00 m  
Water level, 0% of the vertical dimension

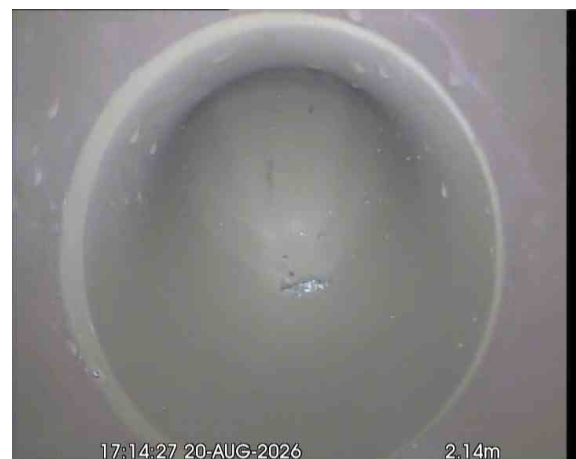
CAPPED  
OFFX\_9192abd0-fe56-4978-b900-76fe471a808c\_20260918\_101850\_913.jpg, 00:00:30, 2.14 m  
Line deviates up, REST BEND

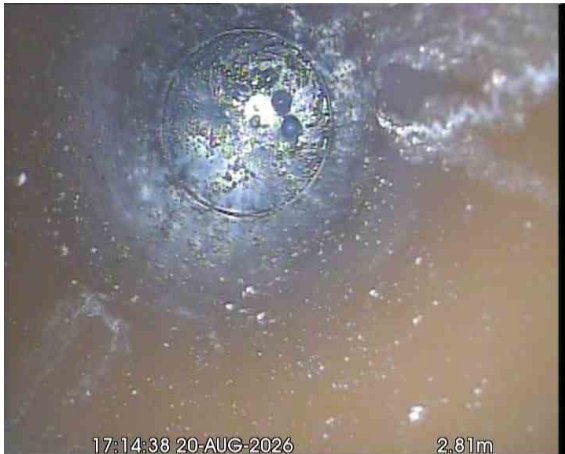
CAPPED  
OFFX\_6afdf43f-b1a4-41c0-ad5f-3105cd8315a7\_20260918\_10  
1913\_775.jpg, 00:00:41, 2.81 m  
Survey abandoned, S/A - CAPPED OFF (WET ROOM)

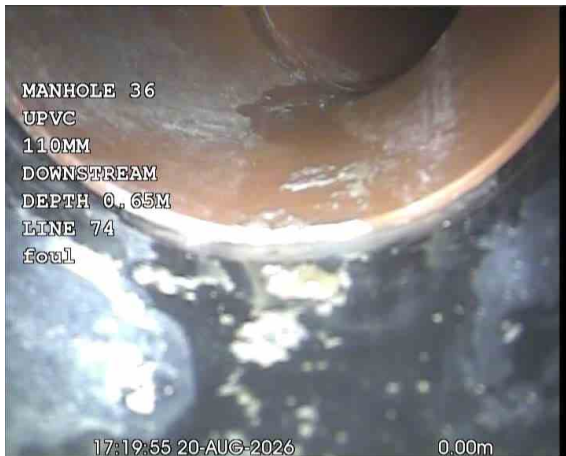
MH36X\_7ff1463f-c8ca-476a-99e8-fccbf27363c\_20260918\_102031\_515.jpg, 00:00:39, 0.00 m  
Start node, manhole, reference: MANHOLE 36 (MH36)

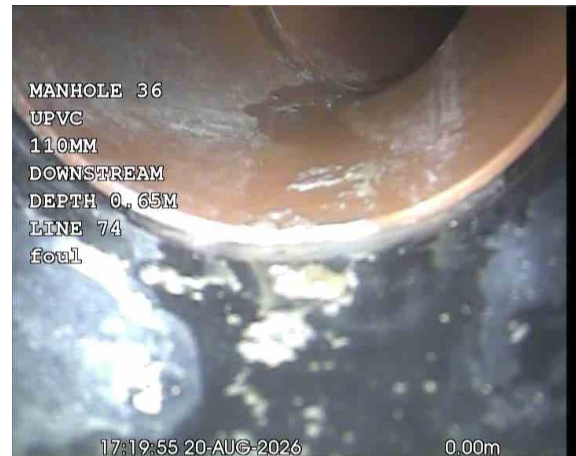
MH36X\_33d8a641-03df-4713-b360-8003568c10dc\_20260918\_102038\_532.jpg, 00:00:39, 0.00 m  
Water level, 0% of the vertical dimension

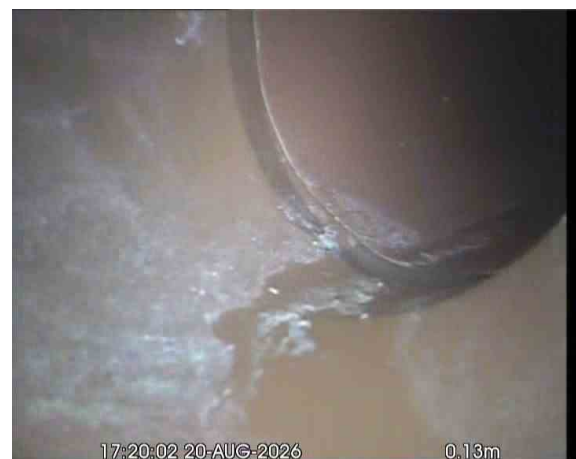
MH36X\_e09b0b01-f82c-40f3-8aca-19f216624f20\_20260918\_102100\_633.jpg, 00:00:46, 0.13 m  
Line deviates right

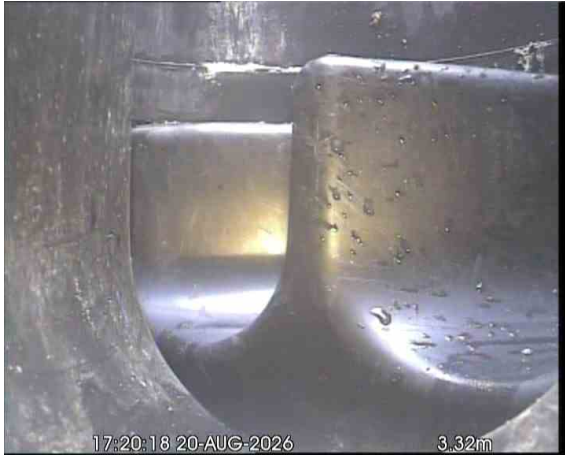
MH36X\_Of967b7a-bd0b-456e-aaef-ba4223fdb025\_20260918\_102125\_884.jpg, 00:01:01, 3.32 m  
Finish node, manhole, reference: MANHOLE 39 (MH39)

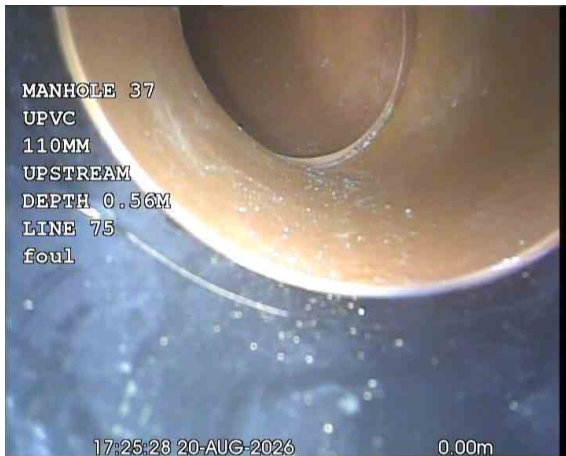
SVPX\_f454dc11-7d36-4197-9d2a-7ded42e46329\_20260918\_102221\_808.jpg, 00:00:21, 0.00 m  
Start node, manhole, reference: MANHOLE 37 (MH37)

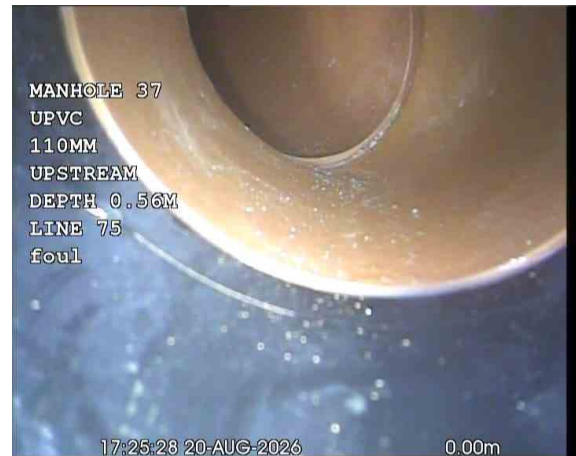
SVPX\_e0f46ae1-a4f0-456c-a37a-4750b331dded\_20260918\_102231\_680.jpg, 00:00:21, 0.00 m  
Water level, 0% of the vertical dimension

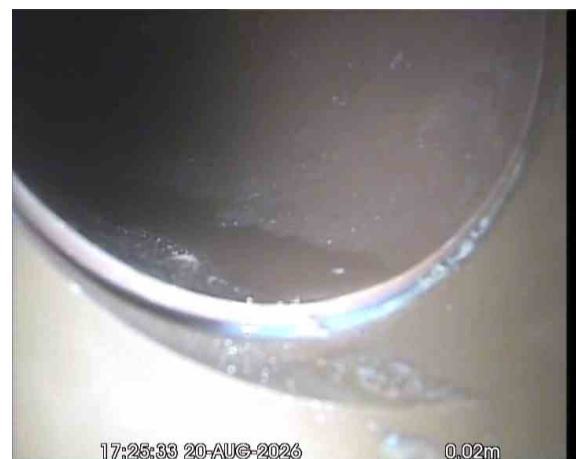
SVPX\_b7ab71b3-2d14-44ea-9f15-2c95f3af226f\_20260918\_102254\_485.jpg, 00:00:27, 0.02 m  
Line deviates left

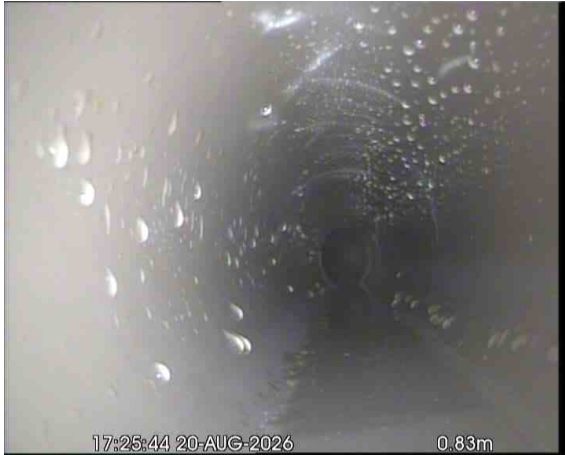
SVPX\_c82a844d-0596-42db-a9f1-8bf3dbabeedd\_20260918\_102312\_479.jpg, 00:00:38, 0.83 m  
Water level, 5% of the vertical dimension

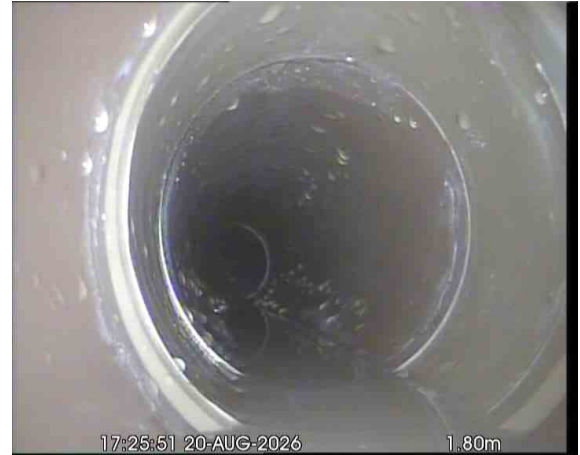
SVPX\_c4796f40-e1a7-4241-85fc-d148100cf665\_20260918\_102327\_175.jpg, 00:00:45, 1.80 m  
Line deviates left

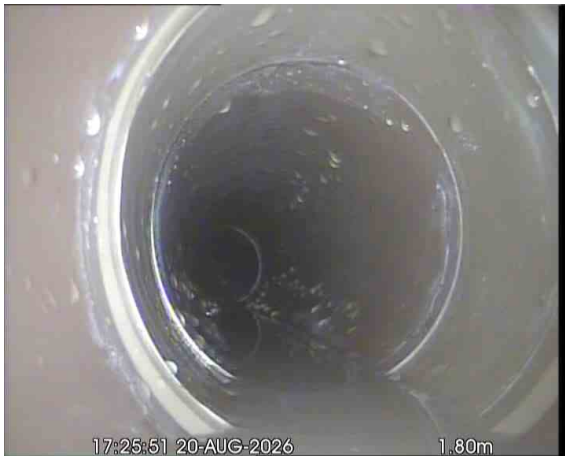
SVPX\_3a130f28-d381-44ea-9998-2b1494308618\_20260918\_102334\_975.jpg, 00:00:45, 1.80 m  
Water level, 5% of the vertical dimension

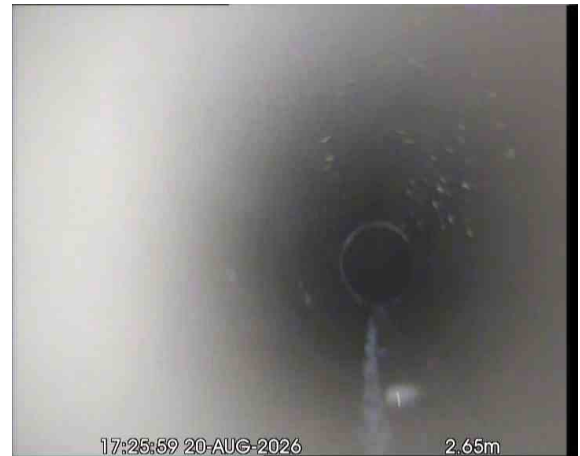
SVPX\_fdd24e5f-bcdd-4f80-be45-3c98fc8299ef\_20260918\_102354\_414.jpg, 00:00:53, 2.65 m  
Water level, 0% of the vertical dimension

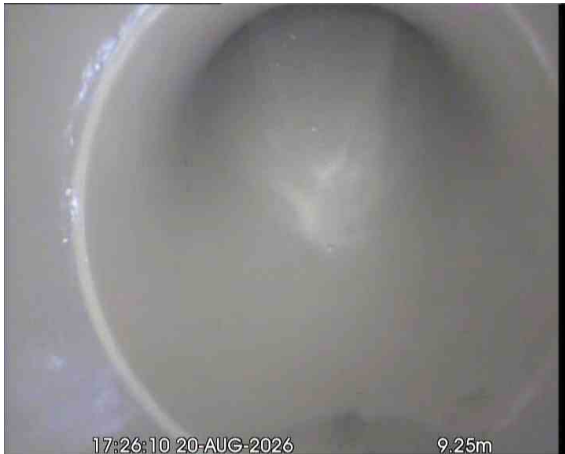
SVPX\_8209400f-7154-4b0f-bf21-6b00a4c60ef7\_20260918\_102417\_128.jpg, 00:01:04, 9.25 m  
Line deviates up, REST BEND

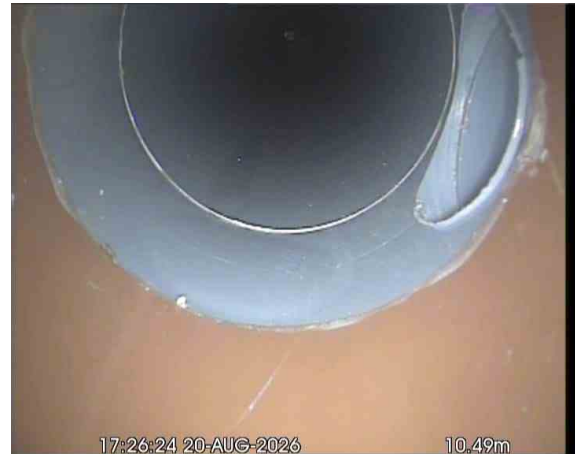
SVPX\_f5f94117-bd53-44f6-ba76-d325dfd2f447\_20260918\_102439\_810.jpg, 00:01:17, 10.49 m  
Finish node, major connection without manhole, reference: SOIL VENT PIPE (SVP) & KITCHEN SINK

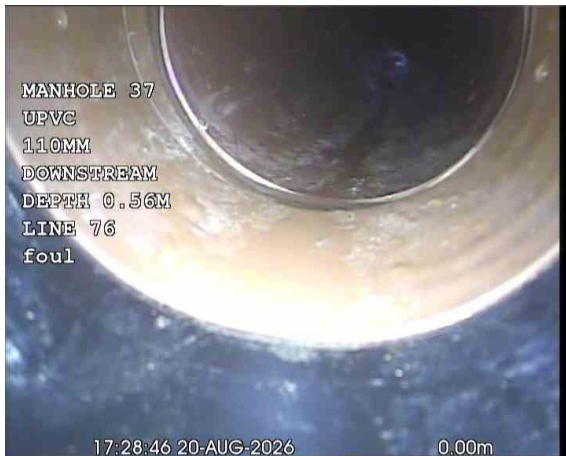
MH37X\_38ed49cf-08e8-4ce0-8b34-251c6df5da31\_20260918\_102743\_618.jpg, 00:00:18, 0.00 m  
Start node, manhole, reference: MANHOLE 37 (MH37)

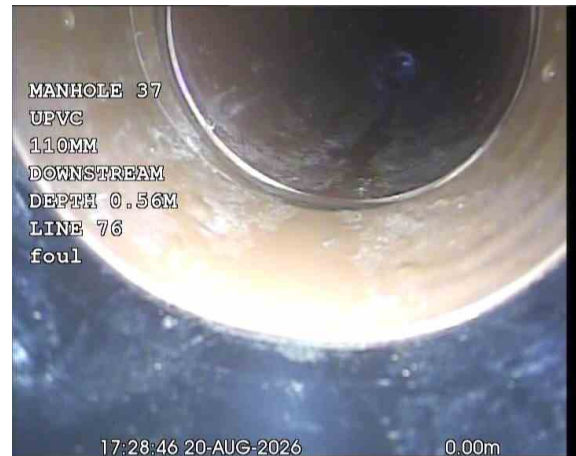
MH37X\_e7ce5ae1-57e0-4593-9ab5-de5c8c31a090\_20260918\_102749\_856.jpg, 00:00:18, 0.00 m  
Water level, 0% of the vertical dimension

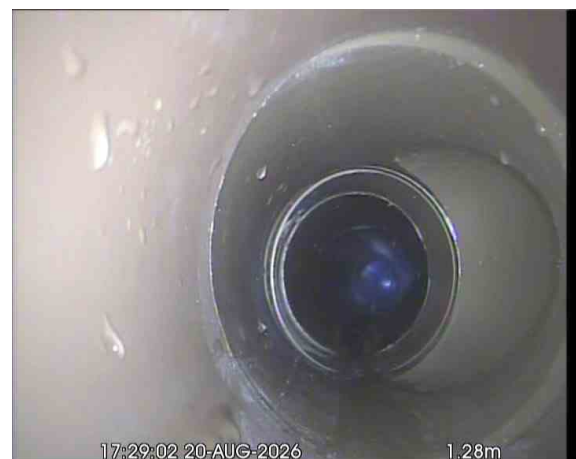
MH37X\_dafdb3b2d-29d2-4ee2-bac9-e90bb8103ebb\_20260918\_102819\_720.jpg, 00:00:34, 1.28 m  
Junction at 3 o'clock, diameter: 110mm, SECTION 78 (S78)

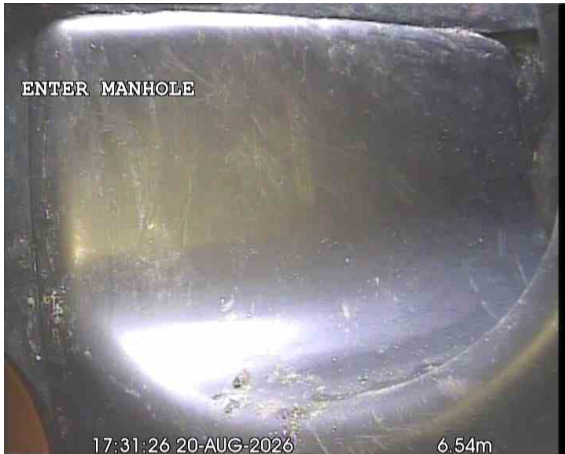
MH37X\_a4a74e2c-3de8-42f1-ac1a-efb002e32e36\_20260918  
\_102900\_167.jpg, 00:01:11, 6.54 m  
Finish node, manhole, reference: MANHOLE 39 (MH39)

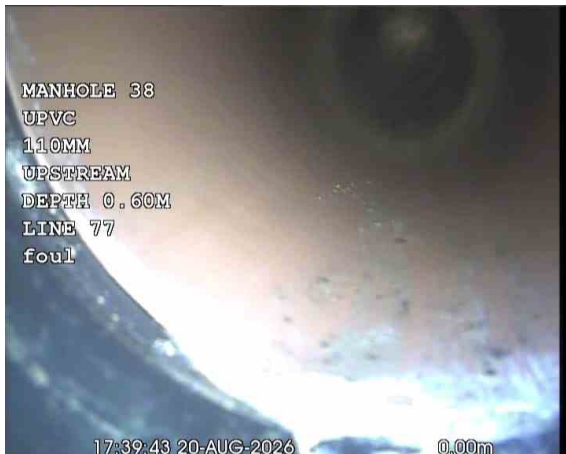
SVPX\_b22644d8-a6d2-40e5-8027-5581d46c021f\_20260918\_103014\_530.jpg, 00:00:40, 0.00 m  
Start node, manhole, reference: MANHOLE 38 (MH38)

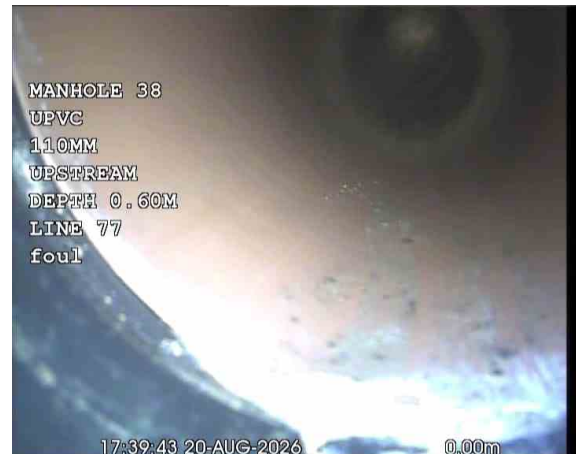
SVPX\_79f91e1a-bc8c-4d67-7916b2337219\_20260918\_103020\_904.jpg, 00:00:40, 0.00 m  
Water level, 0% of the vertical dimension

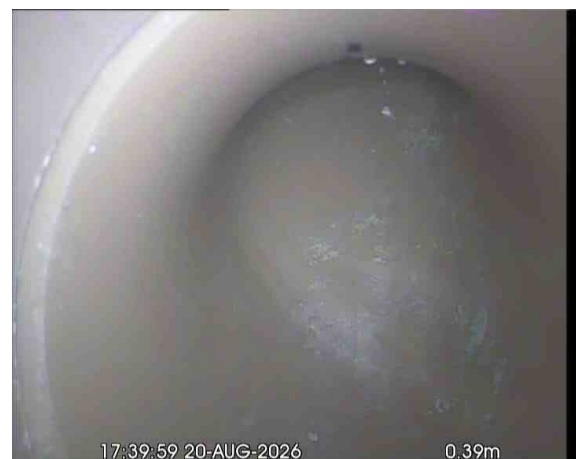
SVPX\_3c8021a0-9ee2-4aa2-984c-97cee8fa075c\_20260918\_103043\_648.jpg, 00:00:56, 0.39 m  
Line deviates up, REST BEND

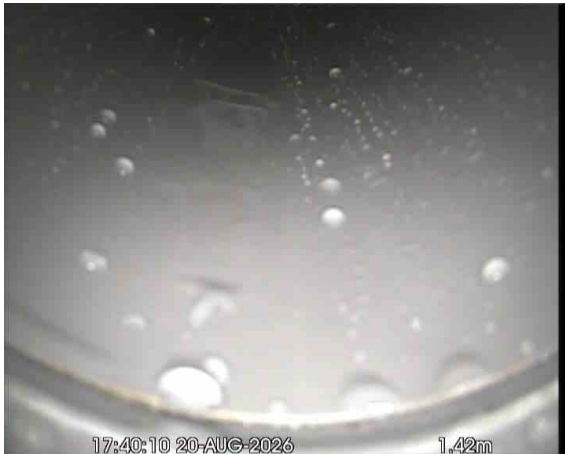
SVPX\_1ace429c-1d1d-4c7c-bfcd-a69acdb00780\_20260918\_1  
03103\_095.jpg, 00:01:08, 1.42 m  
Finish node, major connection without manhole, reference:  
SOIL VENT PIPE (SVP)
