## **Project**

**Project Name:** Arundel Gate BN18 9EX  
**Project Description:** General CCTV - Condition Check  
**Project Number:** JSD10246  
**Project Status:** Complete  
**Project Date:** 17/09/2026  
**Inspection Standard:** MSCC4 Sewers & Drainage GB (SRM4 Scoring)

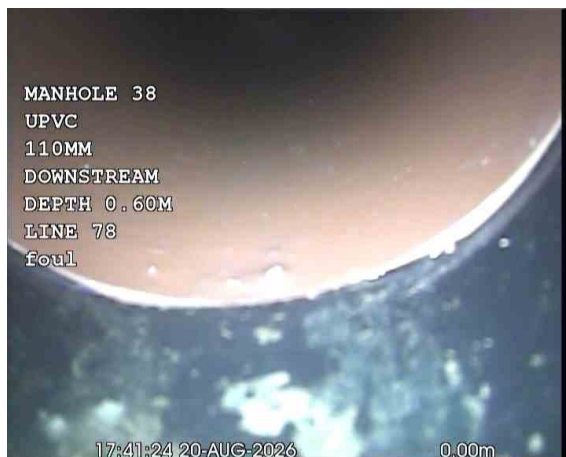
MH38X\_36e04c52-039b-44b7-b53c-852b41b8c2c5\_20260918\_103210\_214.jpg, 00:00:20, 0.00 m  
Start node, manhole, reference: MANHOLE 38 (MH38)

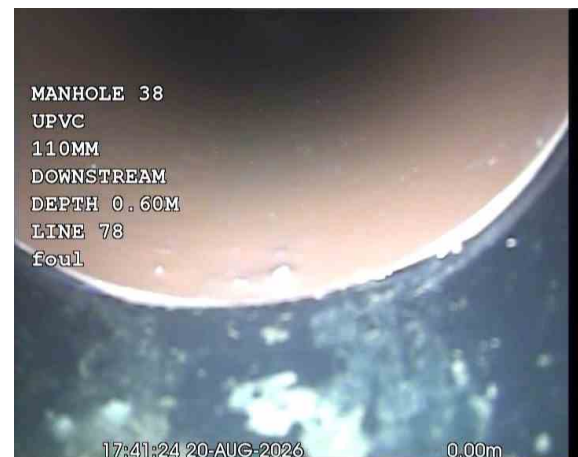
MH38X\_51e12d8f-8138-4ef1-9e86-c642b2442e8a\_20260918\_103216\_561.jpg, 00:00:20, 0.00 m  
Water level, 0% of the vertical dimension

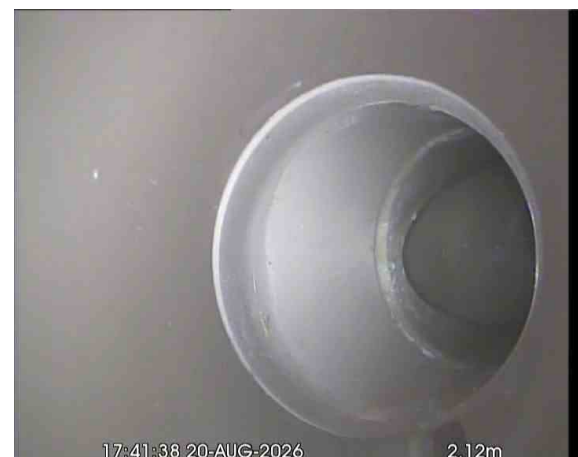
MH38X\_b16c1fe1-a967-40eb-a772-f7dbd54acb74\_20260918\_103238\_514.jpg, 00:00:33, 2.12 m  
Line deviates right

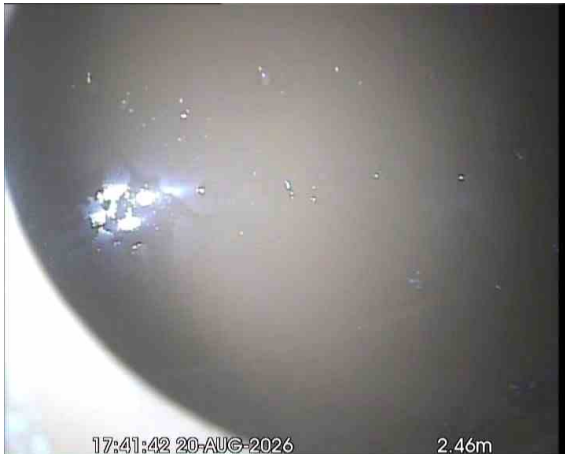
MH38X\_775a63f1-bb46-43ce-804d-5752e9d11c1f\_20260918  
\_103302\_015.jpg, 00:00:37, 2.46 m  
Finish node, major connection without manhole, reference:  
BLIND JUNCTION - JOINS SECTION 76 (S76)

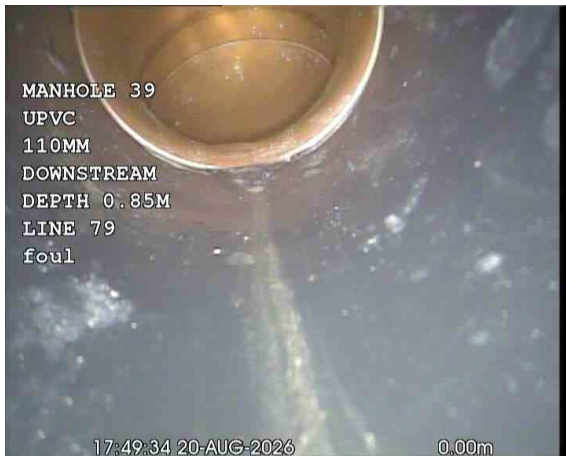
MH39X\_c023d4a9-6269-49bd-b7b9-cf8accdccb14\_20260918\_103439\_624.jpg, 00:00:23, 0.00 m  
Start node, manhole, reference: MANHOLE 39 (MH39)

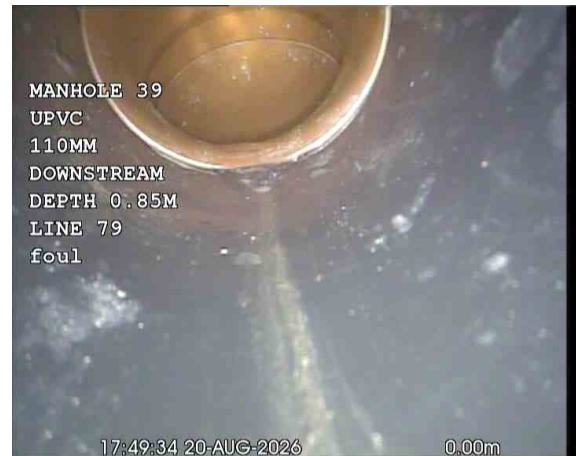
MH39X\_b1249d83-7826-4e8b-8467-5343a7954b2a\_20260918\_103447\_420.jpg, 00:00:23, 0.00 m  
Water level, 0% of the vertical dimension

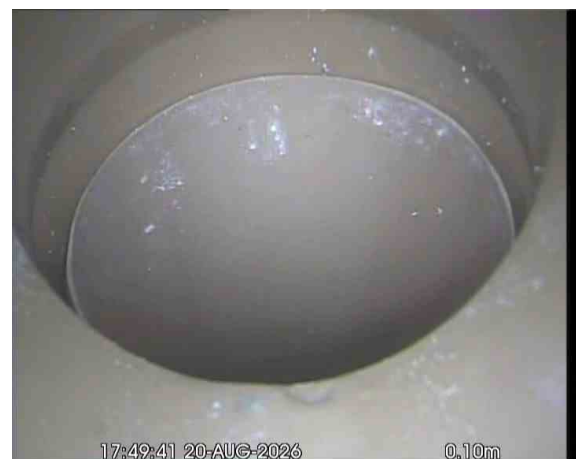
MH39X\_7944ec74-93d7-4598-ac61-282eadb9ab4d\_20260918\_103511\_794.jpg, 00:00:29, 0.10 m  
Line deviates down, \*\*VERTICALLY DOWN\*\*

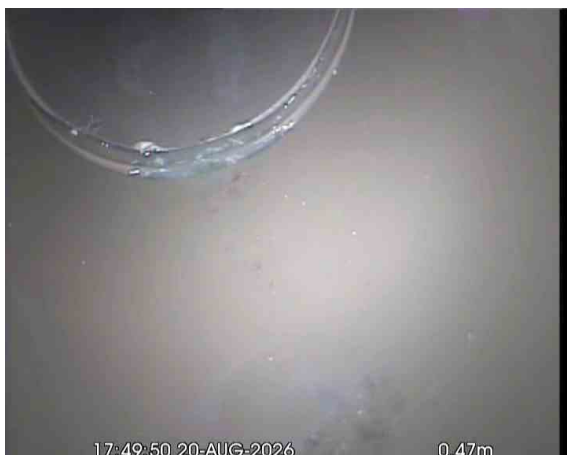
MH39X\_f79daff0-11d6-4245-905a-5bf3eafa14c5\_20260918\_103525\_006.jpg, 00:00:38, 0.47 m  
Line deviates up

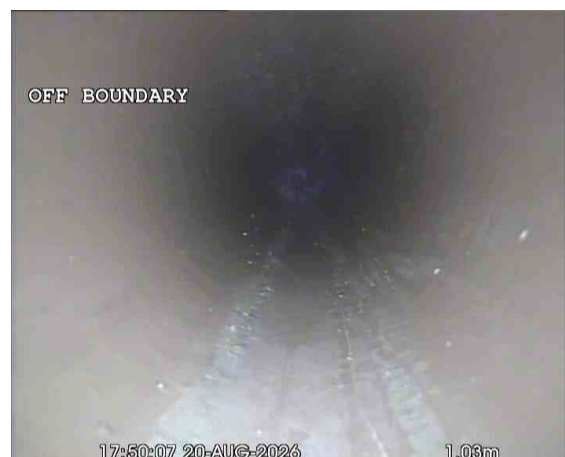
MH39X\_9a53c264-177a-44eb-b9b2-e2f4eab0bc96\_20260918\_103546\_100.jpg, 00:00:49, 1.03 m  
General remark, \*\*BOUNDARY POINT\*\*

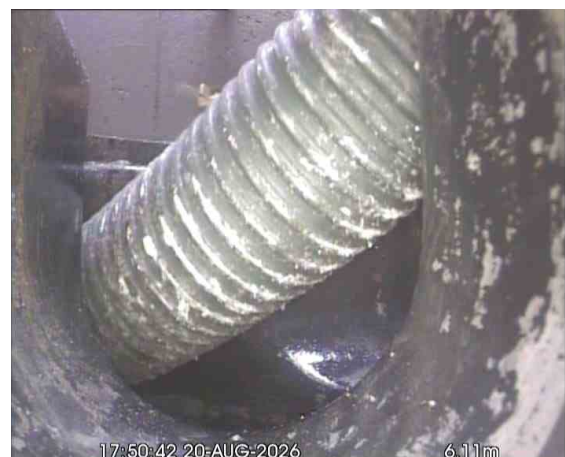
MH39X\_e549956b-95b0-40d2-bfe8-acef5b96bd59\_20260918\_103628\_466.jpg, 00:01:24, 6.11 m  
Finish node, manhole, reference: MANHOLE 11 (MH11) - IN THE ROAD, (F34)
