## Re: LP2430 Lidsey Lodge Farm Winter Groundwater Monitoring

### 1 Introduction

Leap Environmental Ltd (hereafter referred to as LEAP) has been appointed by Melanie Jenkins to undertake winter groundwater monitoring at Lidsey Lodge Farm, Sack Lane, Lidsey, Bognor Regis, PO22 9PE.

It is proposed to partially redevelop the site into 8No. residential dwellings with associated gardens and public open space as per Figure 2, Appendix B.

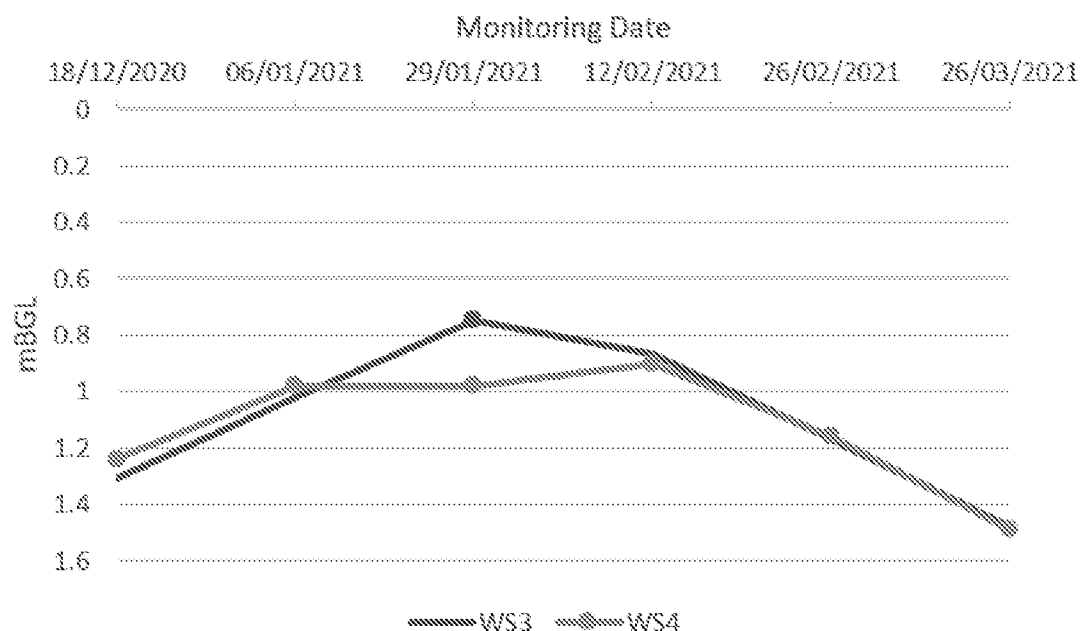
**Chart 3: Summary of groundwater elevations**

Groundwater monitoring was undertaken from the 18<sup>th</sup> December 2020 to the 26<sup>th</sup> March 2021. The first monitoring visit took place on the day of the intrusive investigation, approximately 1 hour after the drilling had ended in order to allow groundwater levels to equalise. The elevations are shown in the chart below and full results are provided in Appendix D.
