**Subject:** AL/20/21/PL - Wings Nursery, Lindsey Road, Woodgate

From those, it seems we are closer to a layout/drainage proposal that affords retained trees the necessary level of respect and protection.

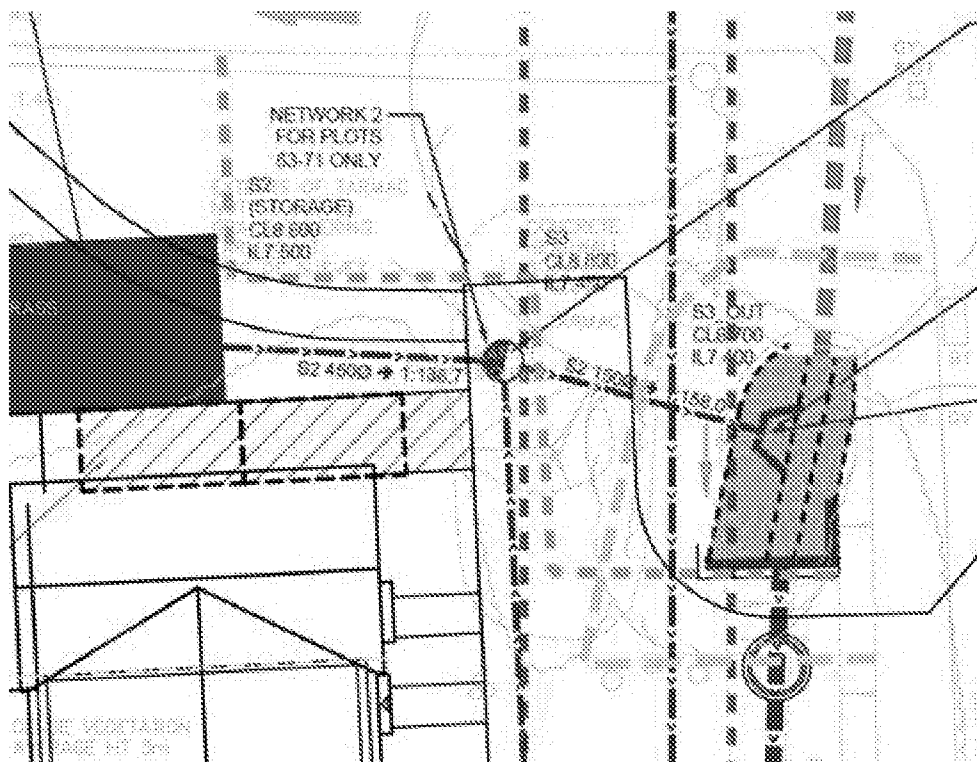
Also attached is a copy of the drainage layout which shows drainage runs positioned outside RPAs of all retained trees bar a short section linking with the existing culvert to the south of T1 (below).

Arboricultural supervision will determine whether a hand dug trench or broken trench within the RPA is acceptable or whether a trenchless approach has to be adopted.

Proposed outfall routing in proximity to T1 appears to be well within the RPA of that tree, and we still do not have a plan showing the precise extent of incursion. I will need to see the RPA of T1 shown in relation to the proposed utility apparatus before considering that concession. In any event, there needs to be overriding justification for RPA incursion – can your client's drainage engineer not present an alternative option?
