## Re: LP2430 Lidsey Lodge Farm Winter Groundwater Monitoring

### 1 Introduction

Leap Environmental Ltd (hereafter referred to as LEAP) has been appointed by Melanie Jenkins to undertake winter groundwater monitoring at Lidsey Lodge Farm, Sack Lane, Lidsey, Bognor Regis, PO22 9PE.

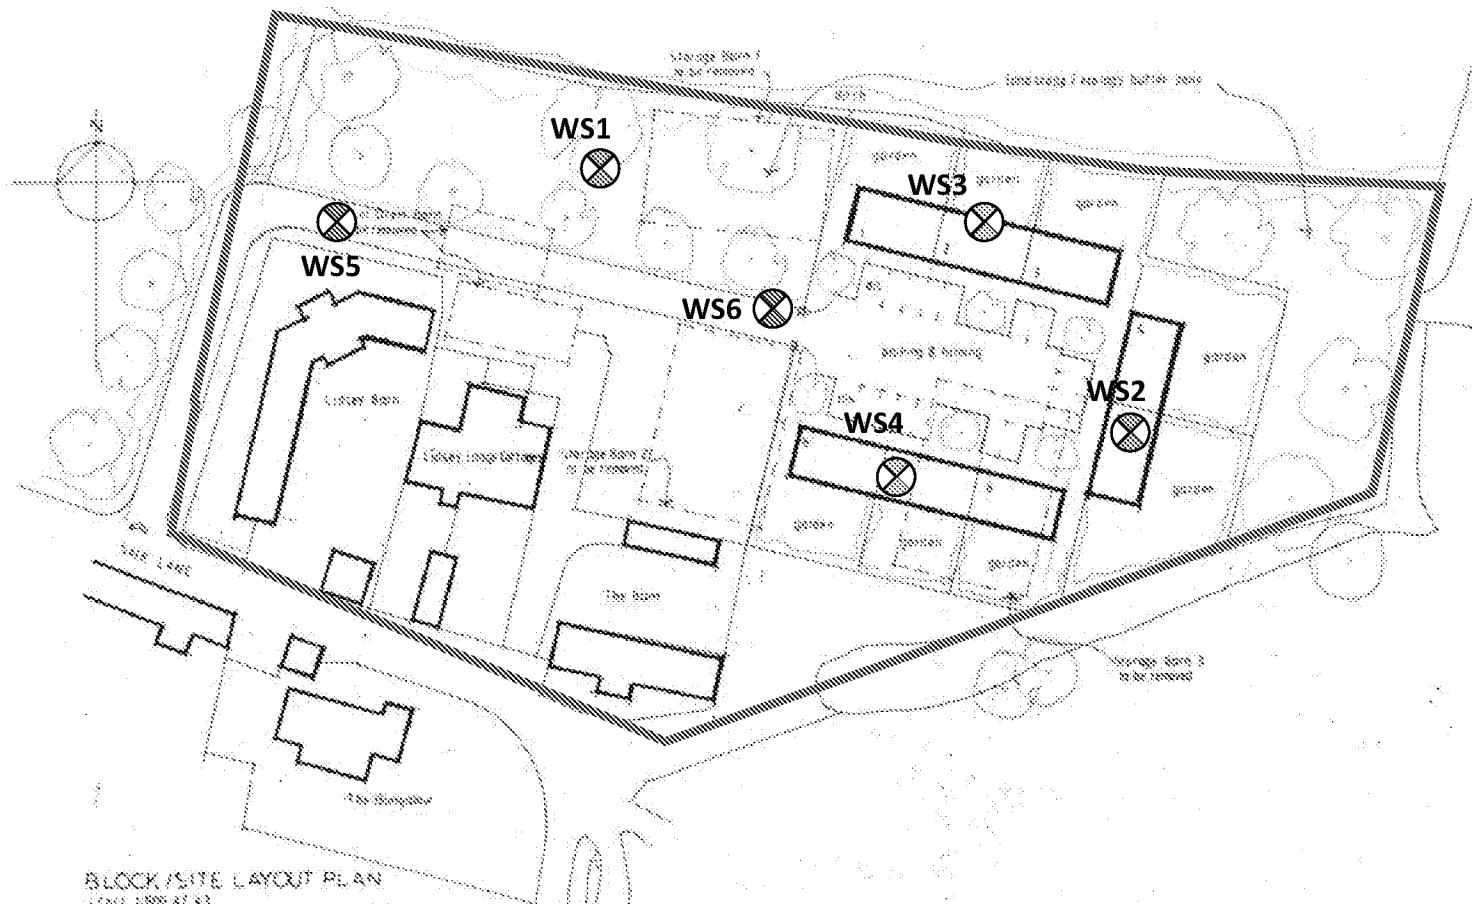
BLOCK/SITE LAYOUT PLAN  
Scale 1:500 at A3  
0 10 20 30m

It is proposed to partially redevelop the site into 8No. residential dwellings with associated gardens and public open space as per Figure 2, Appendix B.
