# Geo-Environmental Assessment

Oldlands Farm, Bognor Regis

Delta-Simons Project No. 20-1543.07

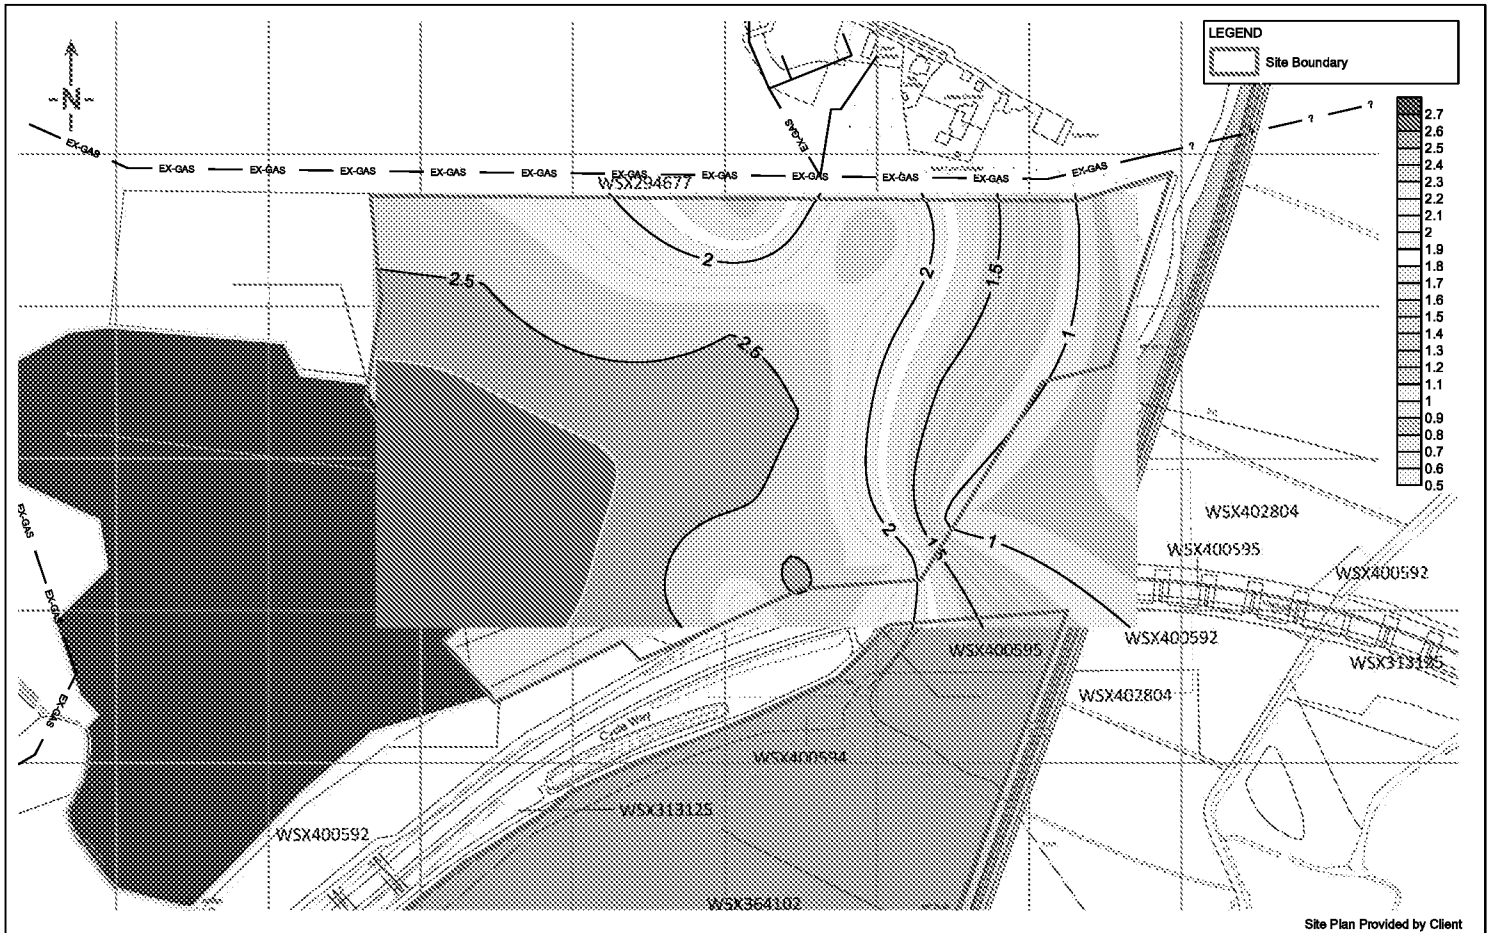
## Figure 5 – Contour Plots

| | <b>TITLE</b><br>Flood Compensation Area, River Terrace Deposits, Thickness (m)<br>Oldlands Farm<br>Bognor Regis | | <b>PROJECT NO:</b><br>20-1543.07 | |

Plots of inferred topsoil, Raised Marine Deposit and River Terrace Deposit thicknesses are included as Figure 5– 5c for the Main Development Area and the Flood Compensation Area.
