## TREE IMPACT ASSESSMENT AND METHOD STATEMENT:

**233 MANOR WAY  
ALDWICK BAY ESTATE  
BOGNOR REGIS  
PO21 4HT**

## Tree Protection Plan

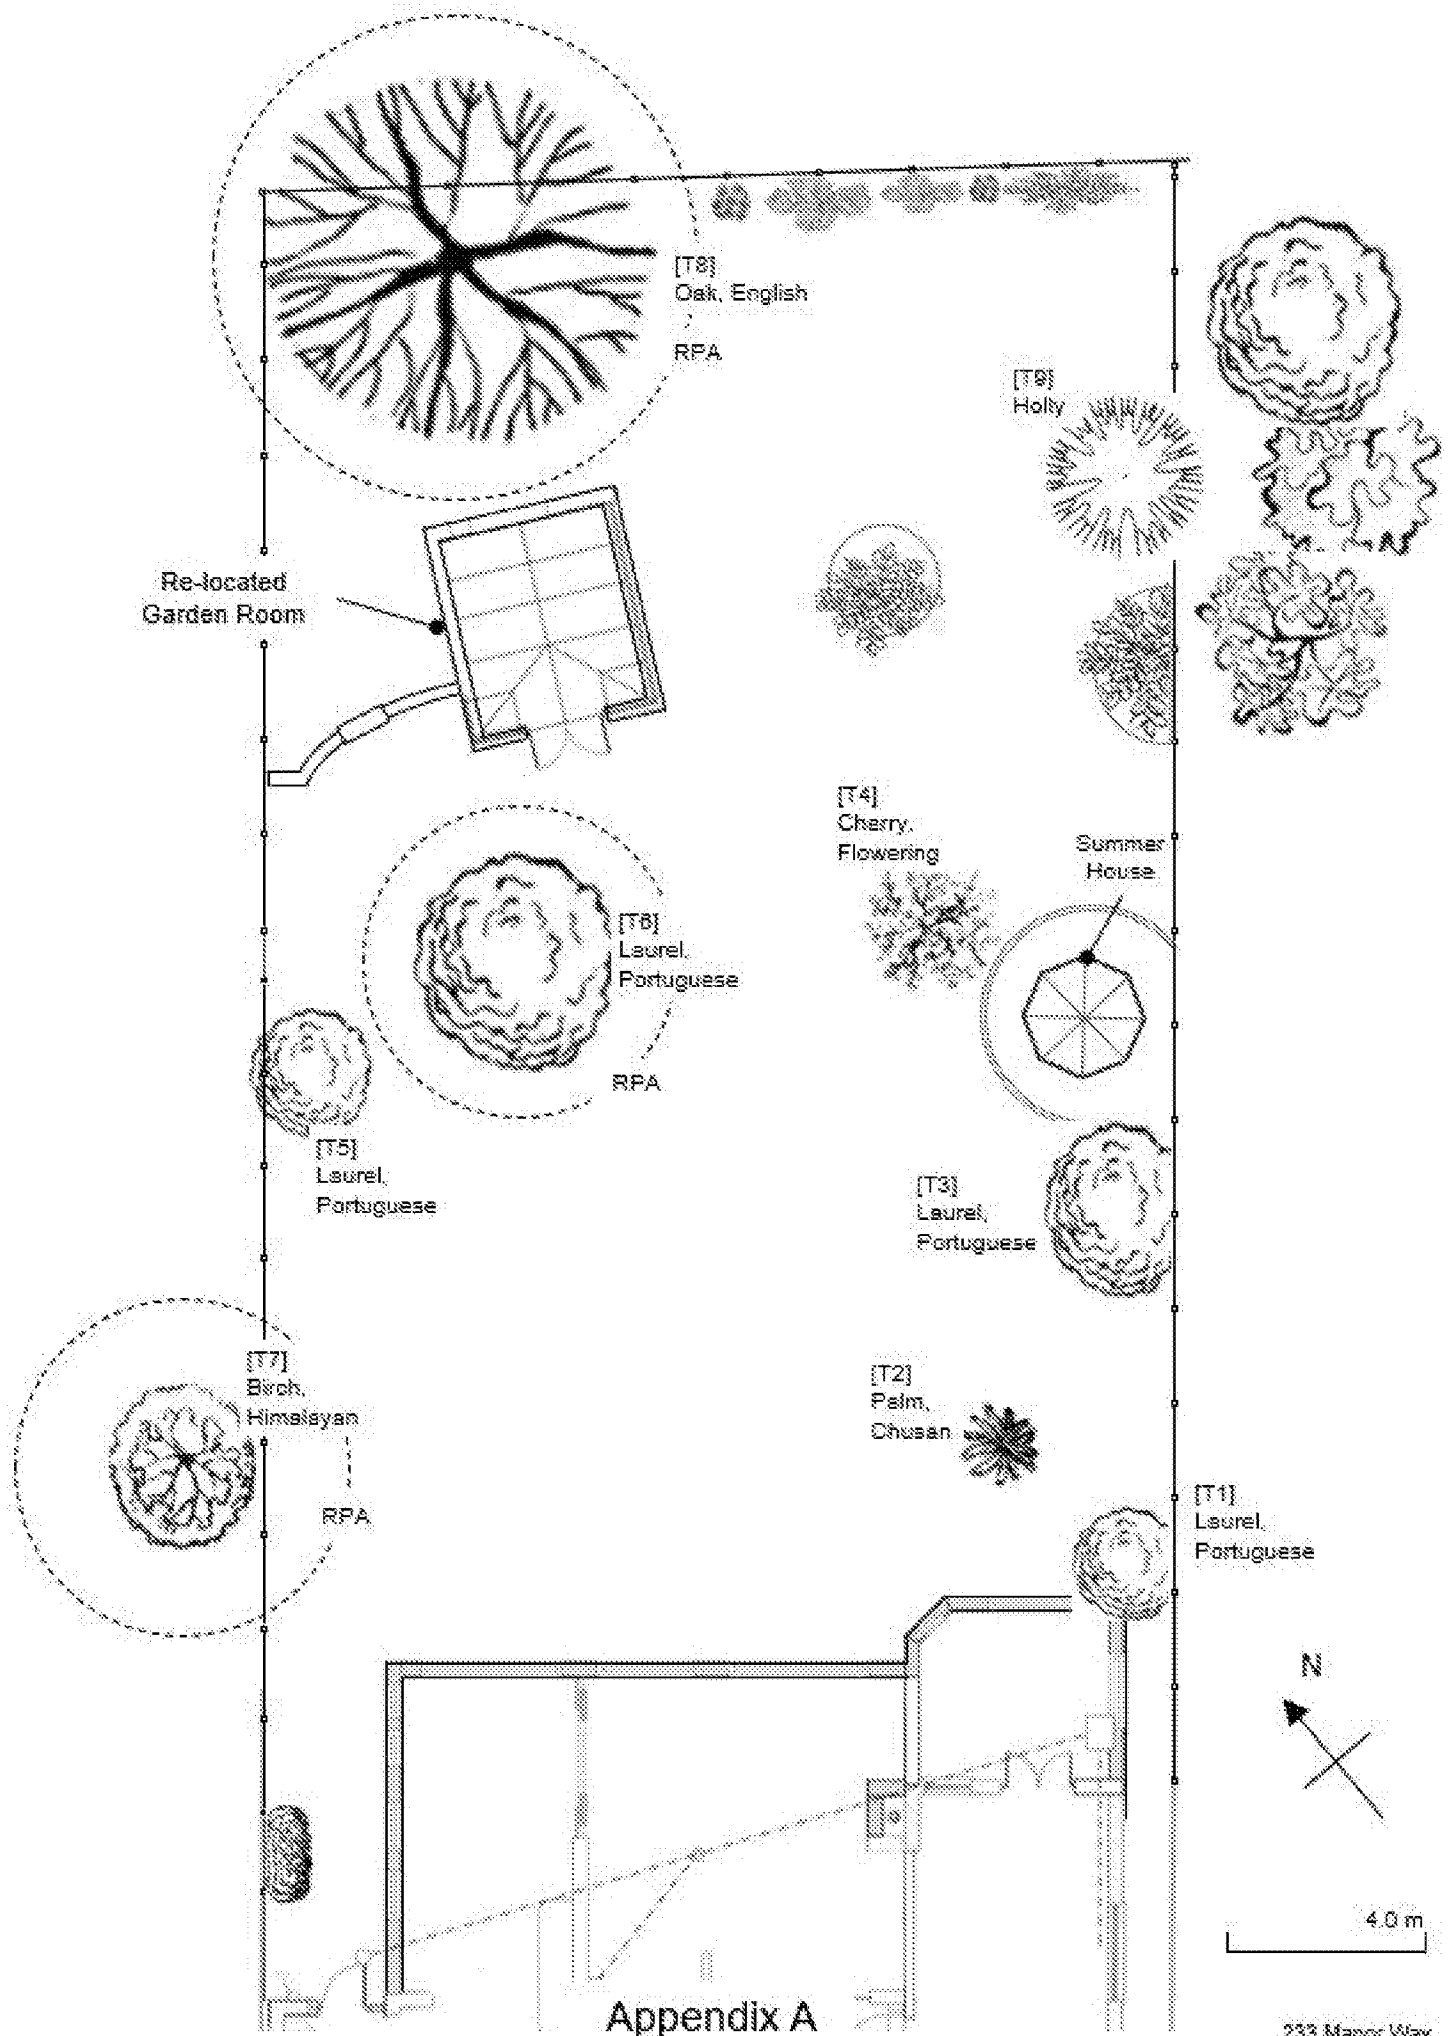
Appendix A

233 Manor Way  
PO21 4HT

Scale 1:150

- The proposed development work is outside of the RPAs for all retained trees both on the site and adjoining offsite.
- The English Oak [T8] will have ground and fence protection to prevent damage when building the Garden Room.
- The Portuguese Laurel [T1] is requested for removal, and substitute planting has been offered to replace it.

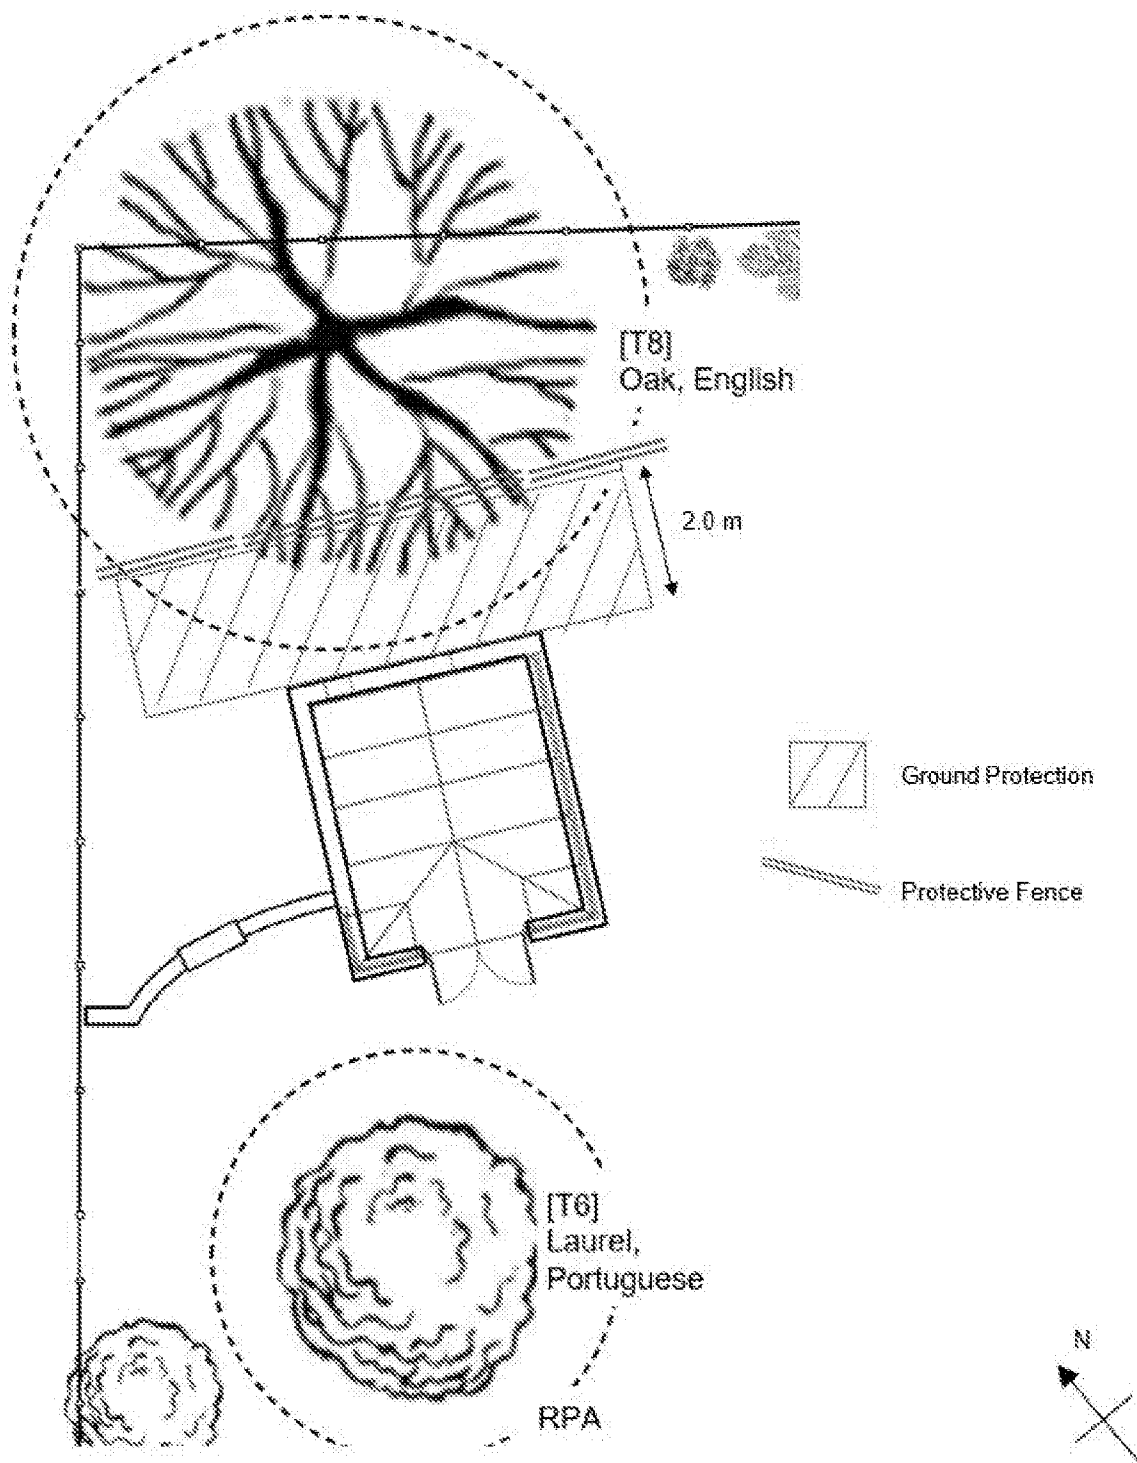
## Appendix C

### Tree Plan – Protection Detail

Whilst still outside the RPA for the English Oak [T8], given the proximity of the re-located Garden Room footings, this tree will be protected throughout the course of development by fencing and ground protection to the specifications recommended by BS5837:2012. See detail in Appendix C.

The ground protection will entail a 150mm layer of bark mulch covered by overlapping screwed together sheets of OSB boarding. The length of time the ground protection is down will be minimised in order to limit the damage to the existing grassed area.

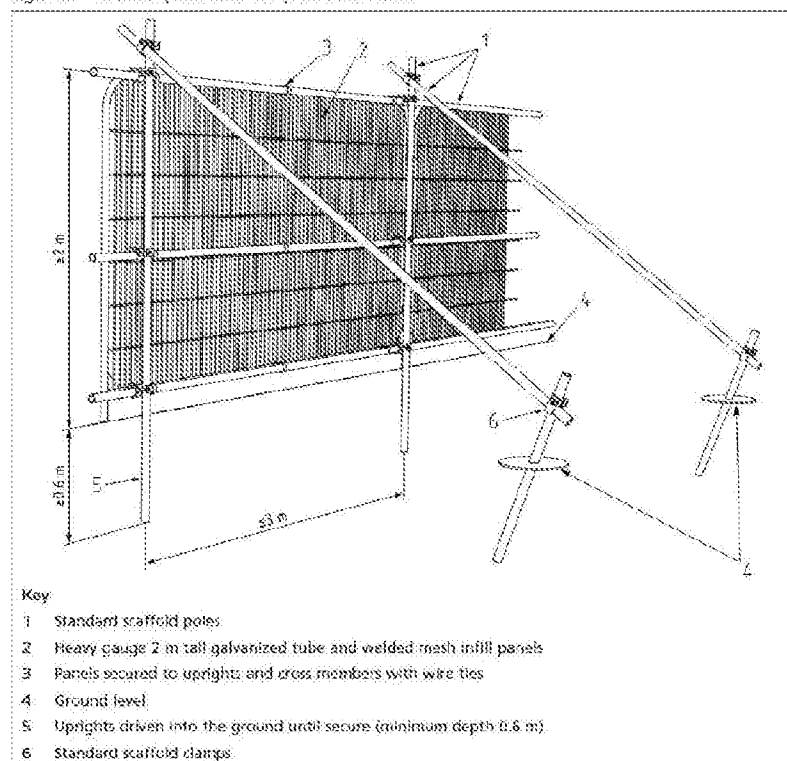
Figure 2 Default specification for protective barrier

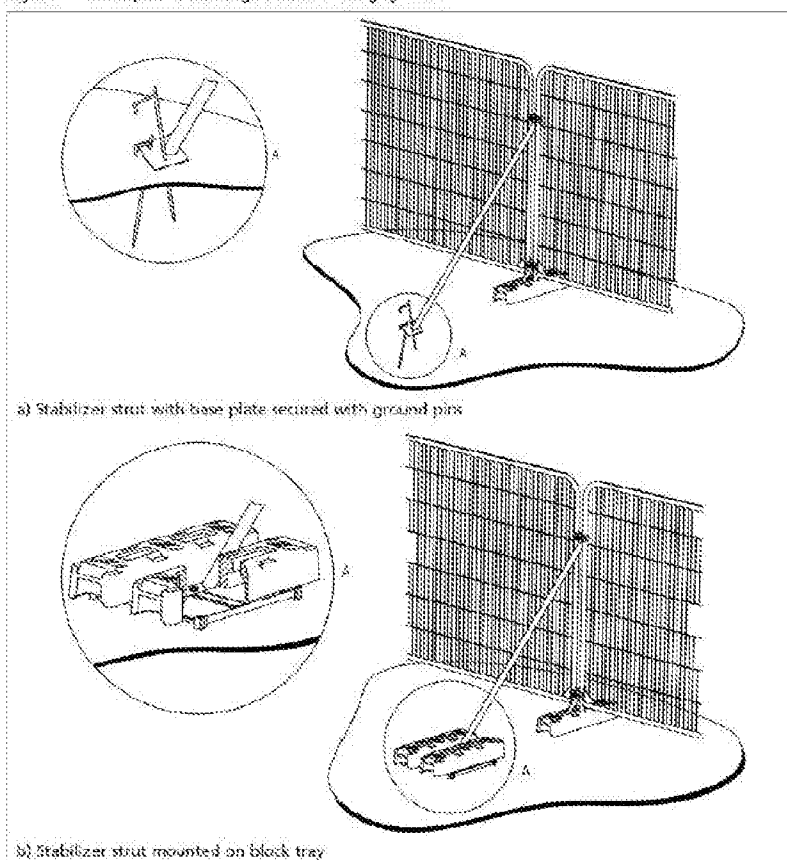
Figure 3 Examples of above-ground stabilizing systems
