# **Crete Nursery, Dappers Lane, Angmering, West Sussex**

## **Arboricultural Method Statement ADDENDUM**

Produced on behalf of Countyoak Homes Ltd on  
13/11/2019

Site Reference: EE-19-10250-01

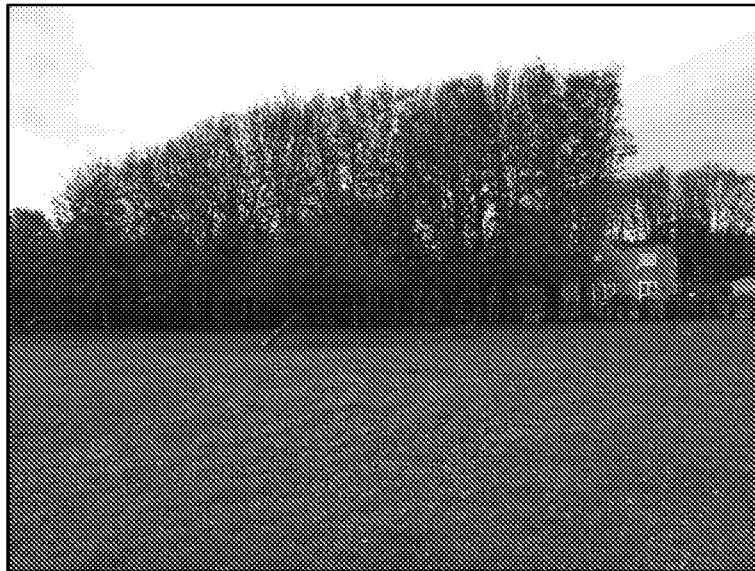
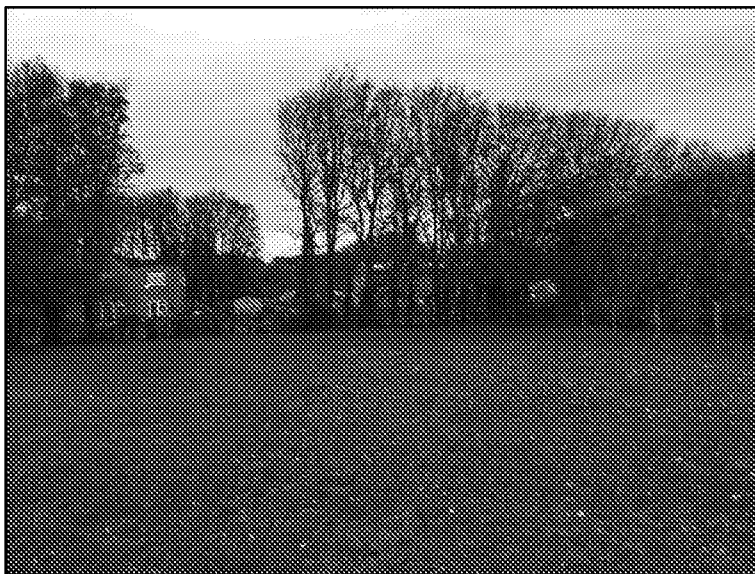
**Plate 1: Line of Hornbeam to the North of Site (Off Site)**

- 2.1 There is a line of hornbeam located offsite to the north of the site on third party land (see Plate 2). The RPAs for this group have been amalgamated to reflect the largest RPA of the group, this has been calculated to be 7.50 metres which extends on to the development site.

Western Section – Photo taken on 29<sup>th</sup> October 2019

Eastern Section – Photo taken on 29<sup>th</sup> October 2019

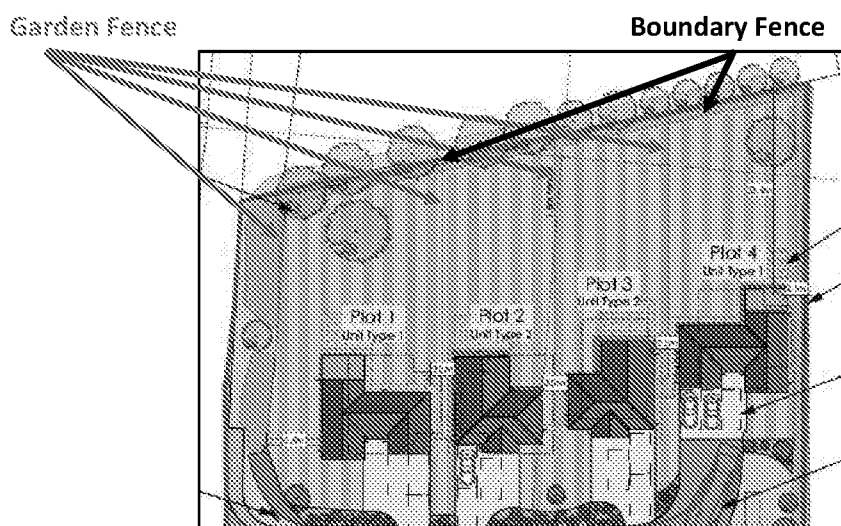
**Plate 2: Garden & Boundary Fences**

- 2.2 The development proposals require the construction of small fences (1.8m high) to delineate the gardens of each plot and the northern boundary of the site (see Plate 2). The boundary and garden fence will be comprised of closeboard panels and posts, the posts will require digging within the RPA of the hornbeams.

- 2.4 The garden fence (see Plate 2) will be constructed using 1.8-metre-wide panels with supporting fence posts. This will require digging a maximum of three fence posts per fence line to be dug within the RPA of the line of hornbeam to the north of the site. The holes for the fence posts will measure L: 0.2m x W: 0.2m x D: 0.5m – the holes will be lined with a series of plastic sheets to ensure damaging leachate from the concrete block base does not enter the RPA of the hornbeams.

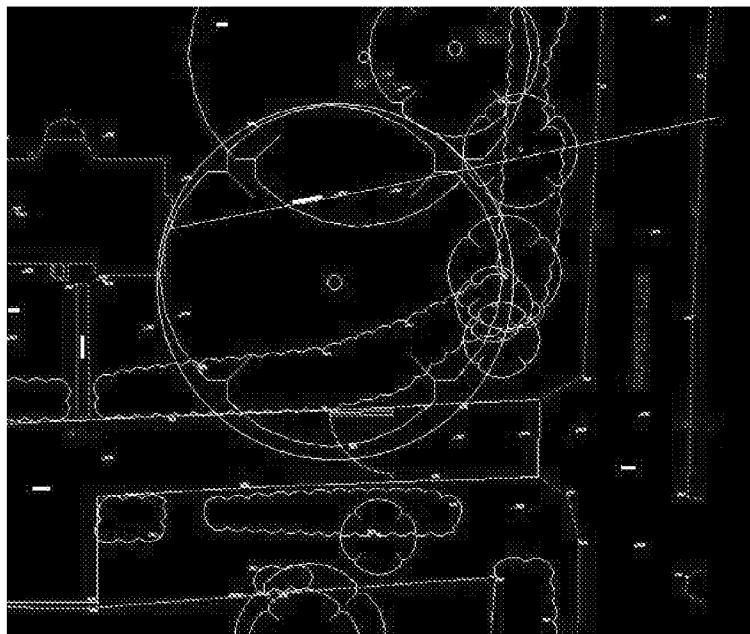
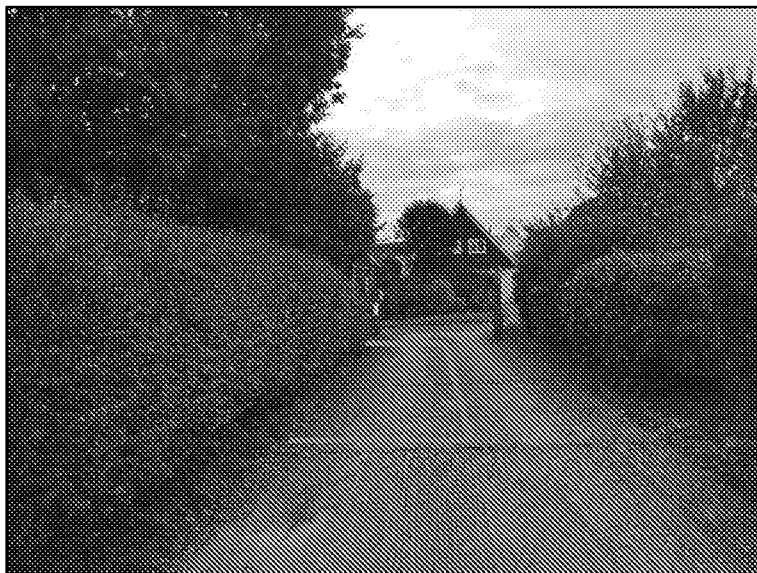
**Plate 4: RPA of T07 in Relation to the Existing Hardstanding Access Track**  
Dominant Category A Oak Tree (T07) With 9.15m RPA Superimposed

- 3.1 The existing access road will be resurfaced and replaced with a permeable hardstanding access track. The RPA of T07 extends beneath the existing hardstanding track therefore its removal will need to be undertaken under an Arboricultural Method Statement and Arboricultural Watching Brief.

Approximate Location of RPA Underneath Existing Hardstanding Access

- 3.6 The RPA of T07 (9.14m) will be measured and marked-out using fluorescent spray paint, where it extends underneath the existing hardstanding access track, to identify the area of concern to all site users. This will be undertaken at the earliest possible convenience following full planning permission being granted. The marked-out area will conform broadly to that highlighted in the bottom picture of Plate 4. The line will be suitably annotated to clearly signify what it is marking out, the hardstanding outside of this line can be removed without the supervision of an arboricultural watching brief.
