**The Laurels  
Dappers Lane  
Angmering  
West Sussex**

## **Remediation Strategy**

**Project Reference: P14215**

**Report Reference: R13936**

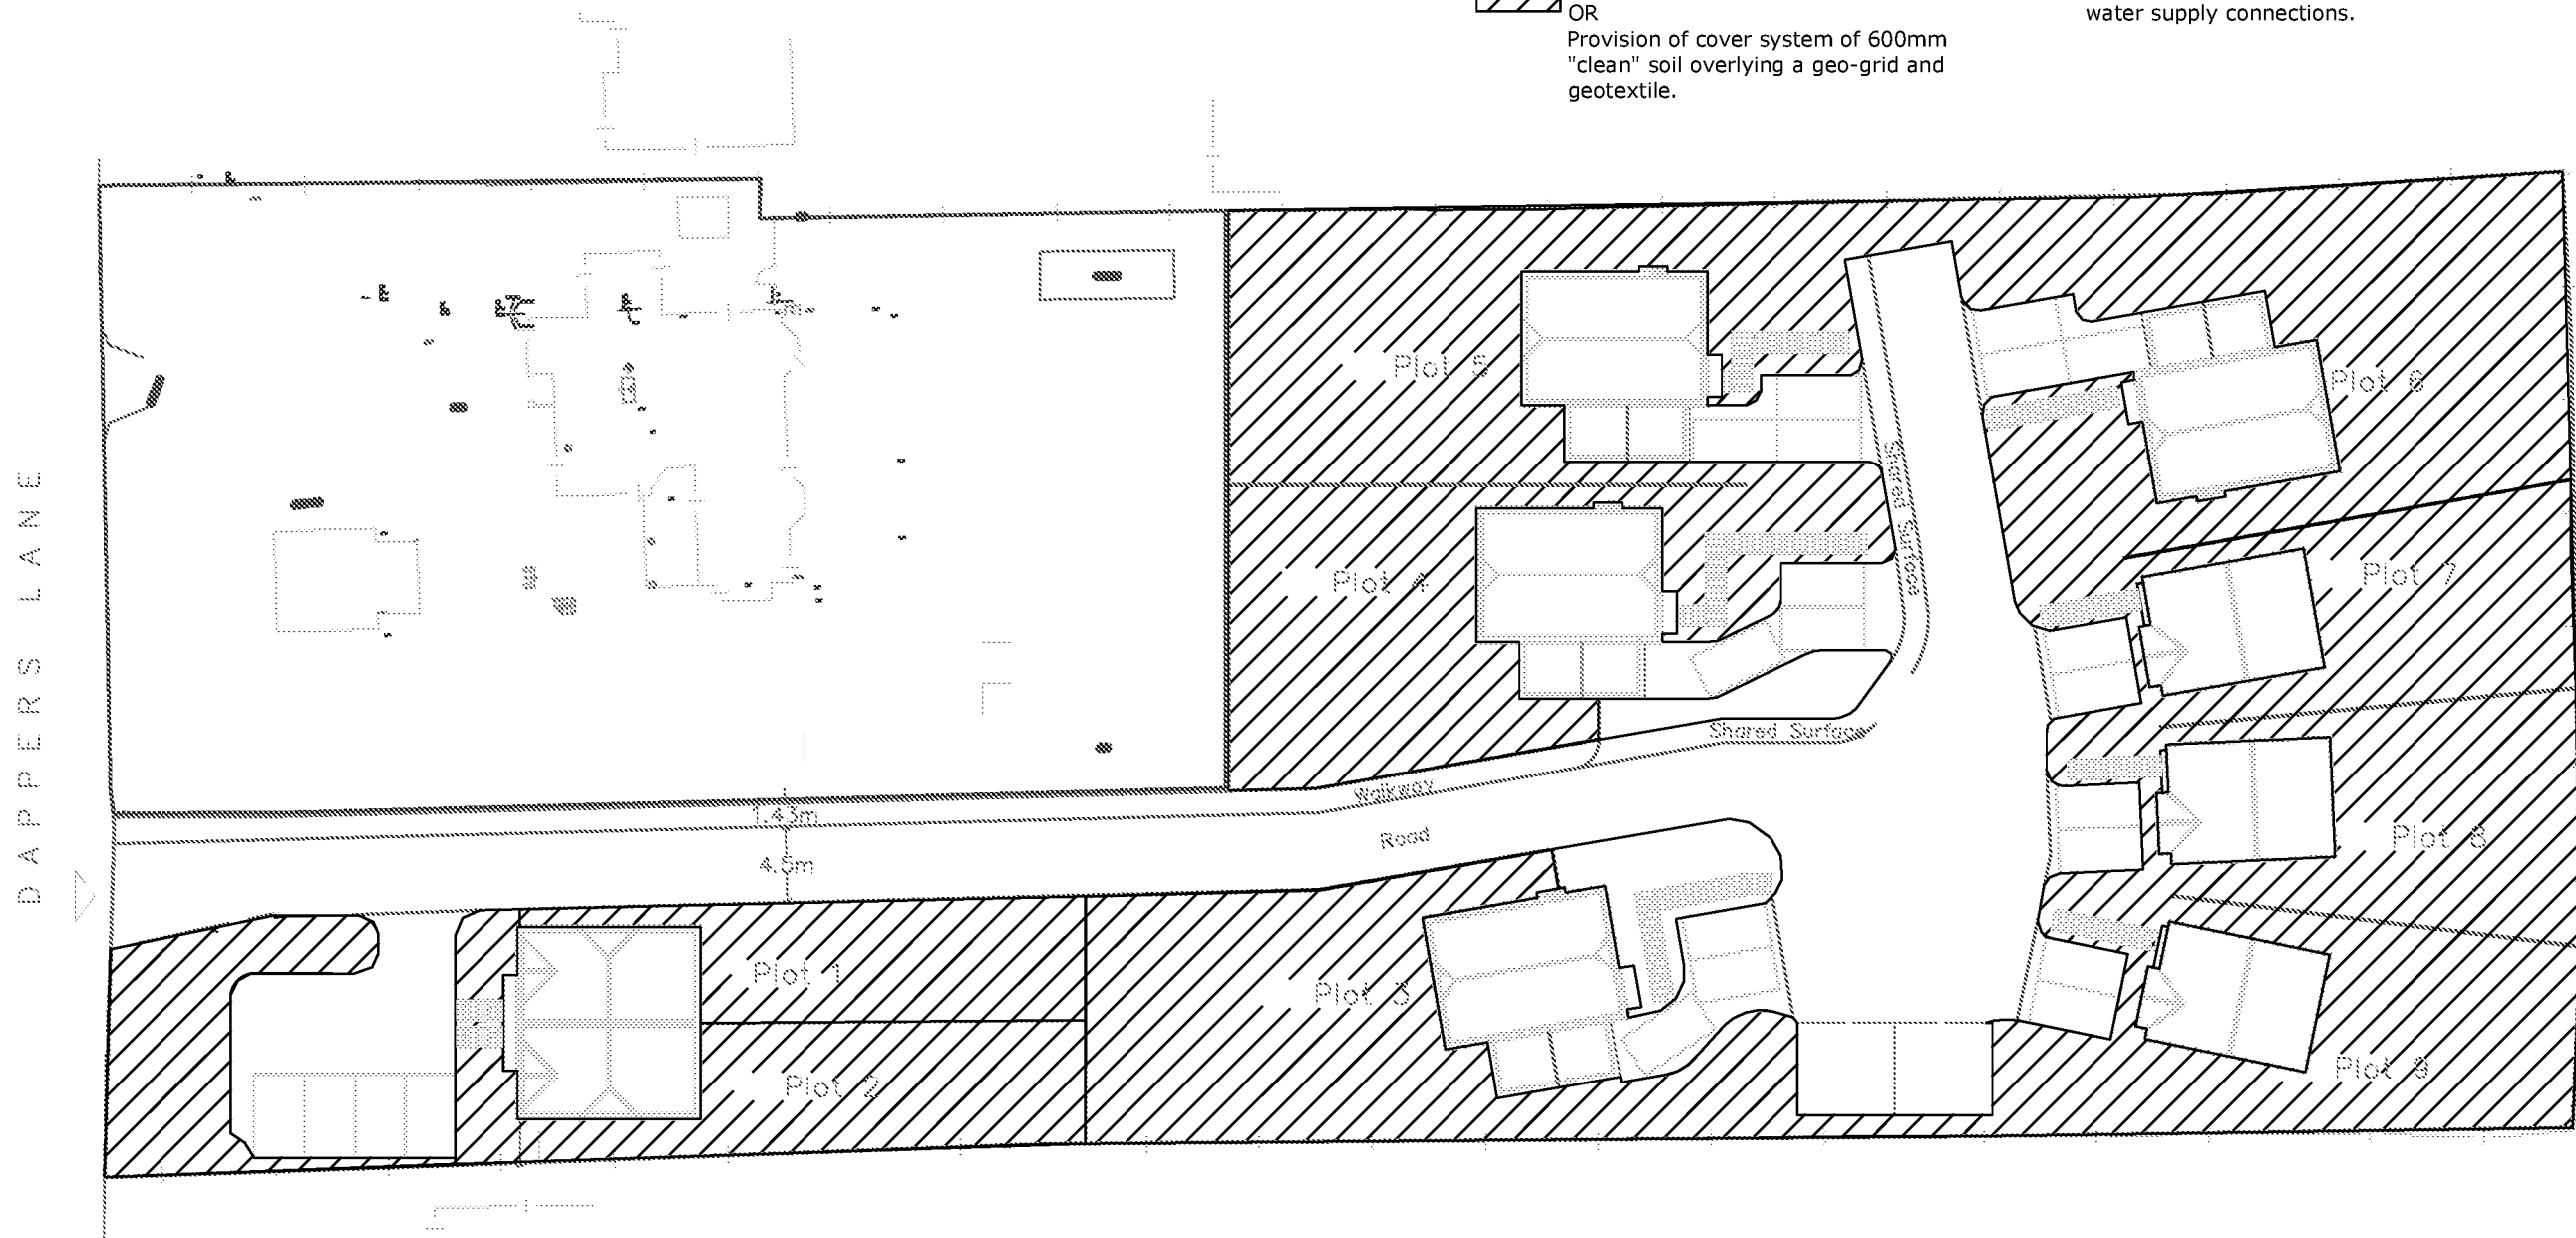
Areas of garden/soft landscaping. All topsoil/ made ground to be removed to expose the undisturbed soils below.  
OR  
Provision of cover system of 600mm "clean" soil overlying a geo-grid and geotextile.

Unless confirmed otherwise by the water supply company, it should be assumed that barrier pipe is required for all new water supply connections.

Within all proposed areas of private garden and/or areas of communal soft landscaping existing topsoil and made ground should be excavated to expose the undisturbed soils below. In the event that localised pockets of deeper made ground are found, these should be excavated to a sufficient depth to allow the placement of a cover system of at least 600mm of verified "clean" soil which must then be underlain by a high visibility geotextile marker and a geo-grid.

For all areas where remediation works are required (reference Figure 2) the formation level of all garden and soft landscaped areas will be inspected to confirm the removal of existing topsoil and made ground to expose the undisturbed soil below.
