# **New Porch and Garage Alterations at Grey Barn, Rectory Lane, Angmering –**

## **Planning Application**

### **Design and Access Statement**

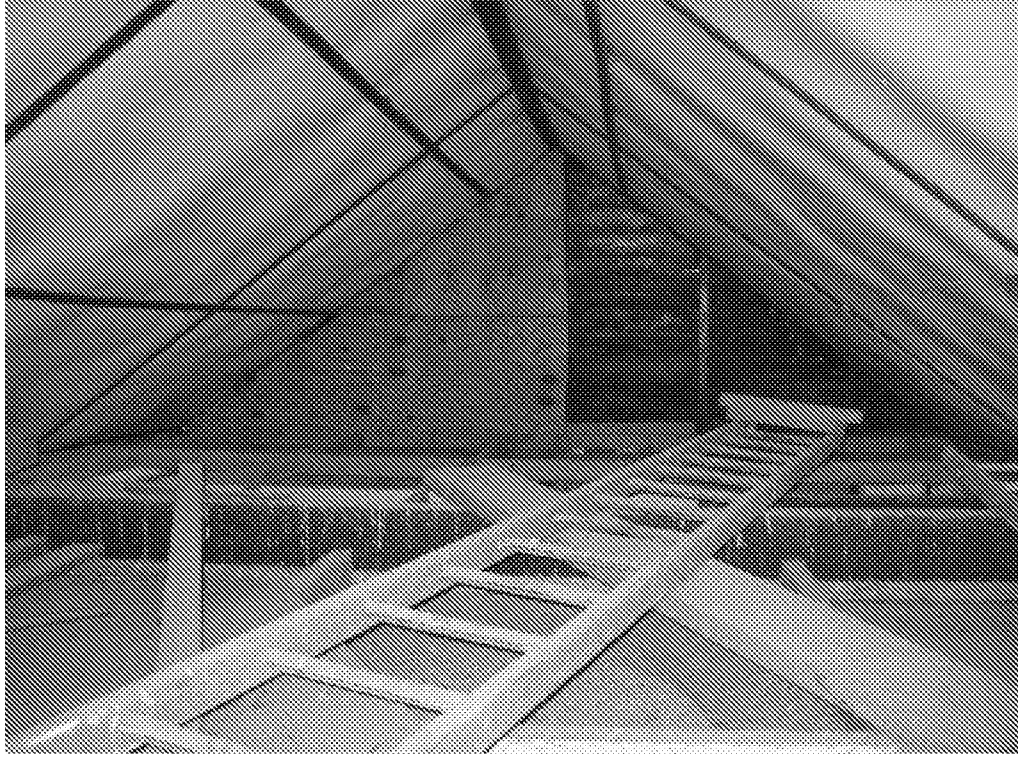
**Photograph B9 – Garage – View of Existing Roof Void  
(Remaining ceiling chord of an original king-post truss visible upstanding above ceiling)**

Summarising the above, it is concluded that the existing garage roof is both in poor material condition and structurally deficient.

- As described above, the existing roof fabric is in poor condition and the supporting structure is deficient. Retention of the existing structure would be extremely problematic in terms of temporary propping etc. required during the process of dismantling of existing supporting walls and construction of replacements. Substantial repairs, strengthening and realignment of the existing members would also be required to enable the structure to be incorporated within the new framework. Consequently, it is concluded that retention of the existing roof structure would not be practical, desirable or worthwhile and the proposal is therefore to fully dismantle it, whilst retaining existing slates etc. as far as possible for re-use on the new roof (new slates will also be used to provide a close match). Any materials that cannot be feasibly incorporated into the new roof will be retained by the applicant for general use or sold off for recycling elsewhere – e.g. reclaimed timber etc. The new roof structure will therefore comprise new properly graded structural timber members, supported on new steel beams as necessary.
