**Mayflower Way  
Angmering**

***Site Investigations & Infiltration Testing***

***Prepared by:***  
**Kazys Narbutas Consulting Limited**

KNC2101/SI-A

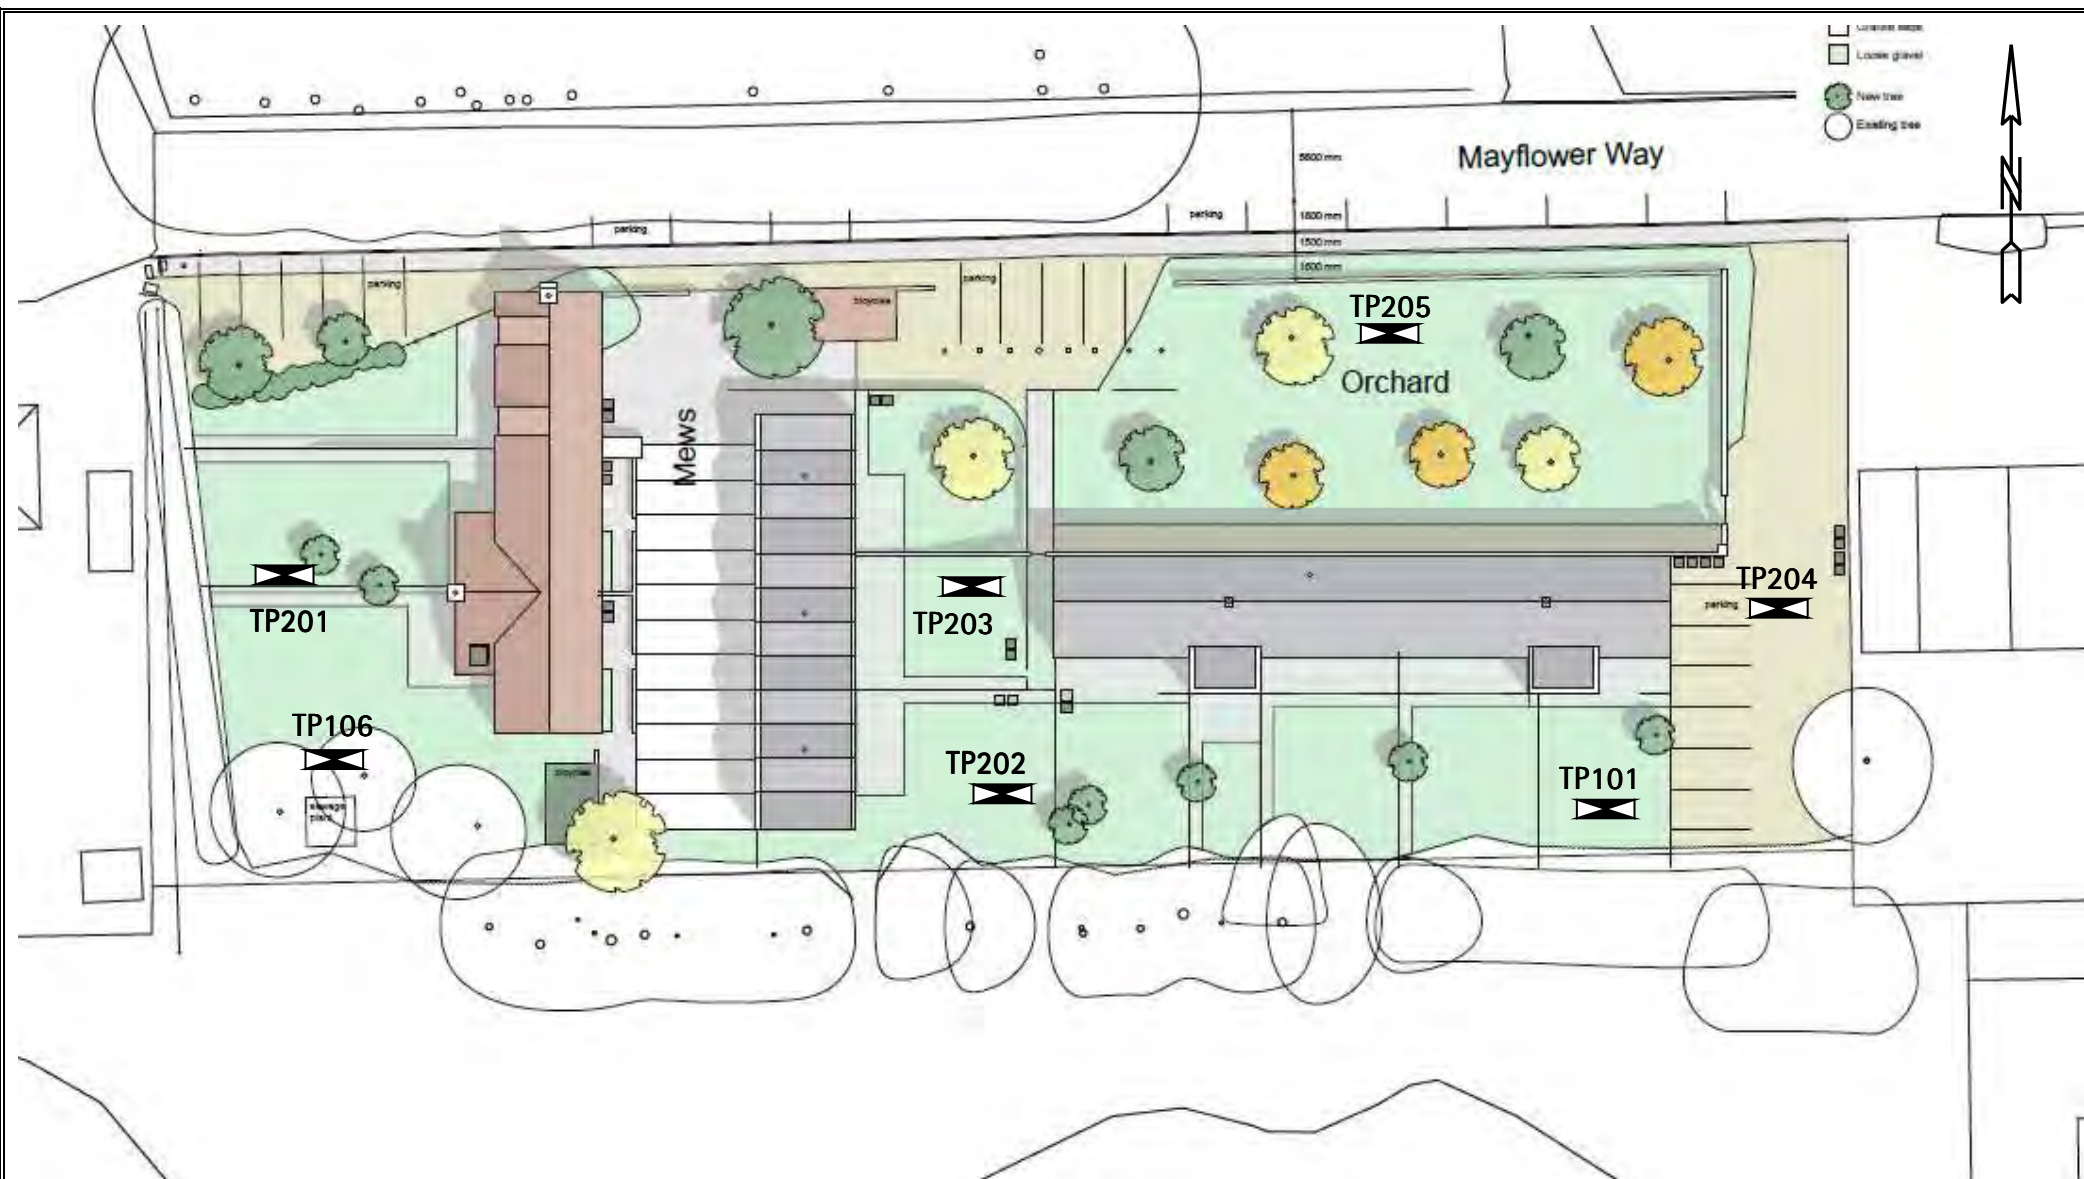
NB: Positions of Trial Pits are only indicative unless dimensioned

Site: Land off Mayflower Way, Angmering
