## APPENDICIES

## Appendix A - Architectural Proposals

| Dapper's Lane, Angmering | | | | | | | | | |

## Appendix E - EEG (Ultraflow) Drainage Investigation

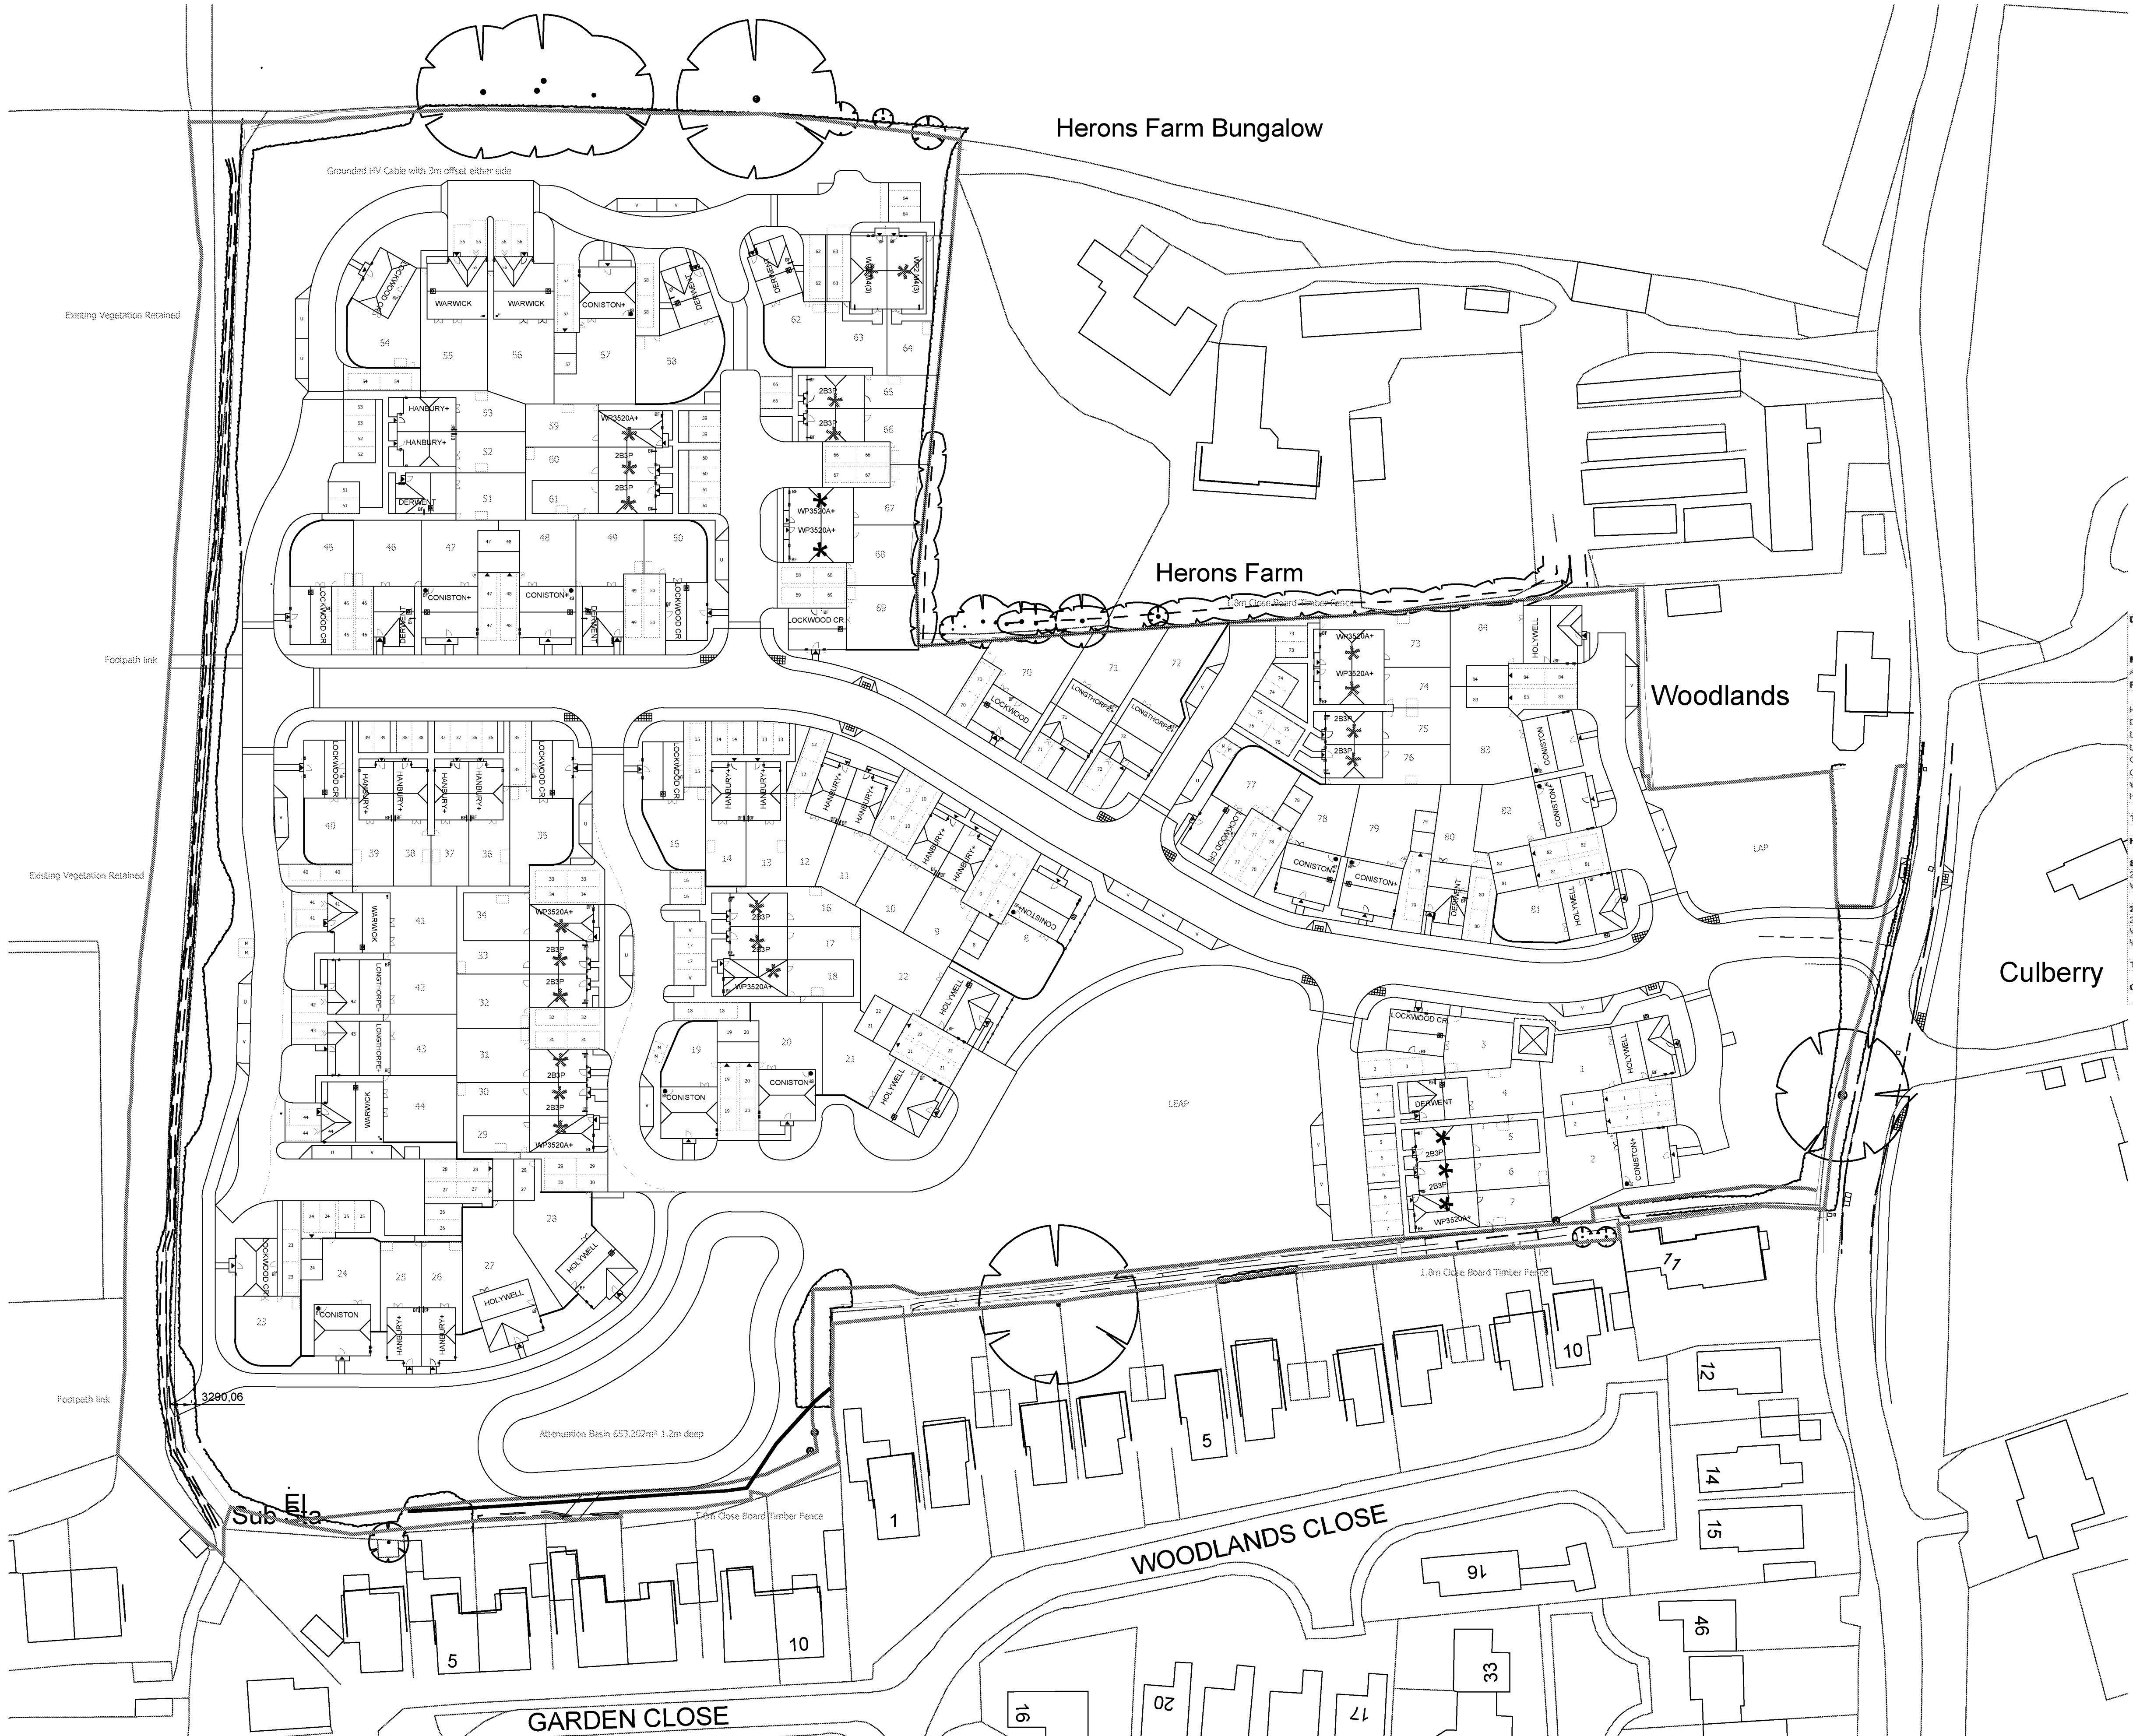
- Red Line Boundary
- HA Rental Property
- HA Shared Ownership Property

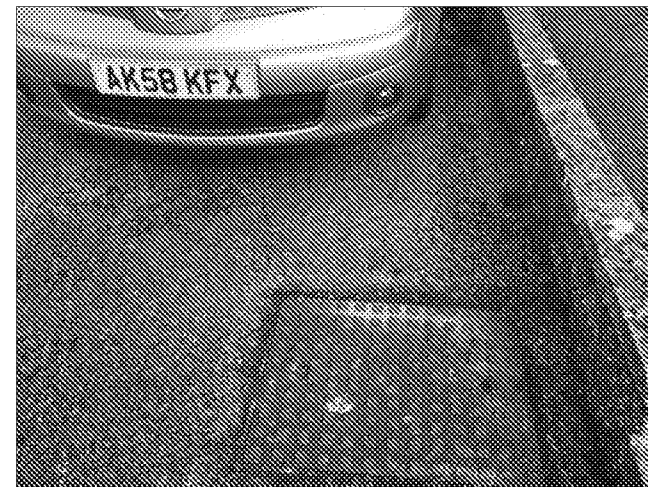
Lid damaged  
unable to lift

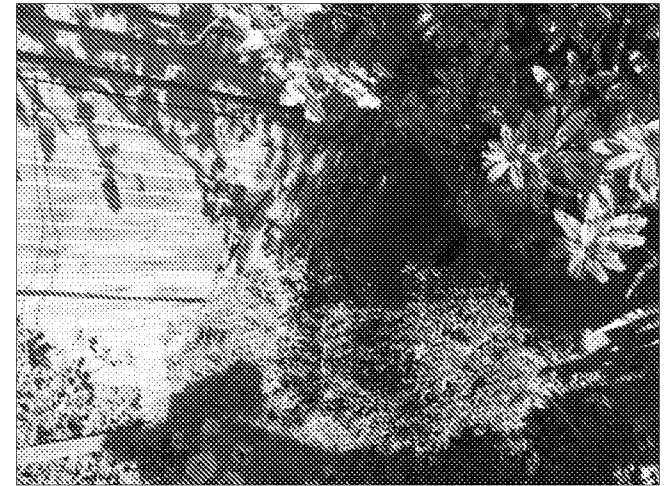
| Manhole Details | | | | | | | | | | | | | | | |
| Item Type | Manhole | | System Type | Surface Water | | Owner | Public | | Date of Survey | 24/09/2019 | | | | | |

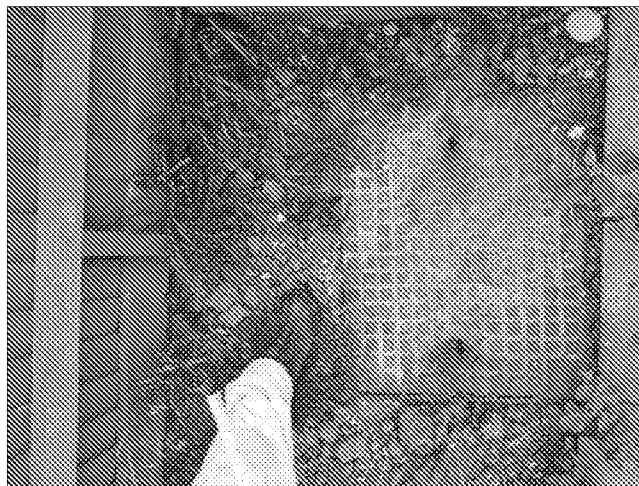
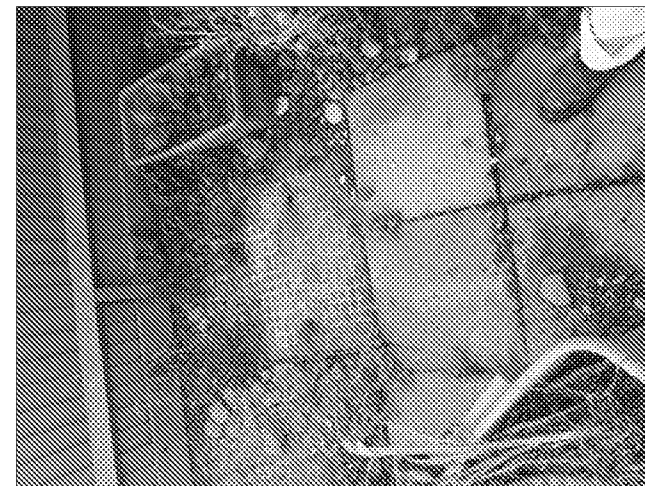
| Manhole Details | | | | | | | | | | | | | | | |
| Item Type | Manhole | | System Type | Surface Water | | Owner | Public | | Date of Survey | 24/09/2019 | | | | | |
