Document ref: C14459/G003/003

**Re: Oldlands Farm - Hybrid Application Ref BE.61.13 – Partial Discharge of Conditions 7**

Hydrock has been commissioned by Hanbury Properties Limited, as the geoenvironmental Consultant for ongoing works at the above site, relating to Arun District Council (ADC) Hybrid Planning Application BE/61/13/ for:

This document provides information to allow Planning Condition 7 of Hybrid Planning Application BE/61/13/ to be partially discharged.

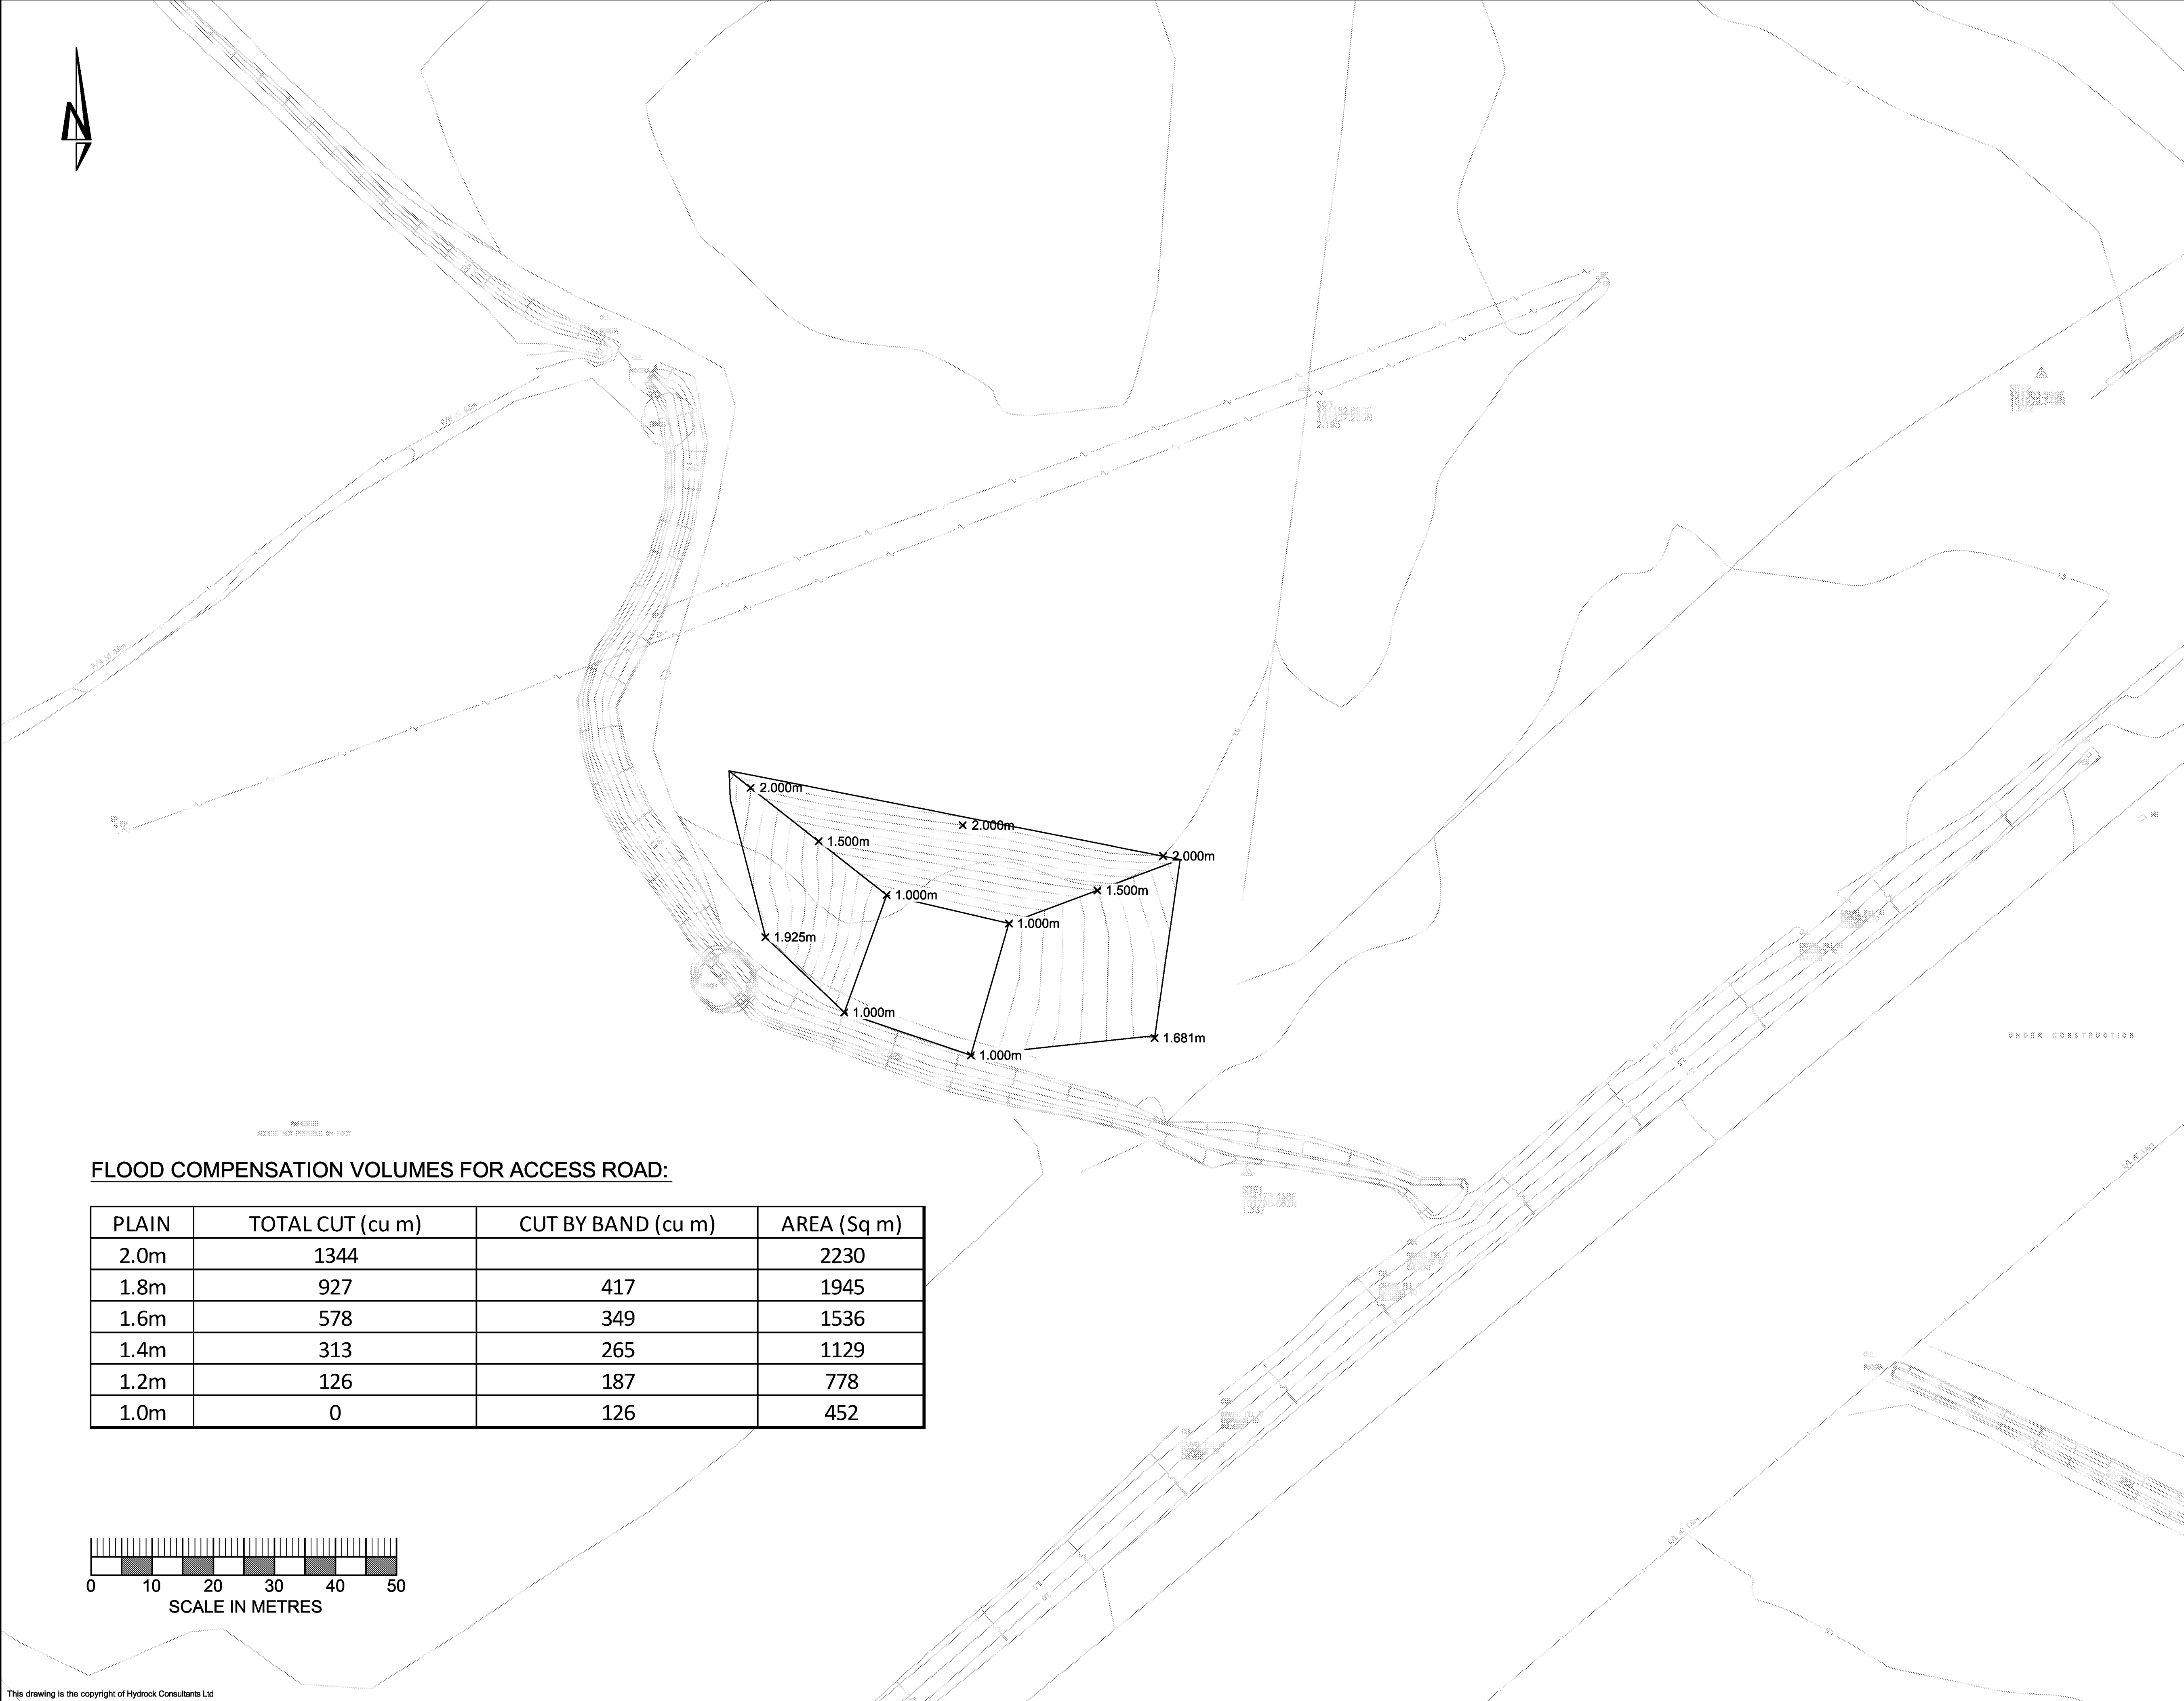
FLOOD COMPENSATION VOLUMES FOR ACCESS ROAD:

This letter refers to the access, road and associated flood compensation areas as depicted on the accompanying plans.

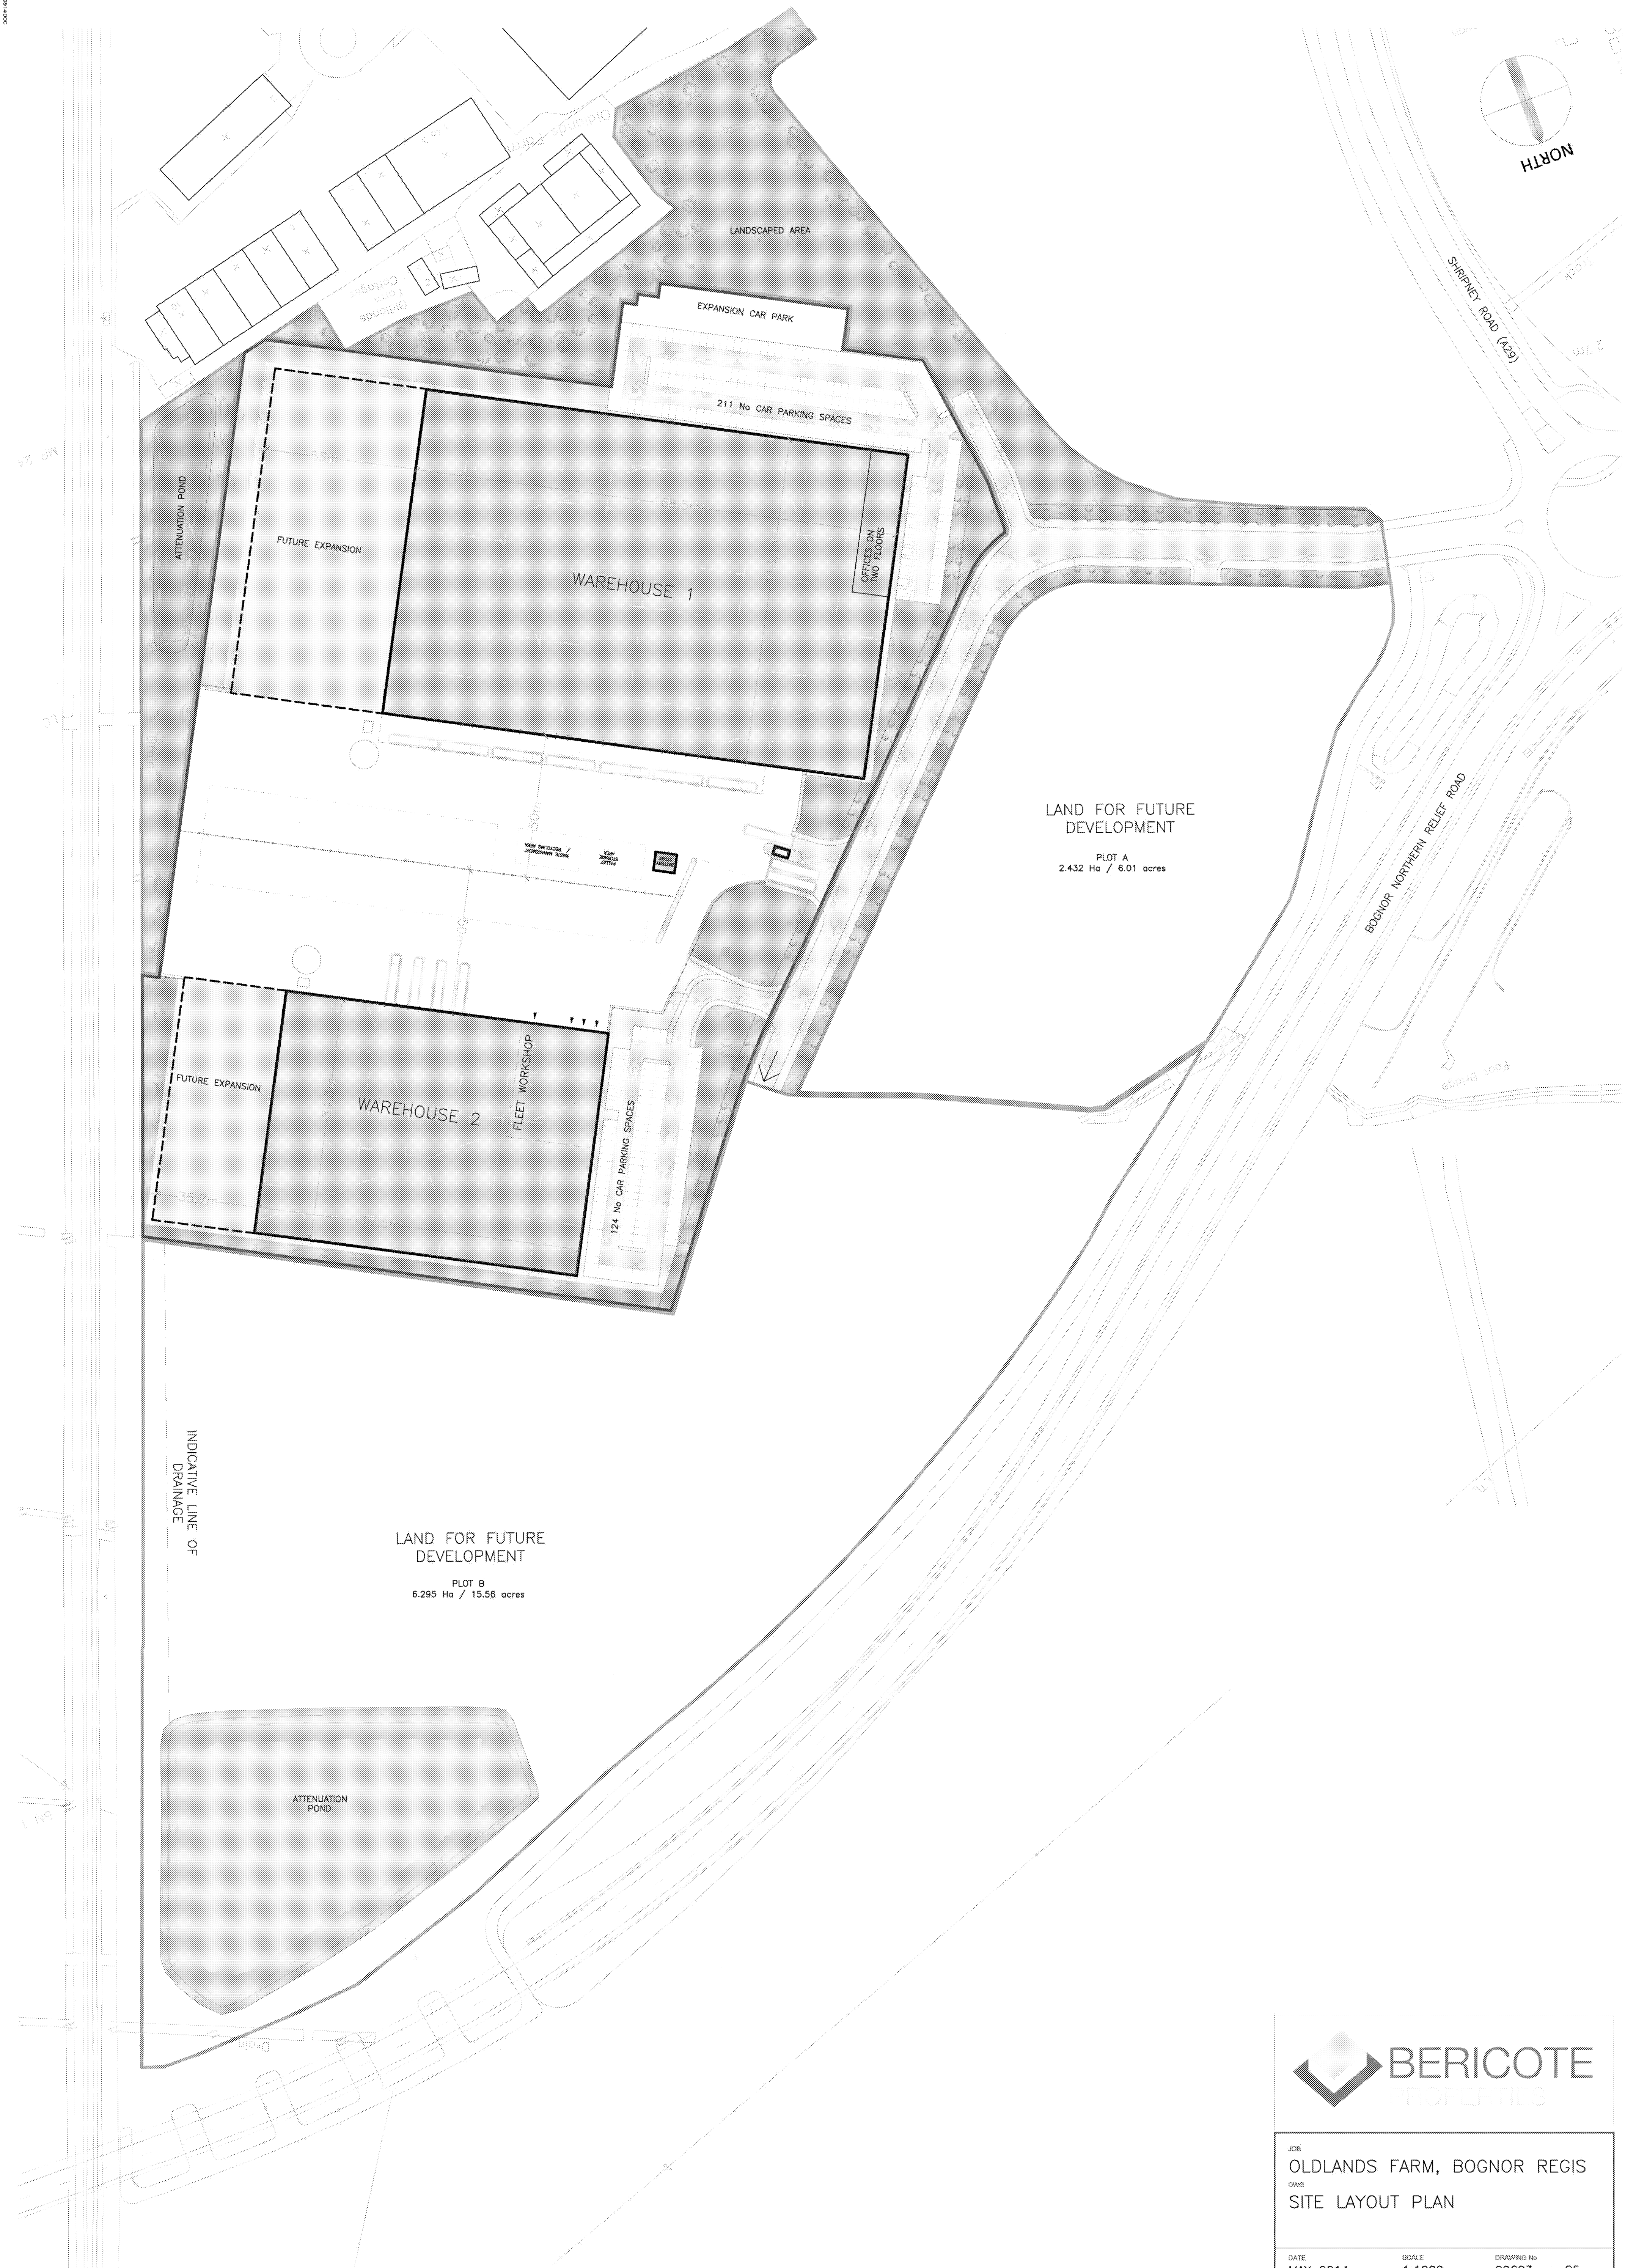
JOB  
OLDLANDS FARM, BOGNOR REGIS  
DWS  
SITE LAYOUT PLAN

| DATE<br>MAY 2014 | SCALE<br>1:1000 | DRAWING NO<br>99603-ss-25 |

Site Layout Plan, reference 99603-ss-25
