# Flood Risk Assessment

Former Bartons Infant School, North Bersted

Bognor Regis PO22 9BD

**GTA Civils Ltd**

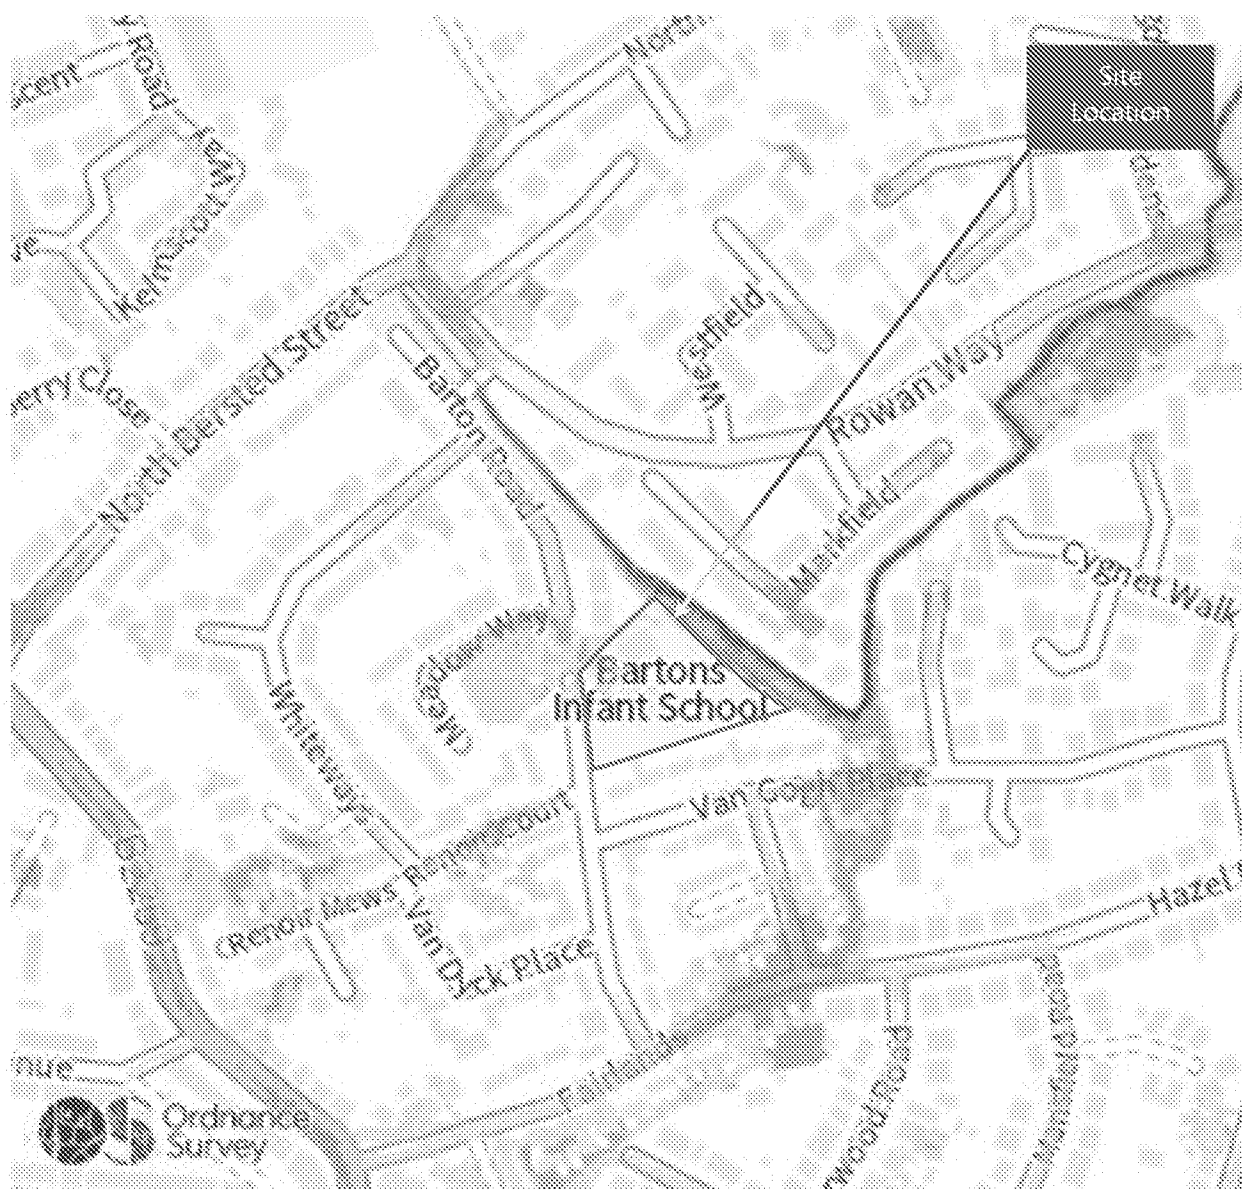
### EA's Online Surface Water Flood Depth Map in the 'Low Risk Scenario' (1 in 1000 years storm event)

## Surface water flood risk: water depth in a low risk scenario Flood depth (millimetres)

The north and northwest of the site are susceptible to flooding – with depths up to 300mm in the main

- 3.2 Surface water flooding: can occur when excess rainwater does not infiltrate into the ground, or is not intercepted by urban drainage systems, and instead flows across the surface. The EA's Online 'Surface Water Depth - Low Risk Scenario' (1 in 1000 years) Flood Map in Appendix B shows the north and northwest of the site are susceptible to flooding up to 300mm in depth. The narrow area along the NE boundary is an overland flown route, while the area affected in the NW corner originates within the site. The overland flow route does not impact the developed area. This source of flood risk is of no consequence, therefore.

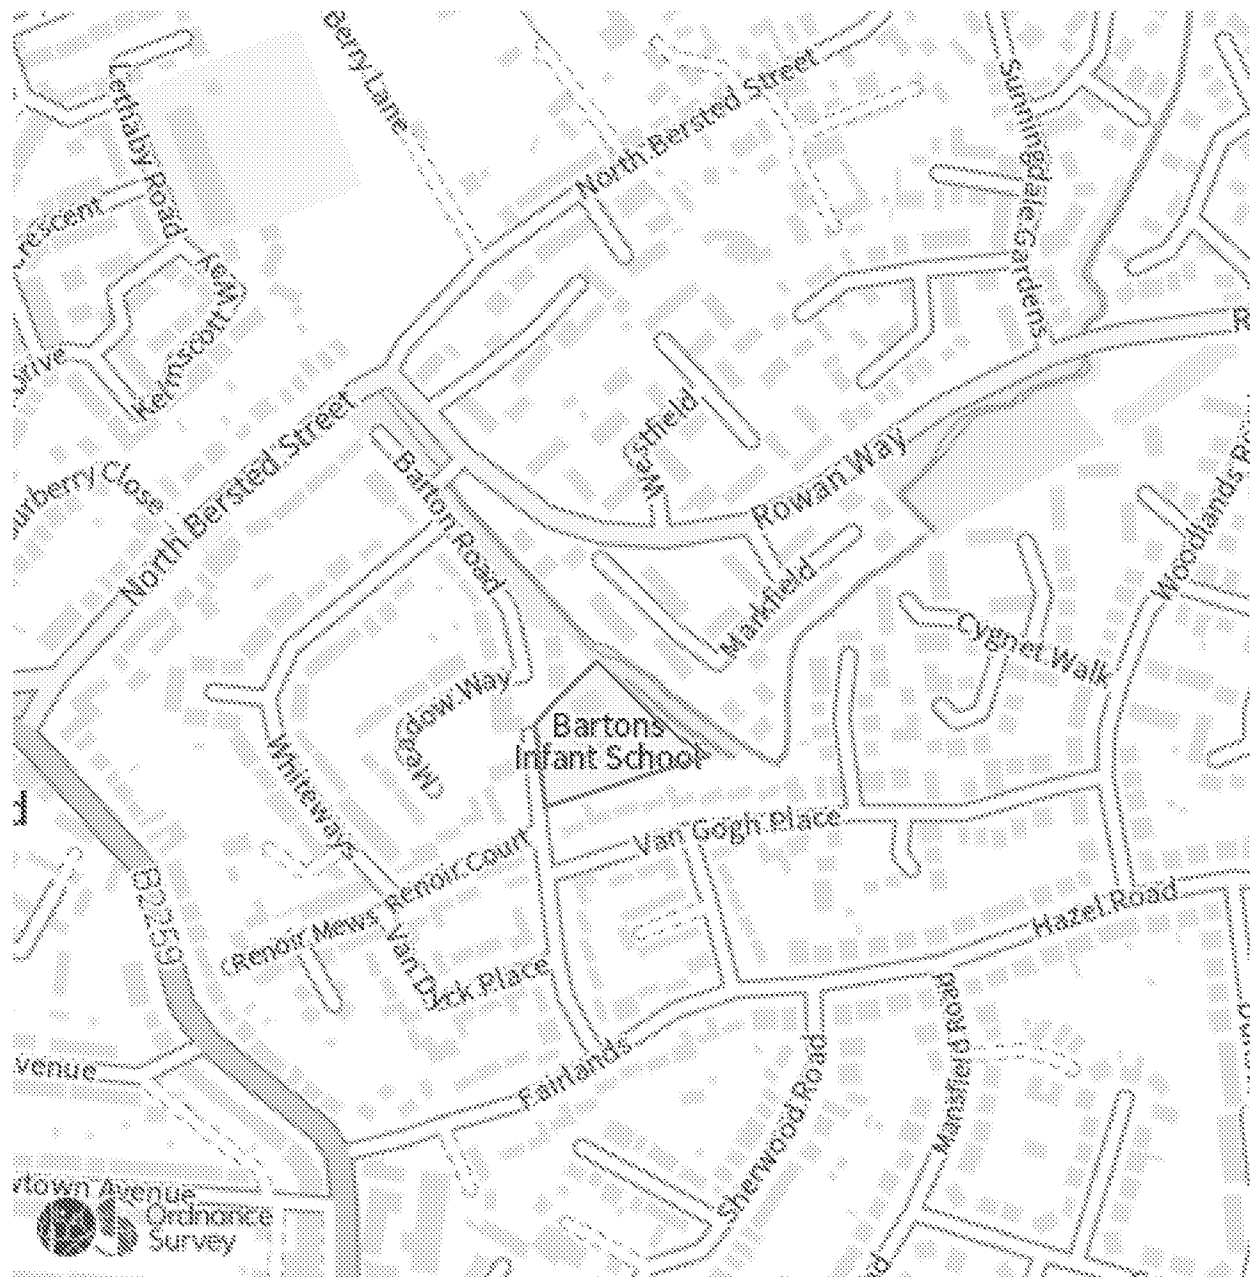
#### EA's Online Risk of Flooding from Reservoirs' Map

### Maximum extent of flooding from reservoirs:

- when river levels are normal
  when there is also flooding from rivers

The site is not susceptible to flooding from this source

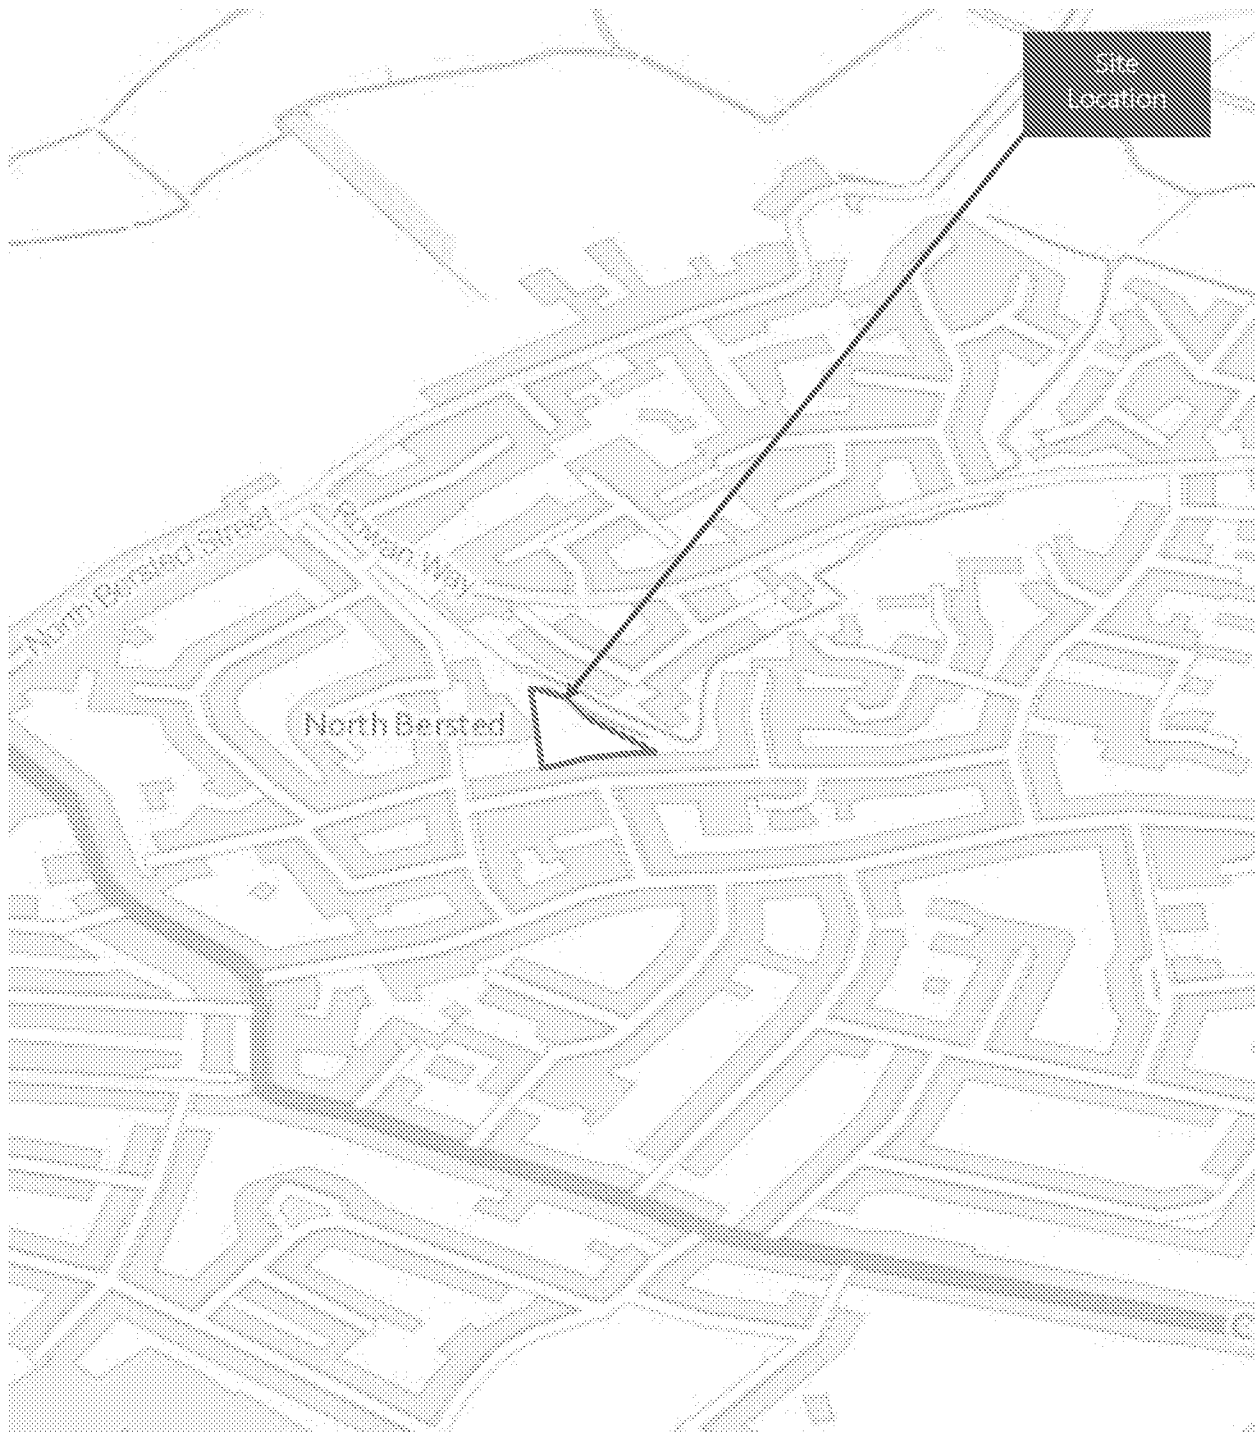
[Environment Agency's Online Historic Flood Map](#)

## Historic Flood Map

The site is removed from the nearest recorded Historical Flood

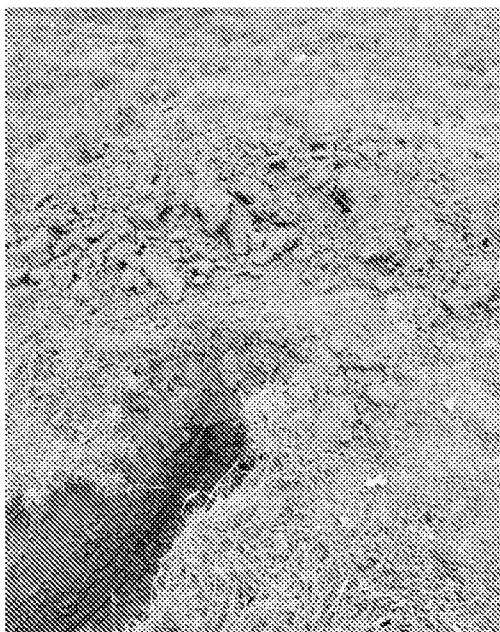
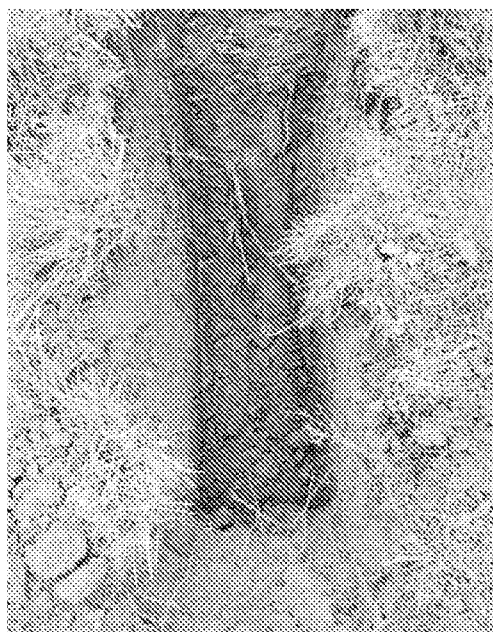
| | Figure No. <b>2</b> | Date : 10th March 2021 |

| | Title : <b>TRIAL PIT SA2</b> | |
| <b>RECORD OF MECHANICALLY EXCAVATED TRIAL PIT</b> | Job No : RML 7634 | Scale : Not To Scale |

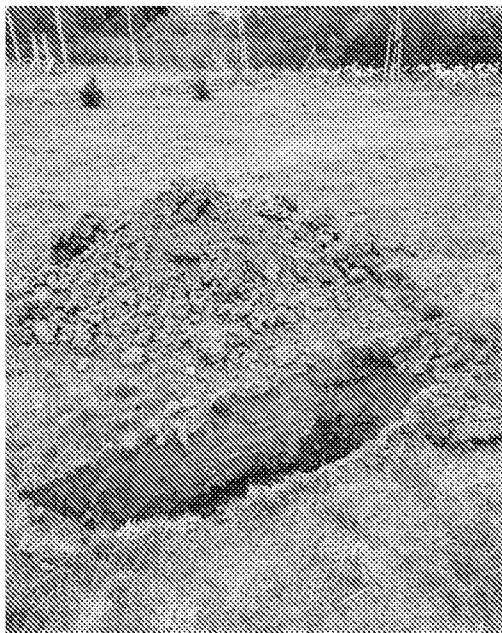
Figure No. **3**

Title : **TRIAL PIT SA3**

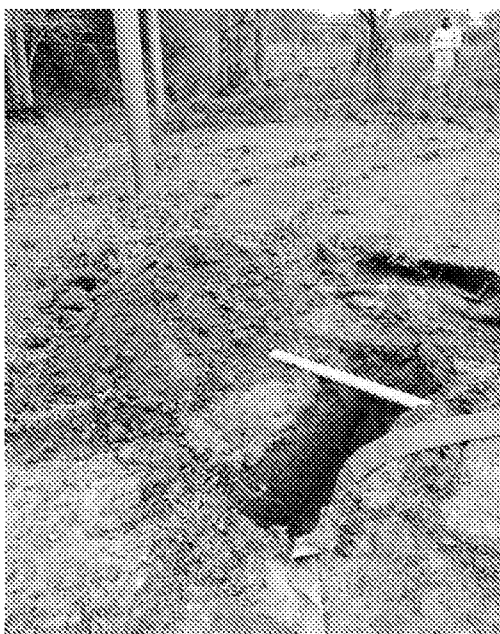
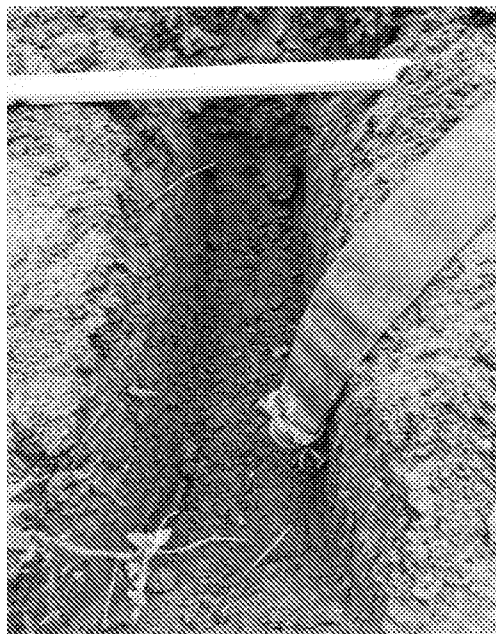
| | Title : <b>TRIAL PIT SA4</b> | |

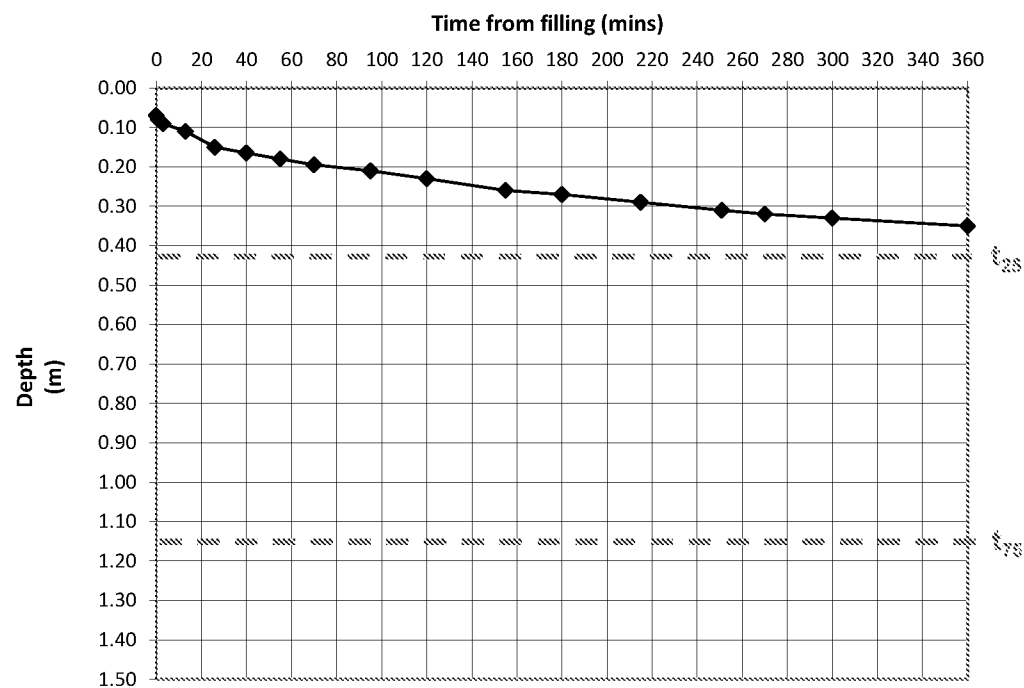
## SOIL PERCOLATION TEST SA1

TIME TAKEN TO FALL BETWEEN 25% and 75% - N/A

| Soil Infiltration Rate (f) m/s = | N/A |

Owing to the poor soakage rate encountered no Soil Infiltration Test Rate ( $f$ ) could be determined for Trial Pit SA1. Extrapolated results for Trial Pits SA2, SA3 & SA4 were used to calculate the following Soil Infiltration Test Rates ( $f$ );
