1.0 Introduction

- 1.1 This Lidsey Drainage Impact Assessment has been undertaken by Motion on behalf of NJS Partnerships Ltd in support of development at Eastmere Stables, Eastergate Lane, Eastergate, West Sussex. The development proposals are for up to nine residential units with associated roads and parking. The nearest grid reference is 495217 N 106198 and postcode PO20 3SJ. The site plan can be found in full in [Appendix A](#).

- 1.4 The site is within the Lidsey Wastewater Treatment Works Catchment Area and therefore a Lidsey Drainage Impact Assessment is required. The aim of this assessment is to detail what measures will be implemented to reduce the impact of foul and surface water drainage in the catchment area. This assessment aims to demonstrate that water quality will not be impacted by proposals that may directly or indirectly affect water bodies.

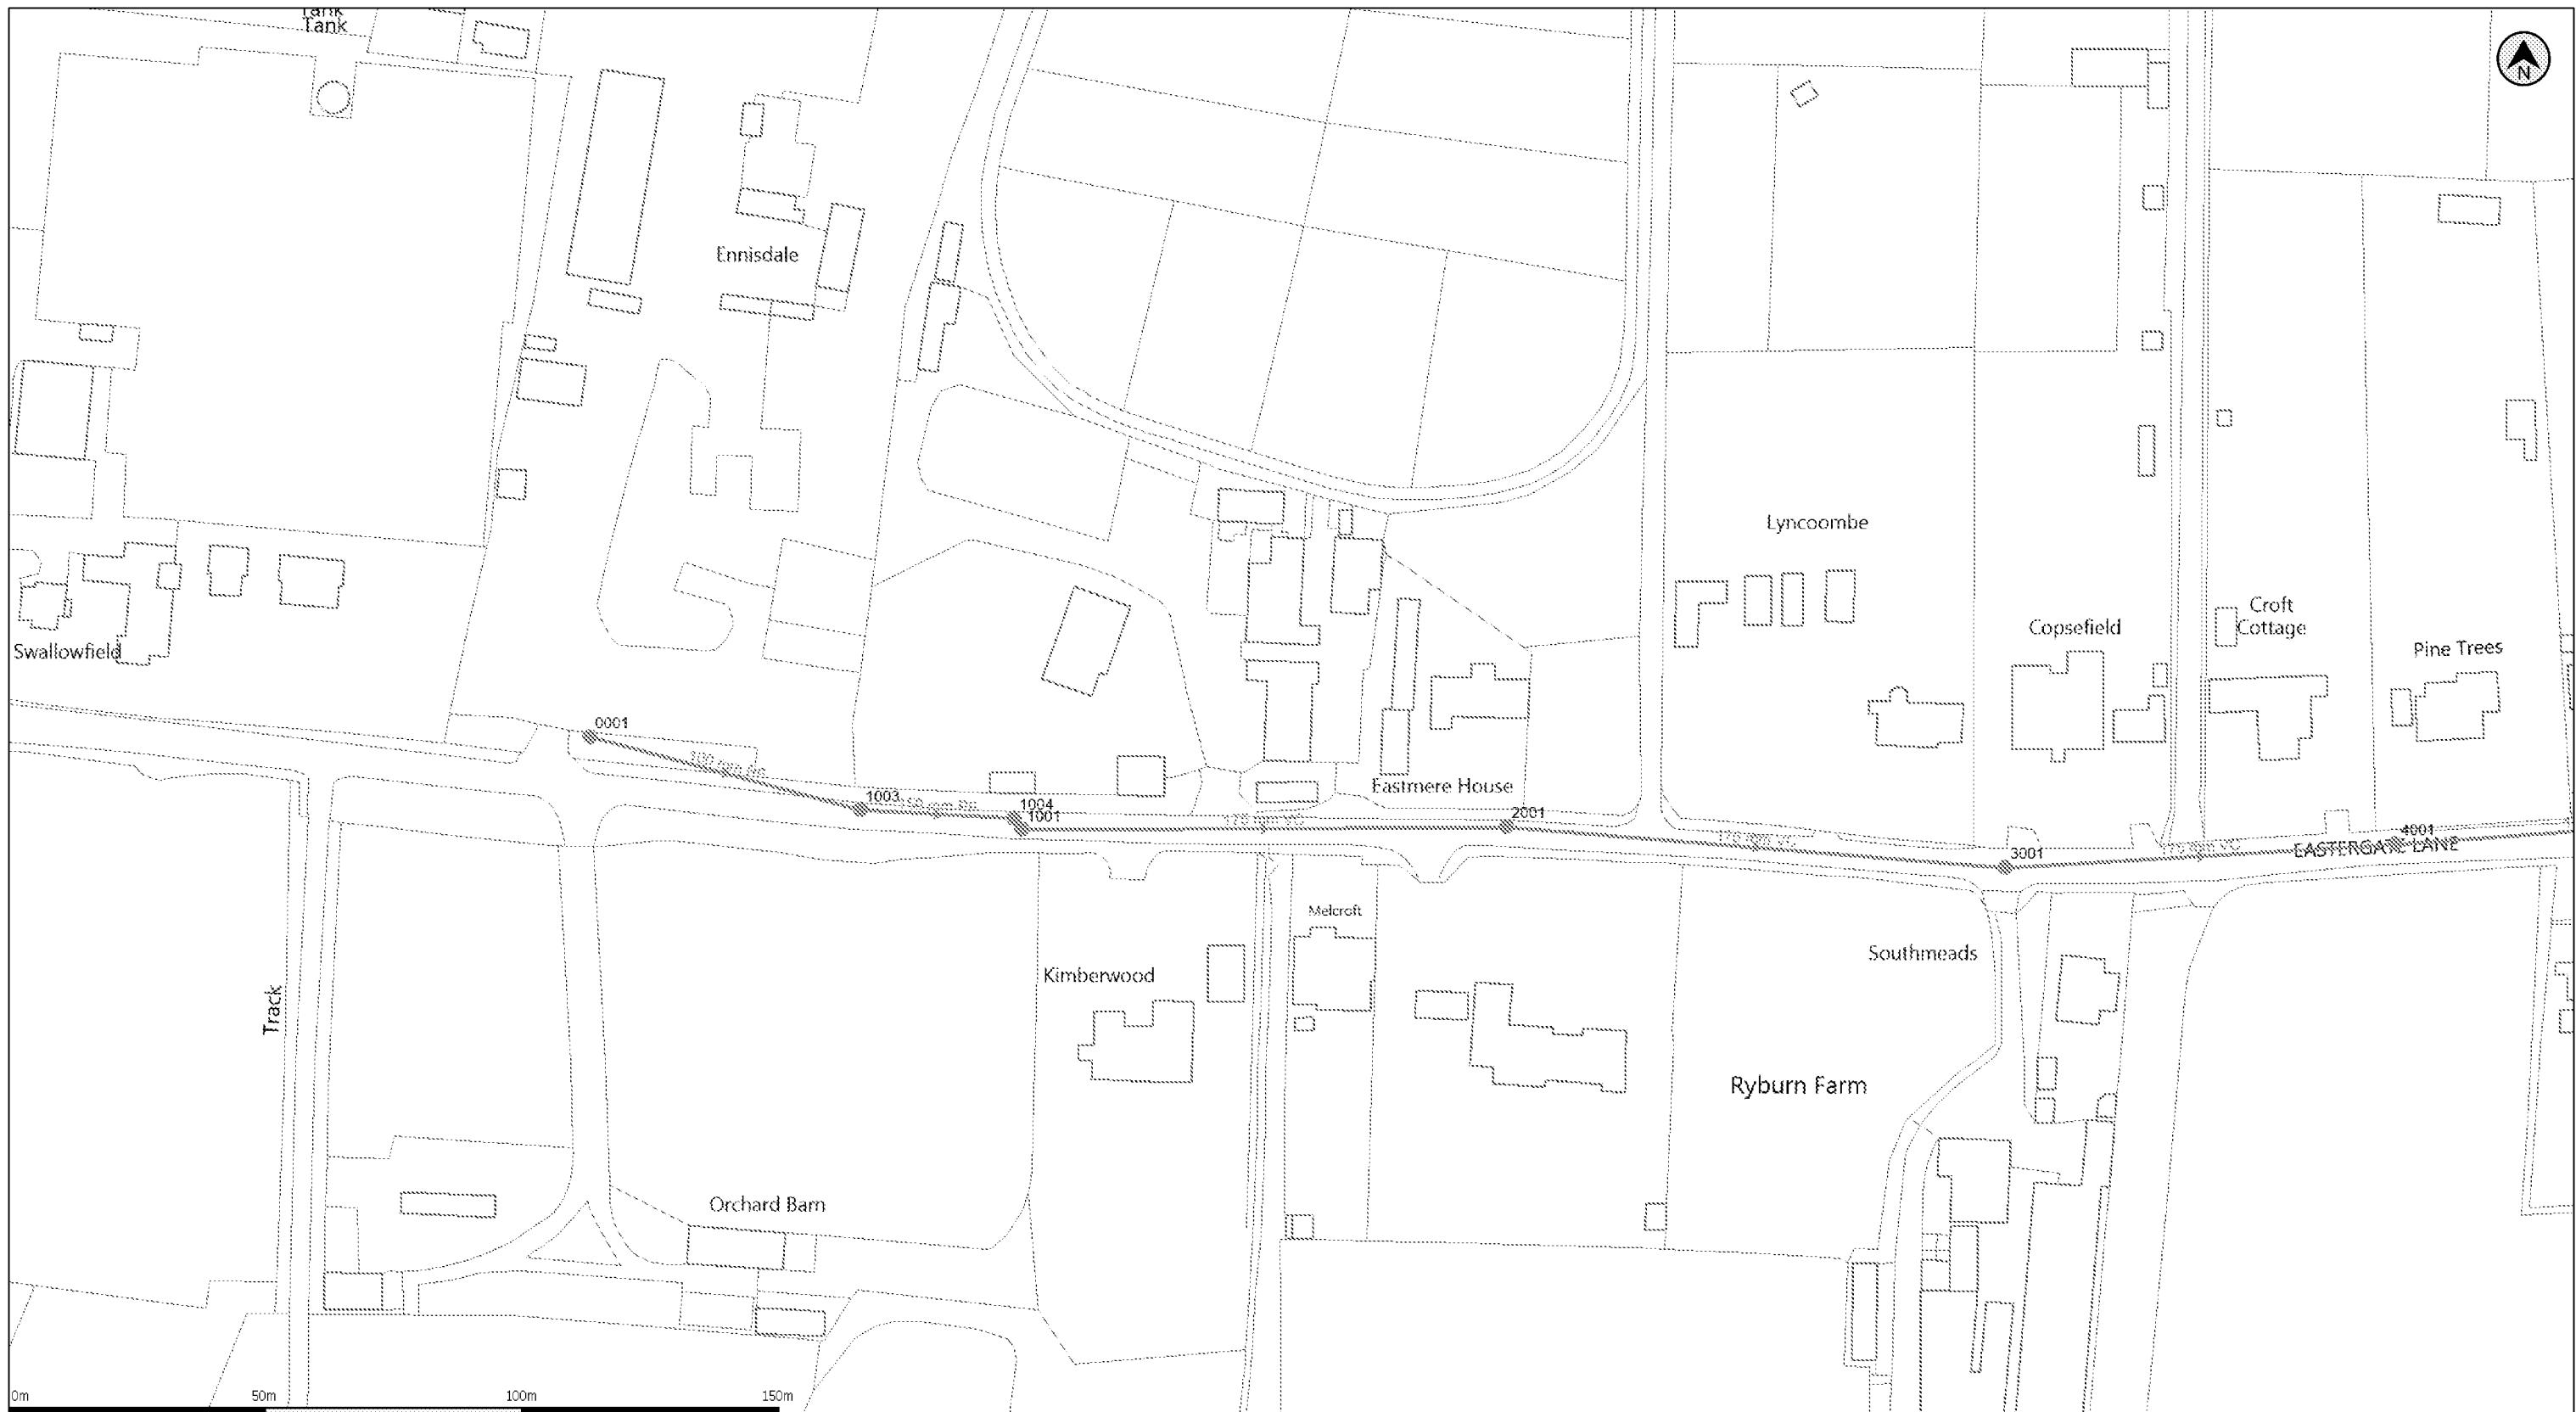
Appendix B
Southern Water Asset Location Plan

WARNING: BAC pipes are constructed of Bonded Asbestos Cement.

WARNING: Unknown (UNK) materials may include Bonded Asbestos Cement.

- 2.4 Asset location plans were obtained from Southern Water (see [Appendix 8](#)), and these indicate there are no surface water sewers which currently serve the site.

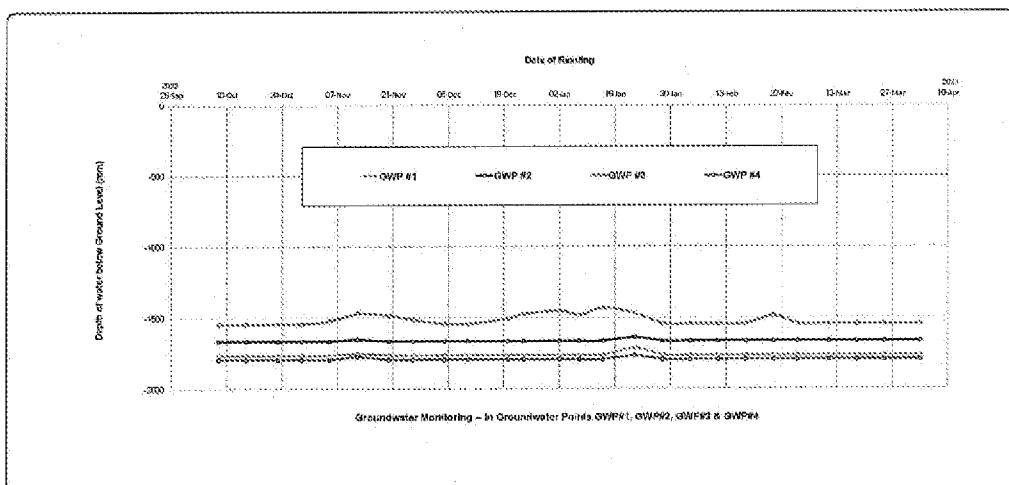
Groundwater Monitoring at Second Development at "Eastmere Stables", Eastgate Lane, Wailbotton

Here are the results of the second Groundwater Monitoring exercise for the winter period 2022-2023 as you requested. It should be noted that the monitoring exercise was carried out within the original 4 monitoring points, which were installed in late September 2021 for the 2021-2022 winter monitoring period. These monitoring points were left in situ in the event of any future monitoring requirement.

2.9 This paviour makeup has a total depth of 600mm. As detailed in [Appendix C](#) the maximum ground water level is 1.7 mbgl and therefore the recommended distance of 1m from the permeable pavours and maximum ground water level is achieved.
