# LAND ADJACENT 37 HILL LANE

## DRAINAGE STATEMENT

**Soil Infiltration Testing and Groundwater Monitoring – 37 Hill Lane, Barnham**

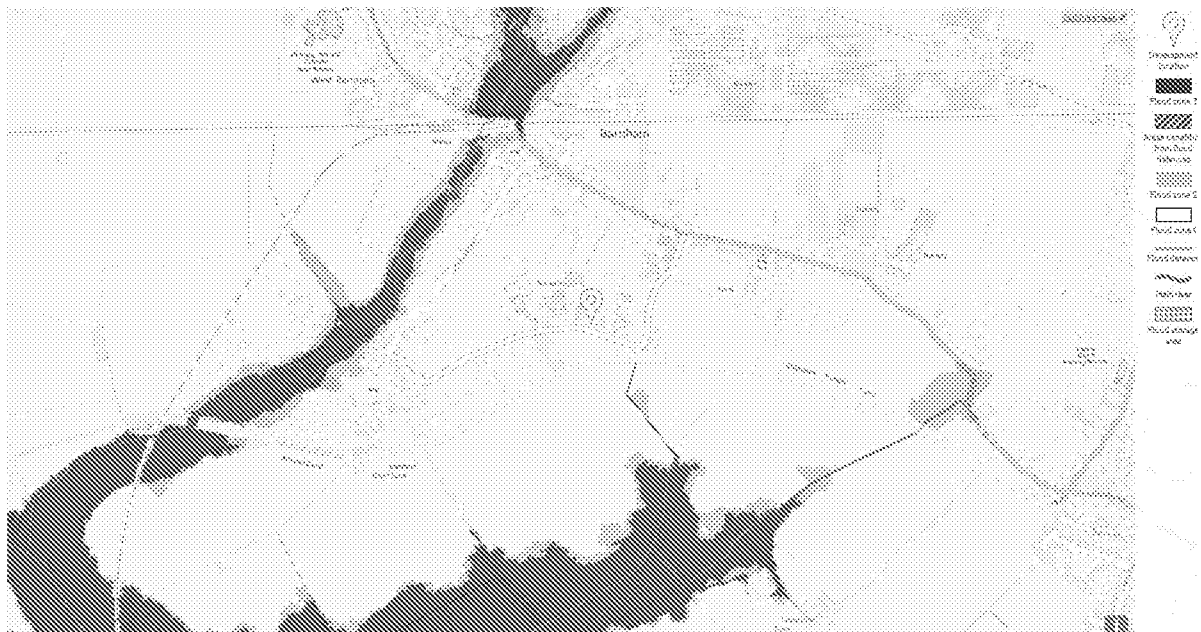
The site sits outside of flood zones 2 and 3 – extract from the Environment Agency mapping below (the yellow pin shows the site location):

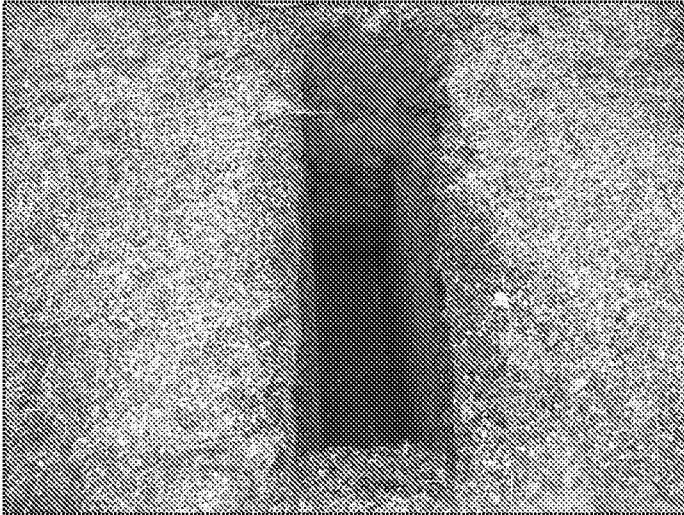
1.

- 1) TP1
- 2) TP1
- 3) TP2

Intrusive site works were completed over two days; Friday 9<sup>th</sup> and Monday 12<sup>th</sup> March 2018, supervised by an Engineering Geologist from CE. Photographs of the works can be viewed to the rear of this report.

Two trial pits (TP1 and TP2) were advanced by way of a mini-excavator to a maximum depth of 2.20mbgl. Following this, both pits were then rapidly filled with potable water from a trailer mounted bowser. Data loggers were then placed within the pits to monitor the fall in water level over time.

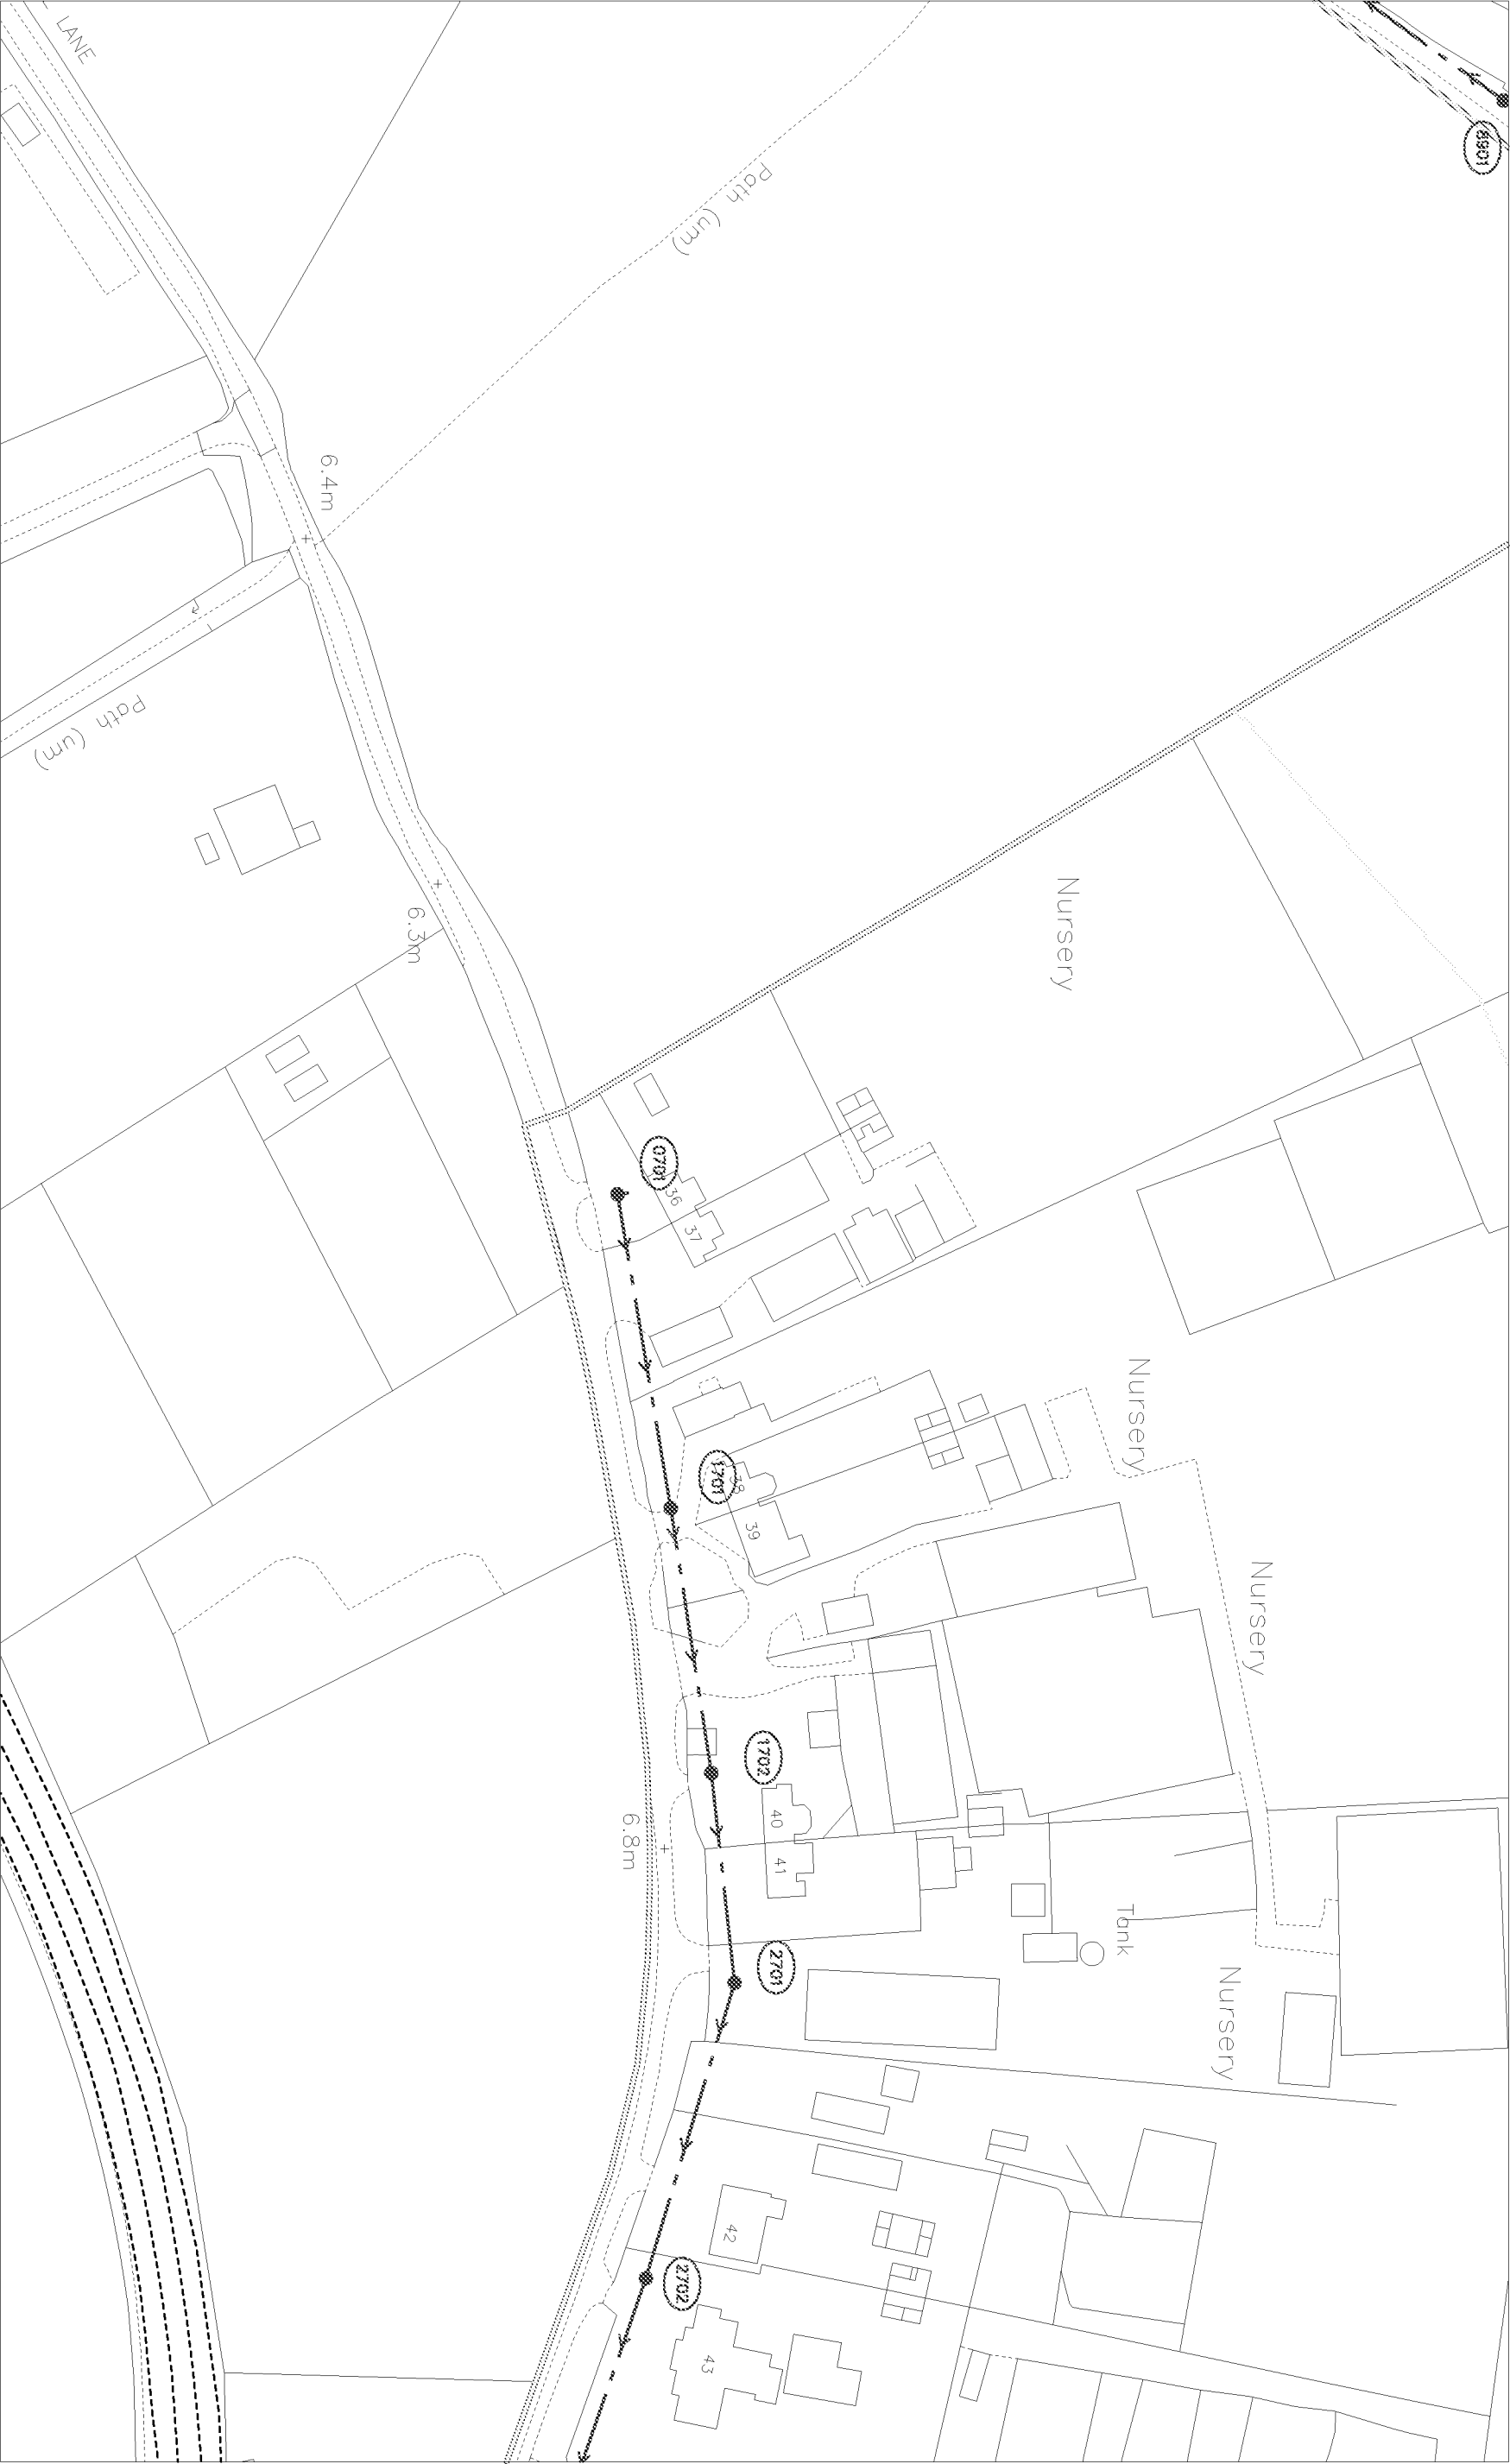
| O.S. REF.<br><b>SU9603NW</b> | | Drawn by:<br><b>yadavsa</b> | | The positions of pipes shown on this plan are believed to be correct, but Southern Water Services Ltd accept no responsibility in the event of inaccuracy.<br>The actual positions should be determined on site.<br><i>WATERWORKS, 824C, 1999 are contributors of British Pathways Company<br/>WATERWORKS, 824C, 1999 are contributors of British Pathways Company</i> | |

Record information from Southern Water is attached (appendix ii). This shows the mains sewer running in front of the houses along Hill Lane. A new connection into the sewer will be formed for the new houses, subject to the normal approvals.
