### Introduction

### Site Investigation

Project CE25.2088 - Hillview, Eastergate Lane  
Eastergate, PO20 3SJ

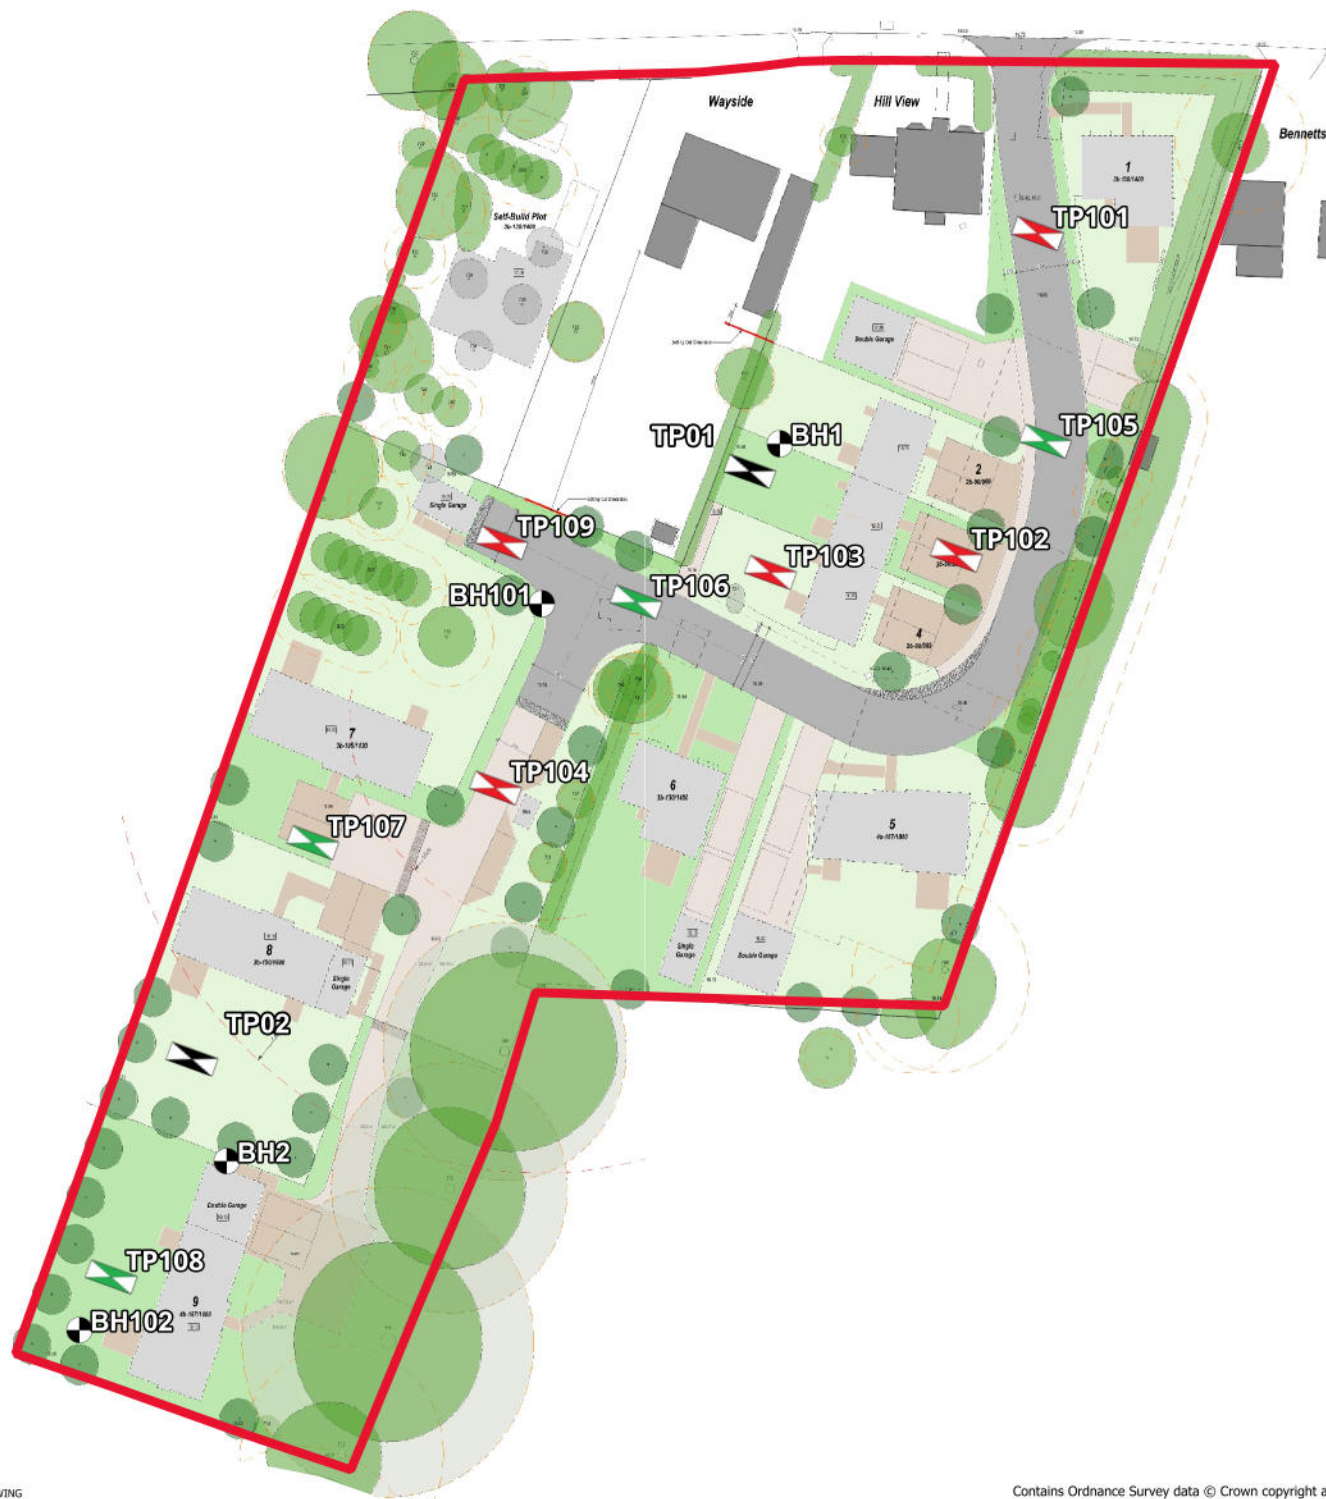
Figure 3

Title Site Investigation Plan

- Site Boundary
- Borehole with standpipe installation
- Trial pits (0.70mbgl)
- Trial Pits (1.70mbgl)
- Existing Trial Pits

- Nine mechanically excavated trial pits (TP101-TP109) to depths of 0.70m and 1.70m bgl
- Two existing mechanically excavated trial pits (TP01 and TP02) were used for testing and had been left open since the previous investigation conducted by CE Ltd in May 2025 (ref: CE25.1632)
- Two windowless sampler boreholes (BH101 and BH102) to a maximum depth of 5.0mbgl and standpipe installation to monitoring groundwater levels
- Three cycles of soil infiltration tests within each trial pit in accordance with BRE Digest 365

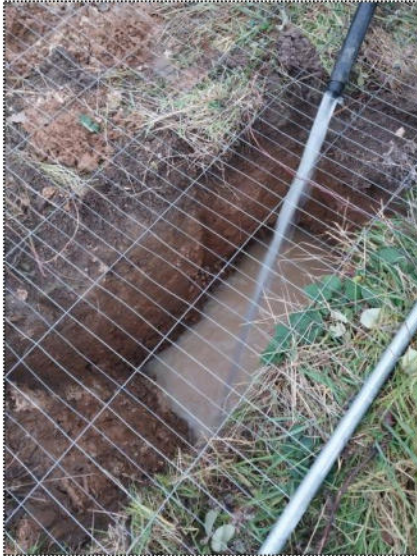
1.

- 1) BRE 365 testing
- 2) BRE 365 testing
- 3) BRE 365 testing
- 4) BRE 365 testing

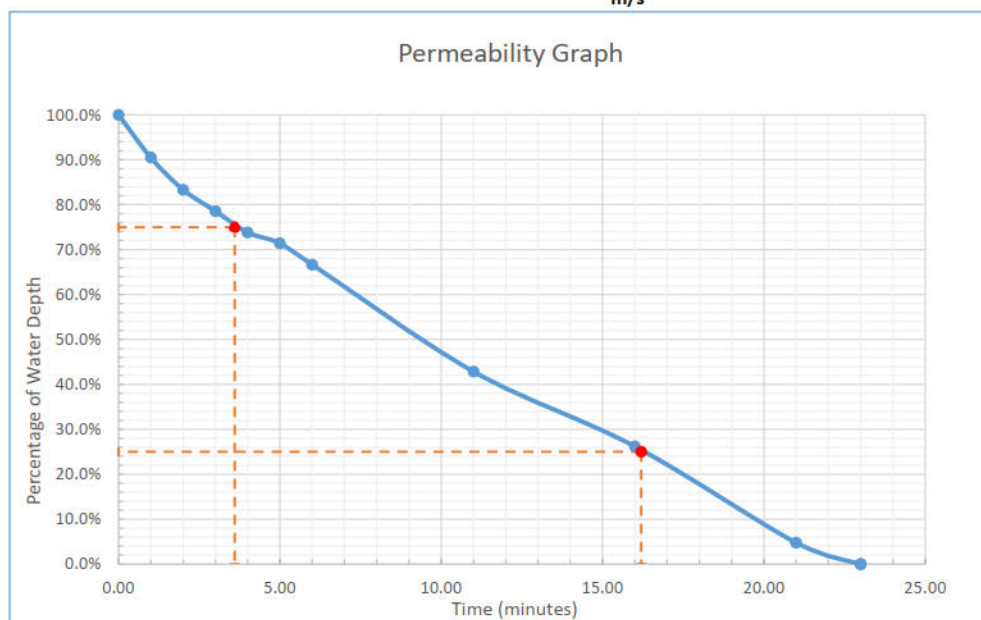
INFILTRATION CALCULATED FROM 75%-25% WATER DEPTH RANGE

| <b><u>Infiltration Rate</u></b> | <b><u>from 75%-25%</u></b> | <b>1.45E-04</b> |

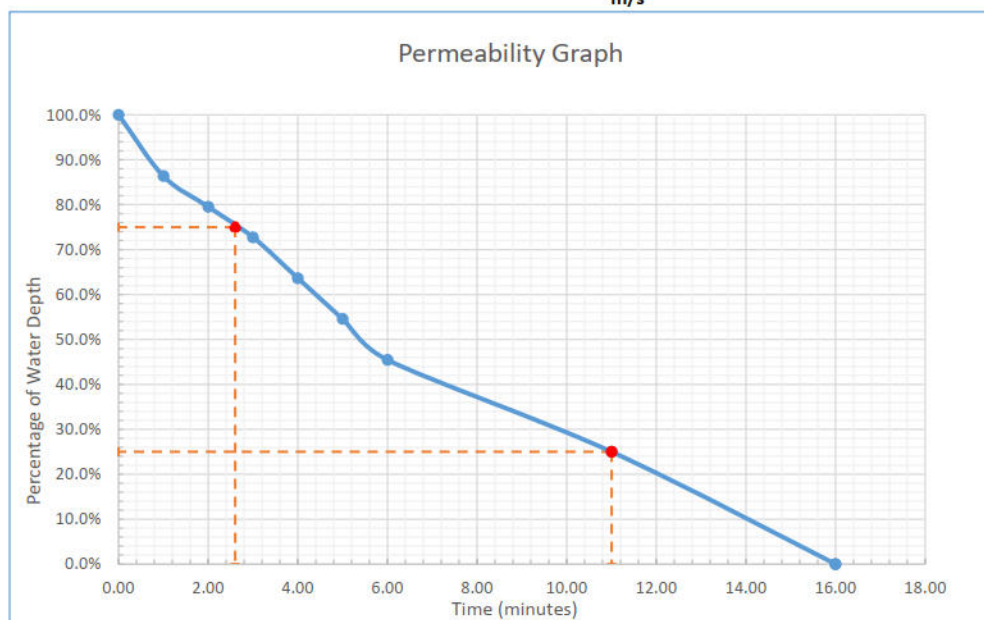
**Trial Hole: TP103**

**INFILTRATION CALCULATED FROM 75%-25% WATER DEPTH RANGE**

| <b><u>Infiltration Rate</u></b> | <b><u>from 75%-25%</u></b> | <b>2.22E-04</b> |

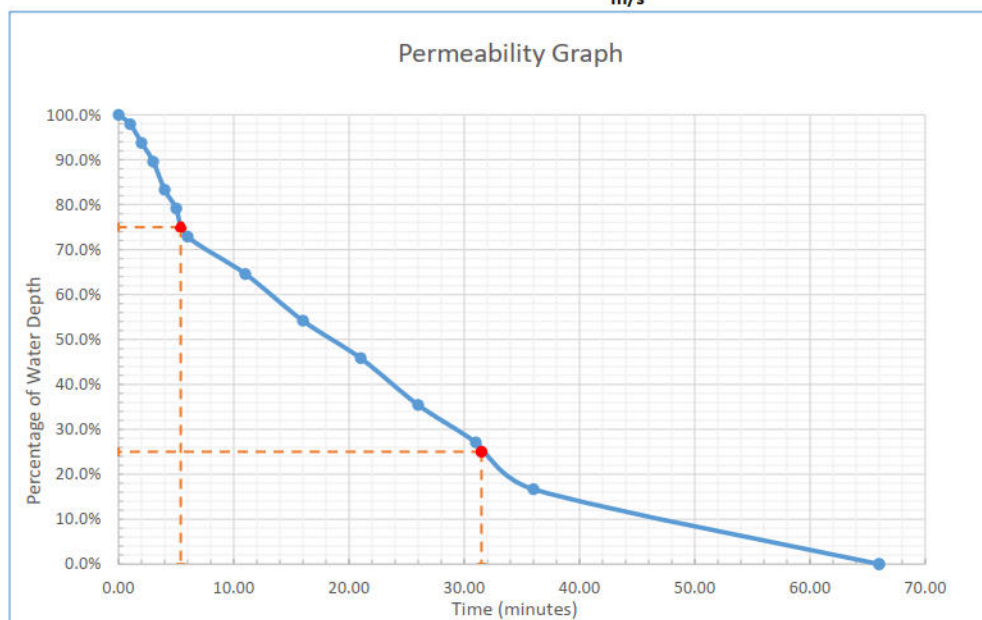
INFILTRATION CALCULATED FROM 75%-25% WATER DEPTH RANGE

7.51258E-05

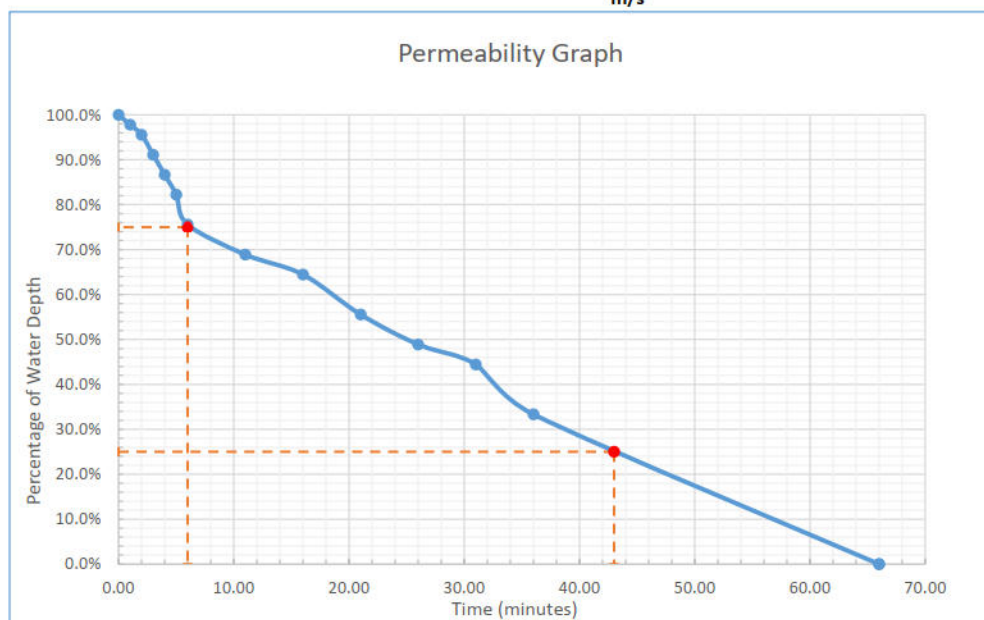
**Trial Hole: TP104**

**INFILTRATION CALCULATED FROM 75%-25% WATER DEPTH RANGE**

| <b><u>Infiltration Rate</u></b> | <b><u>from 75%-25%</u></b> | <b>5.13171E-05</b> |

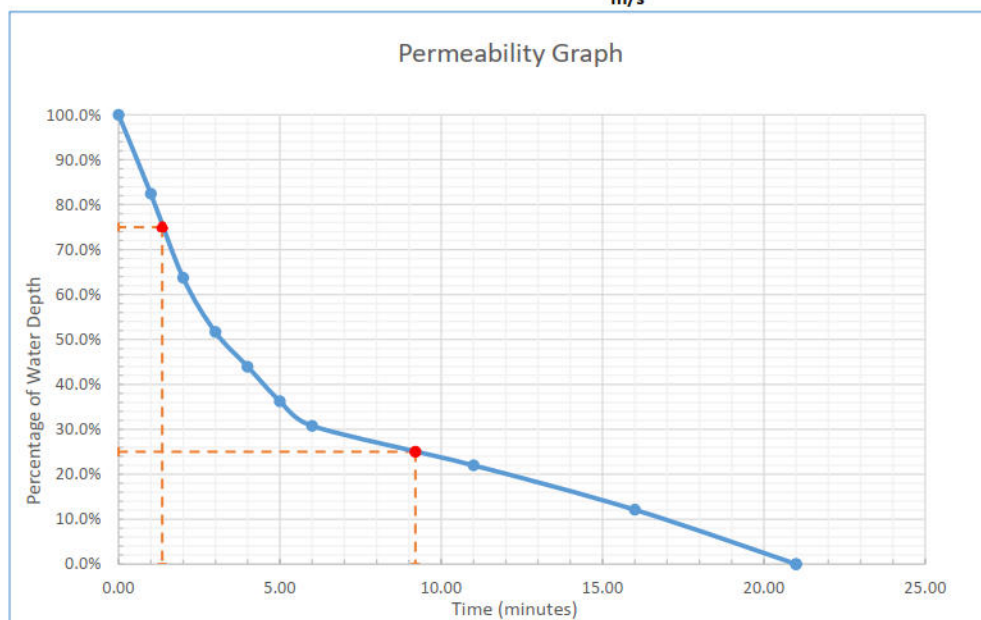
**Trial Hole: TP105**

**INFILTRATION CALCULATED FROM 75%-25% WATER DEPTH RANGE**

| <b><u>Infiltration Rate</u></b> | <b><u>from 75%-25%</u></b> | <b>3.20E-04</b> |

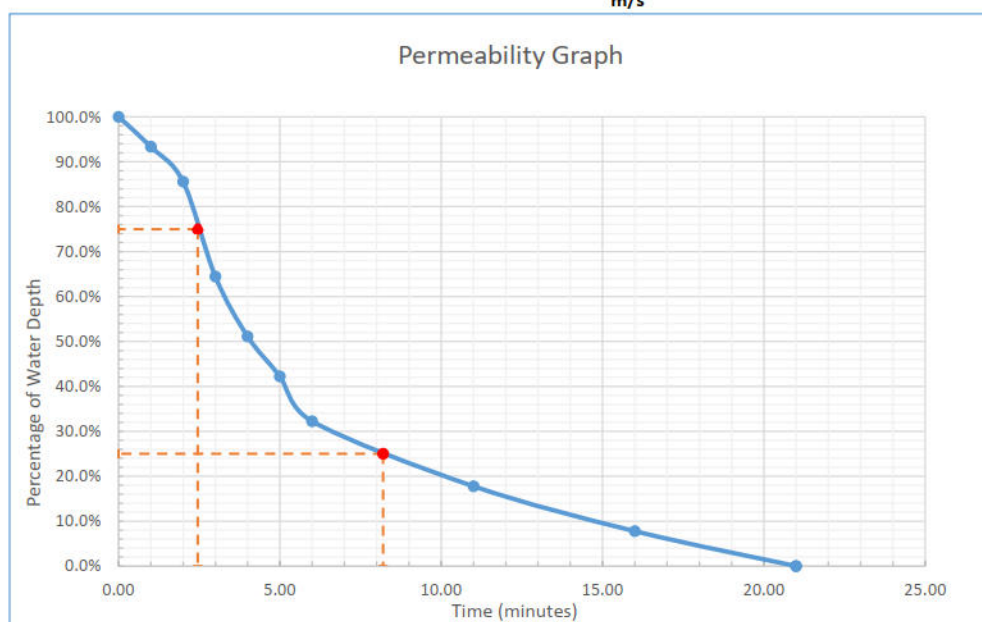
**Trial Hole: TP105**

INFILTRATION CALCULATED FROM 75%-25% WATER DEPTH RANGE

4.35E-04

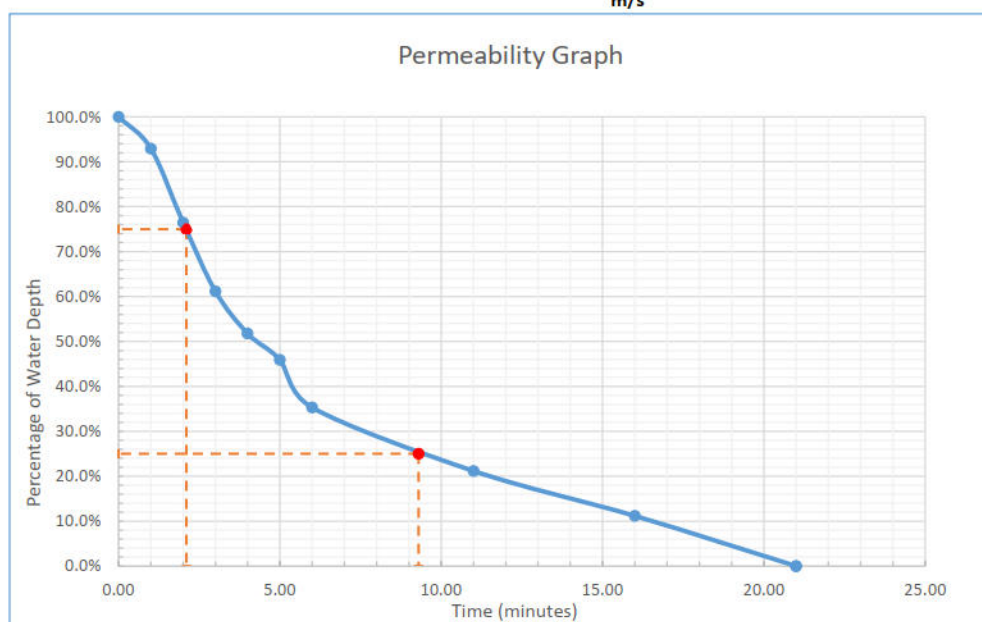
**Trial Hole: TP105**

INFILTRATION CALCULATED FROM 75%-25% WATER DEPTH RANGE

3.41E-04

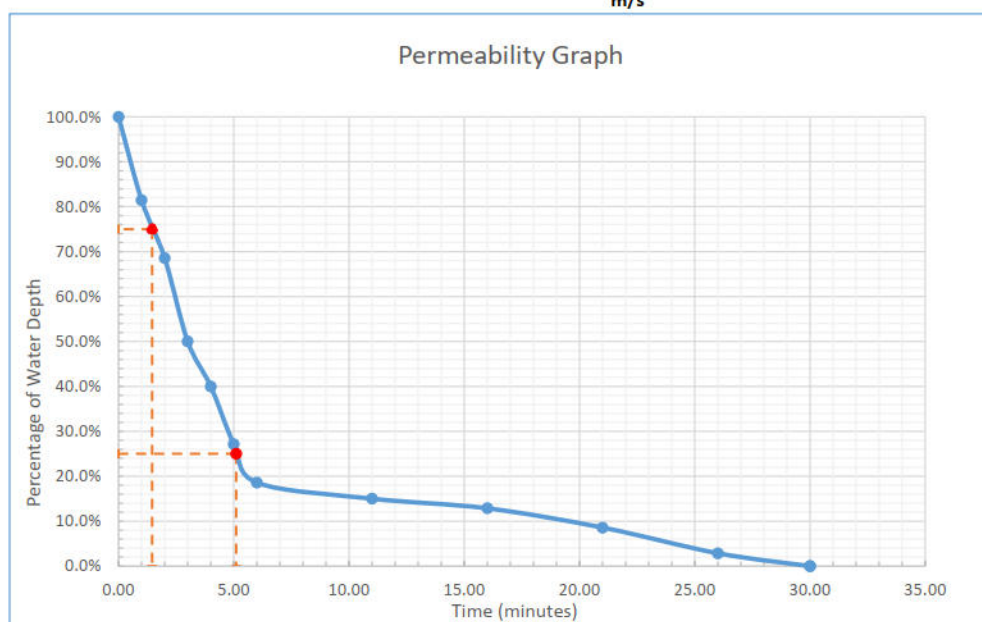
**Trial Hole: TP106**

INFILTRATION CALCULATED FROM 75%-25% WATER DEPTH RANGE

**Infiltration Rate** from 75%-25%

7.06E-04  
m/s

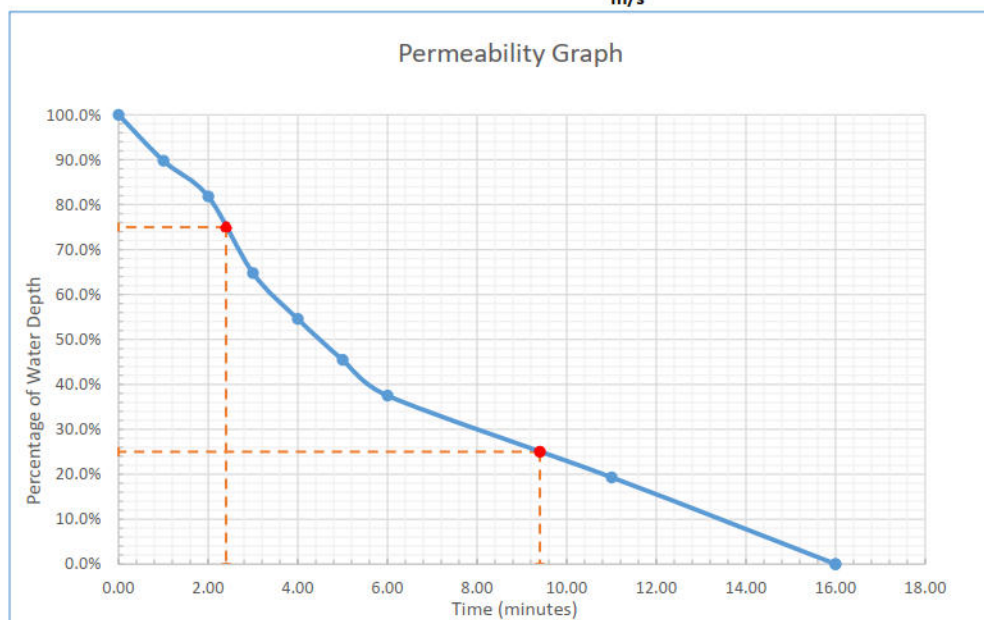
**Trial Hole: TP108**

**INFILTRATION CALCULATED FROM 75%-25% WATER DEPTH RANGE**

| <b><u>Infiltration Rate</u></b> | <b><u>from 75%-25%</u></b> | <b>3.58E-04</b> |

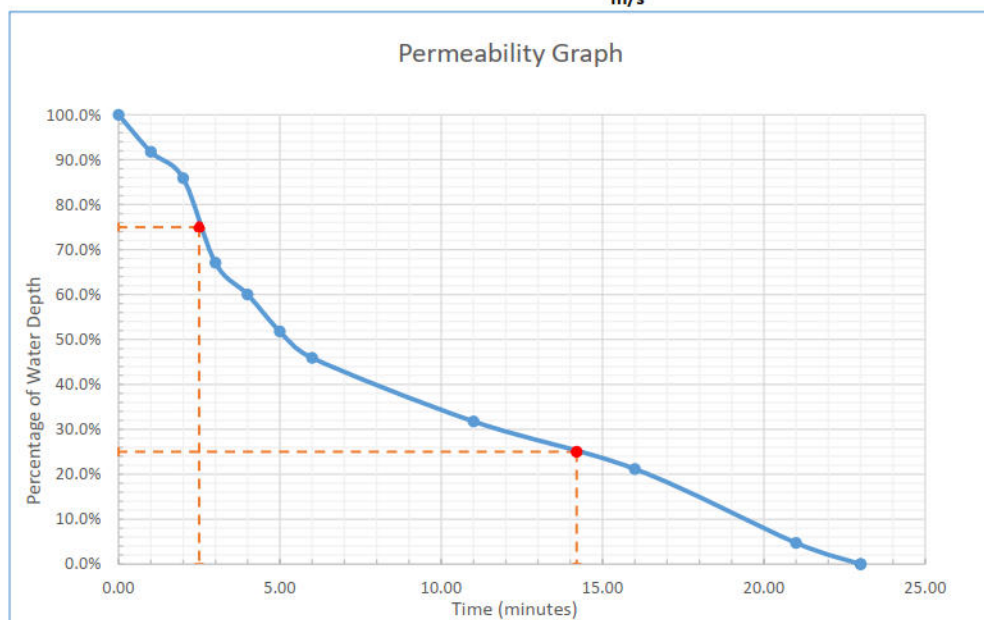
**Trial Hole: TP108**

**INFILTRATION CALCULATED FROM 75%-25% WATER DEPTH RANGE**

| <b><u>Infiltration Rate</u></b> | <b><u>from 75%-25%</u></b> | <b>2.11E-04</b> |

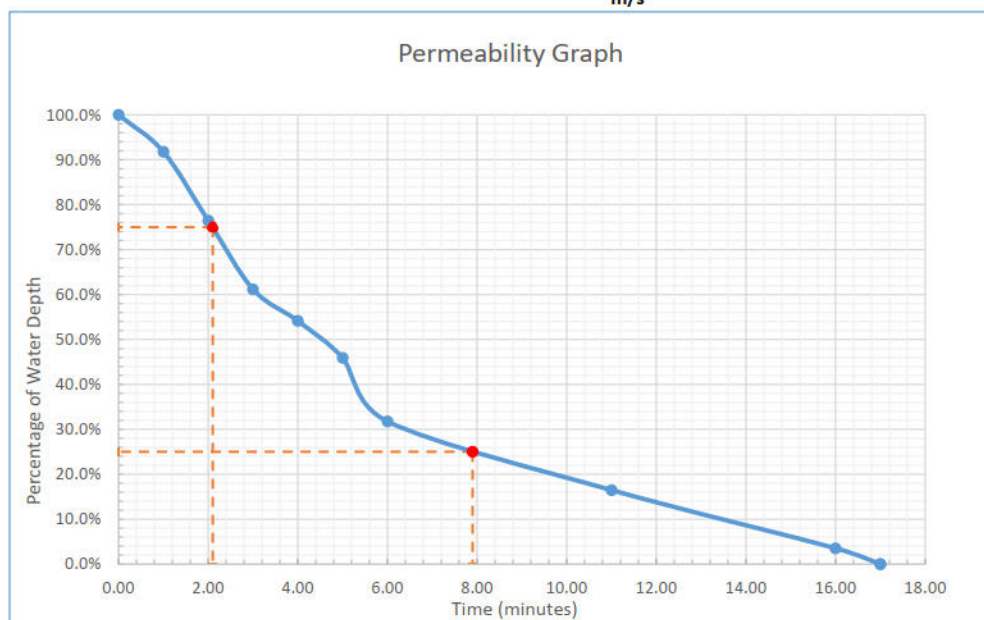
**Trial Hole: TP108**

**INFILTRATION CALCULATED FROM 75%-25% WATER DEPTH RANGE**

| <b><u>Infiltration Rate</u></b> | <b><u>from 75%-25%</u></b> | <b>4.27E-04</b> |

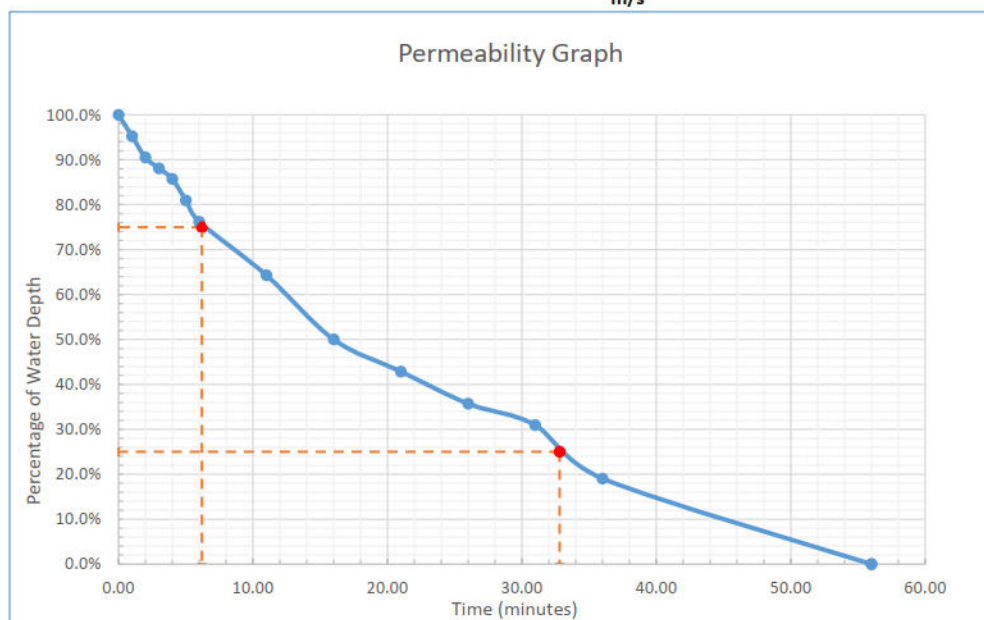
**Trial Hole: TP109**

**INFILTRATION CALCULATED FROM 75%-25% WATER DEPTH RANGE**

| <b><u>Infiltration Rate</u></b> | <b><u>from 75%-25%</u></b> | <b>6.88895E-05</b> |

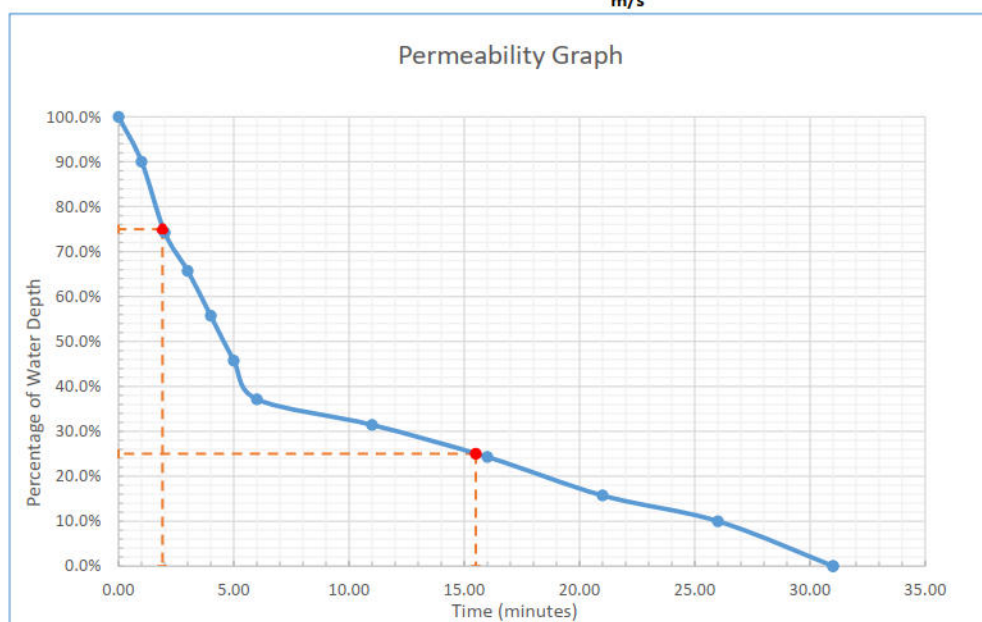
**Trial Hole: TP01**

INFILTRATION CALCULATED FROM 75%-25% WATER DEPTH RANGE

**Infiltration Rate** from 75%-25%

1.81E-04  
m/s
