# Noise Assessment for Planning and Change of use

Site: **6 Ockley Road, Bognor Regis, West Sussex.P021 2HW**  
Client: **Speedy Tyres**

Date: 31/10/2019  
Project: J2834  
Issue 1

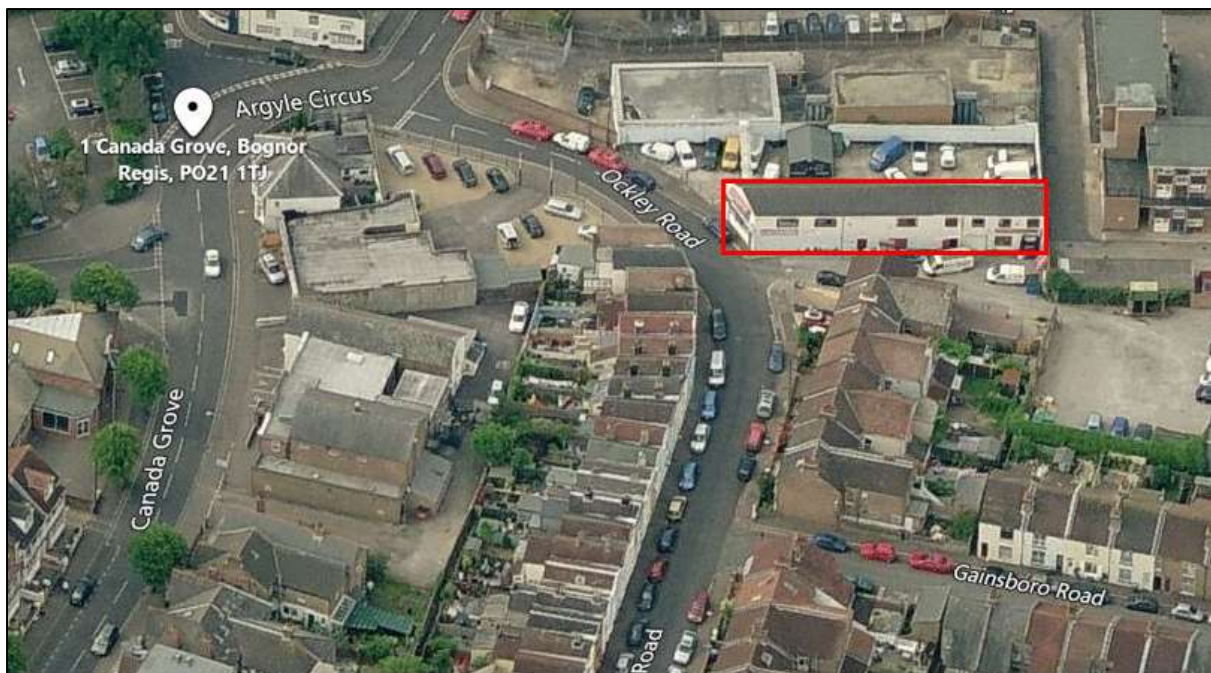
Figure 1. Aerial Image of the site with the site shown in red

The application site can be seen in Figures 1 to 3 below and showing the positioning of the site (Figure 1) as well as closer photographs of the front and side of the site (Figure 2), as well as inside the premises (Figure 3).

Speedy Tyres is located inside a long two storey building which runs East to West. At the Eastern end of the building, as can be seen in Figure 1 above is a roller shutter door used to secure the premises, however it remained open whilst present on site and whilst operations to change wheels etc occurred internally. At the very rear of the building, racks of new tyres in assorted sizes are stored. Recent new build residential development has occurred in the Mews to the North West of the site.

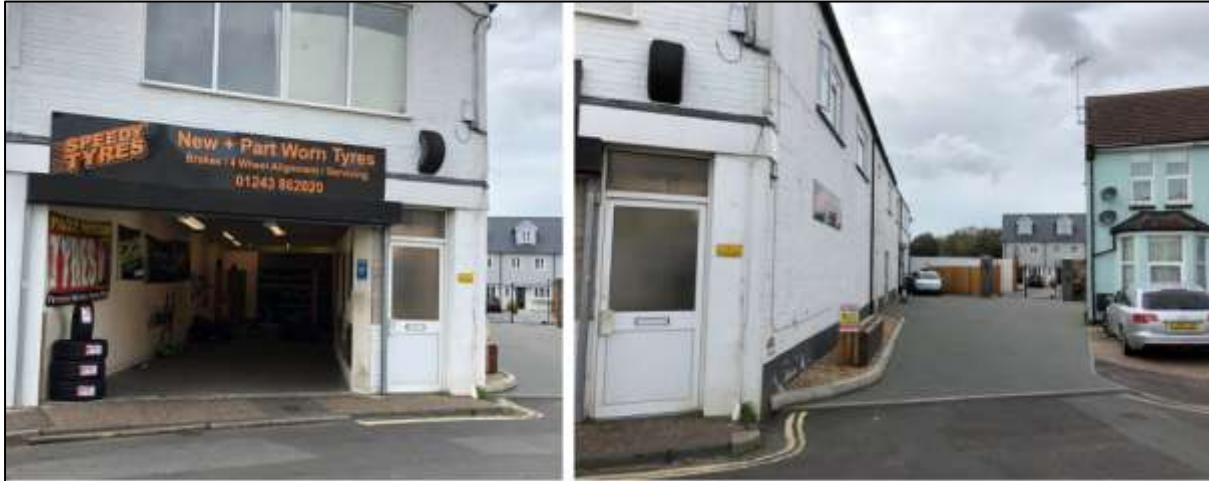
**Figure 2. Location and Context Photograph**

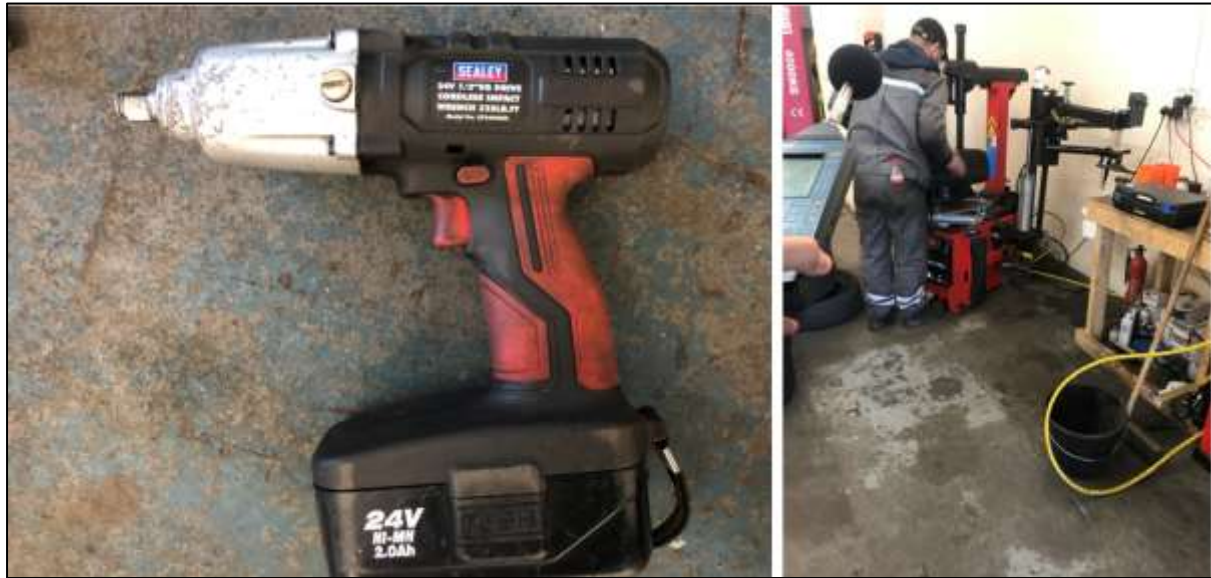
**Figure 4. Hand Held Electric Nut Gun (Left) and Tyre Separator (Right)**

Air tools are not used and wheel nuts are first loosened by hand leverage. An electric operated hand wrench is seen in Figure 4 and was measured removing a number of wheels/tyres. On average, it took approximately eight seconds to remove wheel nuts using the electric gun.

The tyre separator then separates the outer rubber tyre from the metal core/rim, which makes a characteristic pop as the rubber is separated. The machine is seen in Figure 4 below (right hand image).

1. Hand held electric nut gun (Sealey 24V ½" Cordless Impact Wrench)
2. Hydraulic ramp/lift for access to brake callipers
3. Compressor located in a separate room to the rear of the premises which was marked with a Sound Power Level (LWA) Marking Label of 96dB(A).
4. Tyre Separator.

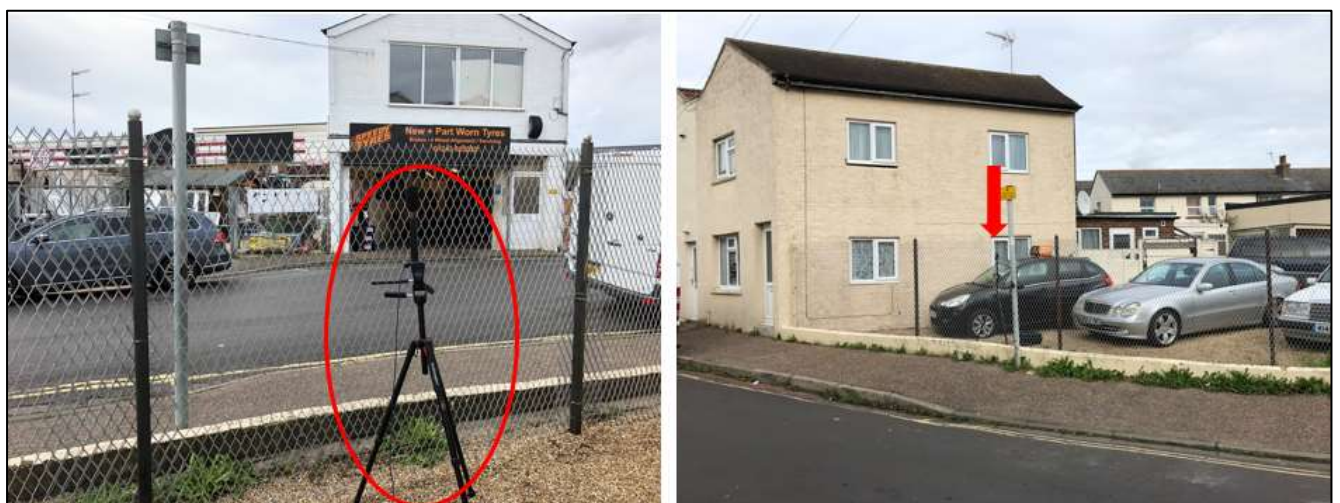
Figure 5. Background Measurement Position 1, adjacent to 7 Ockley Road opposite.

A sound level meter (Norsonic 118 (C)) was left running in front of the premises in line with the façade of 7 Ockley Road to determine background sound levels without garage activities occurring. The sound level meter was tripod mounted at 1.5m high and behind a chain link fence to assist with security and minimise any trip hazards to the frequent pedestrian traffic. The internal time clocks of the two sound levels were synced to allow a comparison of times and sound pressure levels.

As discussed above, measurements were made in front of the business premises in line with the nearest residential property at 7 Ockley Road, at position 1, and additionally, at the Gainsboro and Ockley Road junction, Position 2, the results of which were relatively consistent. Position 1 is shown below in Figure 4

Position 1 was noted to be, 47dB  $L_{A90,15\text{minutes}}$  (ranged from 47dB  $L_{A90,15\text{ minutes}}$  to 49dB  $L_{A90,15\text{ minutes}}$ )

The soundscape at position 1 was increased, as it received a contribution from faster moving traffic at Argyle Road, as well as vehicles loading and unloading at the adjacent Artur's yard and Magic Garage lot opposite. Position 1 is therefore considered to be representative and used in the assessment of background sound levels.
