14<sup>th</sup> August 2015  
ABMH Ref: F2114/AOB

**Kents Yard**  
**Structural Assessment Report of Existing Barn Buildings**

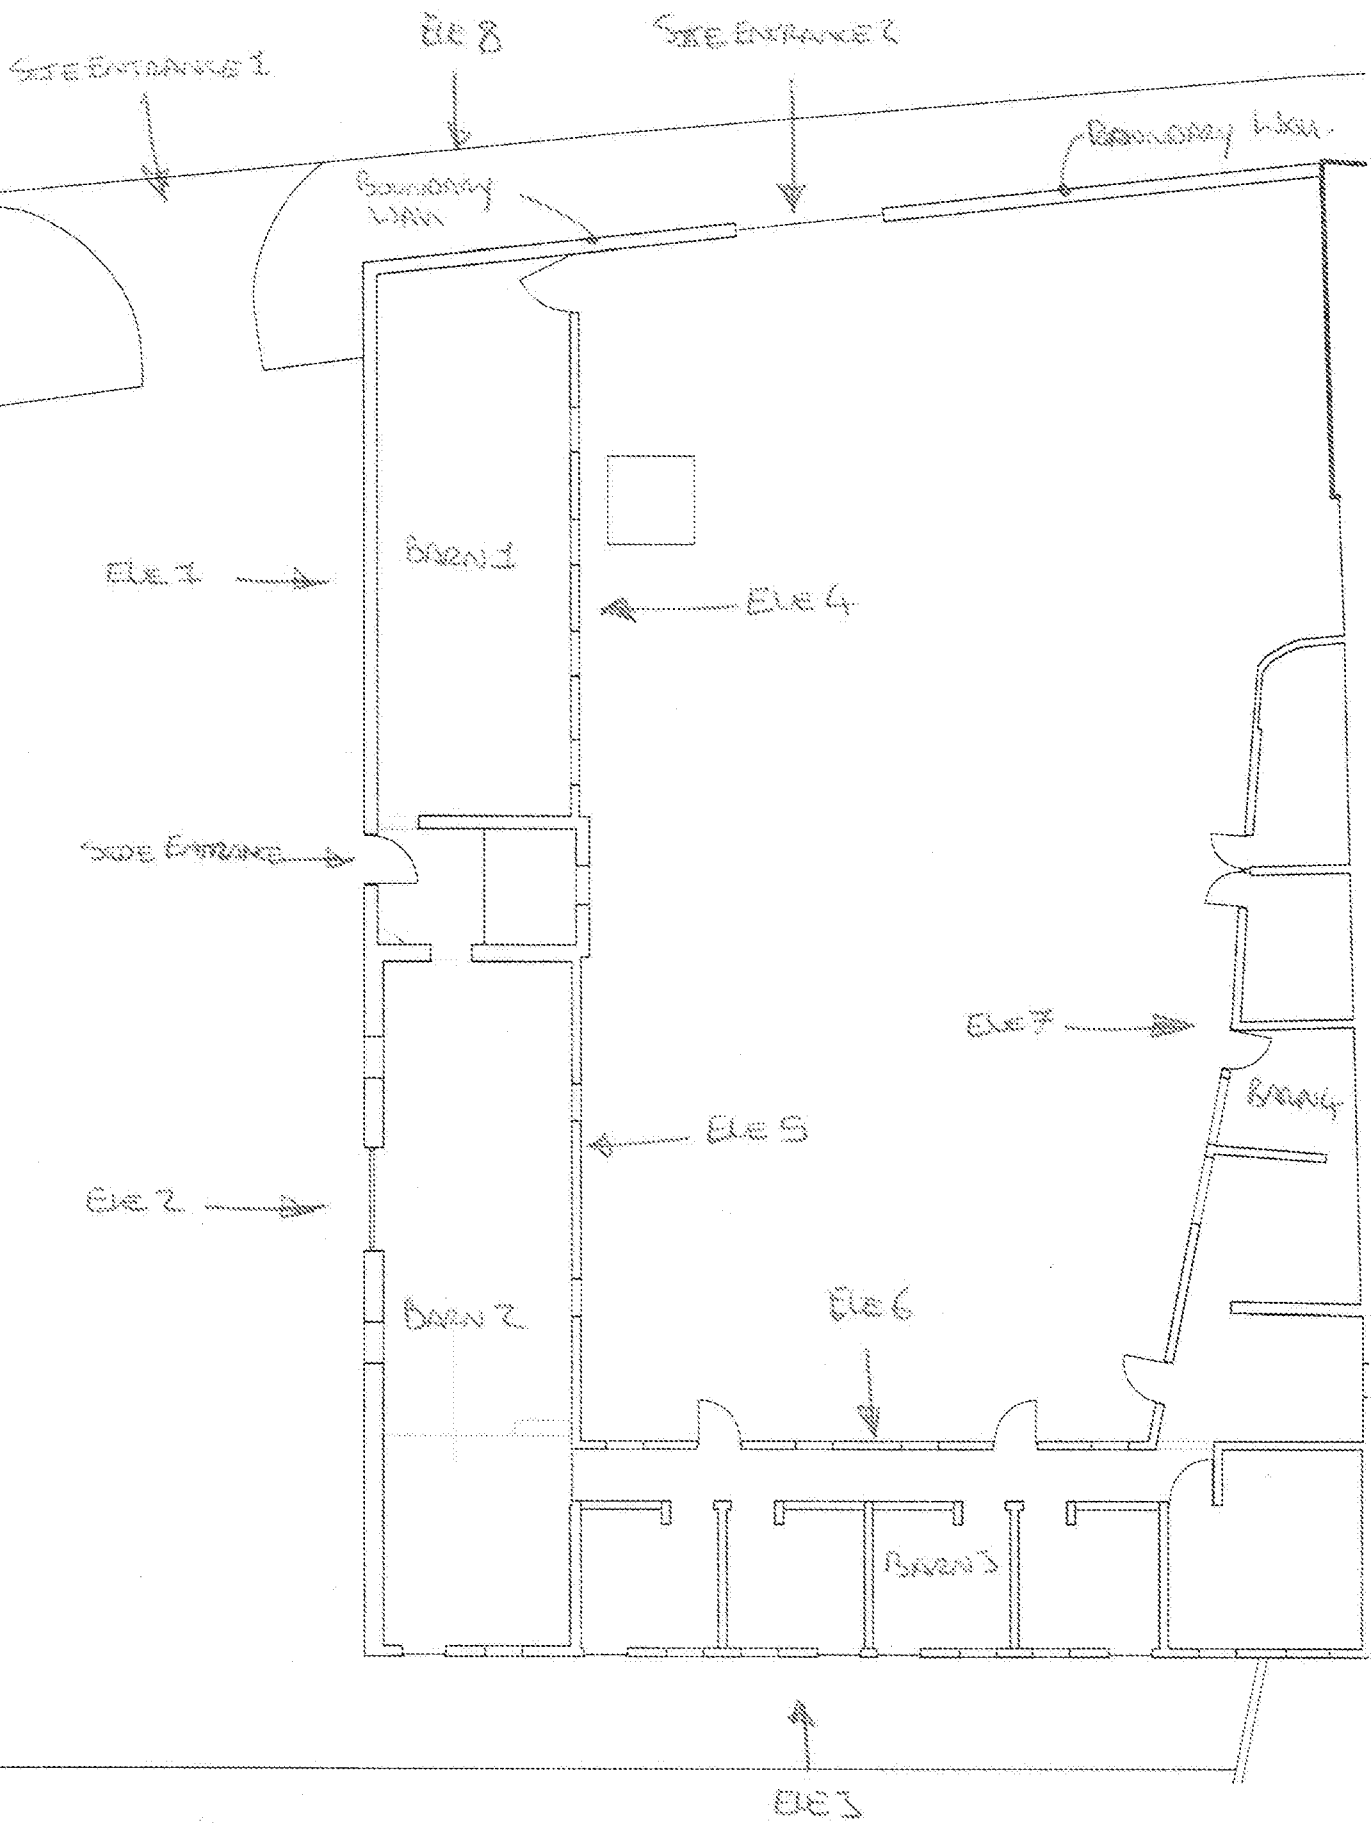
KENTS YARD

Inc. Indicative Site Layout Plan Sketch

The existing barns were interlinked in a 'U' shape and were of different types of construction. The barn buildings to the front of the site (Barns 1, 2 & 4) were of a solid flint with brick construction whereas the barns to the rear of the site (Barn 3) were of a solid brick construction. The roof construction to Barn 1 was a traditional duo pitched timber trussed roof with a slate tile finish. Barns 2 & 3 had a duo pitched steel framed roof with a corrugated sheet (possibly asbestos) roof. Barn 4 had a mixture of a mono pitched timber framed roof with a corrugated (possibly asbestos) roof, and a timber framed flat roof finished with felt with chippings. The boundary wall to the front of the site was a solid flint wall with a wooden gated entrance (site entrance 2) (also refer to the attached site plan).

**Barn 1 -** The external walls (Ele.'s 1 & 4 indicated on the attached site plan) appear to be of a solid flint/brick construction. Both walls externally appear to be a little dilapidated with an area covered in vines. Also visible within Ele. 1 were a few cracks which we believe in our professional opinion could be some sort of movement ie: subsidence/thermal/lateral etc... The flints in some

**Barn 3 -** The external walls (Ele.'s 3 & 6 indicated on the attached site plan) appear to be of a solid brick construction, however Ele. 3 was difficult to fully access and assess due to overgrown vegetation and should be confirm with further investigations. Both Ele.'s 3 & 6 which were visible appear to be in good condition with no signs of movement or structural failure present.

**Barn 4 -** The external wall (Ele. 7 indicated on the attached site plan) consists of approximately 70% solid flint on the left hand side and 30% brick masonry on the right. The brick built part of the external wall appears to be in good condition with no signs of movement or structural failure present. However from our visual inspection the flint built part of the external wall appears to be dilapidated and/or suffered from slight movement which has been remediated in the past at some point however very poorly.
