## False Window to be mounted in vault.

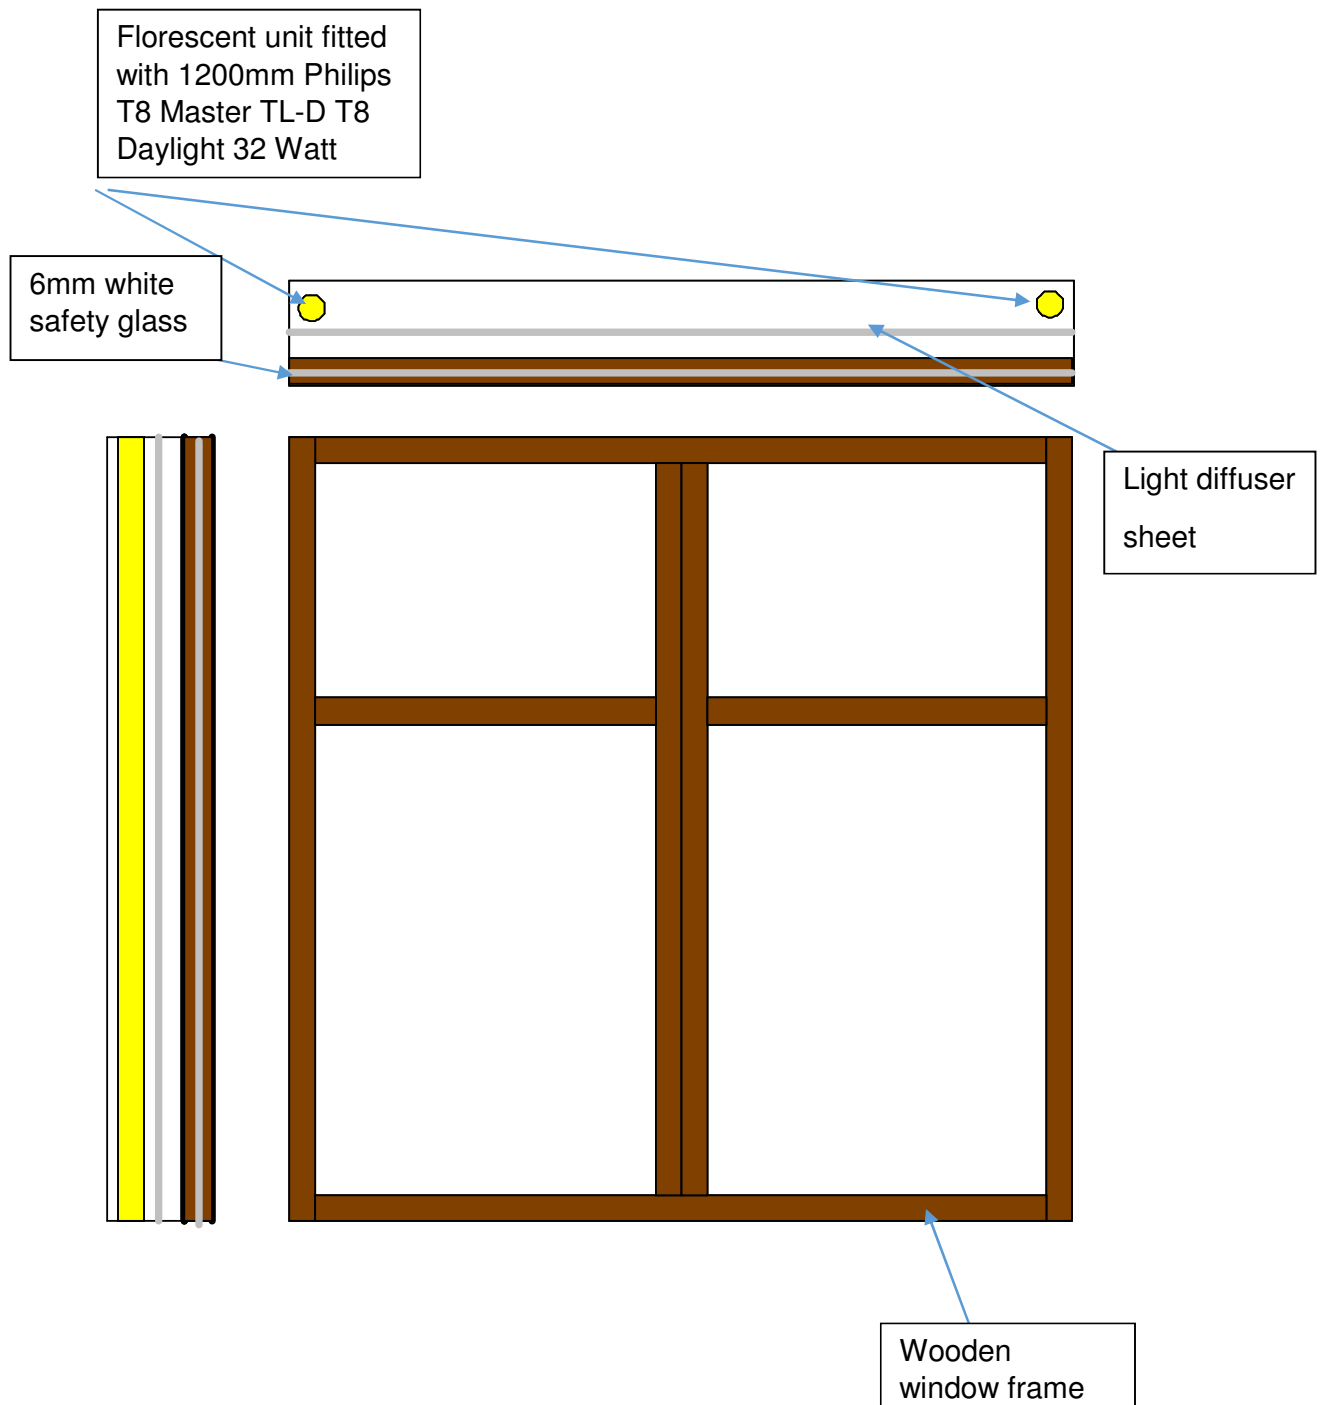
Because the area shown on the layout plan to be the bedroom was formerly used as a vault when Barclays Bank occupied the site in the early 1990's, the walls and roof in this area are constructed in re-enforced concrete impregnated with plastic, such that they cannot be drilled or cut through to form a window. It is proposed that this area be insulated and dry-lined and a false window be installed. The make-up of the latter feature is shown below:
