## DESIGN, ACCESS AND HERITAGE STATEMENT

The Farm  
39 East Street  
Littlehampton  
West Sussex  
BN17 6AU

Project: Subdivision of building into two dwellings

Date: April 2021

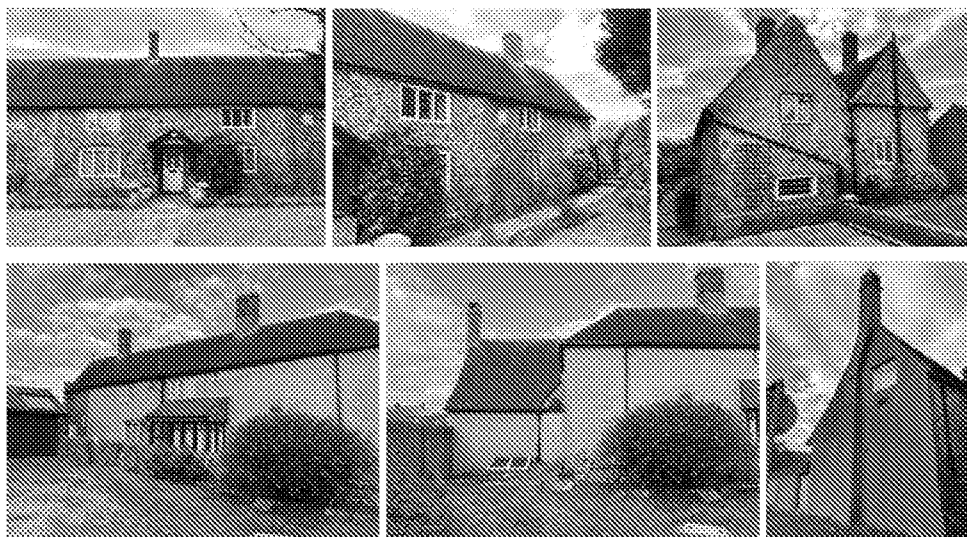
*Top: east and north elevations. Bottom: west and south elevations*

- 2.4. The rear elevation facing west is largely rendered as is the south elevation. The back door has an enclosed lean-to porch. The roof is clay tiled and has three chimney stacks.
- 2.5. To the front the building has a garden mainly laid to lawn, whilst to the rear there is an unmade drive leading to a garage building. A small flint wall sits immediately at the rear of the property. To the north there is an area of garden with a patio, pagoda and some small outbuildings.
- 2.6. To the west is a modern bungalow which clearly sits within the former curtilage of the Farm and has a corresponding area of grass to the north, also with outbuildings.
- 2.7. The Farm is located within an urban environment and on a junction. A primary school is located to the north, St Joseph's Convent to the east and a former school to the south.

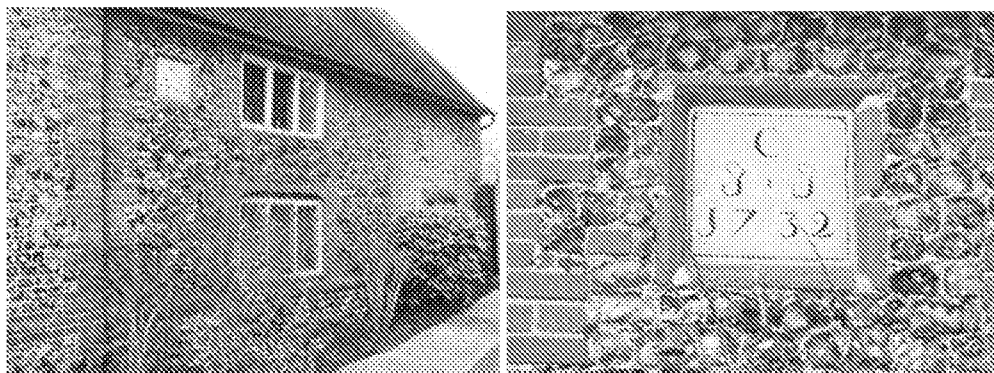
*The date stone on the east elevation with 'C J.J 1732'.*

- 3.18. A date stone on the front of the farmhouse reads 'C. [over] J.J [over] 1732', which one might normally associate with the origins of a house. Date stones however can be deceptive and the building here is clearly earlier than this. The stone most likely refers to alterations and expansion of the building which occurred in the 18<sup>th</sup> century.

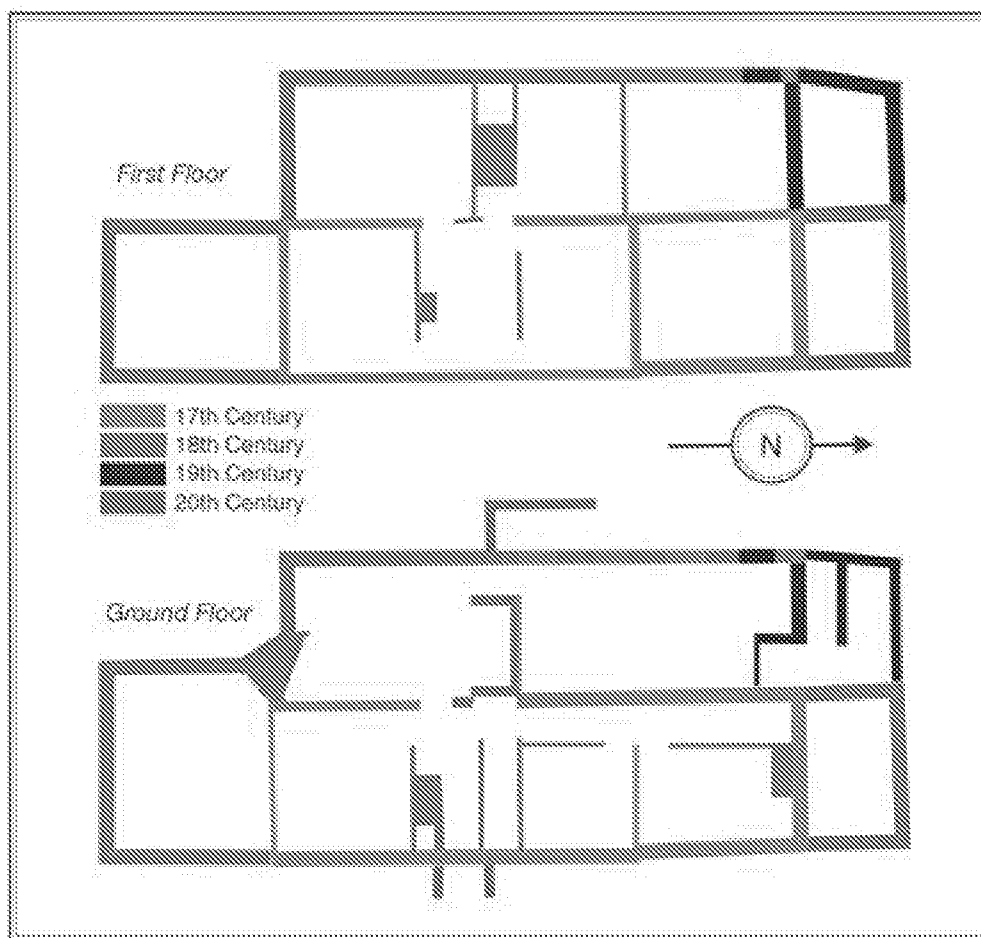
***Phasing plan of the Farm as understood from initial observations***

- 3.15. To assist the understanding of the building's development, the phasing plan above has been produced to indicate the approximate origin of the various elements. These are based on observations of the building as discussed below.

- 3.16. Please note that where internal alterations have been dated, these are based on the perceived remodelling of the building and date attributed to it.

- 3.17. The lines that show alternate colours are an indicator that further assessment is required to pinpoint the date more accurately. The solid lines are more qualified.

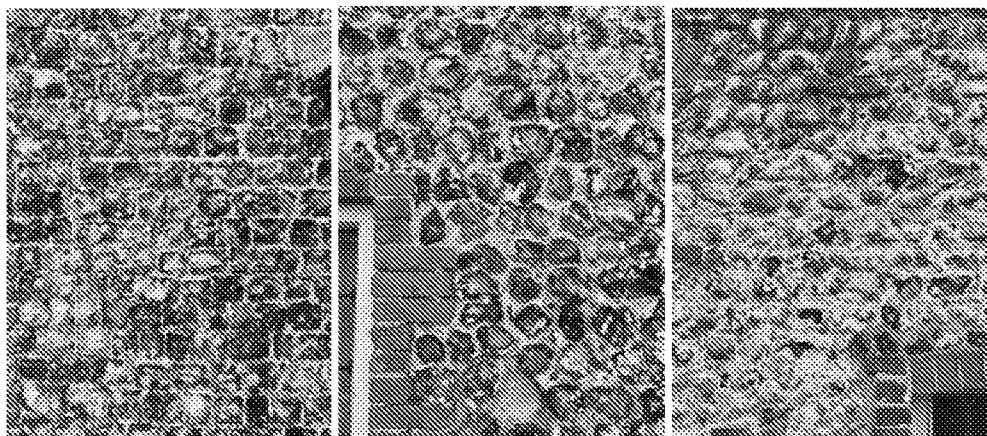
*Flintwork from the 17<sup>th</sup> and 18<sup>th</sup> century phases of the building*

- 3.20. The building is largely timber framed denoting its earliest phases with later additions being constructed in masonry. The east elevation has been replaced in flint, with the best of this work appearing on the earlier phases.

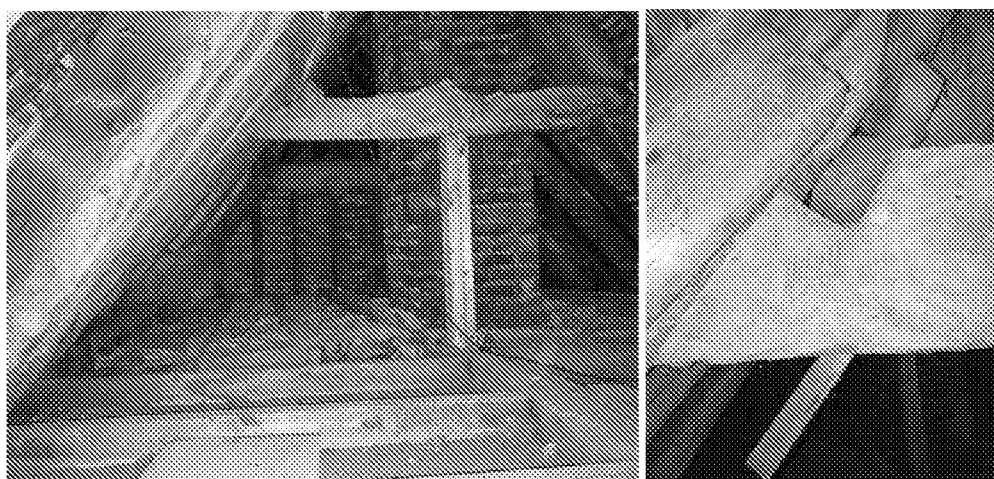
*A clasped purlin within the 17<sup>th</sup> century phase and detail of a clasp*

- 3.21. In its earliest form, the Farm would have had a thatch roof, possibly made from reed. Reed is also evident here as a substrate for a ceiling found in the earlier phase. Thatched roofs normally had a slightly steeper roof pitch which still seems evident.
- 3.22. The phasing of the building has been largely informed by the roof structure which maintains its 17<sup>th</sup> century form with abutted rafters with clasped purlins. Diagnostically clasped purlins have a long date range though have been shown to be more common prior to 1650.

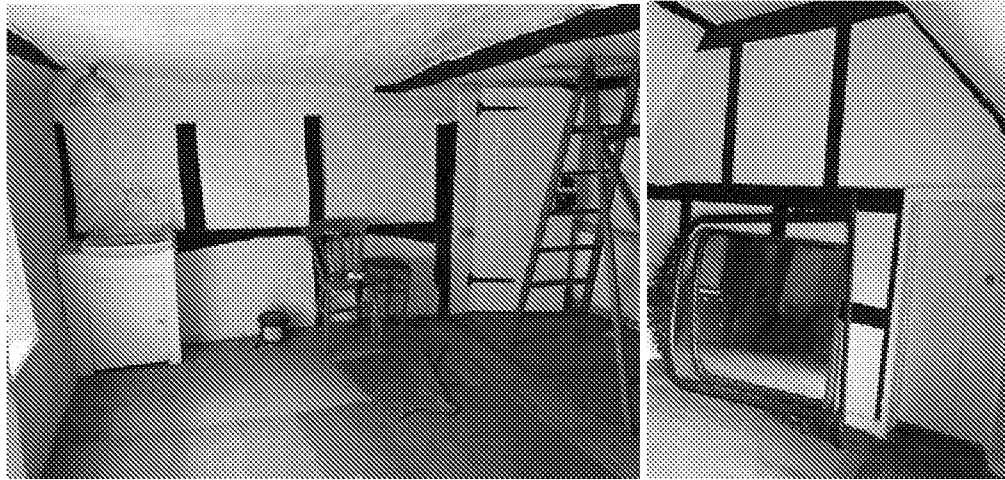
*Timber frame forming the south wall and further north, the queen struts exposed by a high ceiling*

- 3.23. As can be seen internally and primarily at first floor level, the building is of timber-frame construction. A raised bedroom ceiling in the north of phase one exposes two queen struts, which were in common use up until about 1650.
- 3.24. The layout of the 17<sup>th</sup> century phase with rooms either side of what is now a stair, suggests that this may have been a 'baffle entry' type plan with the entrance hall and stair formerly the location of a large inglenook fireplace with the front door opening on to the side of the chimneybreast, which created a lobby.
- 3.25. The apparent infilling of the first-floor ceiling with smaller joists supports this, as does the loss of the chamfer stop on the bressummer beam which runs north-south in the ground floor room to

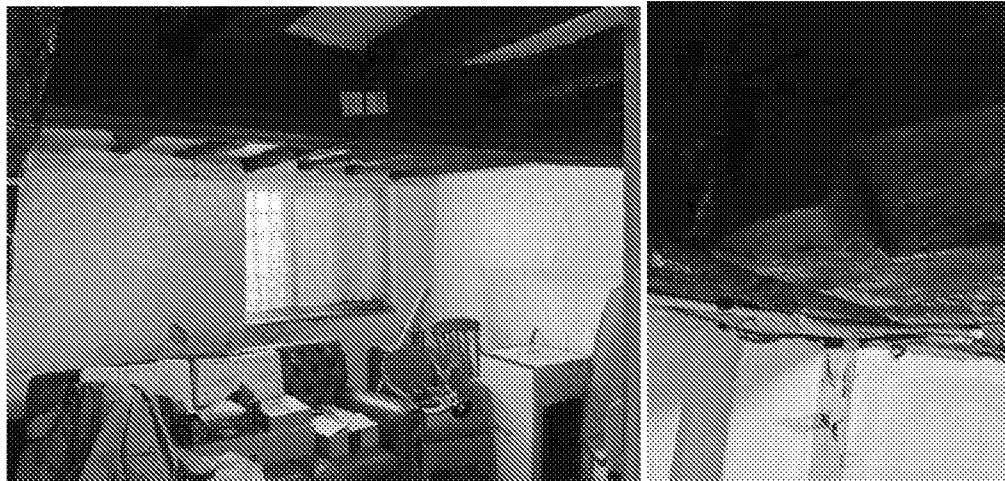
*Ground floor room to the north of the stair with a single chamfer stop in the northern end*

the north of the stair. Chamfer stops would naturally occur where the beam terminates at the wall and where they are missing at one end, will often suggest a reduction in the room width.

3.26. Here, one would expect to find the southern end of the beam inserted into the chimneybreast, were it to still exist. The absence of any heating in the core of the building is also unusual and strongly supports the idea that the principal chimney has been removed.

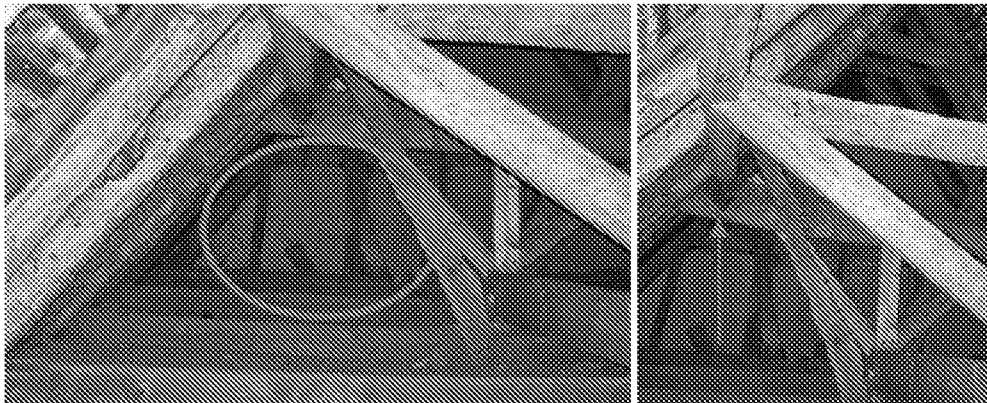
*Rear of wall showing timbers and wattle and daub (circled) and the clasped purlin roof structure*

- 3.29. The 17<sup>th</sup> century house also appears to have originally been three cells rather than two, with an additional room to the north. This is evidenced by the roof and the joists on the ground floor.
- 3.30. In the roof, the northern face of the timbers which form the queen struts are clean with wattle and daub infill panels. Neither of these appear to have been exposed to the elements and would not have been an external wall. The roof structure is also the same as that at the southern end with clasped purlins.

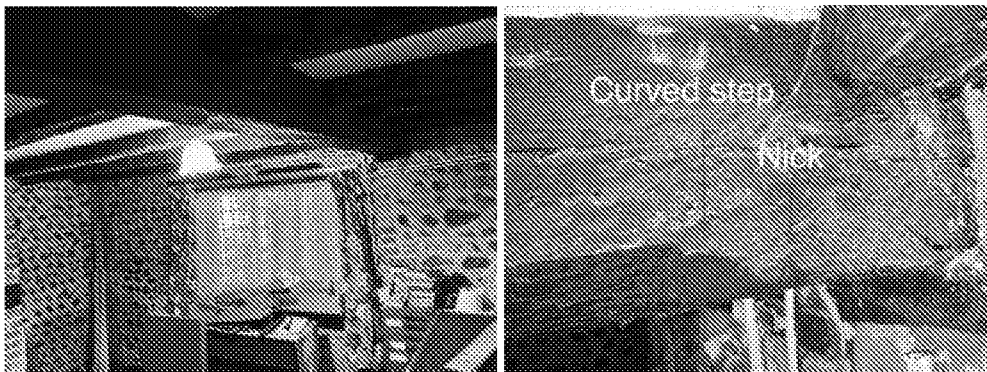
*17<sup>th</sup> century floor structure and detail showing well preserved chamfer stop at eastern end*

- 3.31. On the ground floor a timber beam running east-west and supporting the floor above, has chamfer stops terminating at the outer walls. The chamfer stop is a 'step and nick' design with the step being curved rather than a lamb's tongue shape. This may suggest an earlier date in the 17<sup>th</sup> century. Chamfer stops largely disappear after 1700.

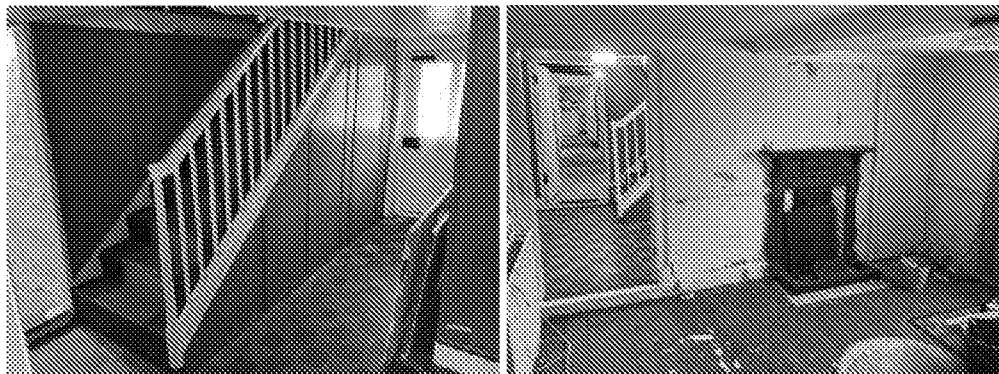
*Entrance hall with 18<sup>th</sup> century stair and room adjacent modified to remove 17<sup>th</sup> century features*

- 3.32. The western stop is now located in a corridor with an old stone floor and a return in the wall which appears to be the remnant of an earlier window. This is likely to have been lost when the parallel range was attached to the west.
- 3.33. The building appears to have undergone significant remodelling in the 18<sup>th</sup> century and perhaps the most likely reason for the date stone. This phase of the building's development includes alterations such as the creation of a new hallway and stair; an extension to the south with cellar and part of the western range.

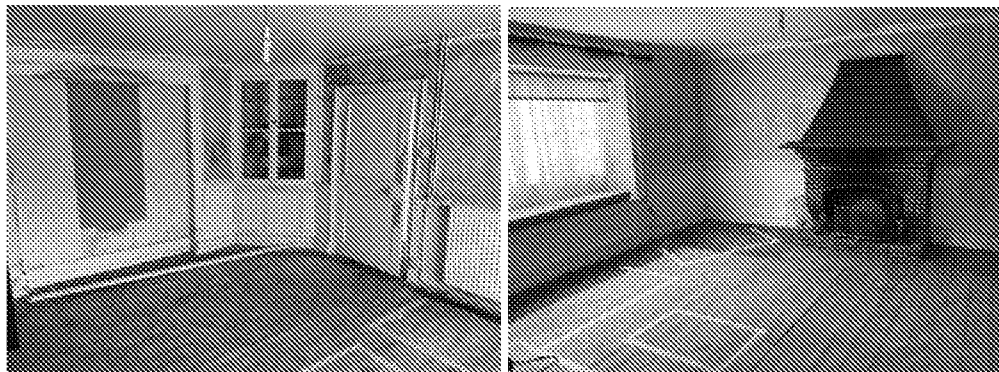
*18<sup>th</sup> century addition which would benefit from the removal of the early 20<sup>th</sup> century fireplace*

- 3.34. In the eastern range, the ground floor room has been remodelled and now includes a 19<sup>th</sup> century fireplace. Here, the bressummer appears to have been boxed in and the floor joists over-boarded, most likely to remove the 17<sup>th</sup> century character.

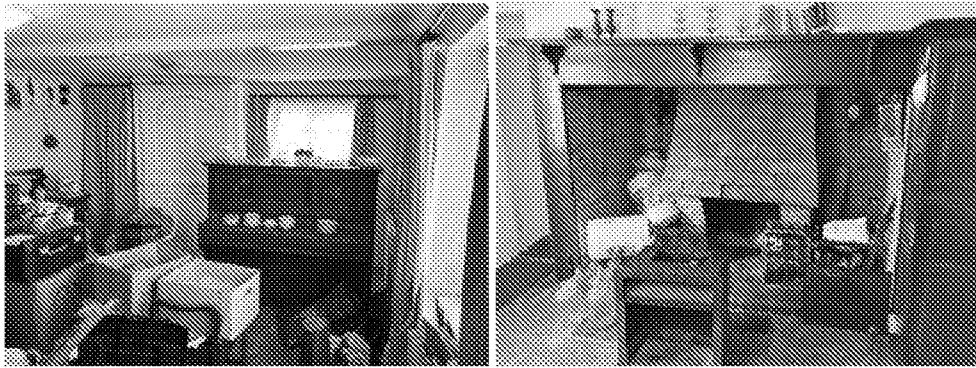
*South room in the western range, probably the kitchen with access to the cellar and an inglenook*

- 3.37. The western range consists of two main rooms on the ground floor, the southernmost of which appears to be the former 18<sup>th</sup> century kitchen. This includes a brick inglenook that has been altered internally to provide a domestic fire. This is clearly a later insertion from the early 20<sup>th</sup> century and probably contemporary with the fireplace in the eastern range. This room also has an historic stone floor and provides access to the cellar. The cellar is located below the 18<sup>th</sup> century addition in the eastern range.

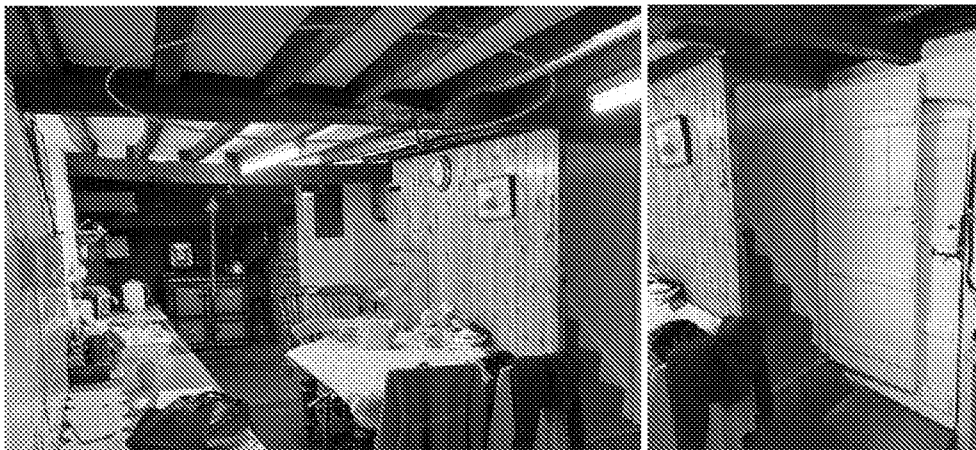
*Floor joists mortised into the central bressummer (circled), whilst to the north they are picked up by a beam (arrowed). A later, enclosed stair has been inserted against the central wall of the two ranges*

- 3.38. To the north of this room is the current kitchen, which includes an enclosed stair to the first floor and a ceiling with exposed beams. Here, the principal bressummer runs east-west with the joists mortise and tenoned in the normal manner. The joists running north however, do not bear 'into' a beam with mortises and instead all sit on top of a supporting beam. This suggests that either an earlier wall was in this location and when it was removed, the floor was simply picked up by the beam; or, the floor structure has been salvaged and re-used.

- 3.39. There is a possibility here that it was the former and that the span of the floor structure was part of an earlier, rear extension with a roof perpendicular to the main house. Further research would be needed to verify this. The lack of chamfers might indicate that the room was low status, but also that it was also a post 1700 addition. The location of the beam would also suggest that it predates the door connecting both ranges. The question mark over this part of the building's development at ground floor is reflected in the phasing plan.

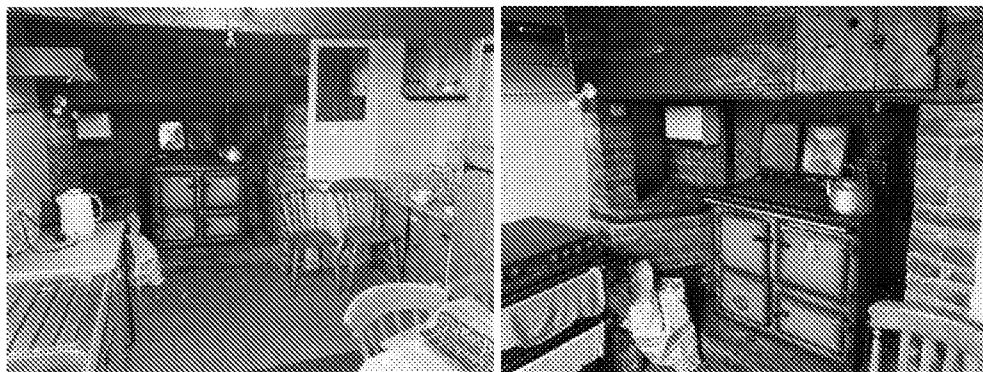
*Northern end of the kitchen with the copper retained within the inglenook*

- 3.40. The north part of the current kitchen appears to be 19<sup>th</sup> century and was most likely a scullery. In the left corner, the copper is still in place and would have provided hot water for washing clothes and dishes, as well as floors.
- 3.41. Some of the brickwork is stretcher-bond which began to be used in the late 1900s and other decorative brickwork appears to be from the early 20<sup>th</sup> century. As mentioned above, the lintel here is likely to have been salvaged from an earlier inglenook.

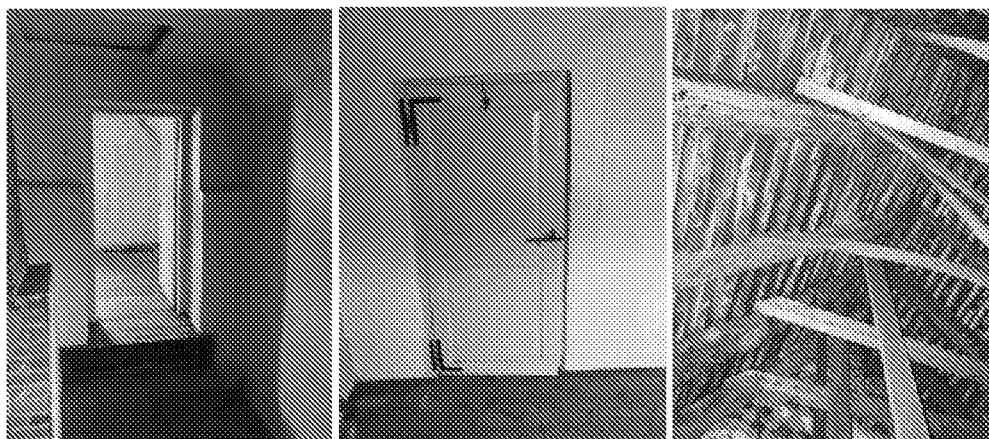
*The doorway into the 18<sup>th</sup> century addition at first floor. Note that the door is 18<sup>th</sup> century with 'L' shaped hinges, whilst the roof is made from split timbers rather than sawn*

- 3.42. The north end of both the east and west ranges have been extended. The addition to the east range appears to be 18<sup>th</sup> century. The door at first floor level is Georgian with one over one panelling and 'L' shaped hinges, similar to those used on the southern addition.

- 3.43. The roof is made of split timbers rather than sawn and supported by a ridge board. On the ground floor there is a window to the east that is the location of a former door and a modern window to the north. This was apparently a dairy room.

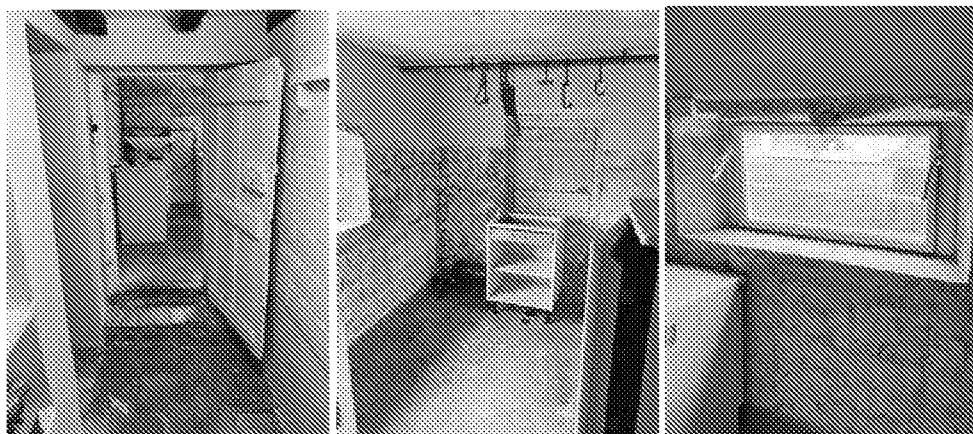
*Entrance to the former dairy room in the north addition believed to date from the 18<sup>th</sup> century*

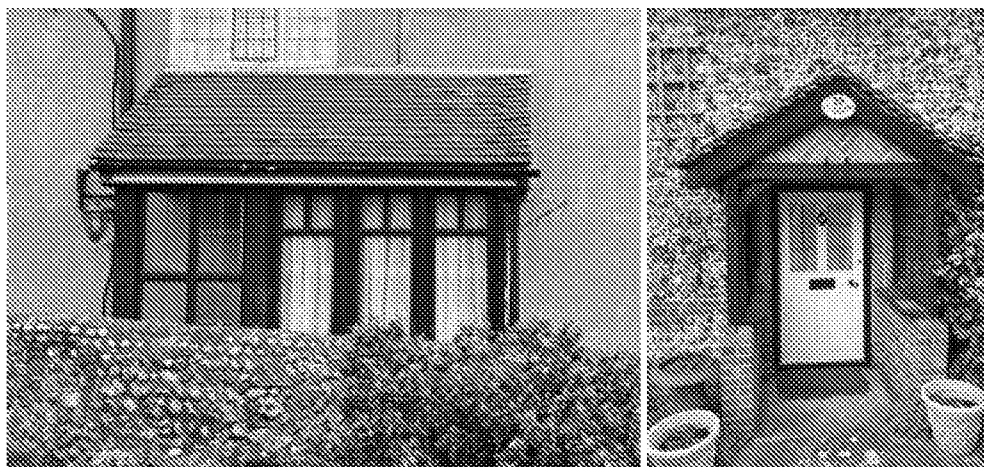
*Porches on the west and east elevations, both from the 20<sup>th</sup> century*

- 3.47. The only obvious 20<sup>th</sup> century additions to the main house are the front and rear porches and the windows. These include Crittel windows of a generic design which are found on the north and south elevations.

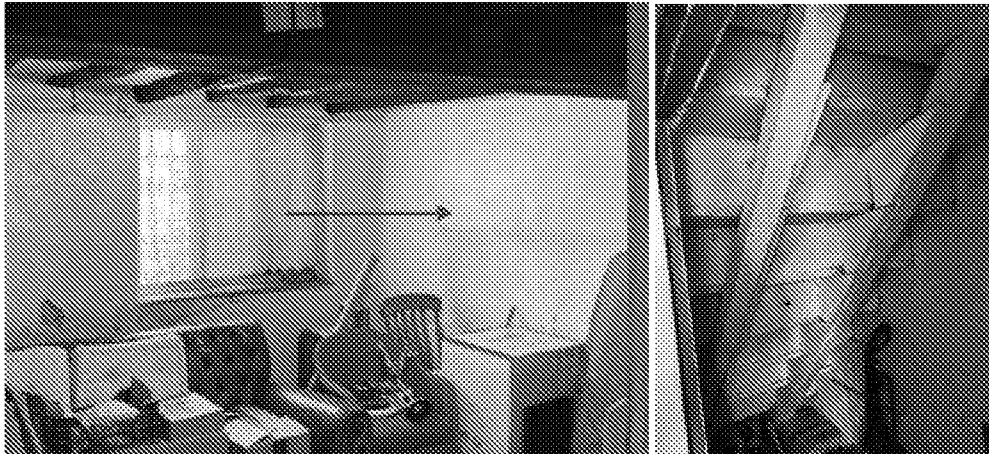
*The wall (arrowed) subdividing the two dwellings should not be insulated on the north side, but opportunities should be taken in the southern half, below stairs and by replacing modern panelling*

- 6.5. Where insulation and fire protection might be required, this should not interfere with historic features where they are found. In the eastern range, the ground floor wall in the northern half is historic brickwork with plaster render which could be over-boarded. Some of the ground floor wall is hidden below the stair in the southern half and therefore there is an opportunity here to provide some additional protection, as well as to the stair structure. Elsewhere insulation could replace the modern timber panelling in the stairwell which is not in keeping with the interior.

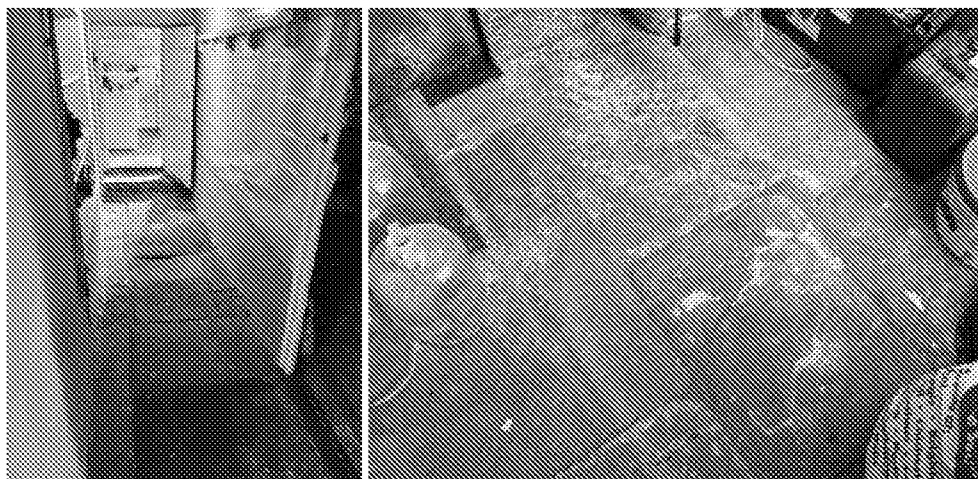
*To preserve their special character the stone floors should not be lifted*

- 6.10. **Floors:** the historic stone floors must not be moved. The character and patina of the stone floor is fundamental to the special interest of the building and one's experience of it. Trying to lift it and insulate will most likely result in harm to its appearance and may require more invasive work below ground. The risk is not justified by the gain.
