## DESIGN, ACCESS AND HERITAGE STATEMENT

The Farm  
39 East Street  
Littlehampton  
West Sussex  
BN17 6AU

Project: Subdivision of building into two dwellings

Date: April 2021

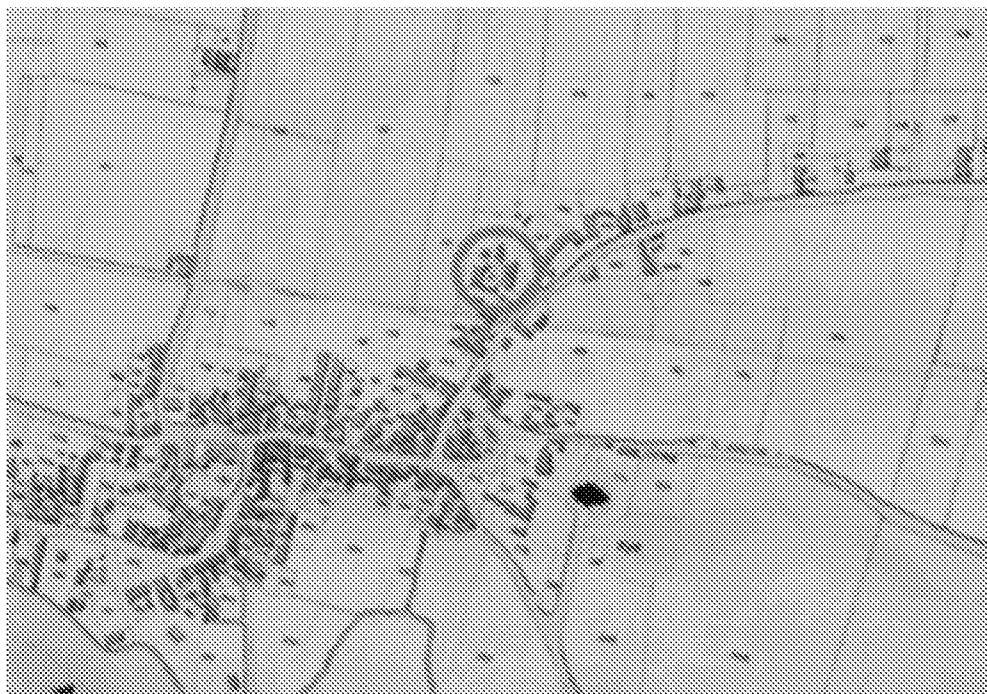
*The tithe map of Littlehampton in 1841 with the Farm circled*

- 3.9. As can be seen from a cartographic assessment of the town beginning in the mid-19<sup>th</sup> century, the development of Littlehampton grew rapidly from the late 19<sup>th</sup> century. The Tithe map of 1841 shows Littlehampton in its very compact form with linear development along what is now East Street. The Farm (circled) appears part of this, but of course predates much of this development and originally would have been slightly more isolated from the historic core which now forms the High Street. Despite this, the Farm can be more easily understood in its agricultural context with countryside largely surrounding the village centre.
- 3.10. The larger buildings to the rear of the farmhouse are likely to be barns and form a regular 'L' shaped courtyard plan. This plan is the most common type employed in West Sussex and accounts for nearly half of all farm plans.

- 3.44. The extension of the western range has exposed brickwork in stretcher bond and houses a WC. This appears to be late 19<sup>th</sup> century in its built form, which is also supported by the cartographic evidence. The tithe map of 1841 indicates that this corner of the building was missing in the mid 19<sup>th</sup> century, but had been infilled by the end of the 19<sup>th</sup> century.

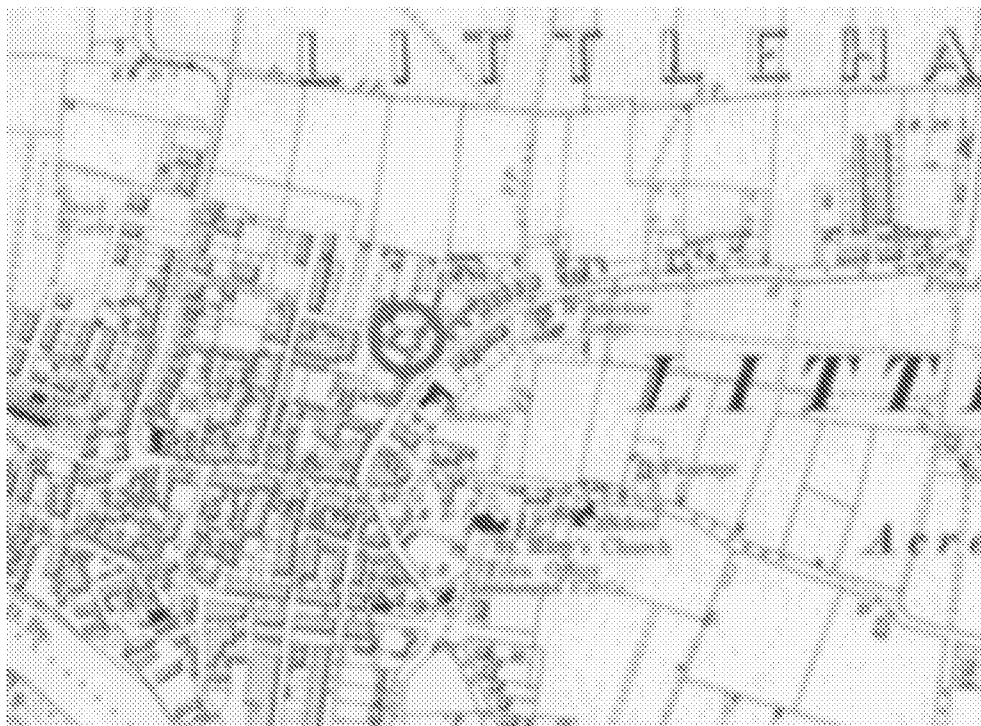
*Reproduced by permission of the National Library of Scotland*  
**The 2<sup>nd</sup> Edition OS map surveyed in 1896 with the Farm circled**

- 3.11. By the time of the 2<sup>nd</sup> Edition OS map surveyed in 1896, development around the train station to the west and to the north of the High Street had encroached into fields and was already consuming land to the west of the Farm. A narrow connection back towards fields in the north still appears to be visible, however the farm is very much part of a more urban environment with development being pushed northwards. This was no doubt due to the restrictions imposed by the sea and river to the south and west.

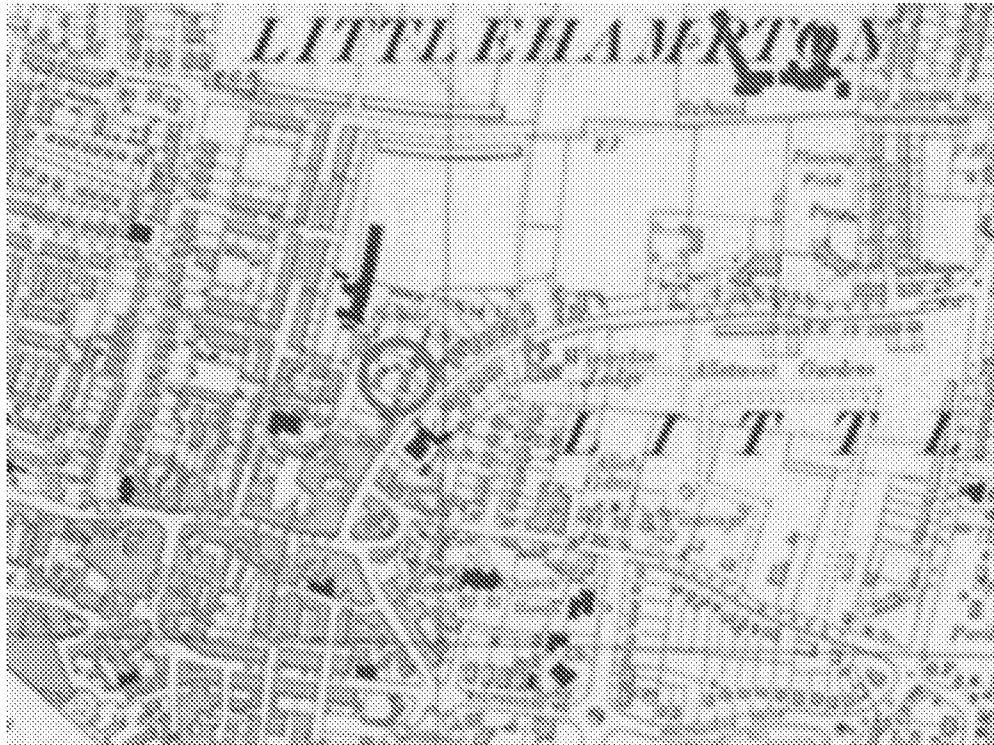
*Reproduced by permission of the National Library of Scotland  
The 4<sup>th</sup> Edition OS map of 1938 with the Farm circled*

- 3.12. By 1938, when the 4<sup>th</sup> Edition OS map was revised, development north of the train station had begun to consume Wick to the north and then started to move eastwards across open fields. As illustrated on the map below, the long unshaded blocks of development running east-west along Cornwall Road are houses under construction at the time of the survey and making their way across to Elmgrove Road and the rear of Stanhope Road. At this time, the semi-rural setting of the Farm is in the process of being completely lost with development along Cornwall road working its way back down towards East Street.

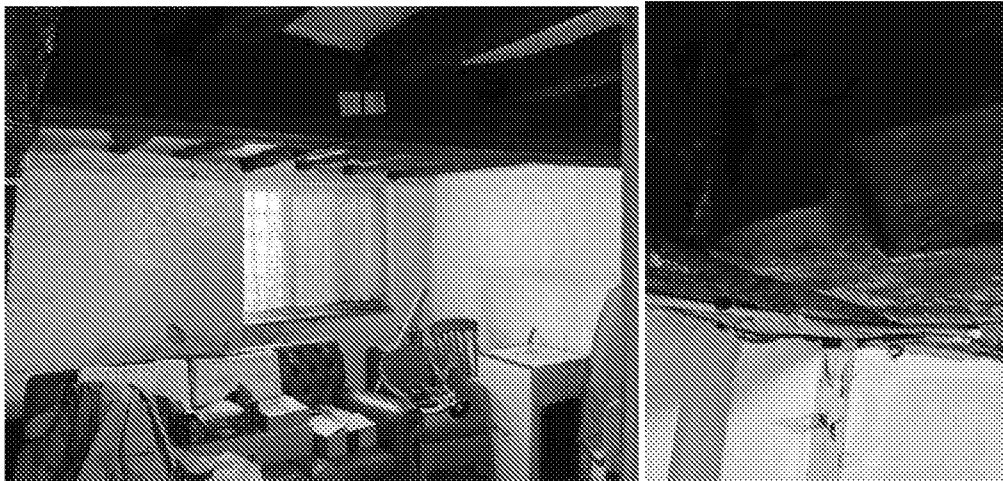
*Ground floor room to the north of the stair with a single chamfer stop in the northern end*

the north of the stair. Chamfer stops would naturally occur where the beam terminates at the wall and where they are missing at one end, will often suggest a reduction in the room width.

3.26. Here, one would expect to find the southern end of the beam inserted into the chimneybreast, were it to still exist. The absence of any heating in the core of the building is also unusual and strongly supports the idea that the principal chimney has been removed.

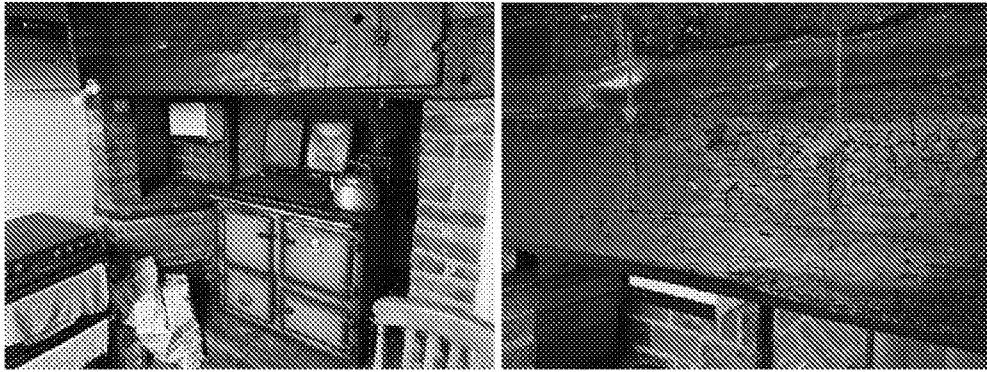
*The beam over the AGA with taper burns that predate this part of the building*

3.28. The notion that an inglenook has been removed is perhaps also supported by evidence discovered in the current kitchen. Here, a large timber beam acting as a lintel to support the opening over the AGA can be seen in the northern wall, though is much earlier than this area of the house. The diagnostic evidence for this are the small taper burns in the wood which are normally found in earlier buildings from the 15<sup>th</sup> to the 17<sup>th</sup> centuries. These scorch marks were once believed to be accidental but are now actually thought to have been purposefully burnt as a form of ritual protection against fire and lightening. Given that the kitchen is a later phase, this beam has clearly been moved here from somewhere else.

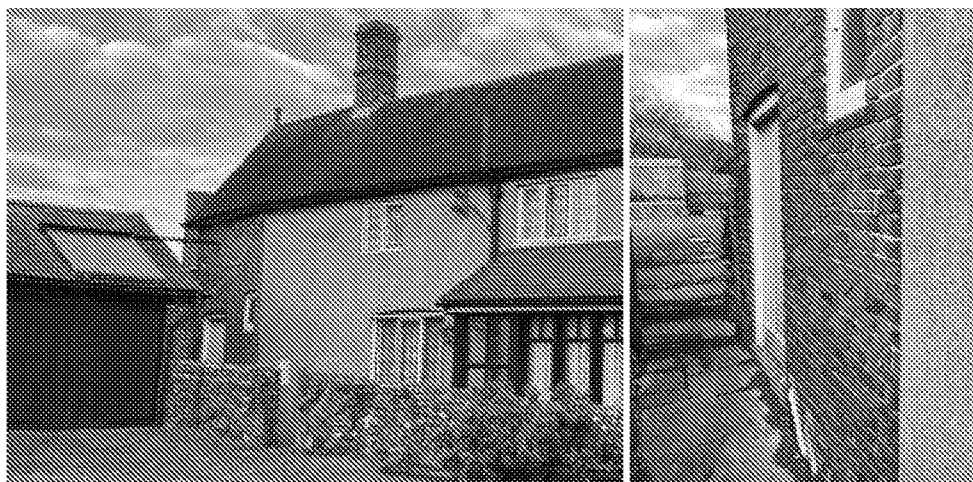
*The most recent addition at the northern end retains late 19<sup>th</sup> brickwork*

- 3.46. At the rear of the building, the walls have been rendered and ashlar-lined, a device commonly used in the 18<sup>th</sup> and 19<sup>th</sup> centuries to give the effect of stone. This terminates on the junction of the 19<sup>th</sup> century addition which retains brickwork in Flemish bond, with segmented arches.

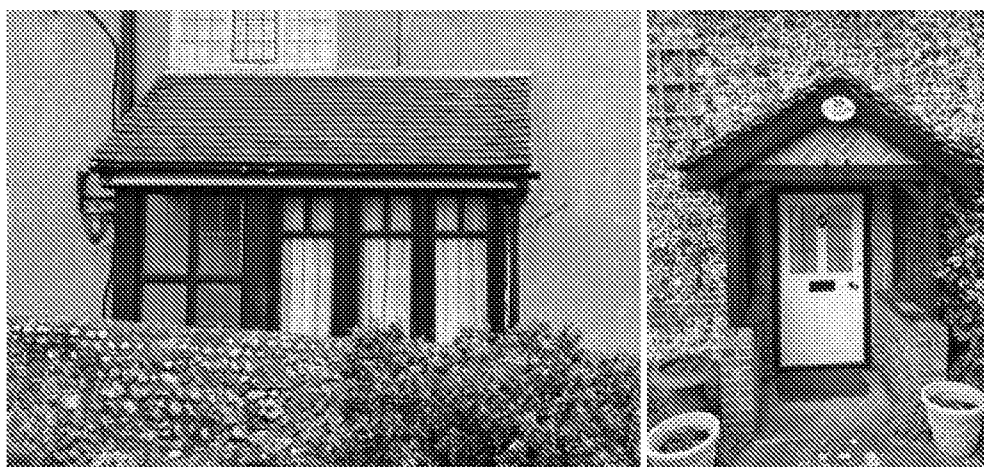
*Porches on the west and east elevations, both from the 20<sup>th</sup> century*

- 3.47. The only obvious 20<sup>th</sup> century additions to the main house are the front and rear porches and the windows. These include Crittel windows of a generic design which are found on the north and south elevations.
