5 RIVER ROAD, LITTLEHAMPTON.  
LISTED BUILDING ALTERATIONS  
SECTION + ELEVATIONS

DRAWING No.  
10637P/3

CAMPBELL CHARLES ASSOCIATES  
BUILDING SURVEYORS AND DESIGNERS

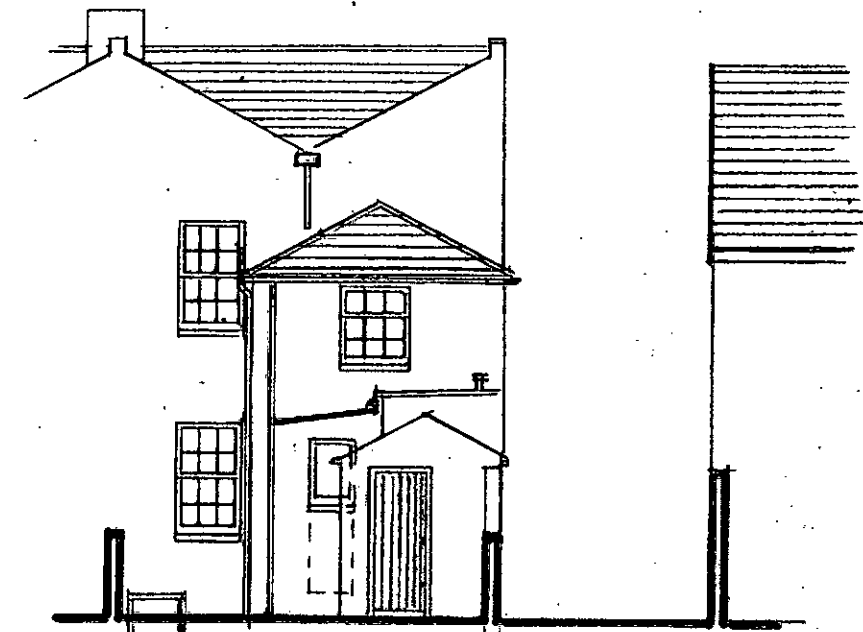
SECTION + SIDE (E) ELEVATION

ORIGINAL SASH WINDOWS  
BOXES + GLAZING -  
FRONT + REAR - RESTORED  
REPAIRED + RETAINED

NON ORIGINAL OVERBOARDING TO  
DAMP DAMAGED CEILINGS AT  
FIRST FLOOR + BASEMENT REMOVED -  
REPLACED WITH 12.5MM P'BOARD +  
SKIM - FR AT BASEMENT LEVEL.

ORIGINAL LATH +  
PLASTER CEILINGS  
REPAIRED + RETAINED.

BOILER FLUE IN NEW  
TIMBER ROLL LEAD ROOF

GAS  
METER  
BOX

NON ORIGINAL PLASTIC  
CLAD LINK REMOVED

EXISTING + PROPOSED
