# PRELIMINARY LAND QUALITY RISK ASSESSMENT

**Proposed Development  
of a Care Home**

**Yapton Road, Middleton-on-Sea**

SLR Ref: 402.06594.00008.RC  
Version No: V1  
July 2020

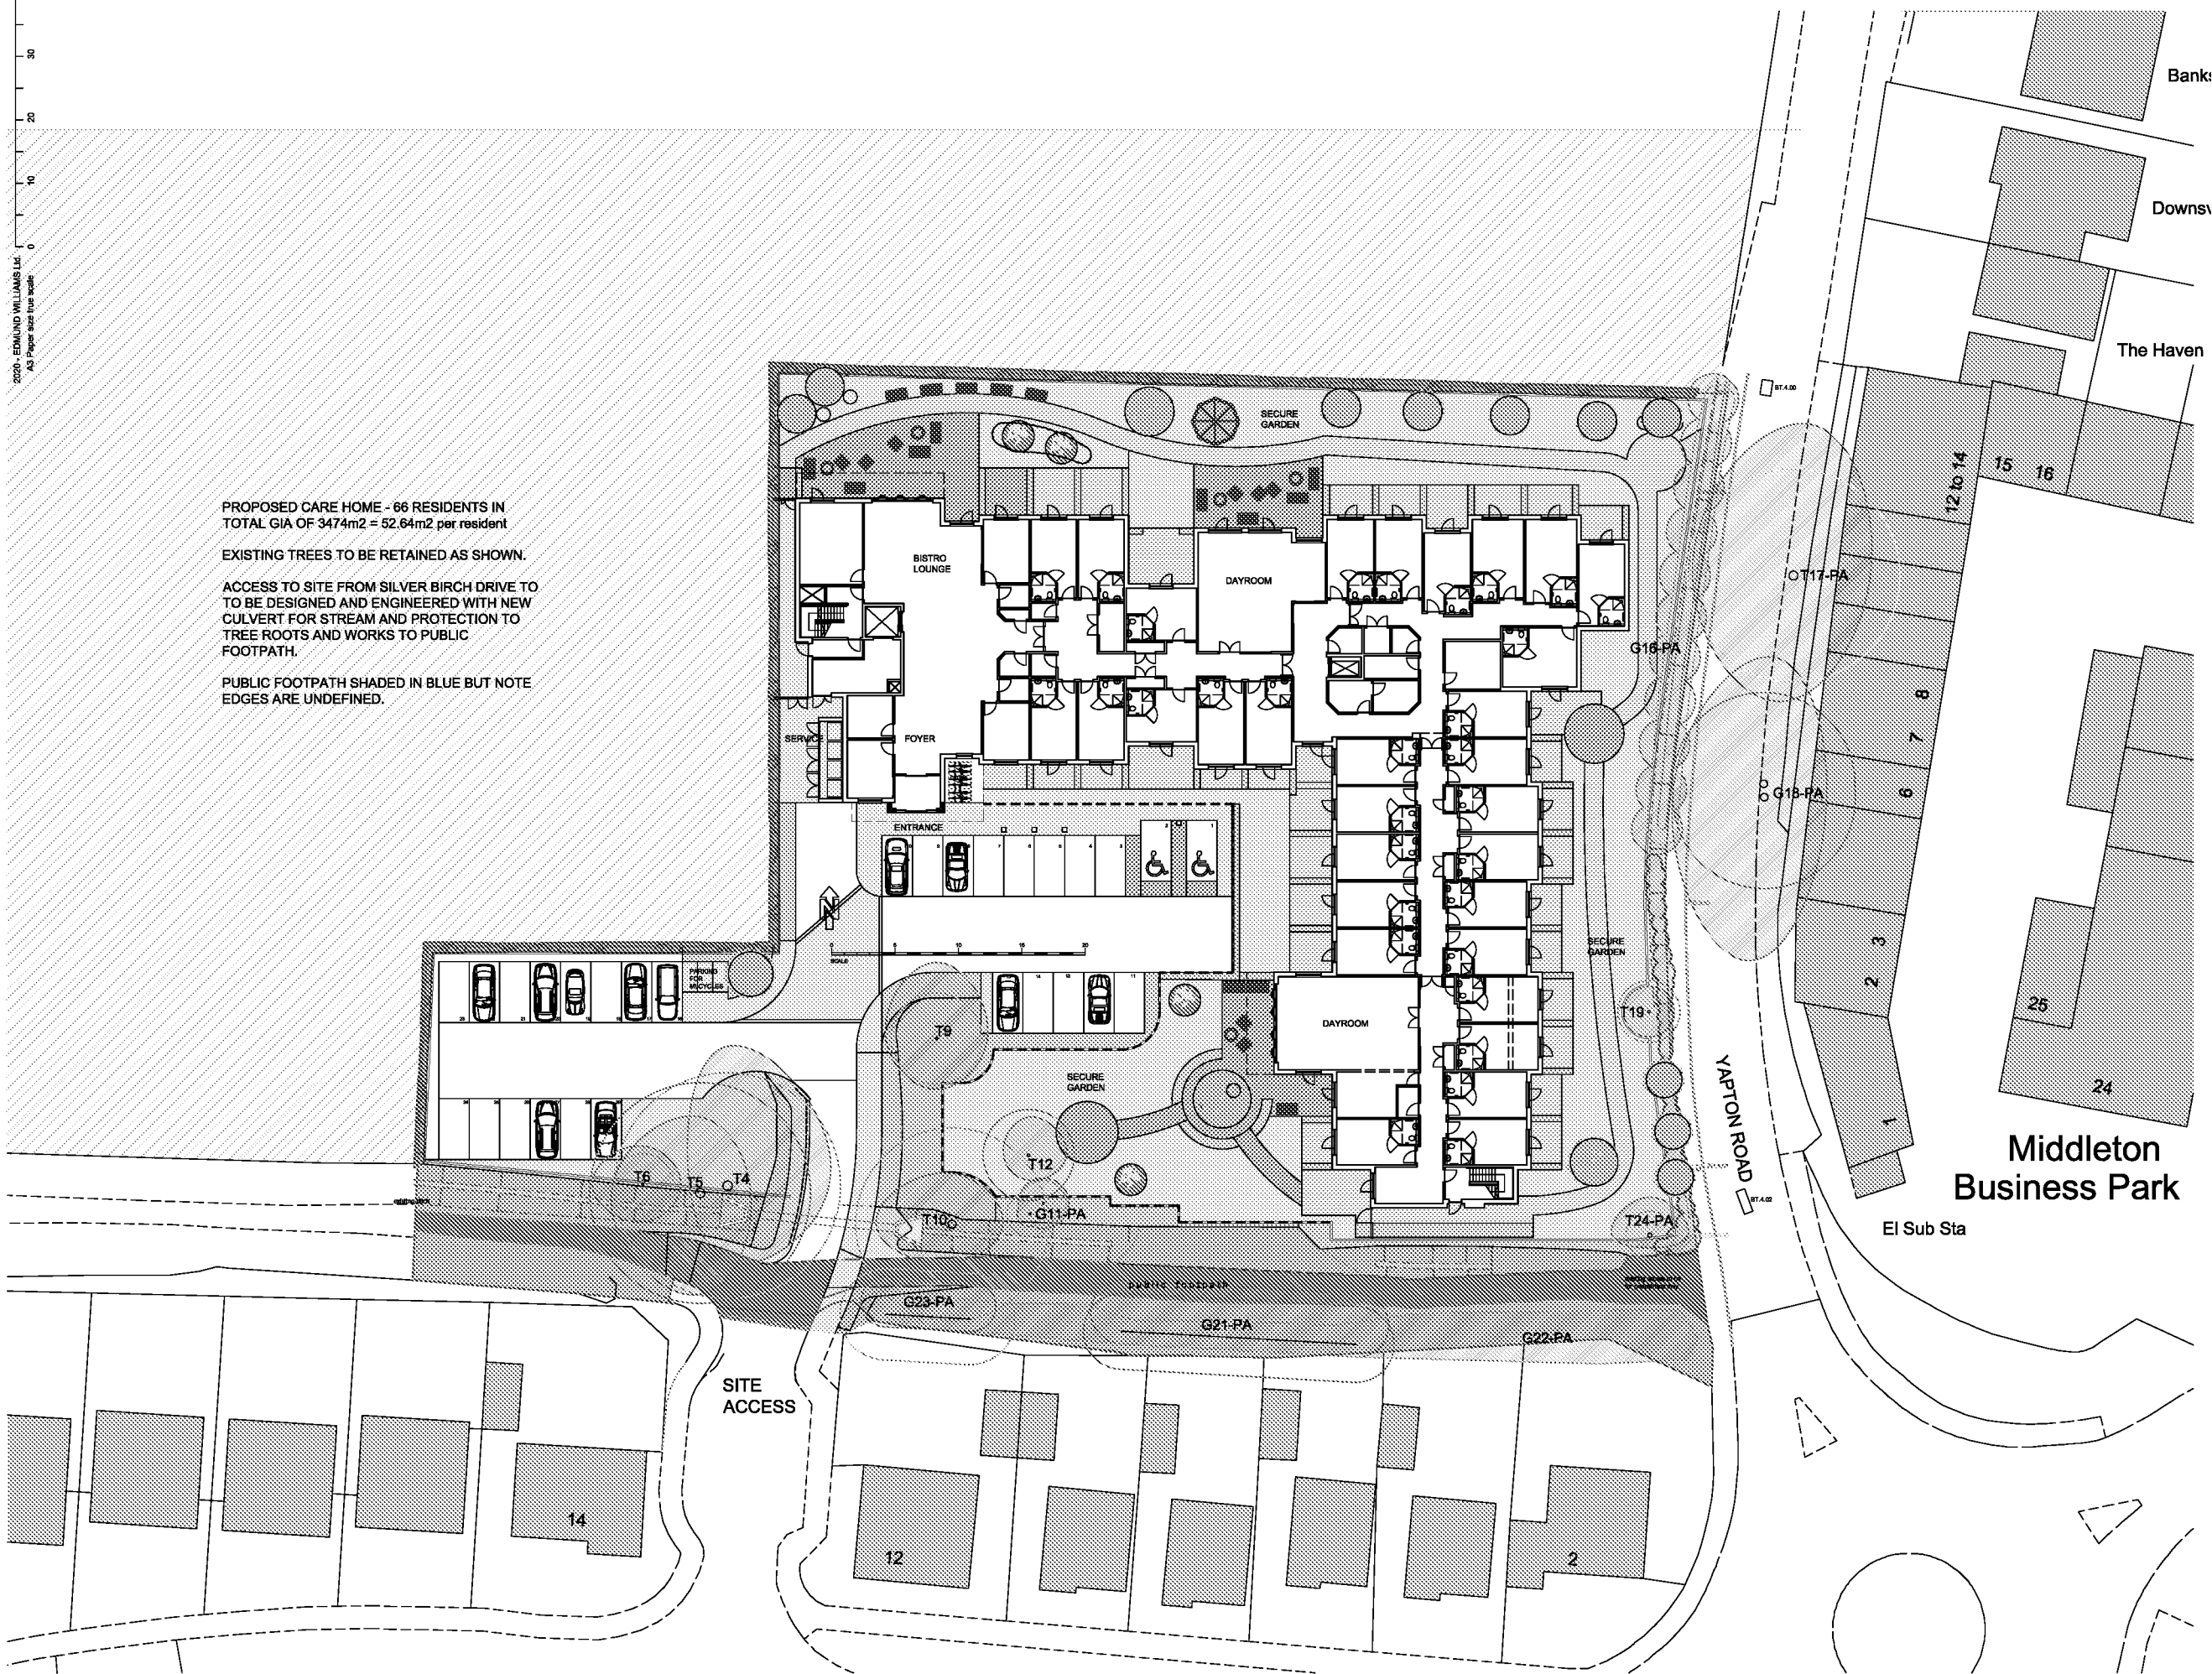
ACCESS TO SITE FROM SILVER BIRCH DRIVE TO  
TO BE DESIGNED AND ENGINEERED WITH NEW  
CULVERT FOR STREAM AND PROTECTION TO  
TREE ROOTS AND WORKS TO PUBLIC  
FOOTPATH.

PUBLIC FOOTPATH SHADED IN BLUE BUT NOTE  
EDGES ARE UNDEFINED.
