David Lawn  
Macar Homes (Rustington) Ltd

13 May 2025

Our ref. PM/25/3750892/R1

**Re: Convalescent Home, Sea Road, Rustington – Additional BRE365 Infiltration Testing & Foul Water Sewer Survey**

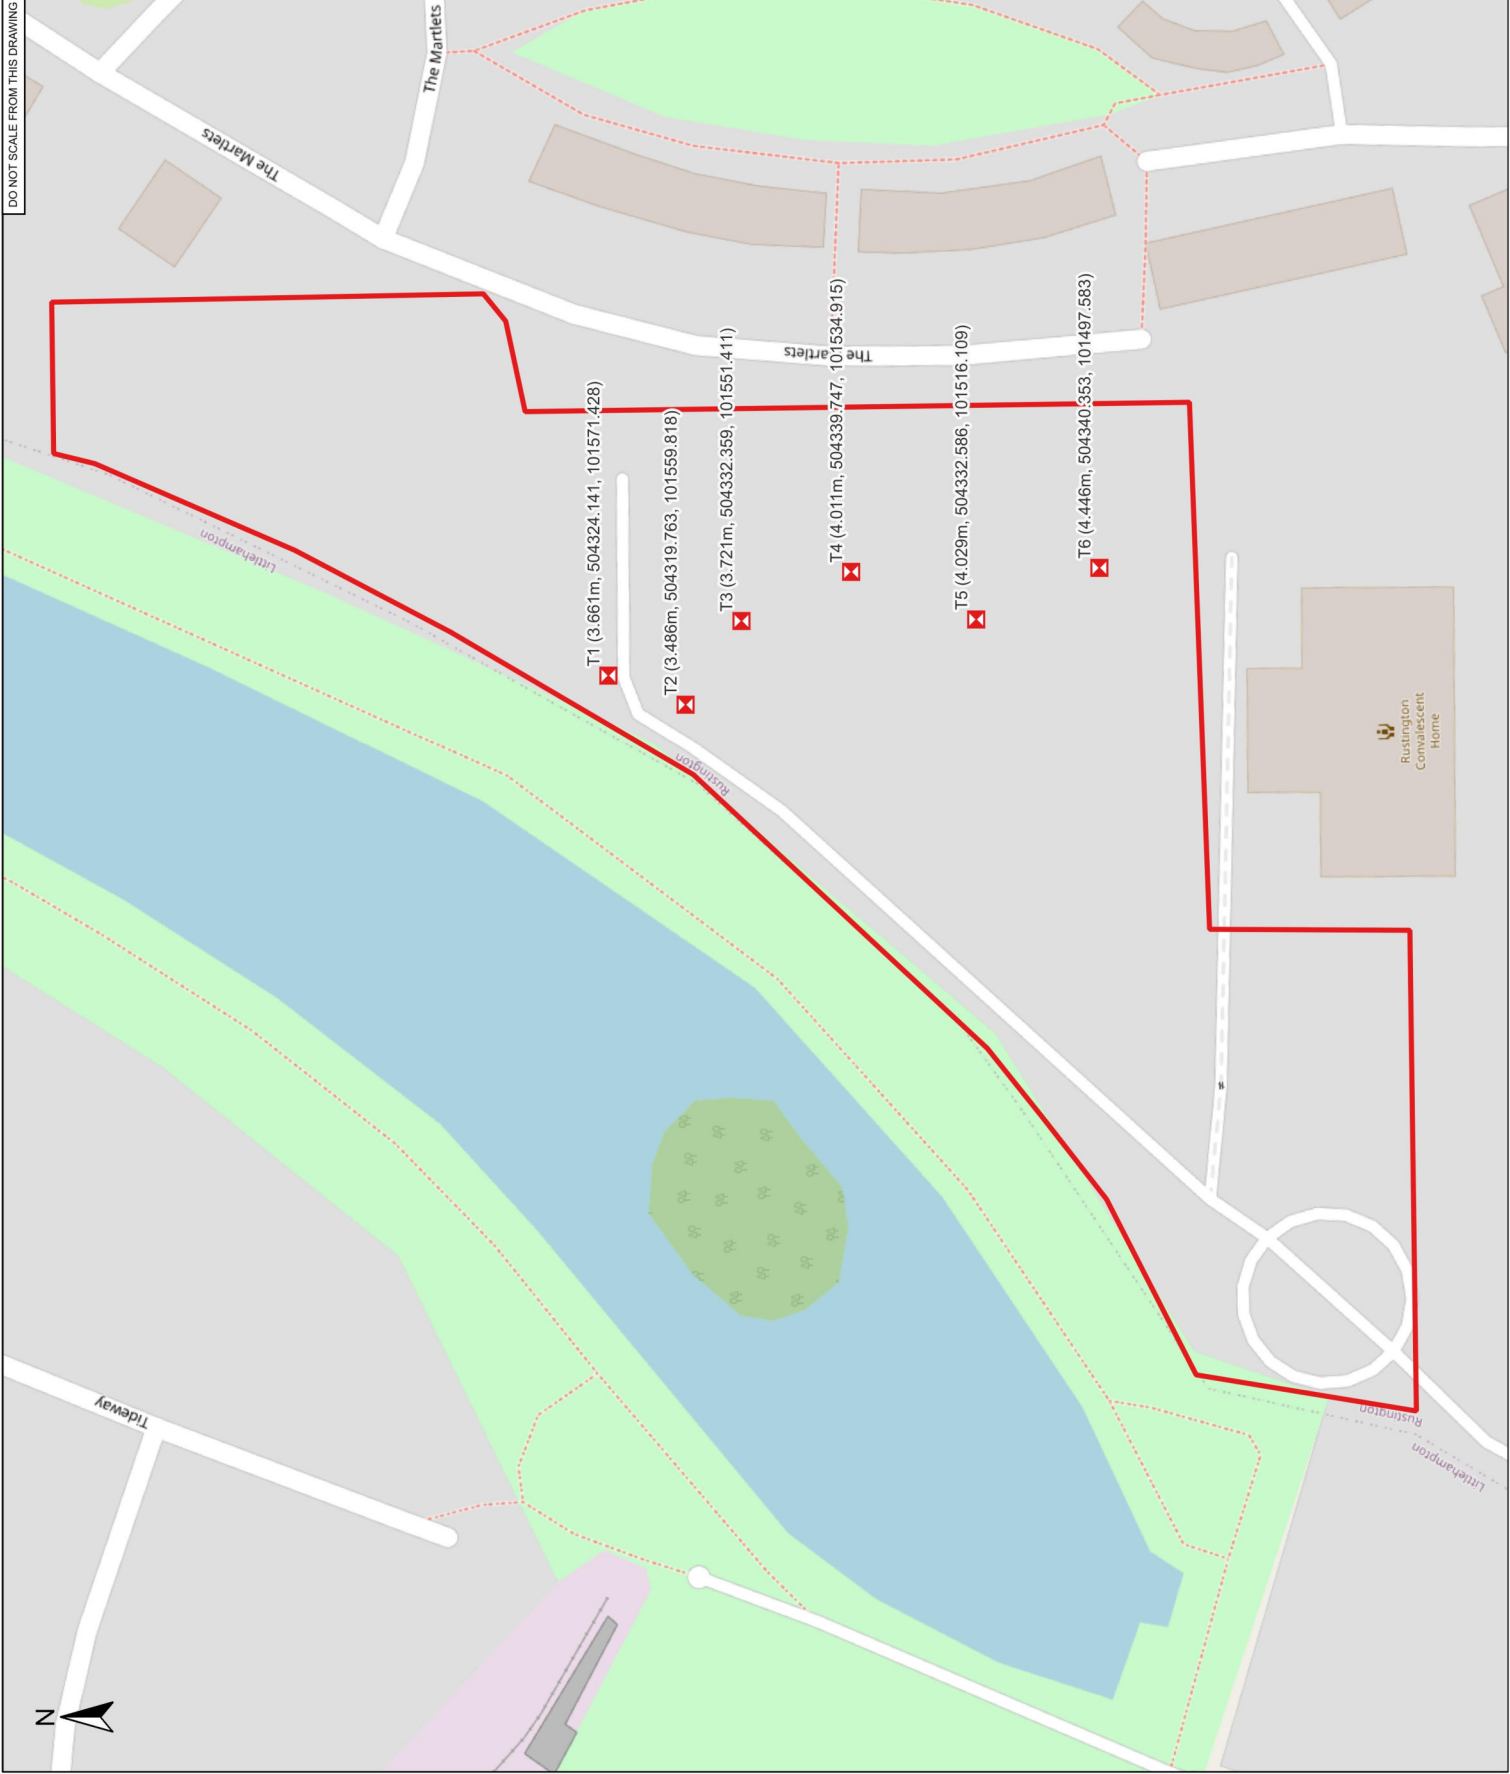
- Site Boundary
- Infiltration Test Location (Elevation, Eastings, Northings)

| Description | Infiltration Test Locations T1 to T6 | | | | | | | | | |

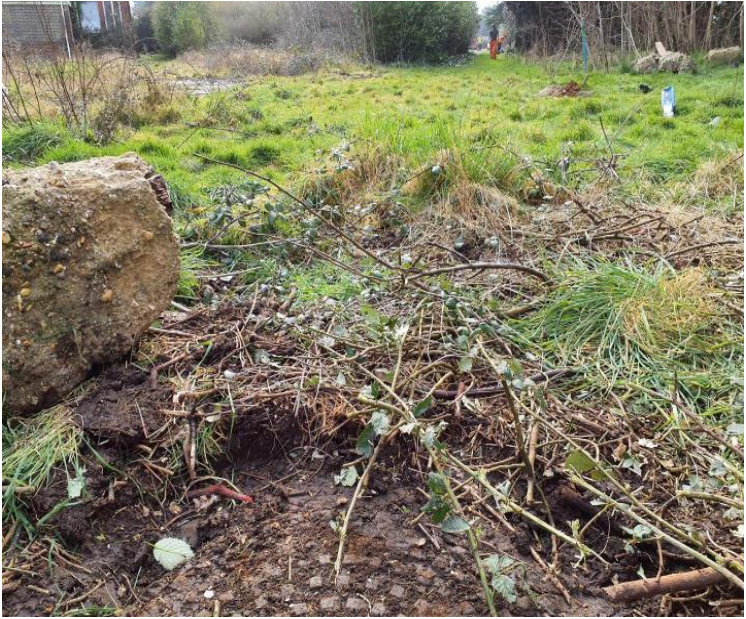
| <p><b>Photo No. 6</b><br/> <b>Date</b> 10/03/2025 13:04:00</p> <p><b>Description</b><br/> Route of FW picked up with tracer at 1.15 m</p> <p><b>Co-ordinates</b><br/> 50.804959818:-0.520163209</p> | |
