Flood Risk Assessment

Lake Lane, Barnham, Bognor Regis PO22 0AJ

Ref: 12188

Date: February 2024

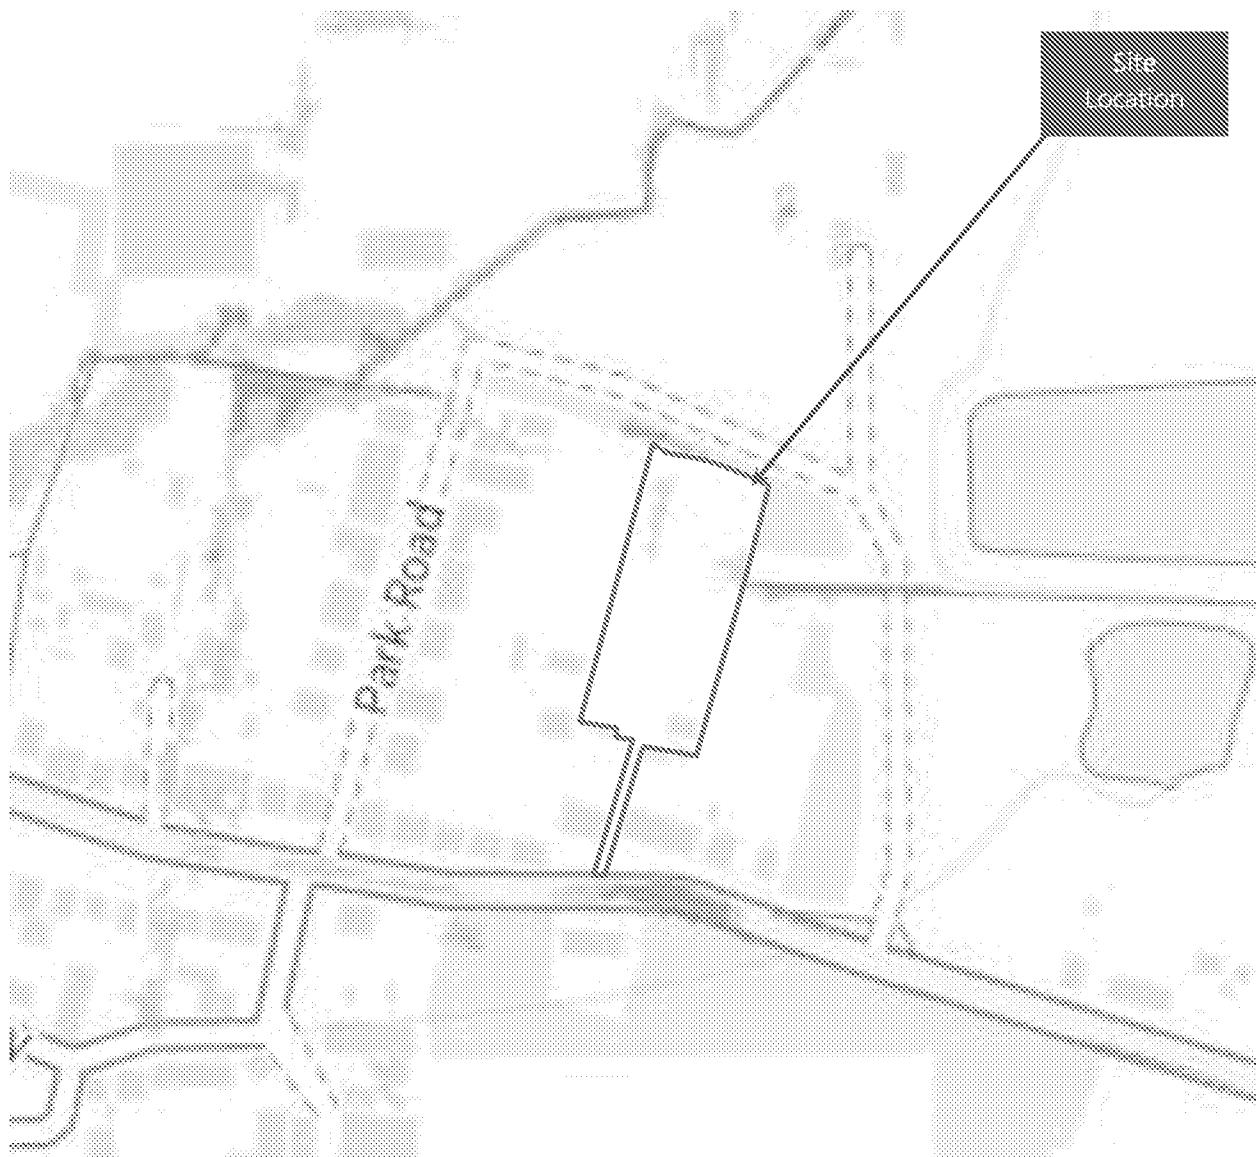
EA's Online Surface Water Flood Depth Map in a 'Low Risk Scenario'
(1 in 1000 years storm event)

Surface water flood risk: water depth in a low risk scenario

Areas in the northwest and on the eastern boundary are liable to surface water flooding up to 300mm

- 2.10 Surface water flooding: can occur when excess rainwater does not infiltrate into the ground, or is not intercepted by urban drainage systems, and instead flows across the surface. The EA's online 'Surface Water Depth - Low Risk Scenario' (1 in 1000 years) Flood Map in Appendix B shows areas in the northwest is liable to surface water flooding. The EA's 'Surface Water Velocity - Low Risk Scenario' (1 in 1000 years) Flood Map in Appendix B shows this flood pattern originates within the site. (The pattern on the east boundary is contained within the ditch.)

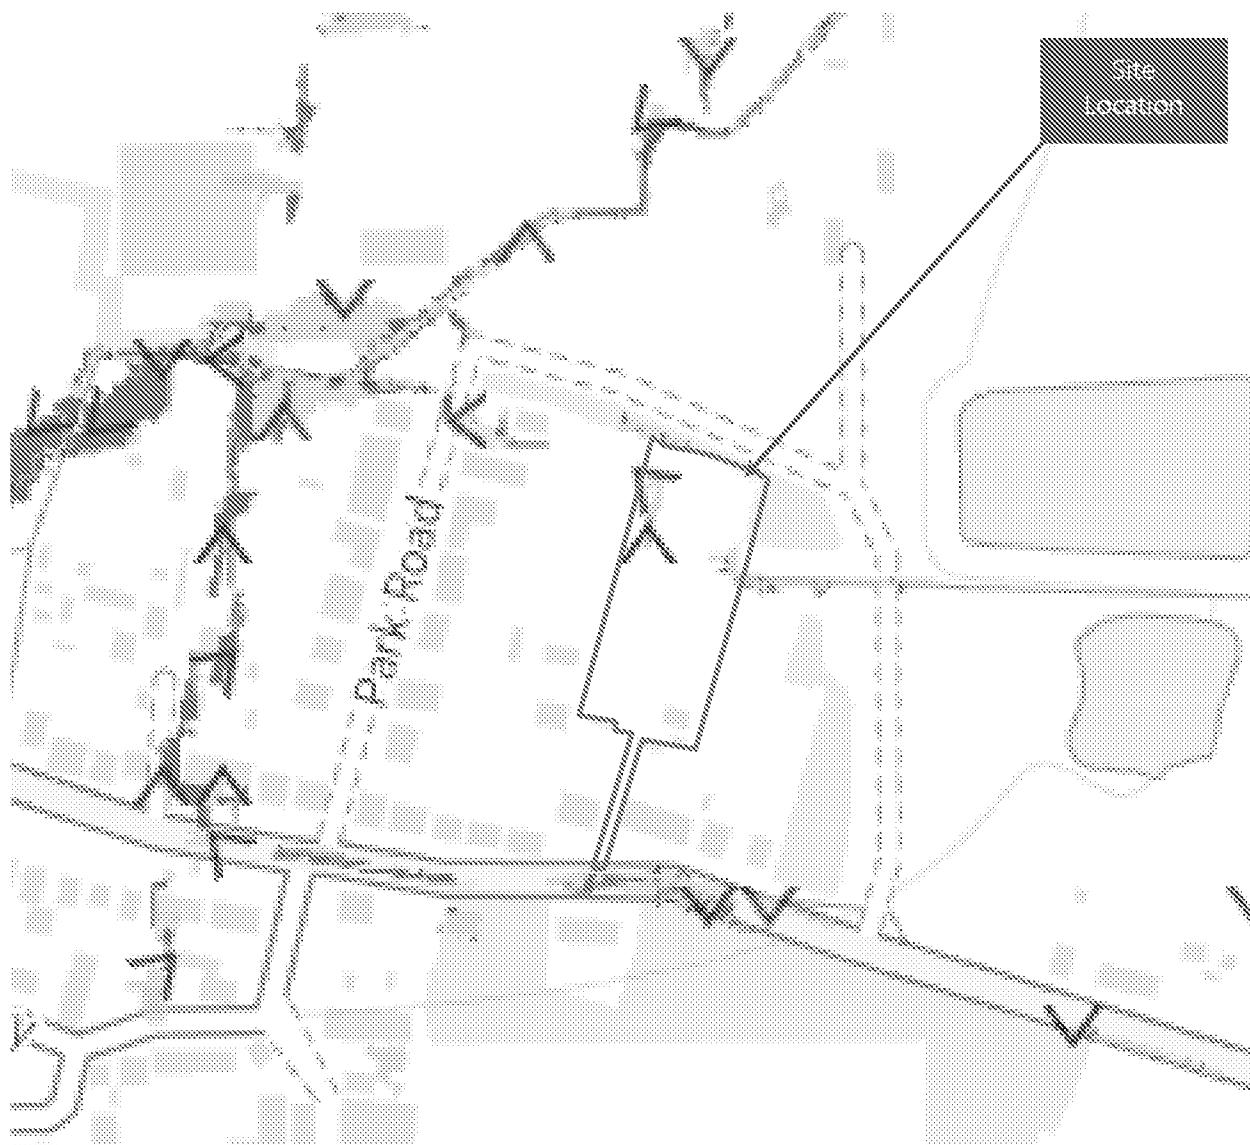
EA's Online Surface Water Flood Velocity Map in a 'Low Risk Scenario' (1 in 1000 years storm event)

Surface water flood risk: water velocity in a low risk scenario

The surface water flooding originates within the site

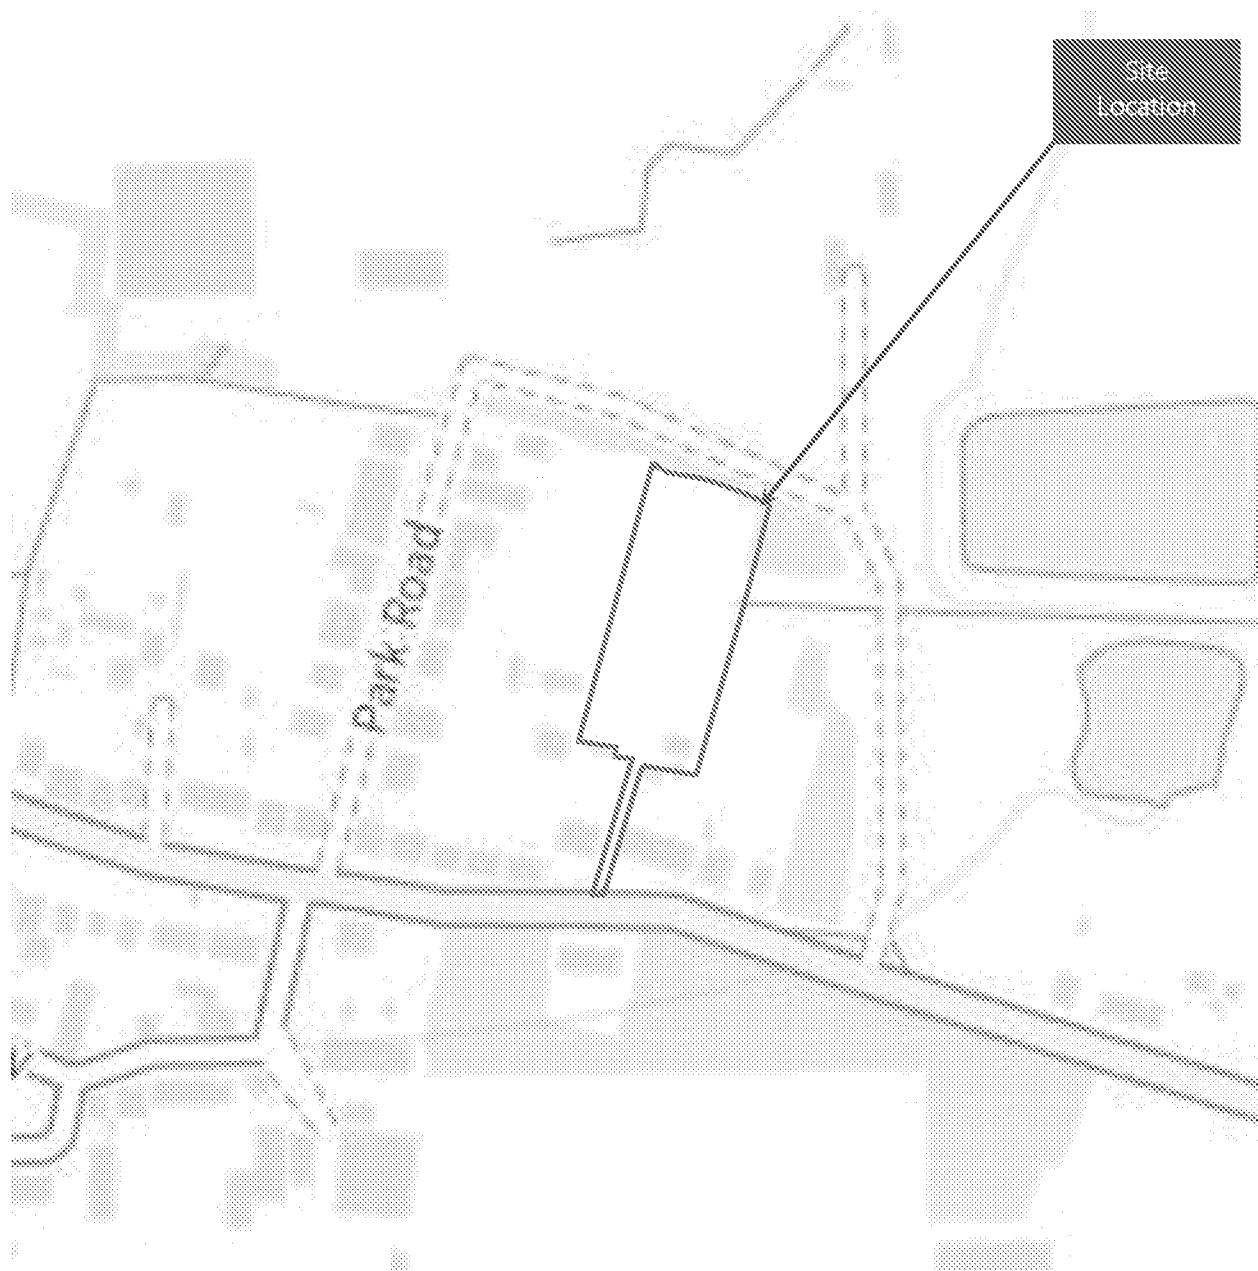
[EA's Online Risk of Flooding from Reservoirs' Map](#)

Maximum extent of flooding from reservoirs:

- when river levels are normal
- when there is also flooding from rivers

The site is not liable to flood from this source

- 2.12 Artificial sources: flooding from reservoirs, canals and docks. The EA's Reservoirs Flood Map in Appendix B shows the site is not liable to flood from a nearby reservoir failing. There are no docks or canals nearby.

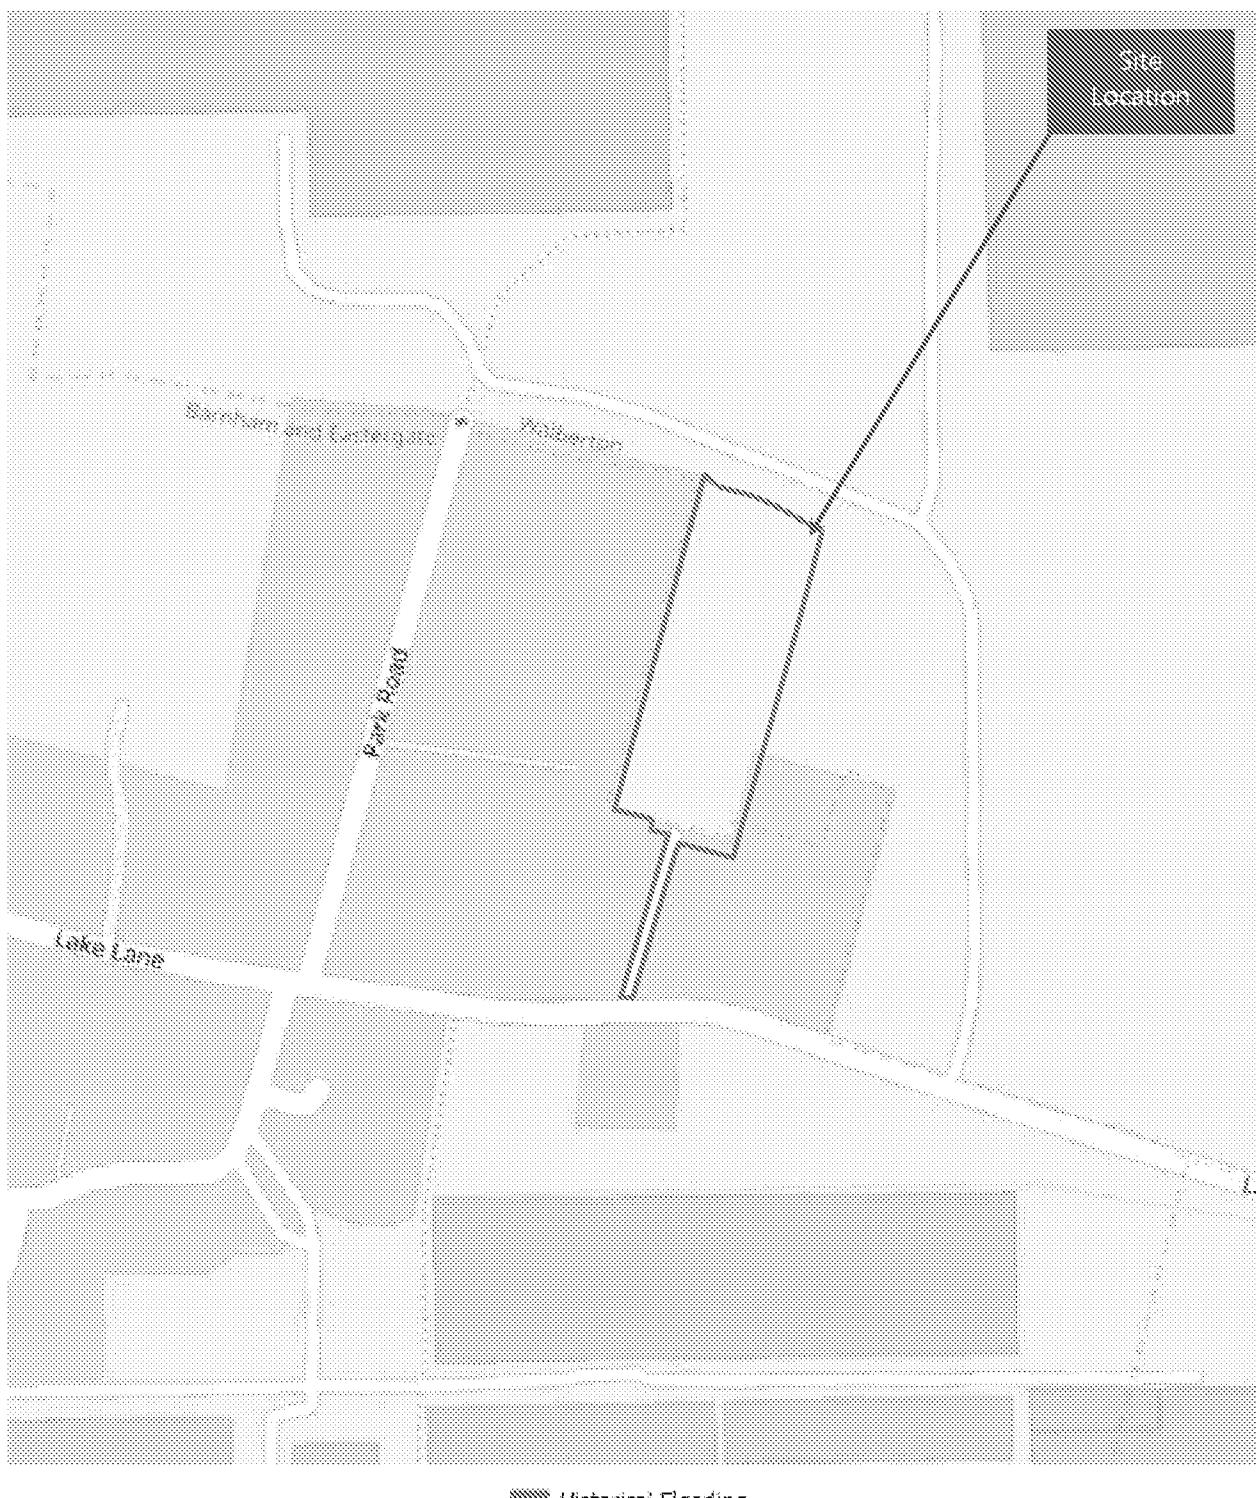
Environment Agency's Online Historic(al) Flood Map

The site has not been affected by flooding in the past

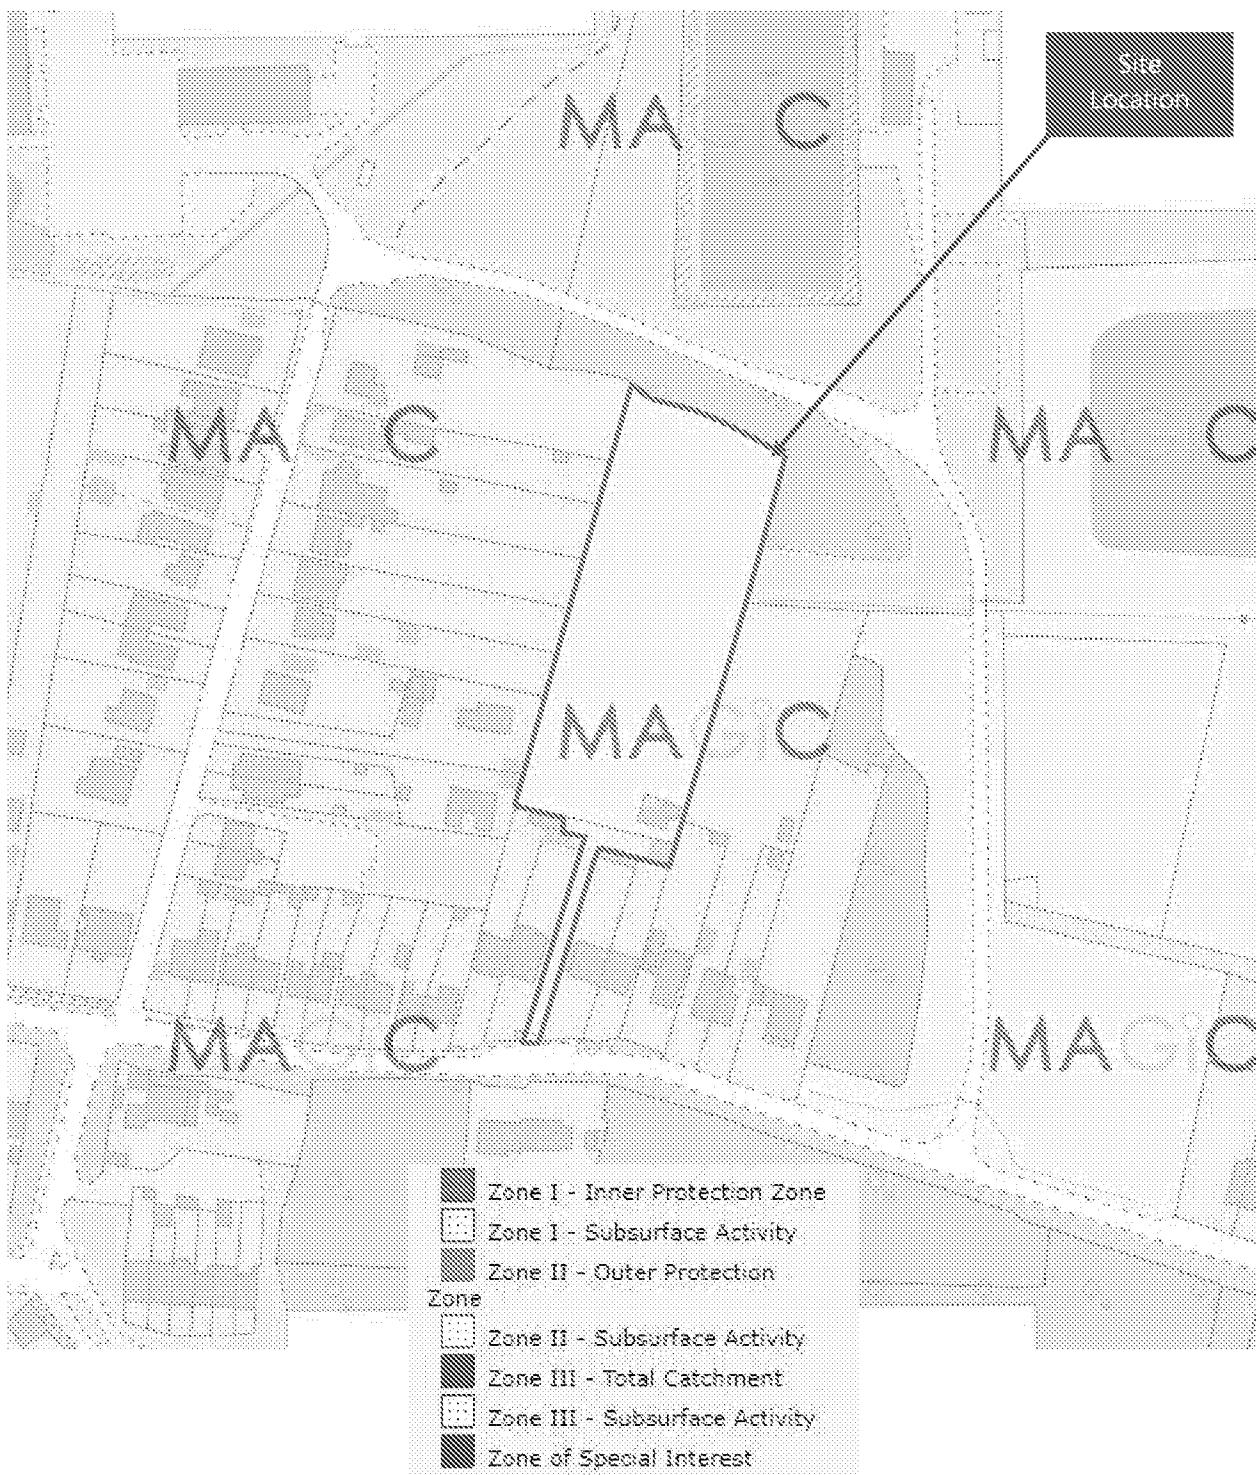
Environment Agency's Online Groundwater Source Protection Zones Map

The site lies outside of all recorded Groundwater Protection Zones

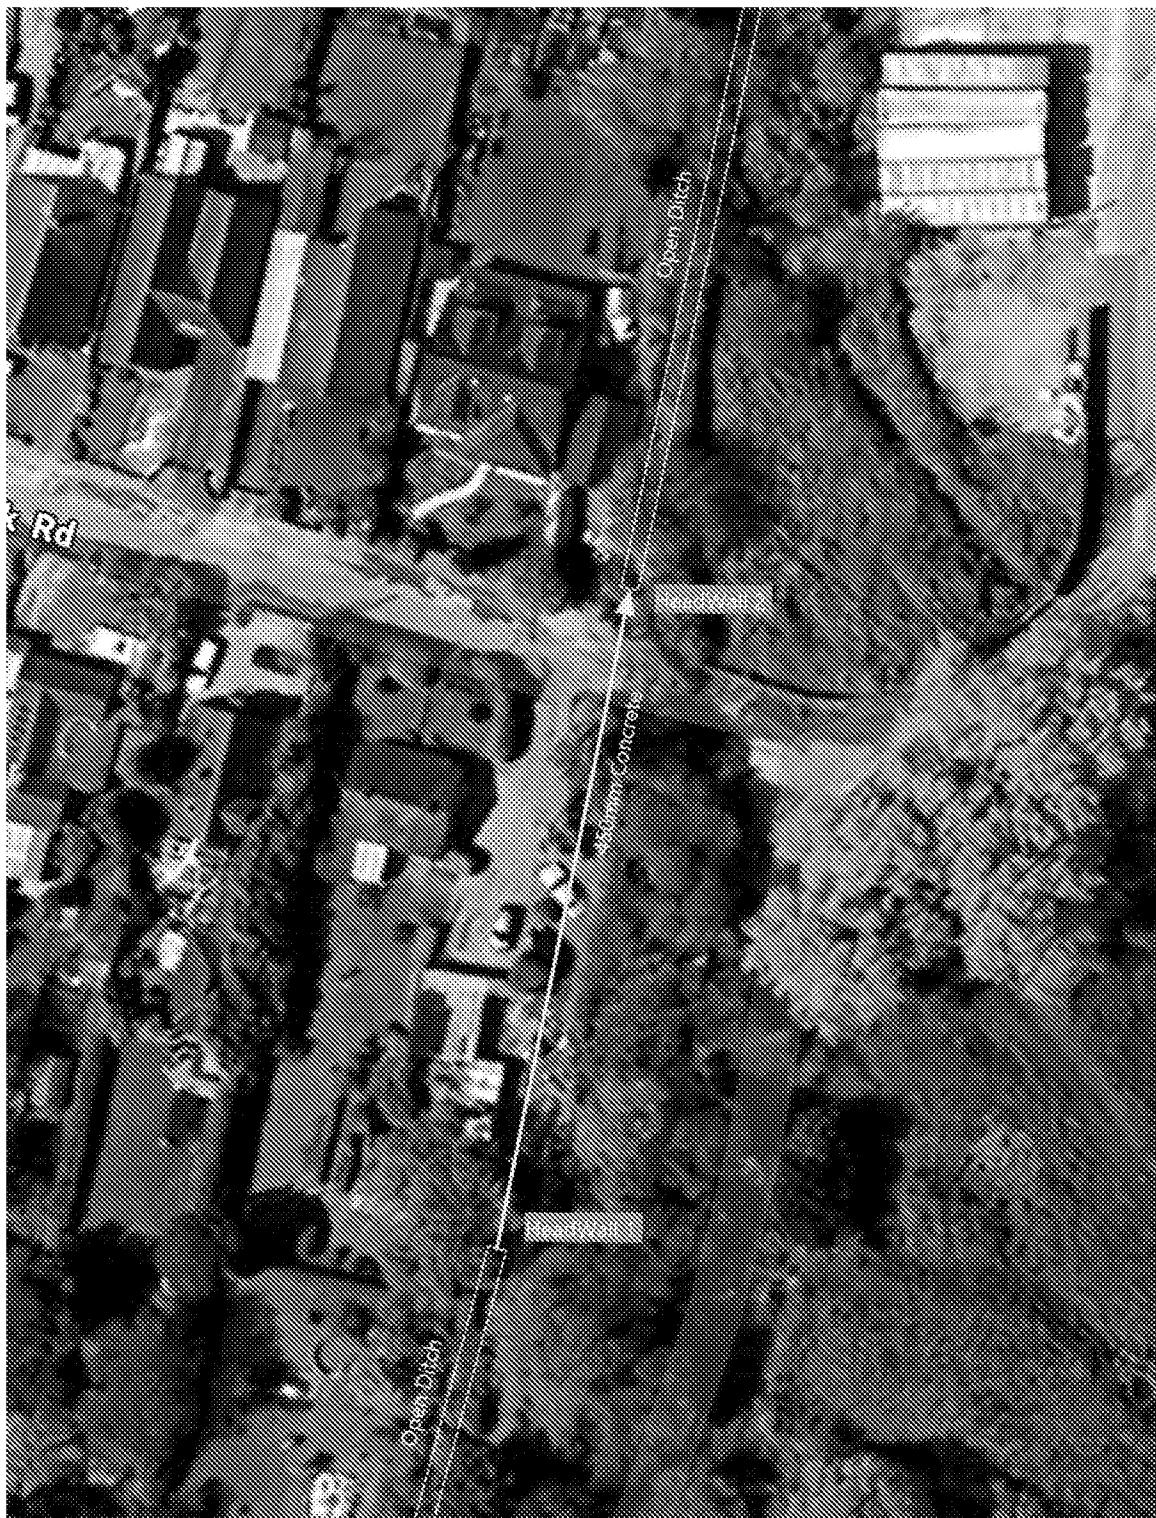
Project Drawing, Page 'Park Rd Culvert - Barnham'

Section	PLR	Grade	Description
All inspected pipes are in an acceptable structural condition (< grade 3).

Section	PLR	Grade	Description
All inspected pipes are in an acceptable service condition (< grade 3).

Appendix C. The neighbour did not give the drainage surveyor permission to enter the property to finish the survey. A large trash screen covers the culverted section under this garden. Paul Cann, the LLFA engineer, agreed that no more could be done to confirm the condition of this culverted section - refer to the correspondence in Appendix H.

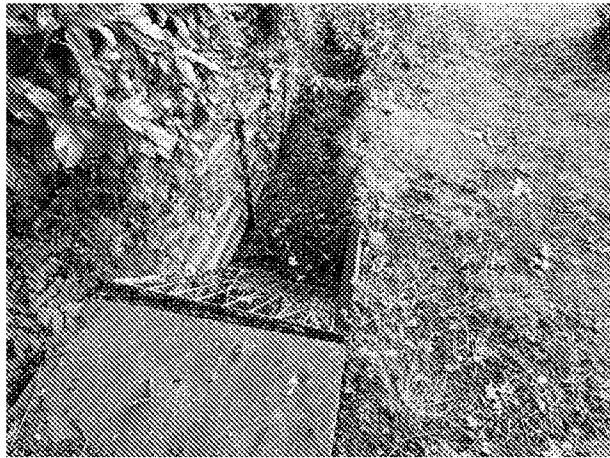
1, 0.00 m
Start node, outfall, reference: HW1, Located within private grounds

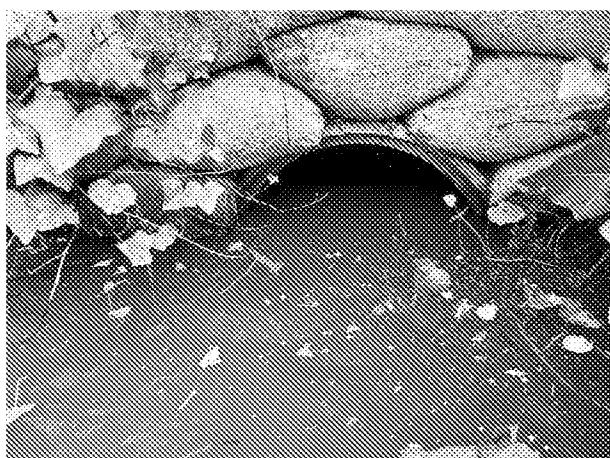
3, 55.00 m
Finish node, outfall, reference: HW2, Unable to carry out full CCTV survey due to permissions.

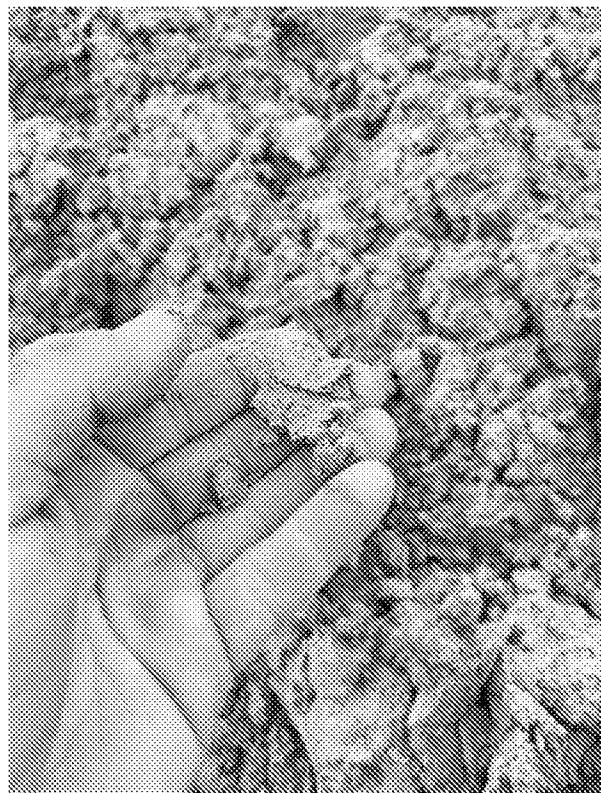
The gap between the stick and water level actually *decreased* slightly as the pit slowly filled up with water. From the discussion I had with John on completion of the work, I believe this is a fail.

[The soil type is clearly cohesive]

- 2.5 Soil soakage testing was carried out on site in accordance with BRE Digest 365. The water level rose during the test – and, given the obvious cohesive nature of the soil, this was deemed 'a fail' (nil result). The test report, including photographs of the pit and site conditions, is shown in Appendix D.
