# Arboricultural Impact Assessment

Land East of Tye Lane, Walberton. December 2020

*This short arboricultural impact assessment (AIA) has been prepared by Barton Hyett Associates on behalf of CSA Environmental for Vistry Southeast., in relation to the land to the east of Tye Lane, Walberton (hereafter the 'Site'). It considers the impacts to trees of the proposal to construct a new vehicular access point from Tye Lane where an emergency access has already been approved.*

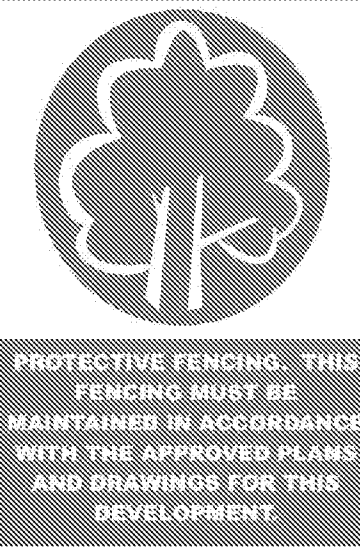
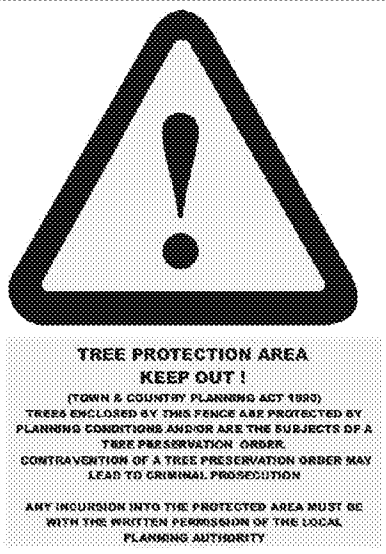
Tree Protection Barrier - Barrier to be erected prior to the commencement of works on site and not to be altered or removed until works are complete (cross check with specific requirements of any relevant planning conditions)
