**LAND WEST OF BILSHAM ROAD (PLANNING REF: Y/3/22/OUT)**

We refer to the Drainage Engineer's email response to the above planning application and provide the below response.

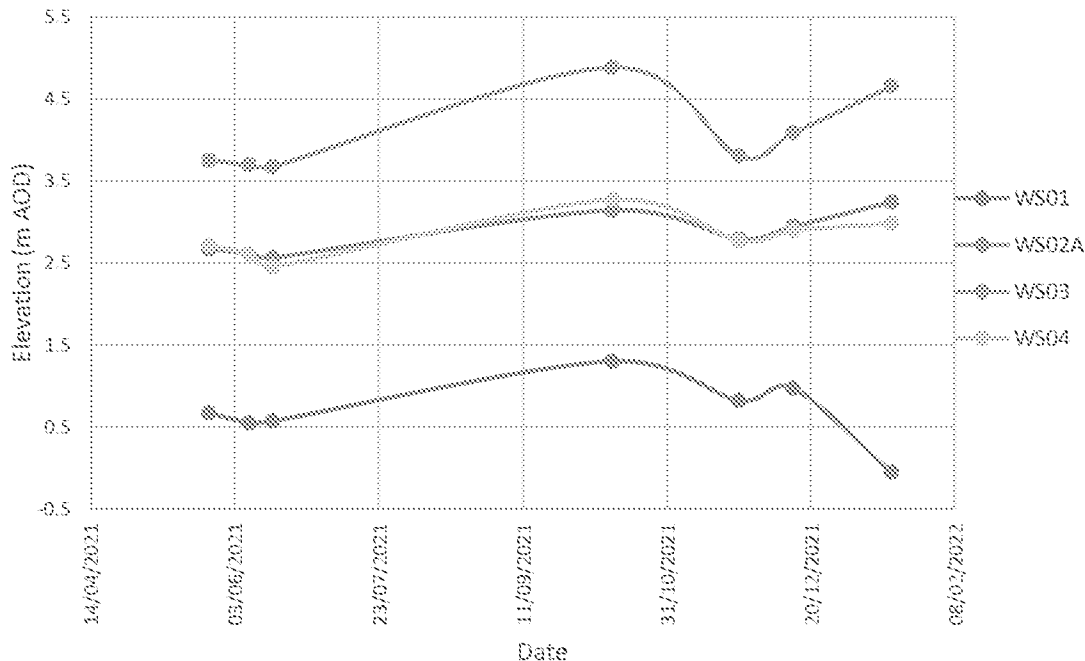
The groundwater level varies between 0.57m bgl and 2.41m bgl across the site as shown in the chart below.

Each of the exploratory holes installed with groundwater monitoring equipment: WS01, WS02A, WS03 and WS04 recorded an increase in the groundwater level between 8<sup>th</sup> June 2021 and 12<sup>th</sup> October 2021. The location of the exploratory holes is shown on the attached layout drawing 13684-CRH-XX-XX-FG-G-7017-P5.

The groundwater level rose between 0.53m and 0.75m in WS01, WS02A and WS04 while the level within WS03 rose 1.19m. The greater increase in WS03 is likely due to the cohesive composition of the response zone (firm clay) within the hole, the lower permeability and hence the greater the build-up of water. The other installations have a response zone comprising sand which would account for the reduced increase in groundwater level as the water is able to drain away at a faster rate.

With the exception of WS01, following 12<sup>th</sup> October 2021 the groundwater levels reduced towards their initial level and then increased again into January 2022. WS01 however reduced in elevation after 14<sup>th</sup> December which is potentially due to a more granular material being present within the response zone. The borehole log records the material as "becoming loose" at 1.2m bgl (0.67m AOD) and "gravelly" from 2.0m bgl (-0.13m AOD), hence the material becomes more porous and the water is able to readily disperse within the granular material.
