# Discharge of Conditions The Steddles, Yapton

Condition: 8

Planning ref Y/158/21/PL

**Arboricultural Impact Assessment & Method Statement in accordance  
with BS5837:2012 '*Trees in relation to design, demolition and  
construction – Recommendations*'**

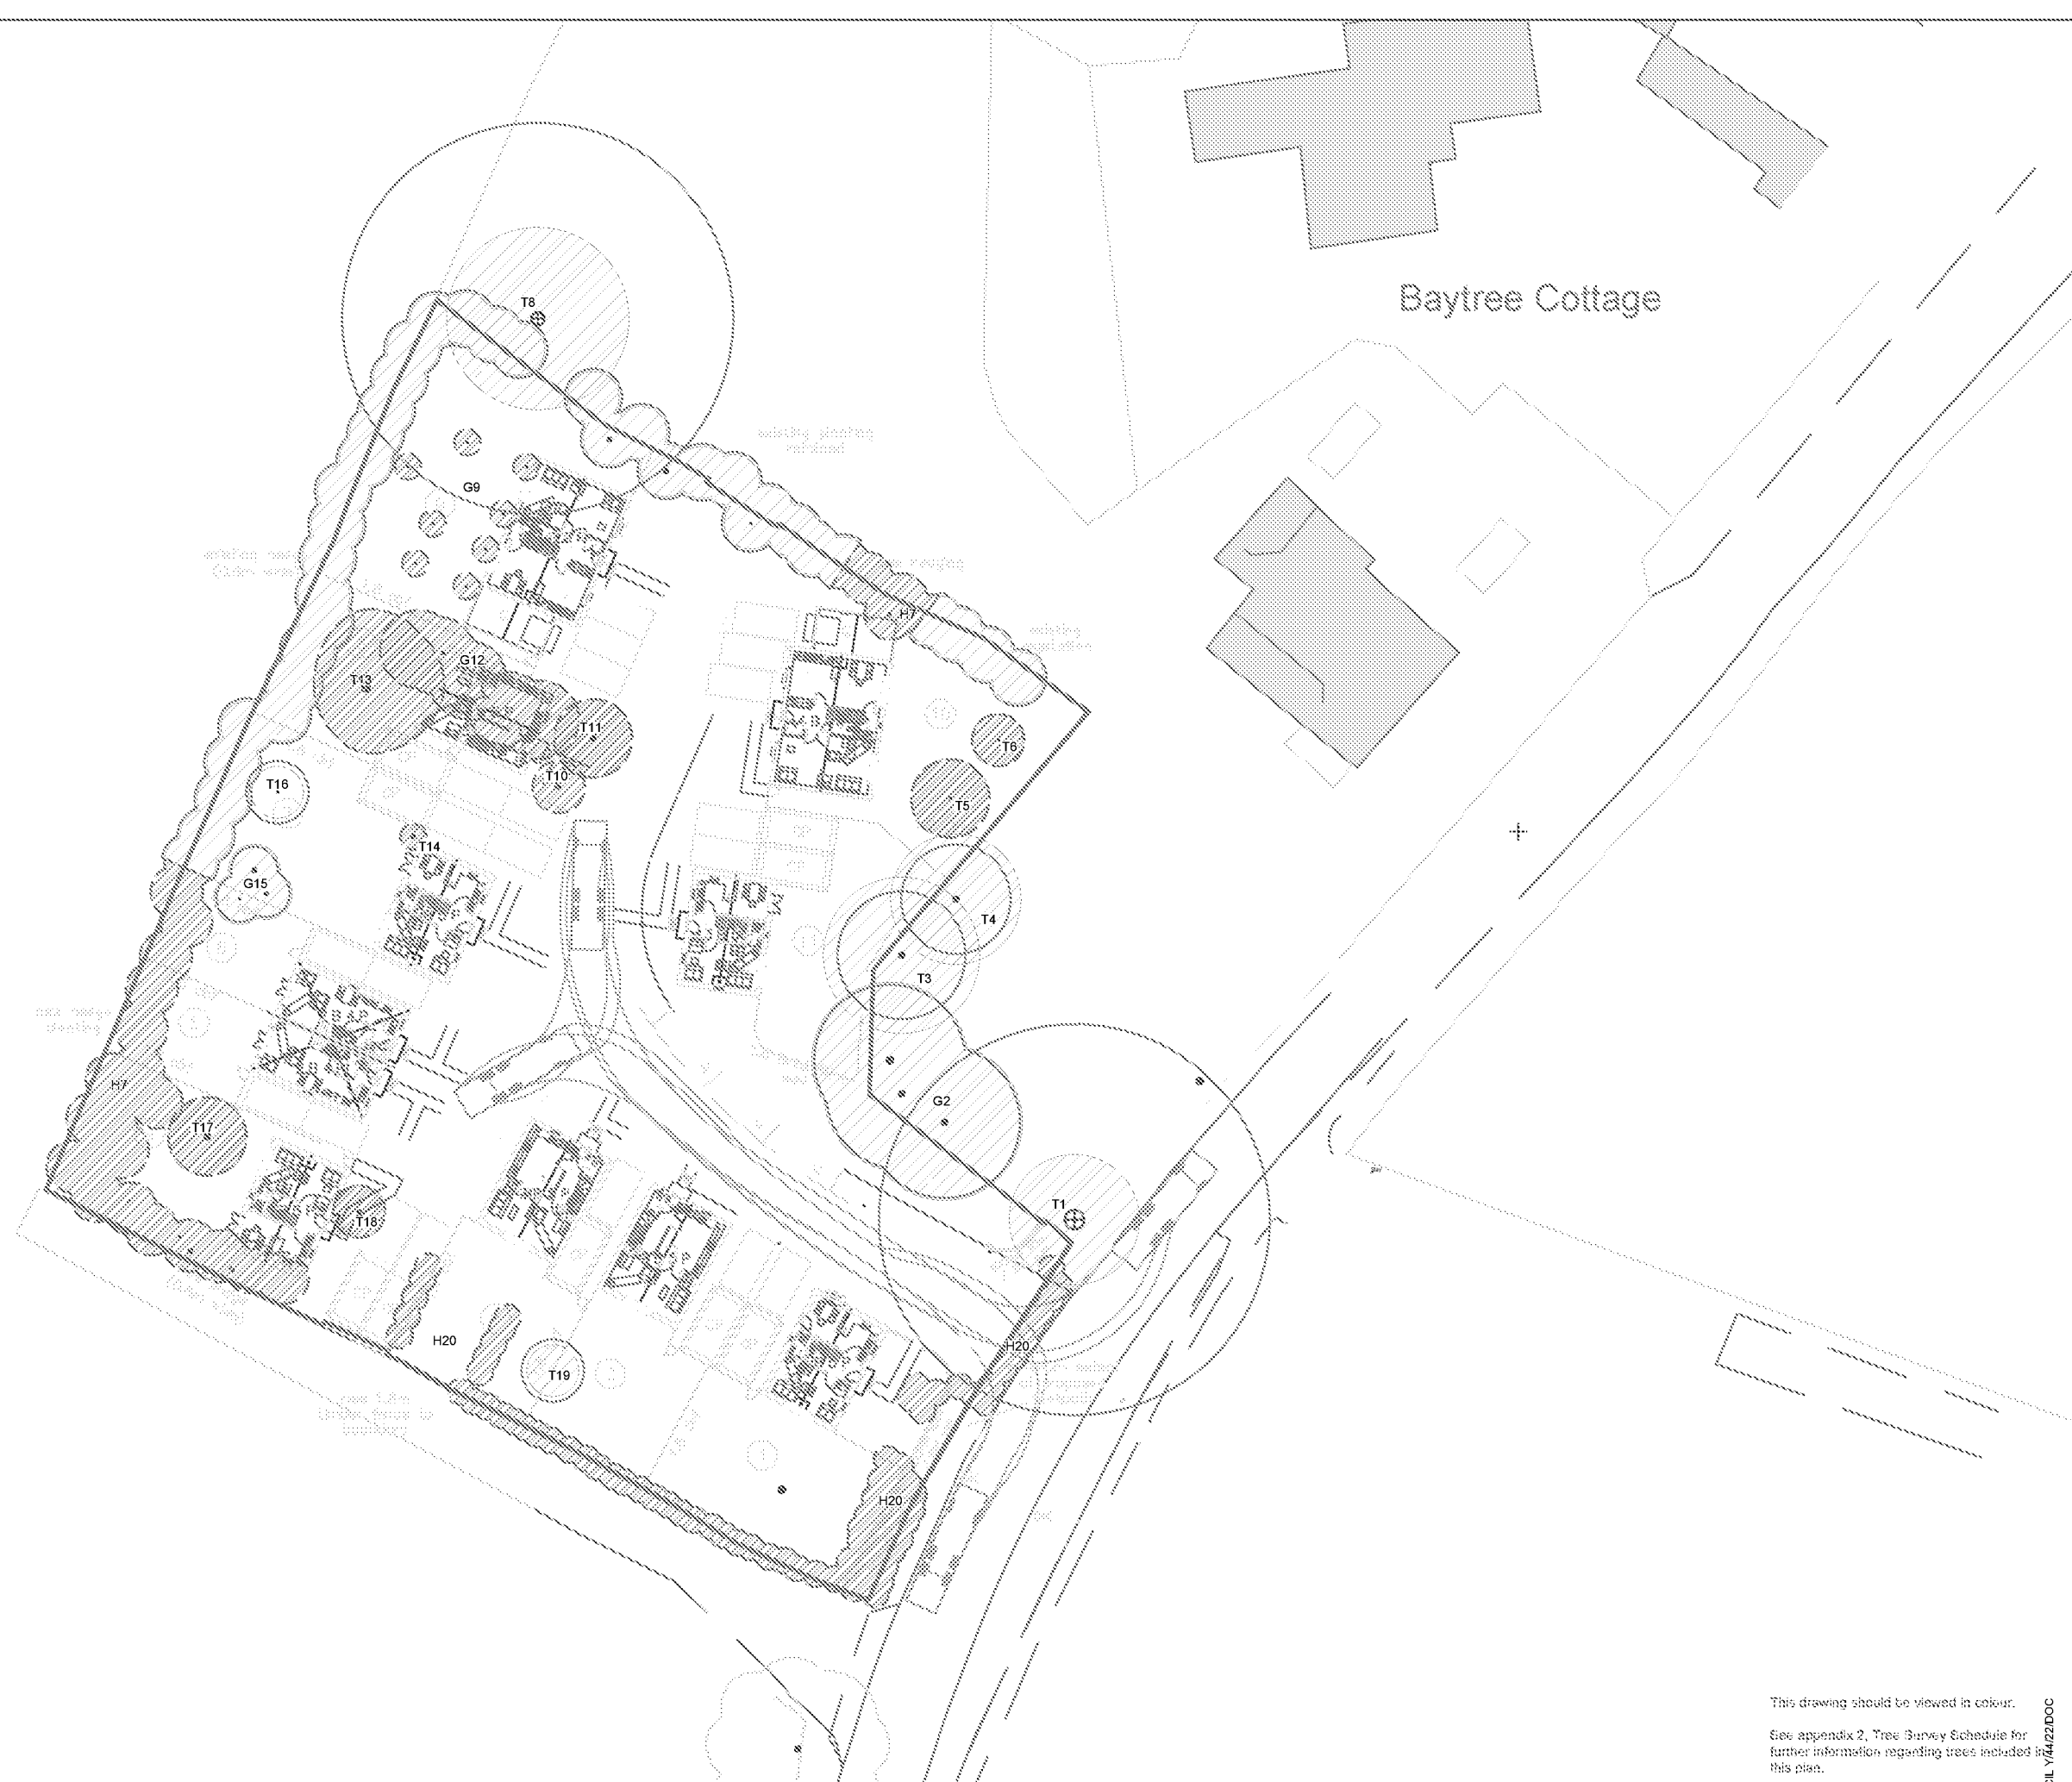
Detail: 1:100 at A3

This drawing should be viewed in colour.  
 See appendix 2, Tree Survey Schedule for further information regarding trees included in this plan.

Minor 2.9%  
encroachment into  
(capped) T8 RPA by  
new footings

Temporary ground  
protection for 1.8m  
around periphery of new  
dwelling to create  
working area for scaffold.  
Tree protection fencing  
at extremity.

**3.5 Works within root protection areas:** A small encroachment is set to occur within the RPA of T8. Given that the RPA of this tree is capped, (making it very large), along with the encroachment, (measured at 2.9% of the total unimpeded RPA), being at the periphery the RPA it is not considered to be significant nor likely to present a detrimental impact to the trees longer term retention. Suitable foundation design should be put forward by a structural engineer based on the relevant industry best practice. No specialist foundation methods such as piles are recommended on arboricultural grounds. Ground protection will be installed at an offset of 1.8 from the line of the proposed new dwelling within the RPA of T8. Ground protection will consist of striping top soil to a depth of 200mm to allow temporary structural fill supported on an impermeable membrane for scaffold base.
