Ref: Arboricultural Survey at: Olive Branch, North End Road, Yapton, West  
Sussex, BN18 0DU  
Insured: Mr A Harding

## Arboricultural Appraisal Report

| <b>Scope of Report:</b> | To assess the current potential for trees to cause or contribute to damage to built structures due to clay shrinkage subsidence by the abstraction of soil moisture. |

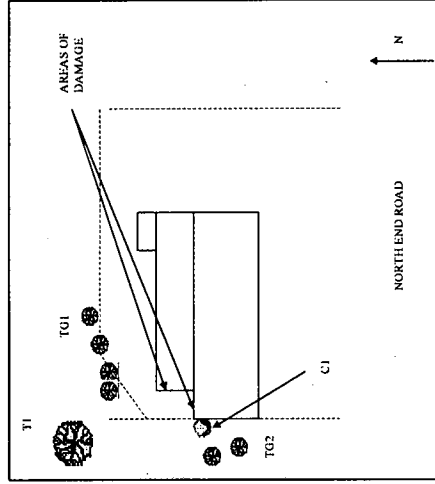
SITE PLAN

Please note that this plan is not to scale  
OS Licence No. 100043218
