# Arundel Cathedral

## St. Marys Hall Refurbishment

Lower Level Floor Plan  
As Proposed

Dwg no. 766/22/5/10 Rev. B

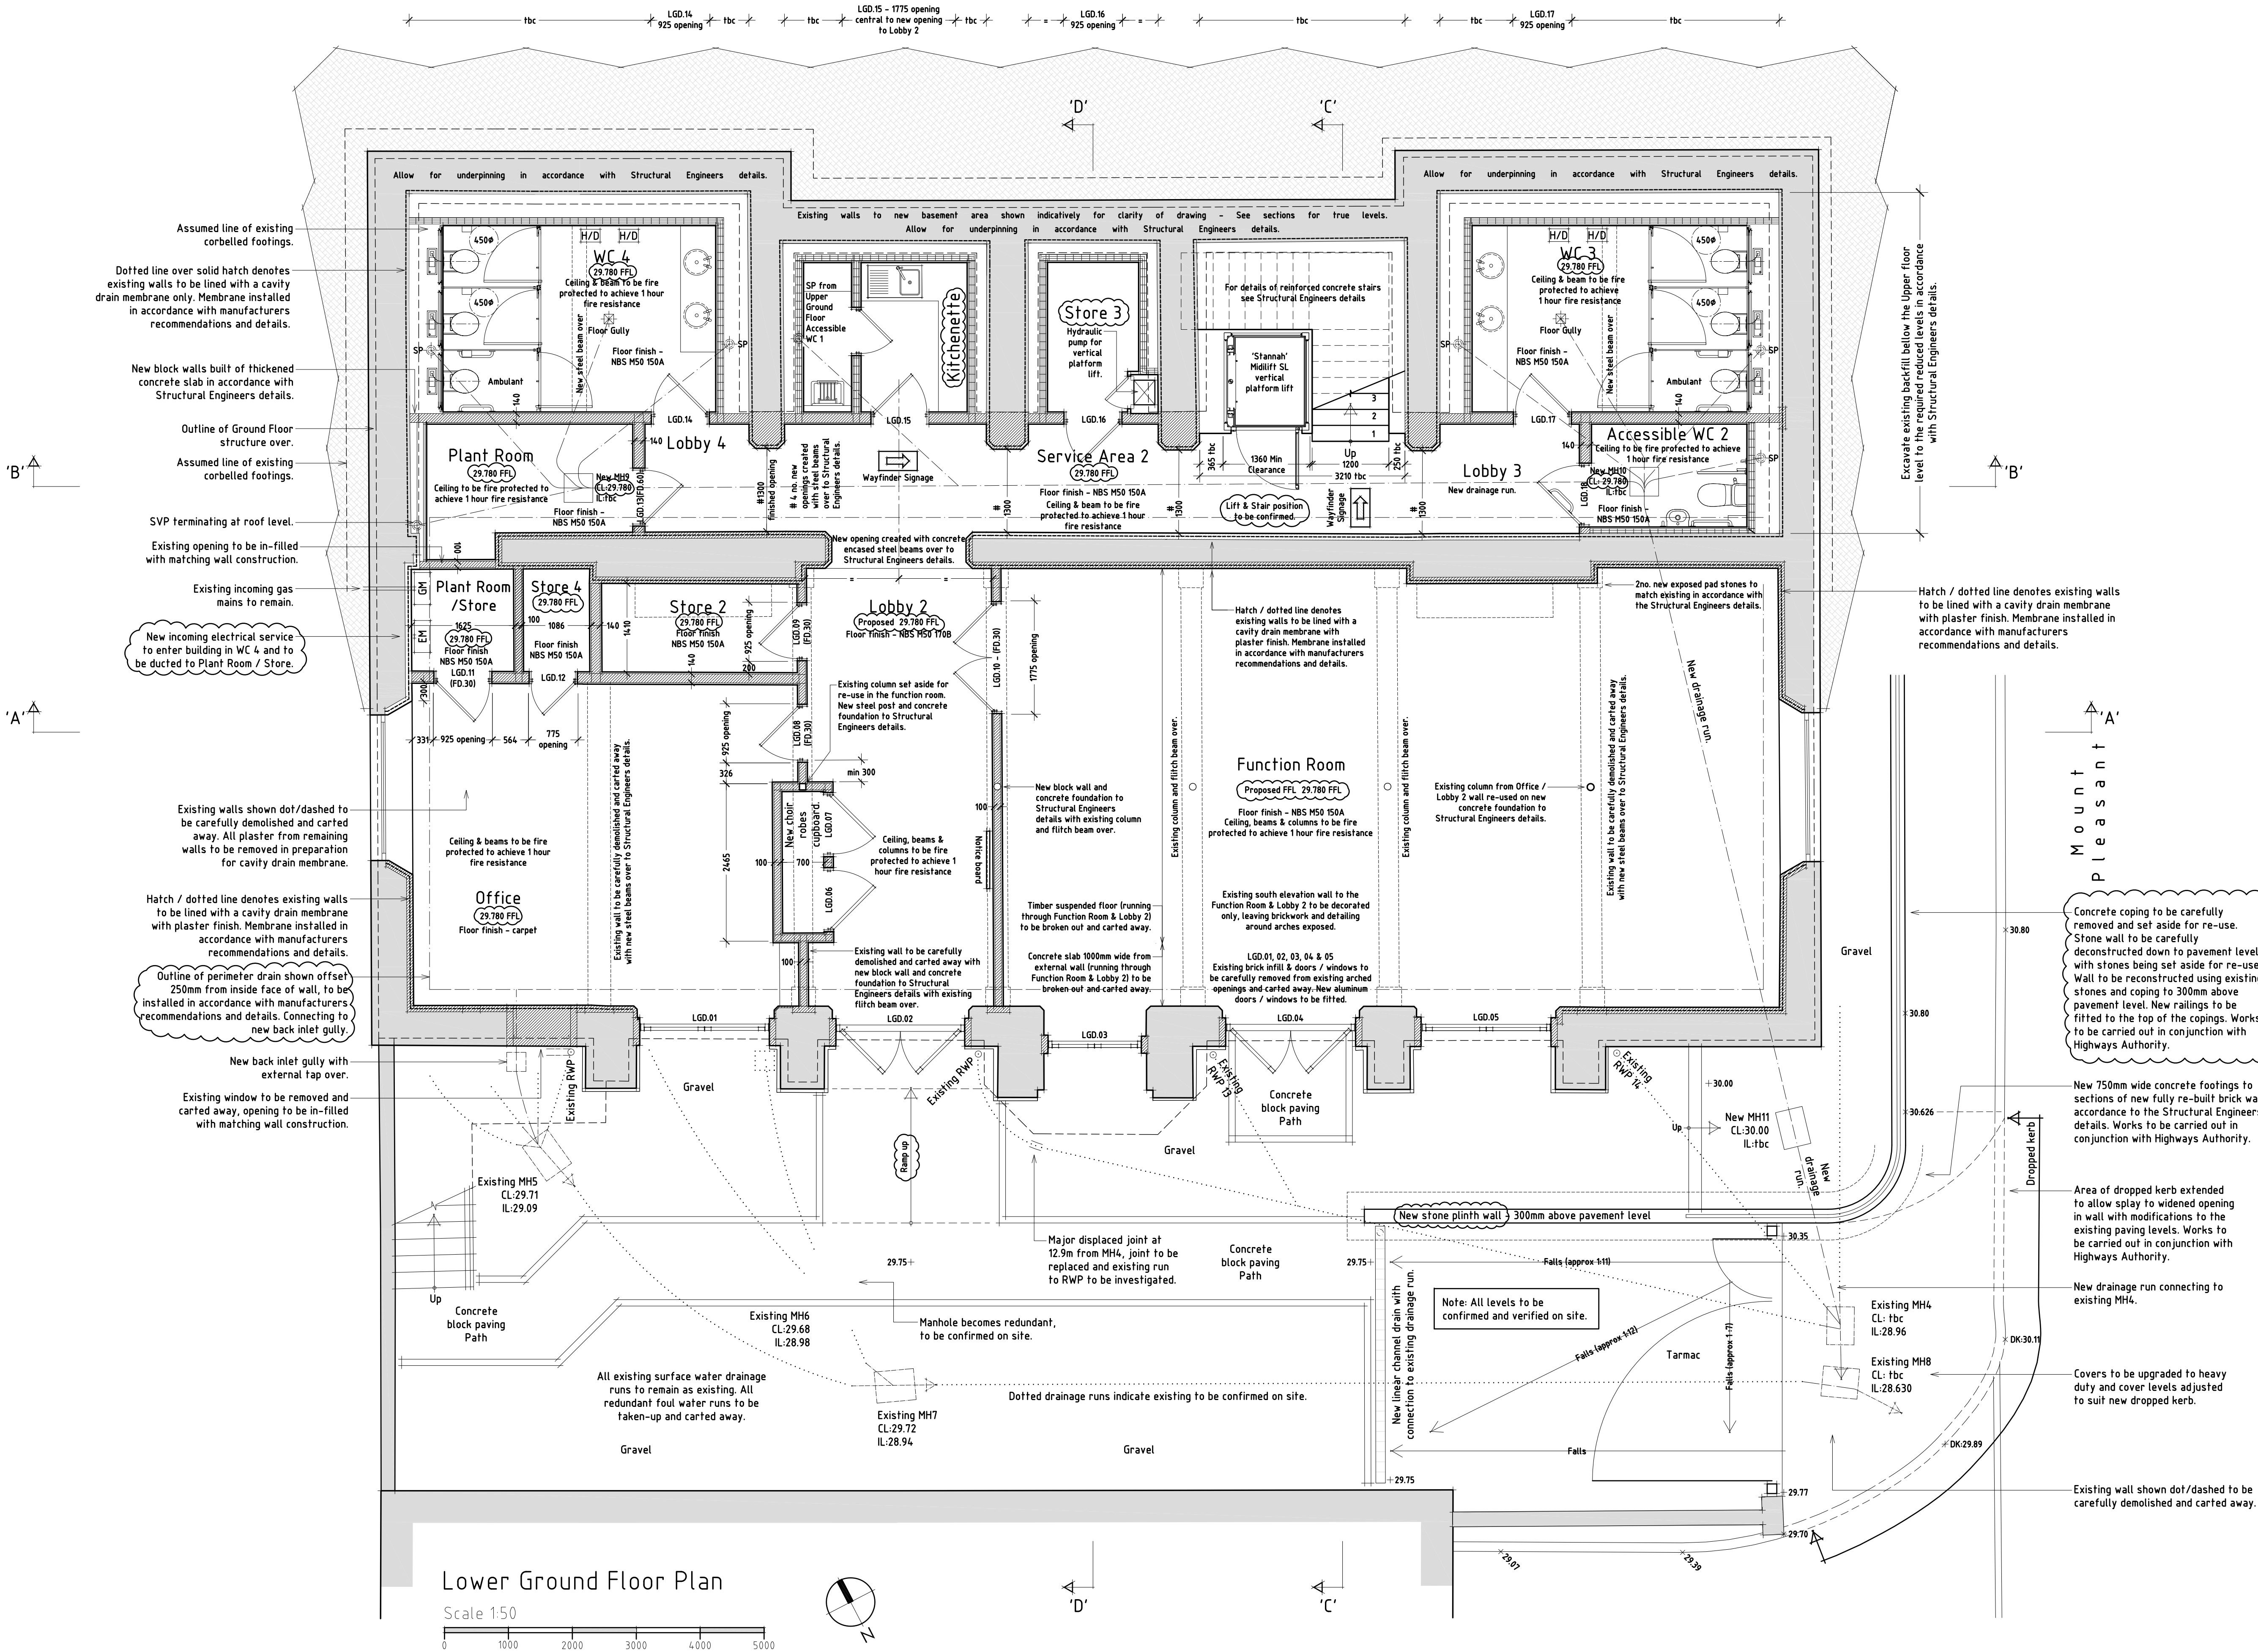
Revision B - 22/11/2011 - SN  
See clouded:-  
FFL levels updated  
Kitchenette & Store 3 updated  
Stairs & Lift updated  
Plant Room external wall updated  
Cavity drain returned on South Elevation walls / perimeter drainage channel added  
External wall construction to Mount Pleasant updated  
Brick nib removed from Office.  
Position of new chair robes cupboard adjusted to suit steel post position

Revision A - 19/10/2011 - SN  
See clouded:-  
Existing structure to be demolished removed from drawing  
FFL levels updated  
Step between Service Area 2 & Lobby 4 removed  
Kitchenette, Store 3 & Service Area 2 updated  
Settling out dimensions added  
Stairs updated
