**GROUND APPRAISAL REPORT**

**LAND OFF LIDSEY ROAD, WOODGATE**

**WEST SUSSEX, PO20 3SU**

| Reference: | GE18390-GAR-OCT-19 |

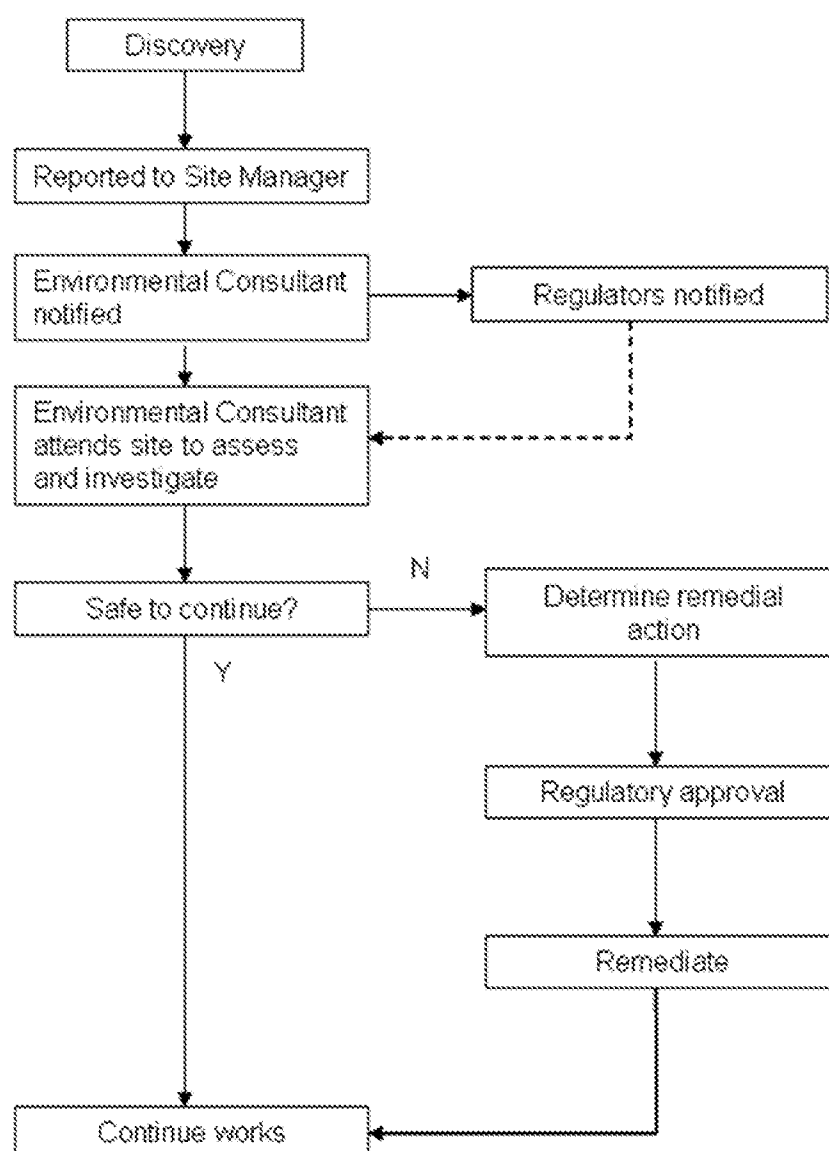
Chart 1 Discovery Strategy Process

- The Environmental Consultant shall attend the site to record the location, extent and nature of the discovery and implement an appropriate sampling and analysis regime, taking due account of the type and nature of the discovery, known and probable land uses in that area of the site;
- Where remedial action is required, regulatory consultation and approval will be sought;
- A record will be produced by the Environmental Consultant and held on site (with copies held by the Environmental Consultant, Client and Local Authority), detailing the discovery, assessment works undertaken, findings thereof, confirmation either of no action required or detailing the remedial action taken and validation thereof.

The process is shown below.

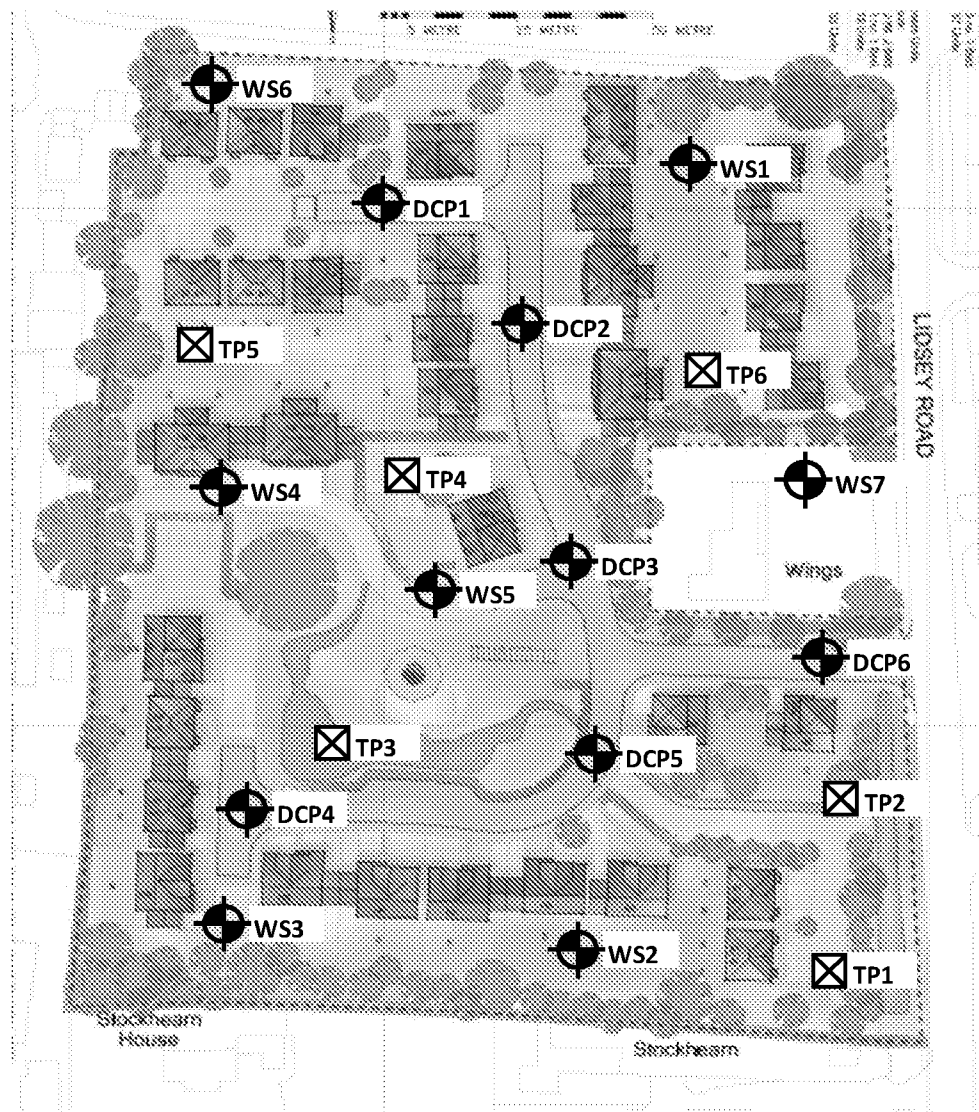
**FIGURE 2**

**Site Investigation Plan**

For further details of the encountered ground conditions, reference should be made to the engineer's logs presented in Appendix A, the groundwater/gas monitoring assessment presented in Appendix B, the geotechnical testing results in Appendix C and the chemical testing results in Appendix D.
