### **Exploratory Hole Logs & DCP Results**

Project Name: Land Off Lidsey Road, Woodgate

Project No.  
GE18390

Location: Woodgate, West Sussex

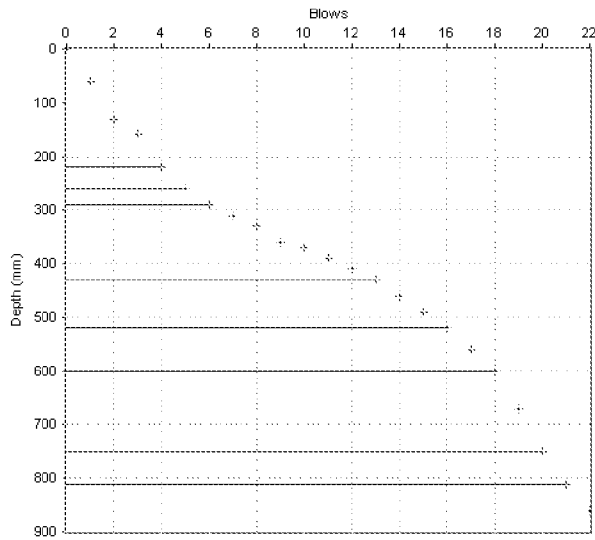
Layer Boundaries Chart

Layer Boundaries: Chainage 0.000

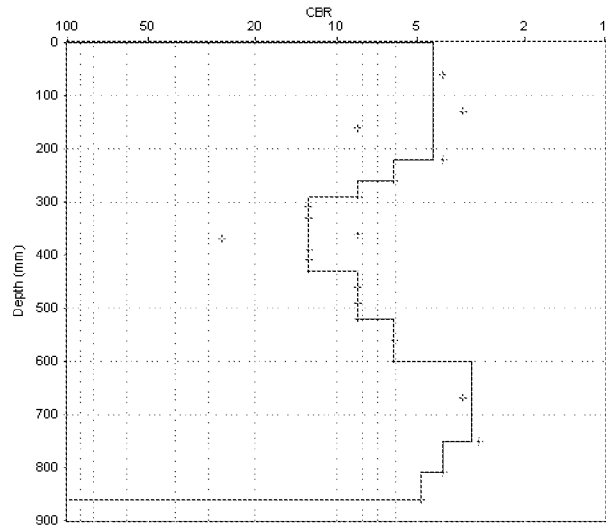
CBR Chart

TRL equation:  $\log_{10}(\text{CBR}) = 2.48 - 1.057 \times \log_{10}(\text{Strength})$

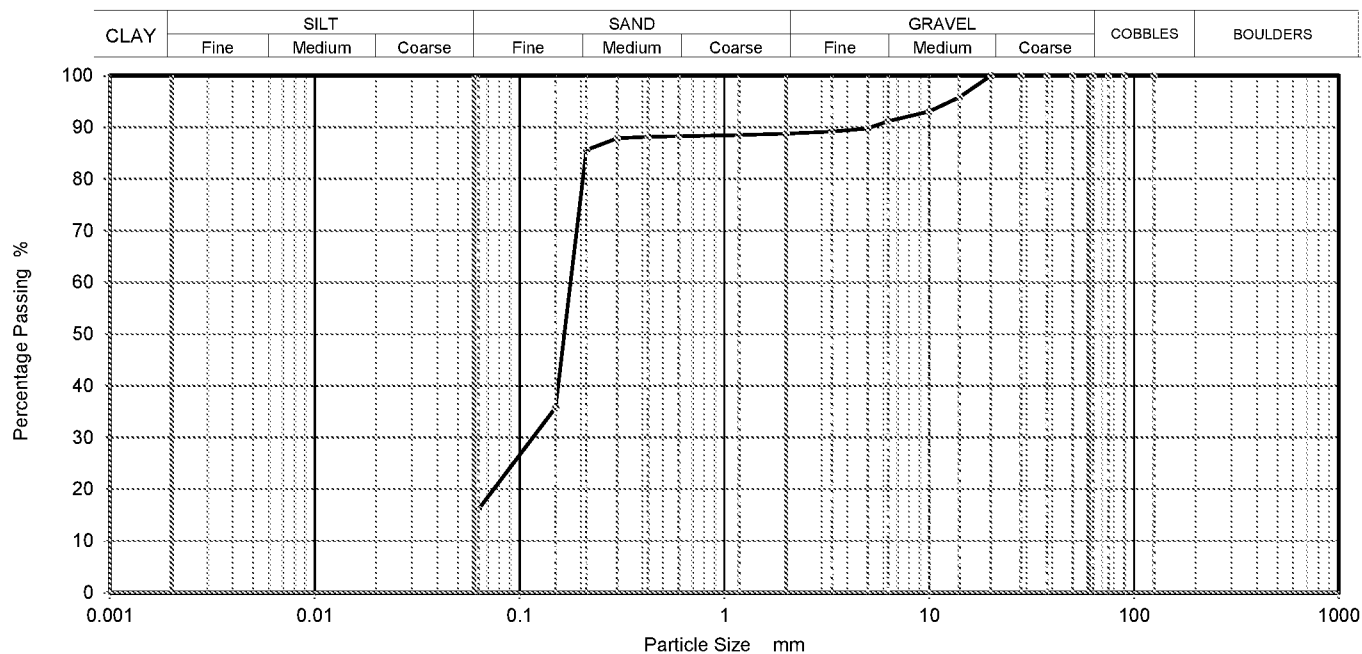
| Soil Description | Light brown gravelly SAND with occasional lumps of sandy clay (gravel is fm and sub-angular to sub-rounded) | | |
| Test Method | BS1377:Part 2: 1990, clause 9.0 | | |

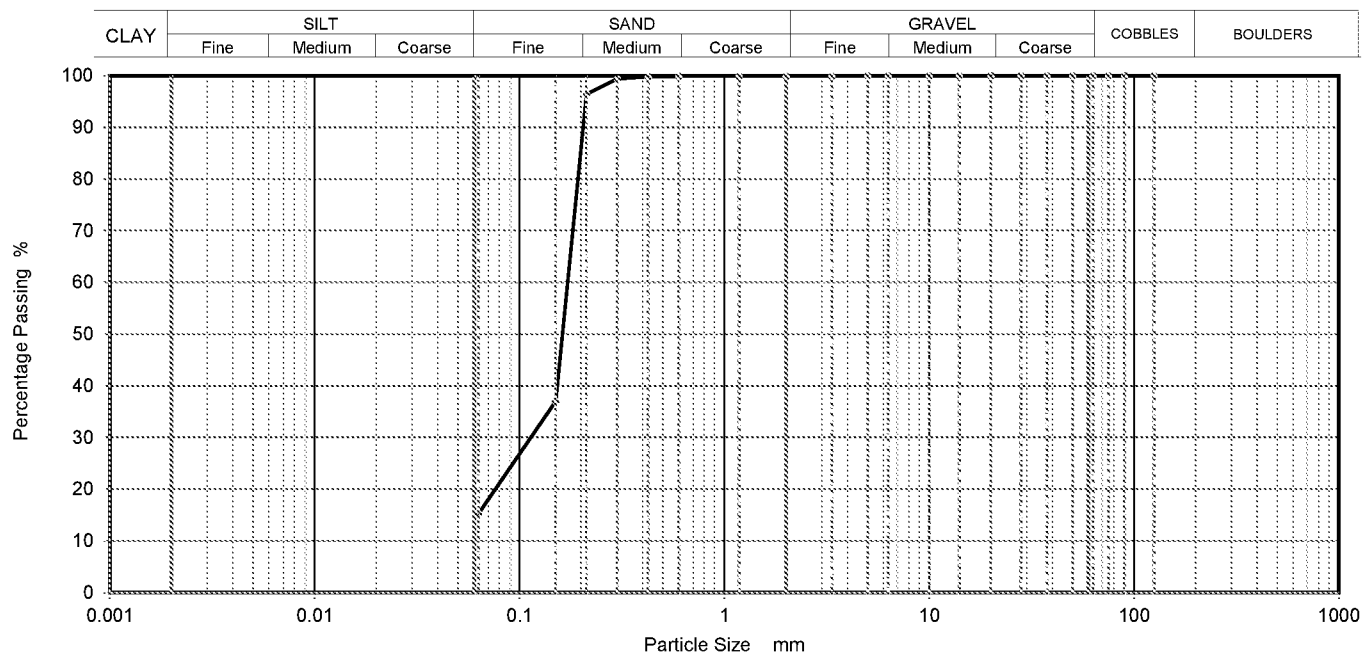
| Soil Description | Light brown silty SAND | | |
| Test Method | BS1377:Part 2: 1990, clause 9.0 | | |

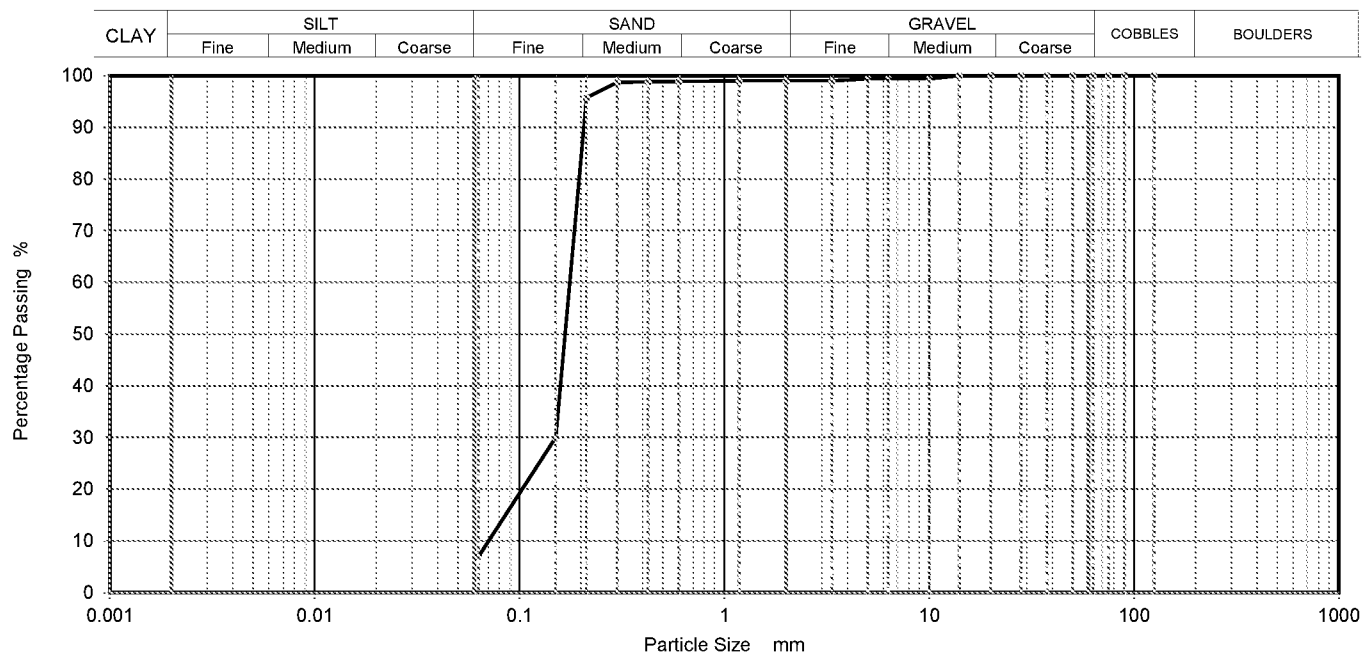
| Soil Description | Light brown silty SAND with rare fm sub-angular gravel | | |
| Test Method | BS1377:Part 2: 1990, clause 9.0 | | |

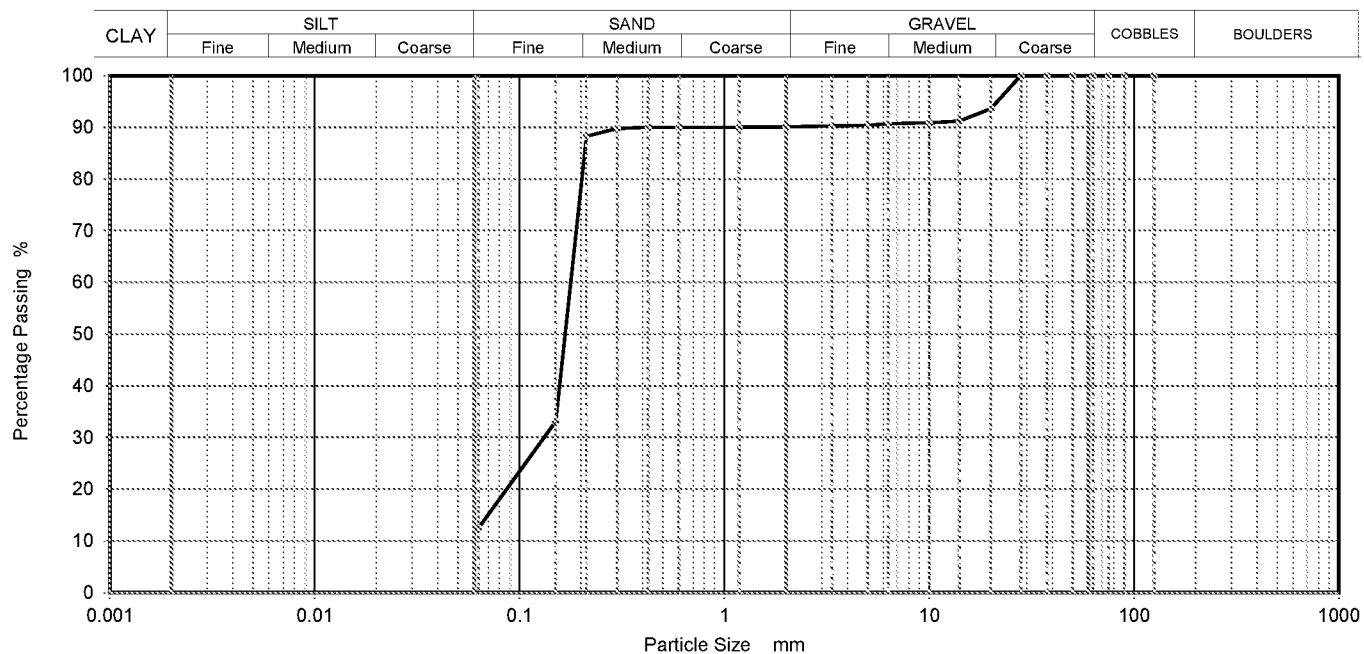
| Soil Description | Light brown gravelly silty SAND (gravel is fmc and sub-angular) | | |
| Test Method | BS1377:Part 2: 1990, clause 9.0 | | |

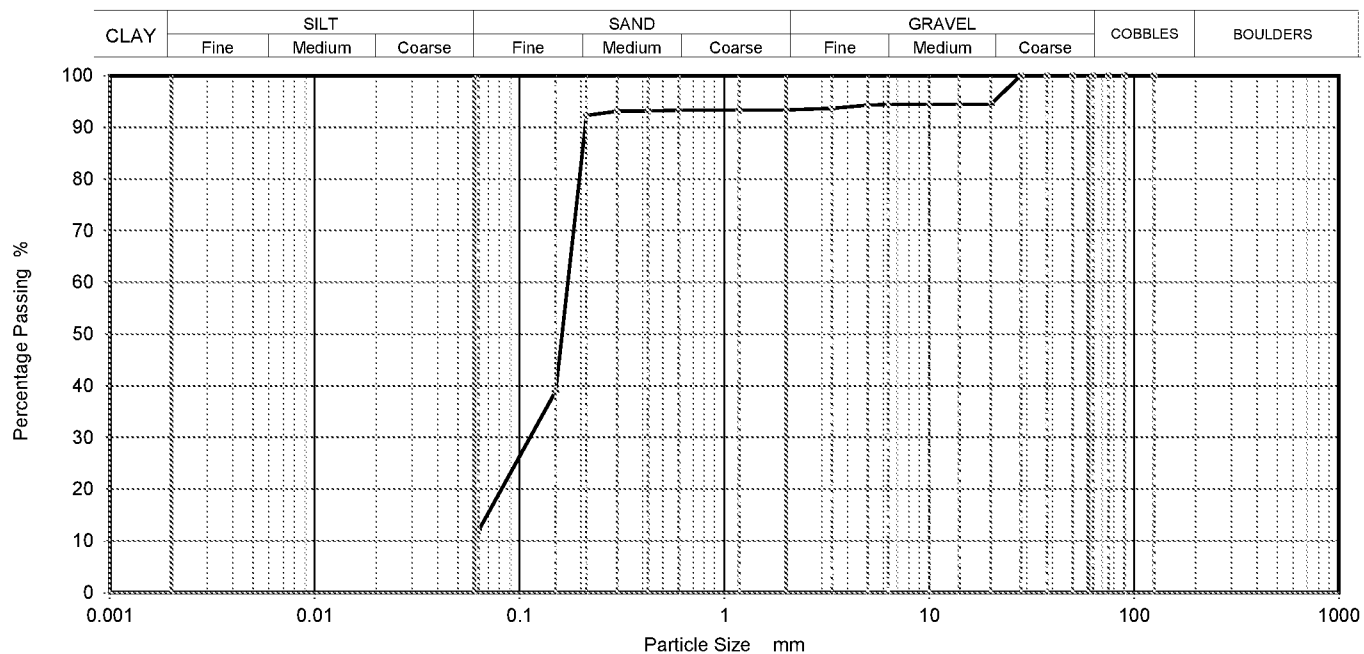
| Soil Description | Orangish brown gravelly silty SAND (gravel is fmc and sub-angular to sub-rounded) | | |
| Test Method | BS1377:Part 2: 1990, clause 9.0 | | |

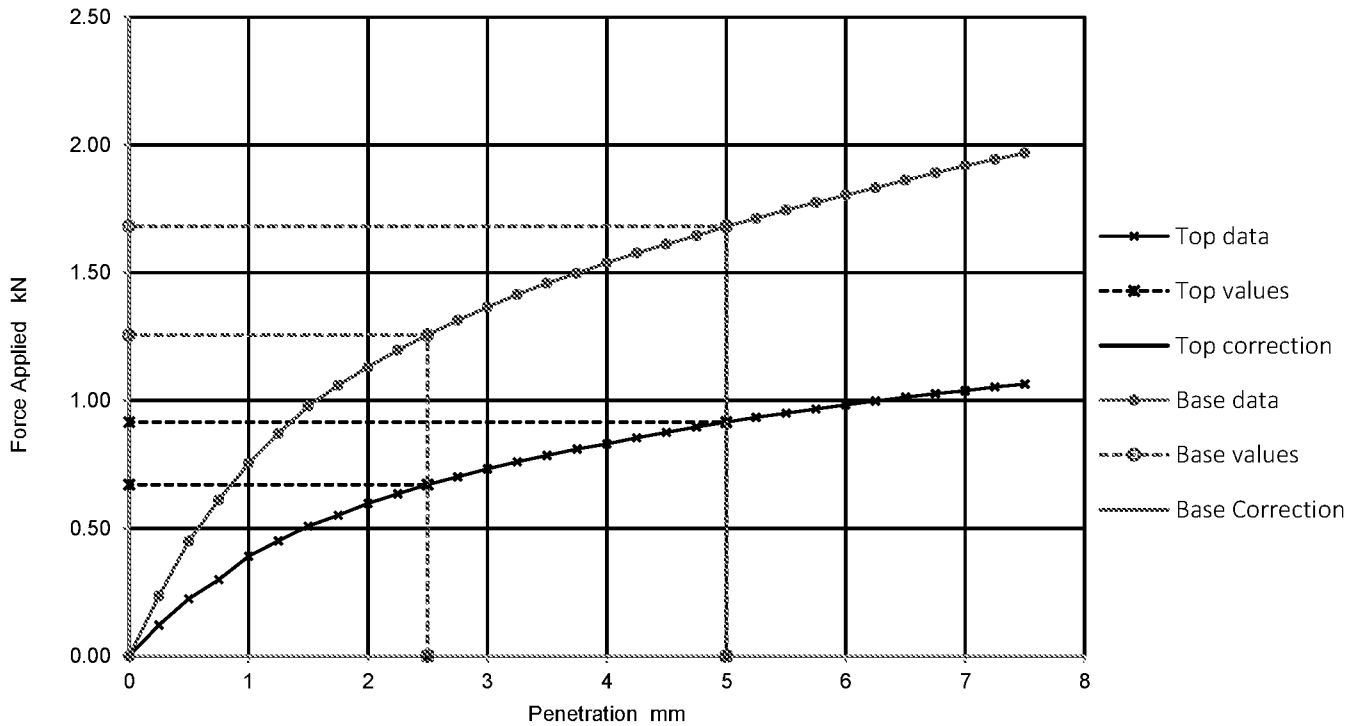
Force v Penetration Plots

Condition REMOULDED

Initial Specimen details Bulk density 1.93 Mg/m<sup>3</sup> Surcharge applied 6 kg  
Dry density 1.66 Mg/m<sup>3</sup> 4 kPa  
Moisture content 17 %

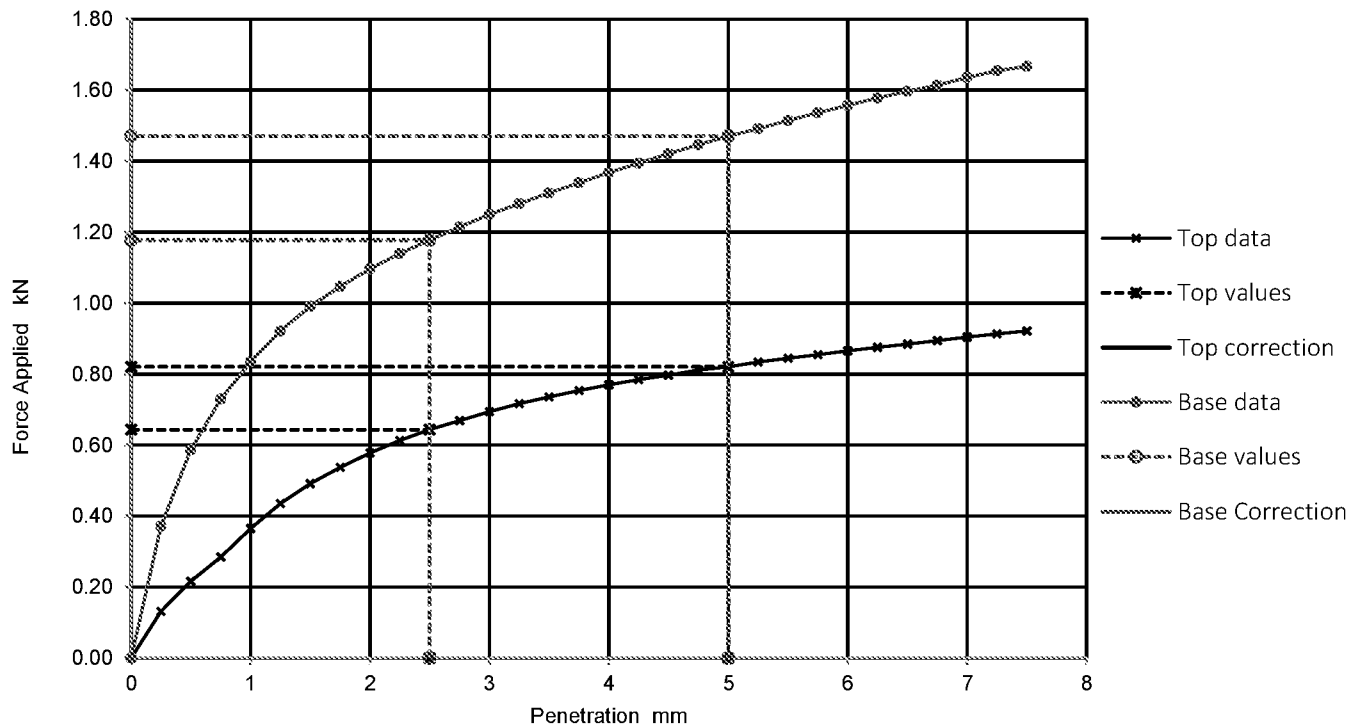
Force v Penetration Plots

Condition REMOULDED

Moisture content 19 %

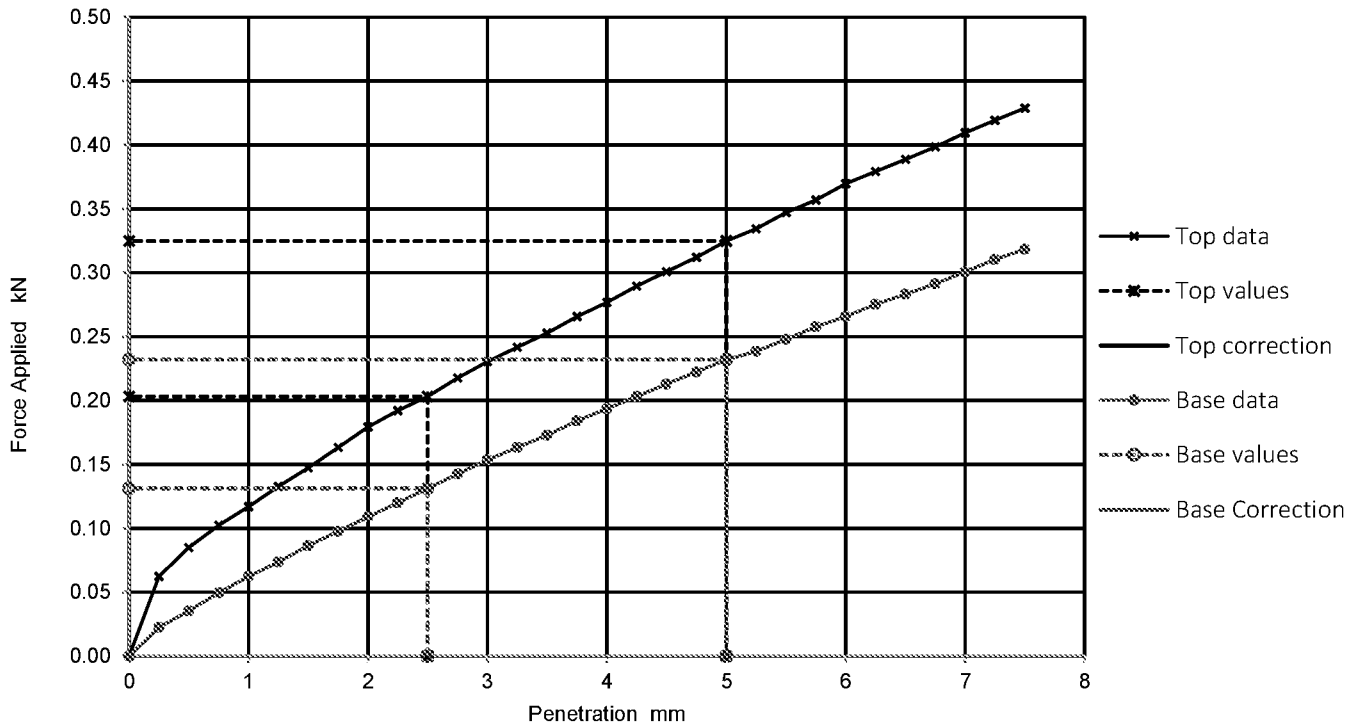
Force v Penetration Plots

Condition REMOULDED

Initial Specimen details Bulk density 2.00 Mg/m<sup>3</sup> Surcharge applied 6 kg  
Dry density 1.65 Mg/m<sup>3</sup> 4 kPa  
Moisture content 21 %

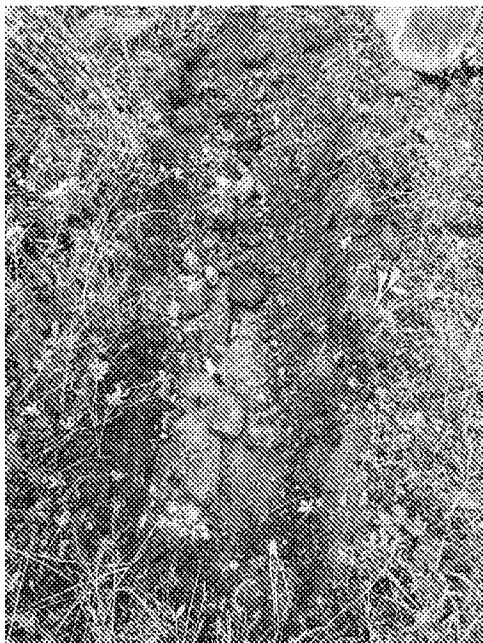
Hole ID                      TP1

Photo of Pit

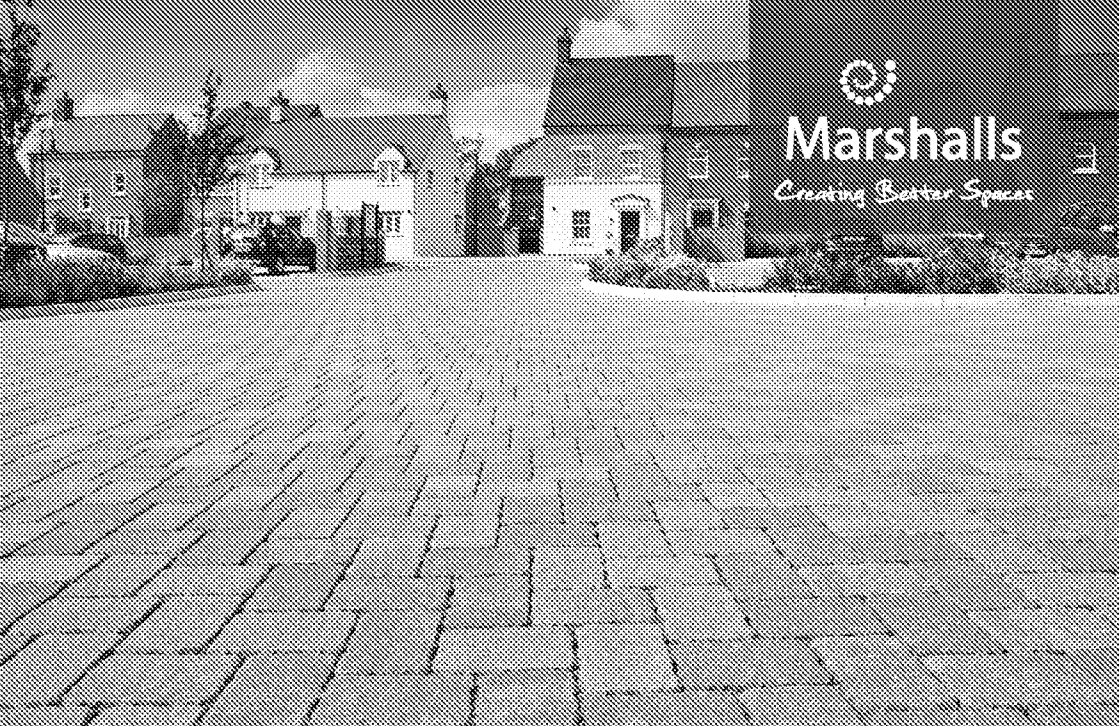
## Appendix D Marshalls Permeable Paving Details

Maintaining your Marshalls Priors Permeable Paving System is easy: simply ensure that the voids between the blocks don't get blocked and prevent water from flowing through the surface and into the sub-base.

However, it's important to remember that even if the voids do appear to be blocked, it's unlikely to stop the system working. This is because the voids on a Marshalls Priors surface have been specially engineered to be far wider than they need to be – so blocked voids are likely to only slow the flow of water, not stop it completely.

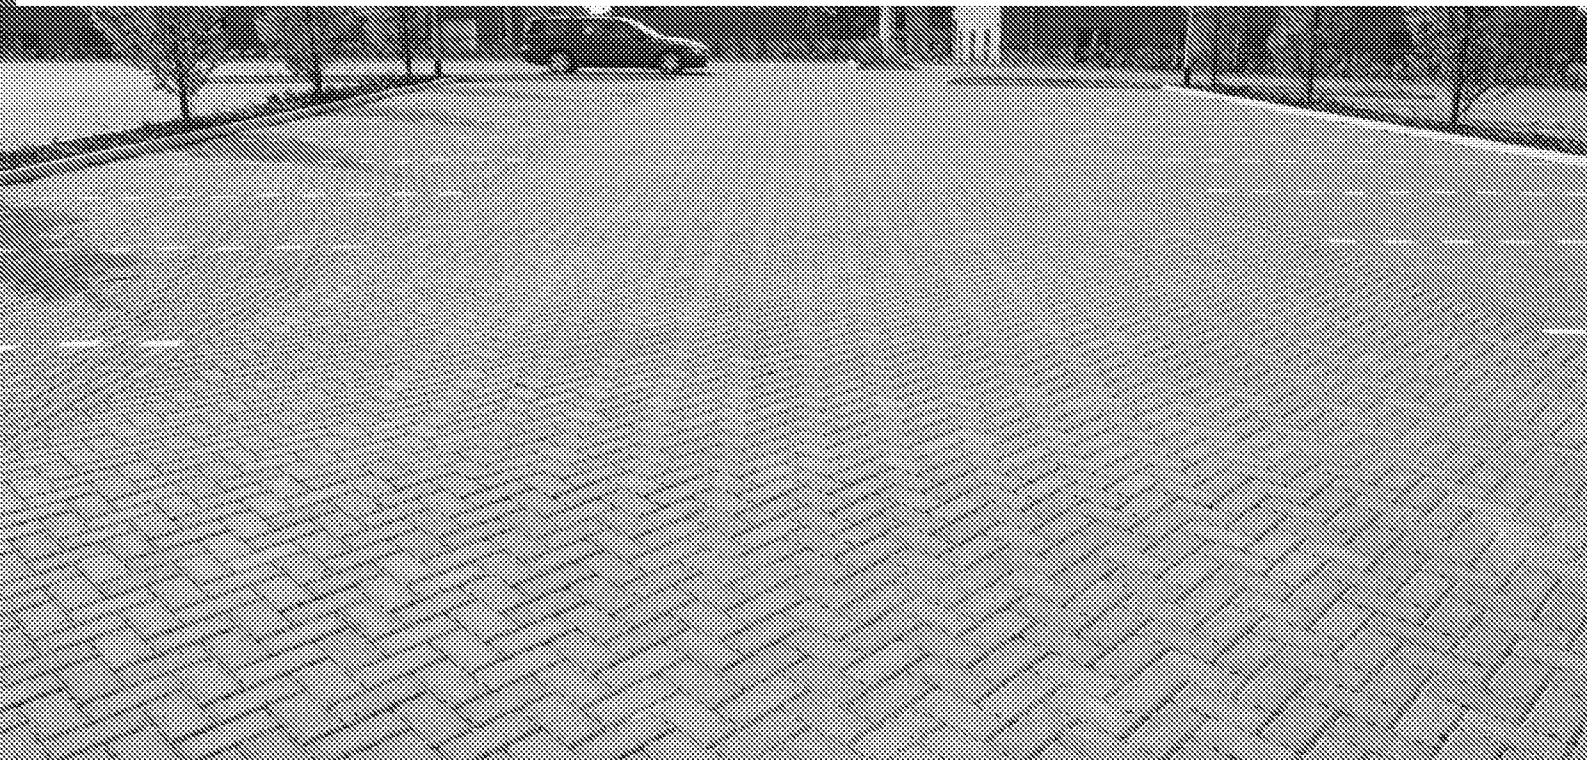
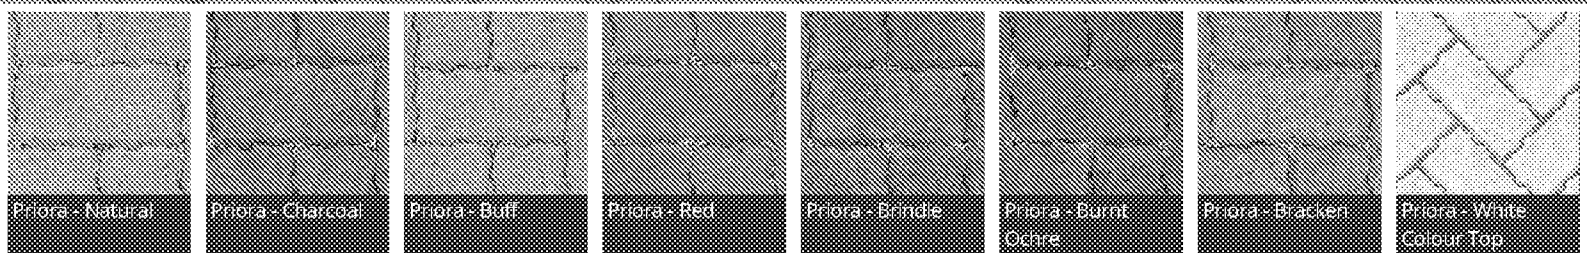
# Priora 200 x 100 x 60

Priora is Marshall's original Concrete Block Permeable Paving (CBPP) system, and the best selling system of its type in the UK. Combining the ever popular aesthetics of Keyblok block paving with a source-control SuDS solution, Priora not only looks great but also mitigates flood risk, removes surface water and improves water quality - without the need for additional linear drainage systems.

The Priora system has been proven over 10 years of successfully installed projects. The patented nib on the edge of the Priora blocks creates voids through which water falls into a specially prepared sub-base. The nibs also interlock to enhance surface stability.
