### **Exploratory Hole Logs & DCP Results**

Project Name: Land Off Lidsey Road, Woodgate

Project No.  
GE18390

Location: Woodgate, West Sussex

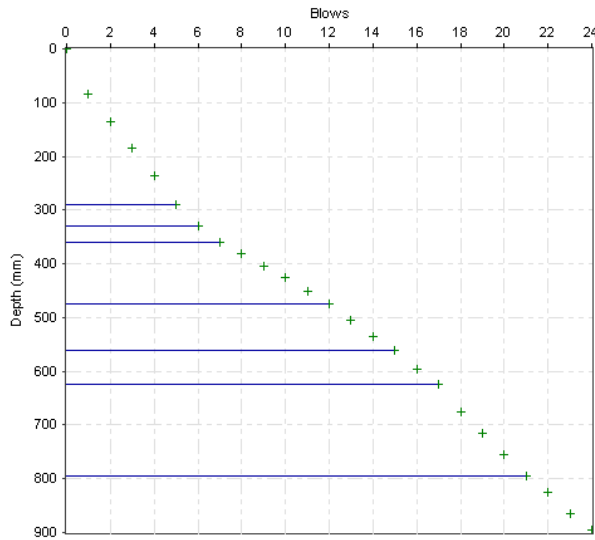
Layer Boundaries Chart

Layer Boundaries: Chainage 0.000

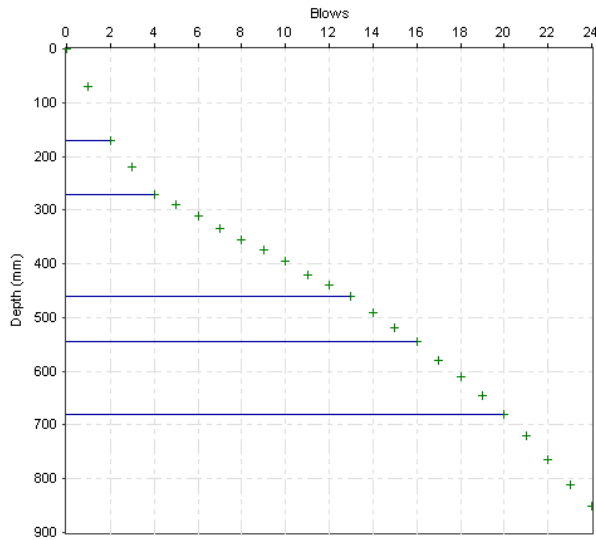
Layer Boundaries Chart

Layer Boundaries: Chainage 0.000

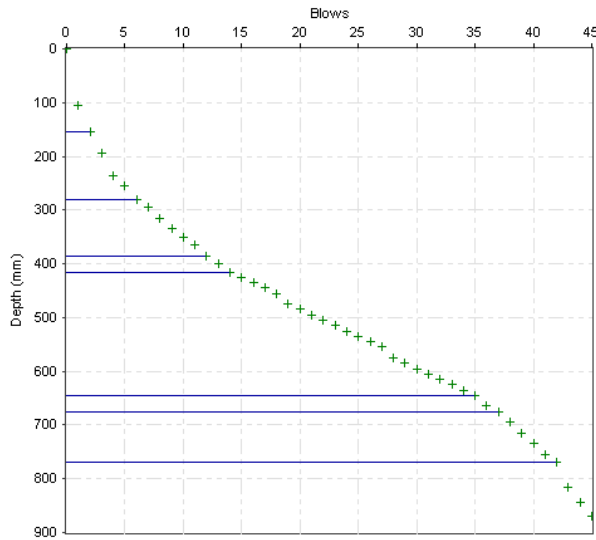
Layer Boundaries Chart

Layer Boundaries: Chainage 0.000

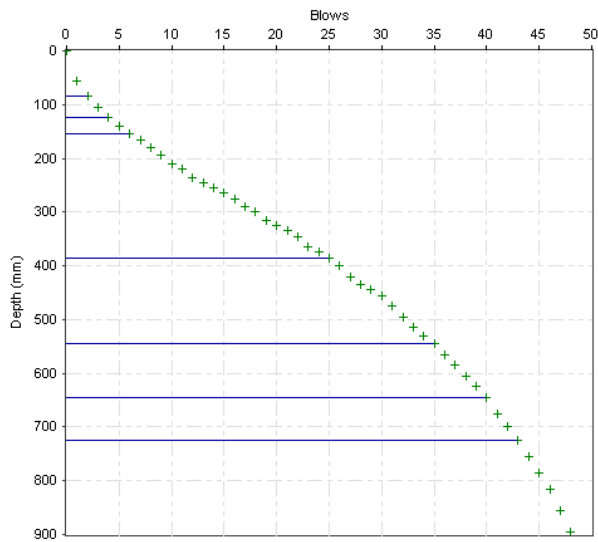
Layer Boundaries Chart

Layer Boundaries: Chainage 0.000

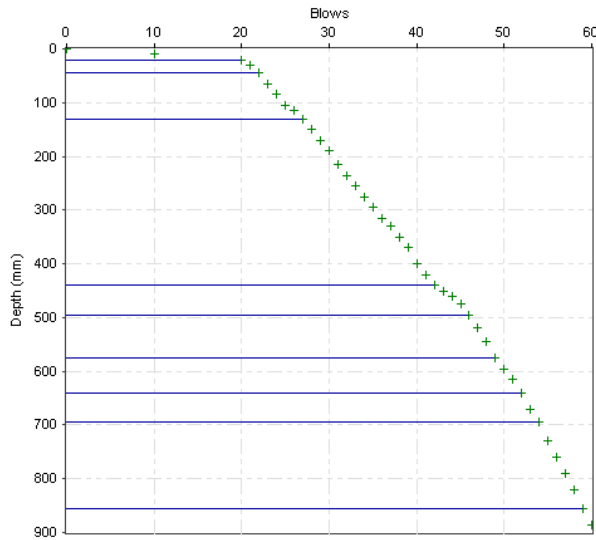
Layer Boundaries Chart

Layer Boundaries: Chainage 0.000

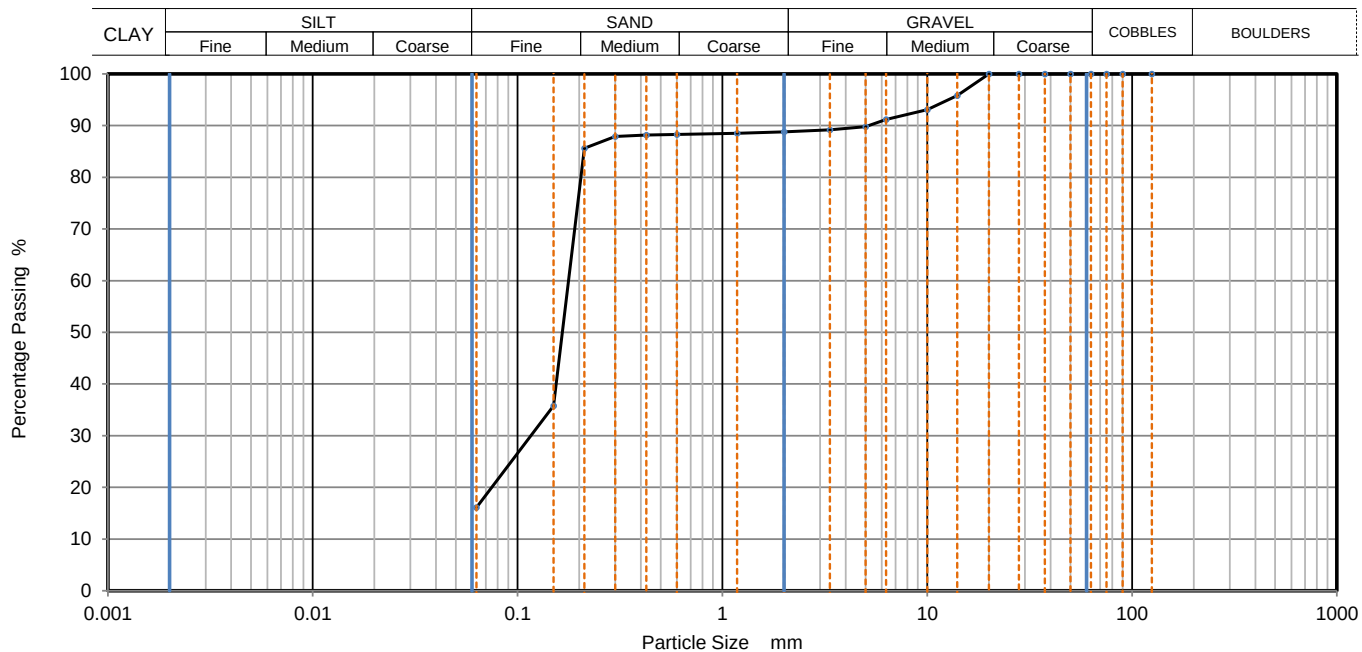
| Soil Description | Light brown gravelly SAND with occasional lumps of sandy clay (gravel is fm and sub-angular to sub-rounded) | | |
| Test Method | BS1377:Part 2: 1990, clause 9.0 | | |

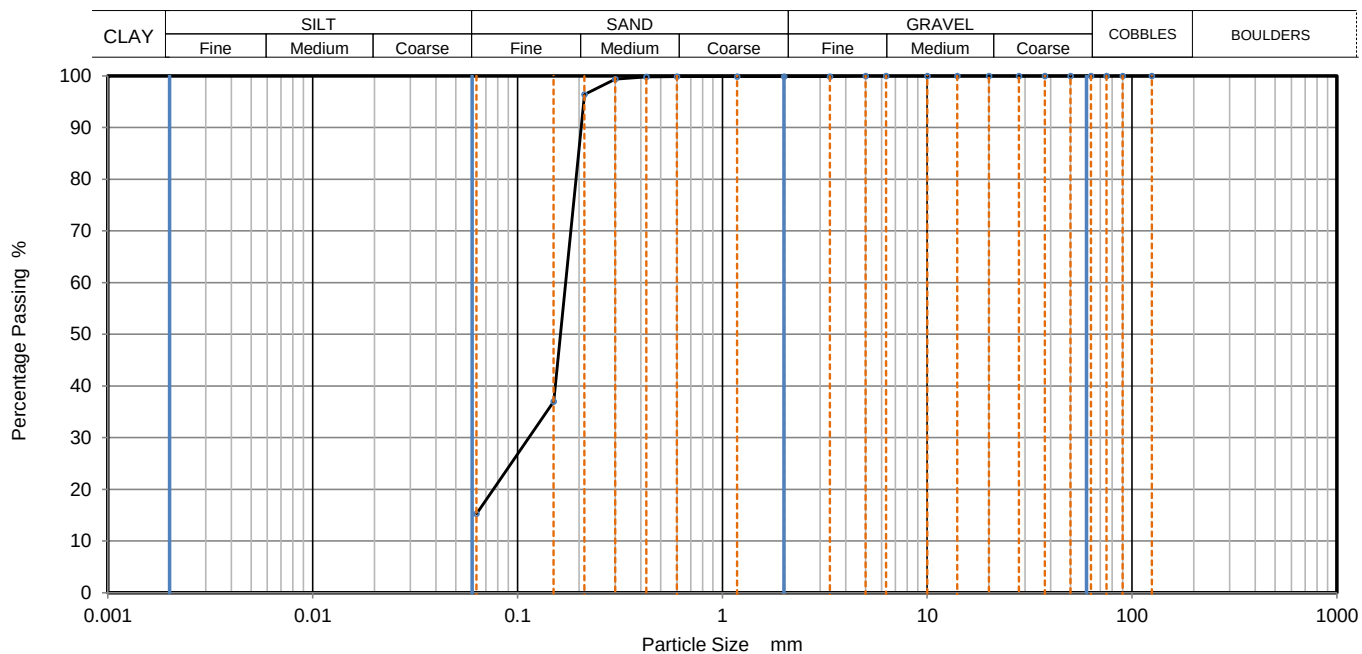
| Soil Description | Light brown silty SAND | | |
| Test Method | BS1377:Part 2: 1990, clause 9.0 | | |

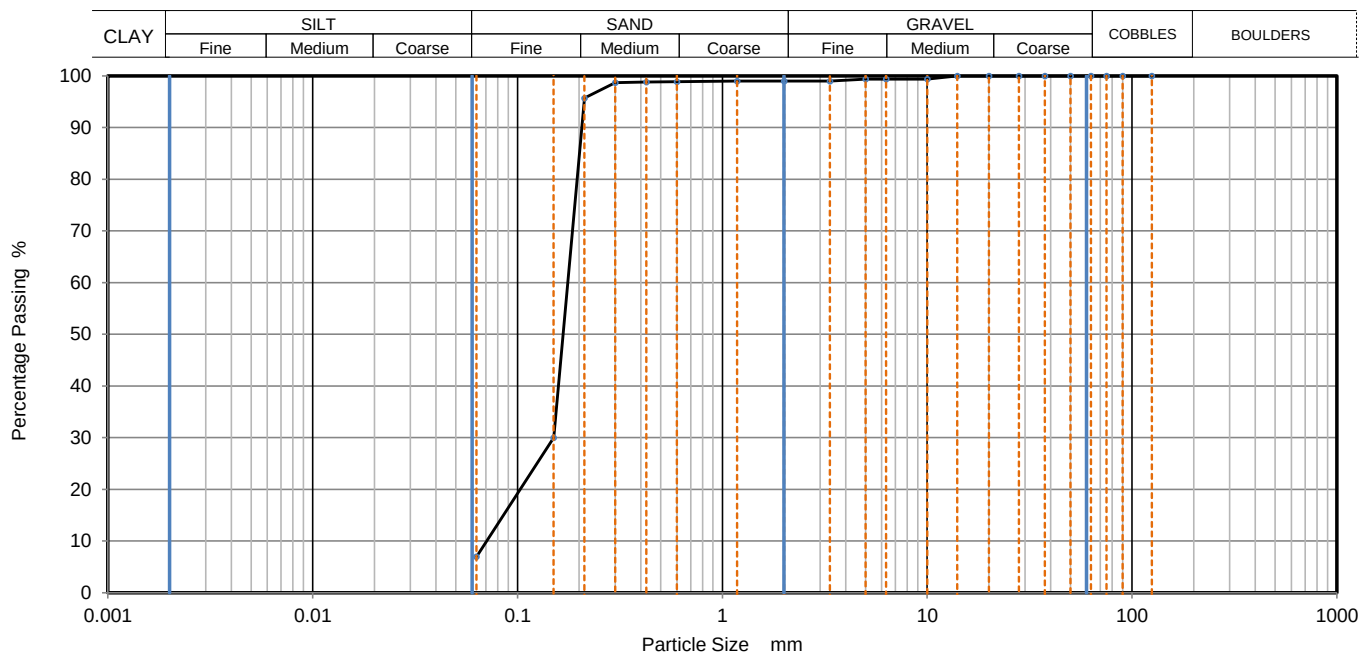
| Soil Description | Light brown silty SAND with rare fm sub-angular gravel | | |
| Test Method | BS1377:Part 2: 1990, clause 9.0 | | |

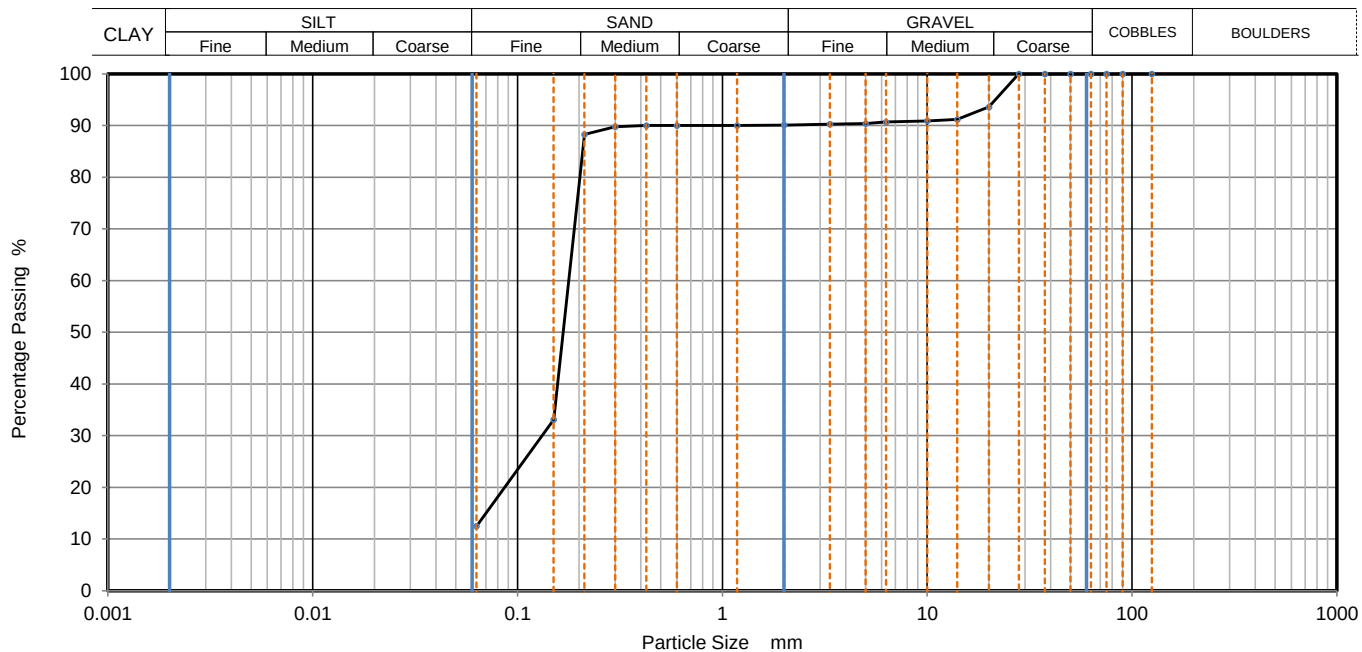
| Soil Description | Light brown gravelly silty SAND (gravel is fmc and sub-angular) | | |
| Test Method | BS1377:Part 2: 1990, clause 9.0 | | |

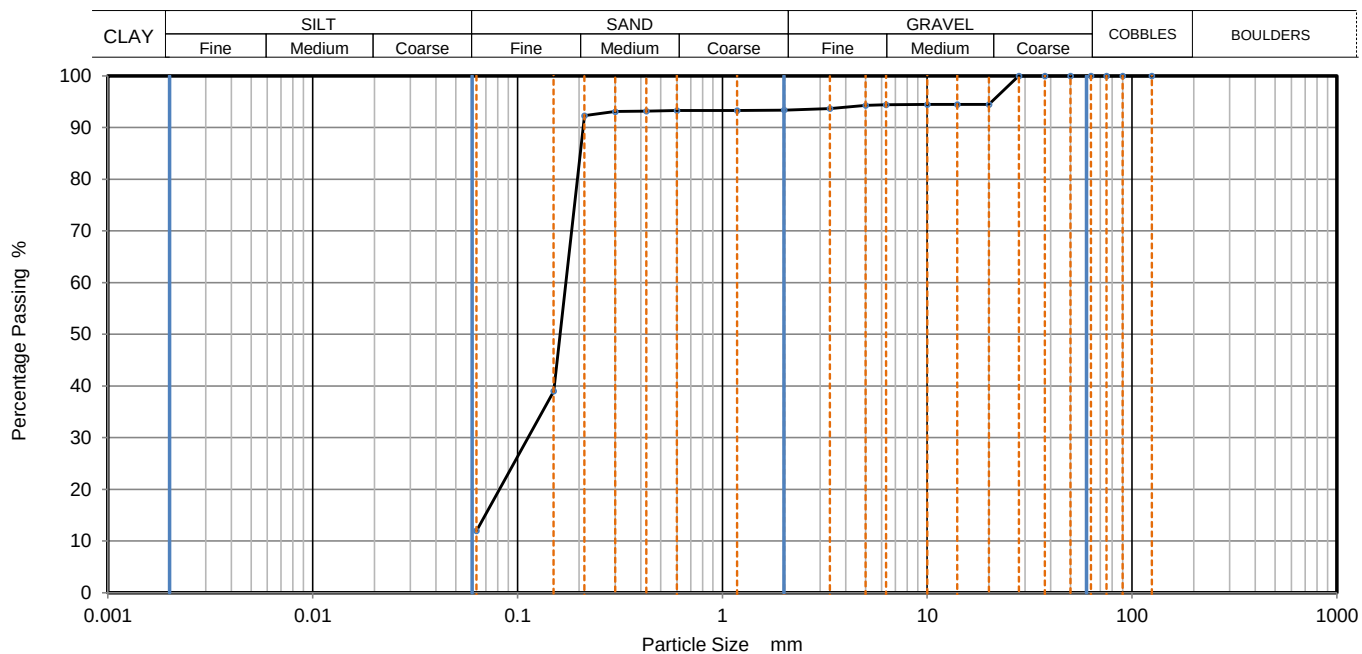
| Soil Description | Orangish brown gravelly silty SAND (gravel is fmc and sub-angular to sub-rounded) | | |
| Test Method | BS1377:Part 2: 1990, clause 9.0 | | |

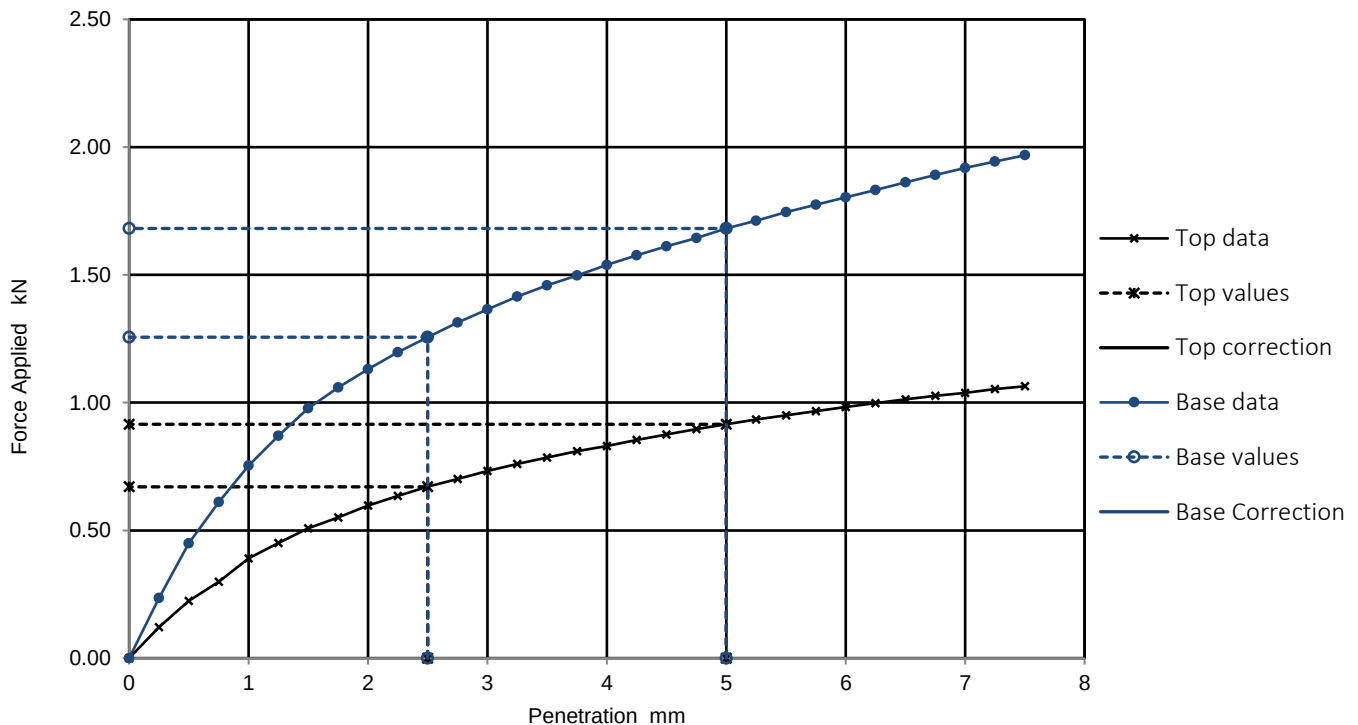
Force v Penetration Plots

Condition REMOULDED

Moisture content 17 %

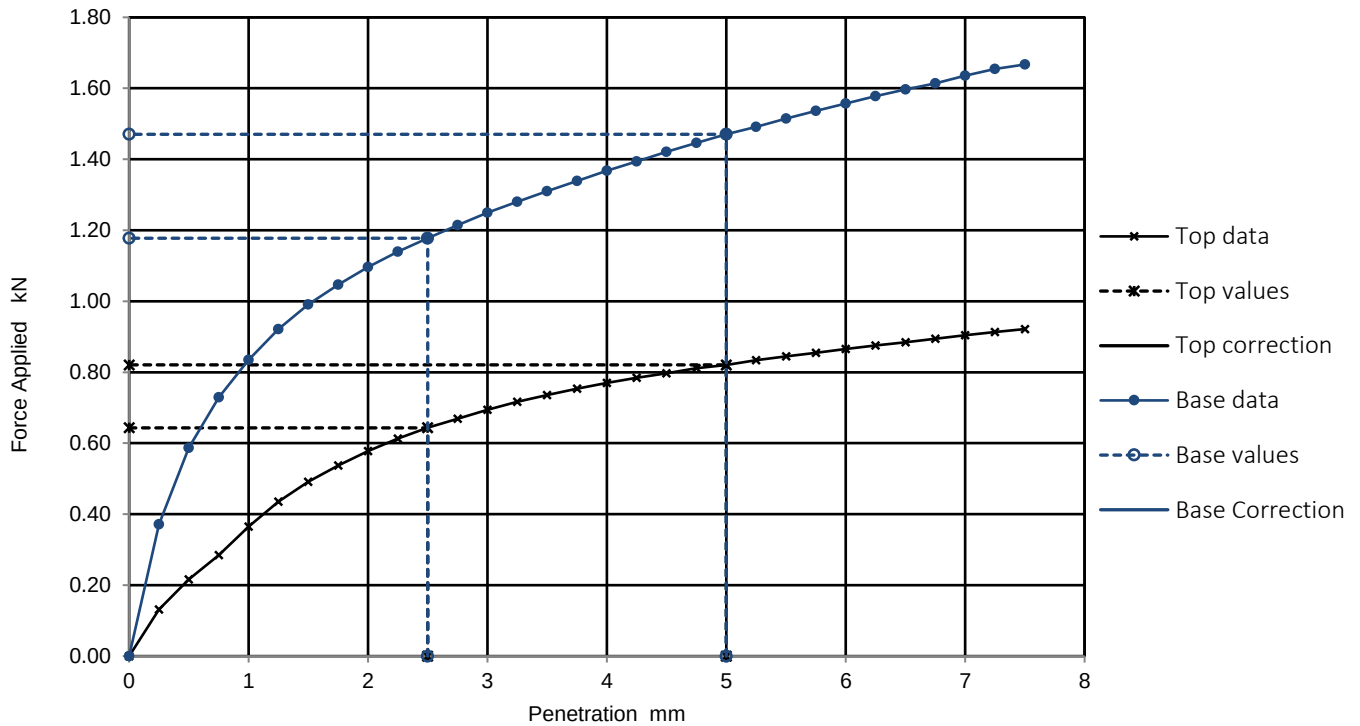
Force v Penetration Plots

Initial Specimen details Bulk density 1.90 Mg/m<sup>3</sup> Surcharge applied 6 kg  
Dry density 1.60 Mg/m<sup>3</sup> 4 kPa  
Moisture content 19 %

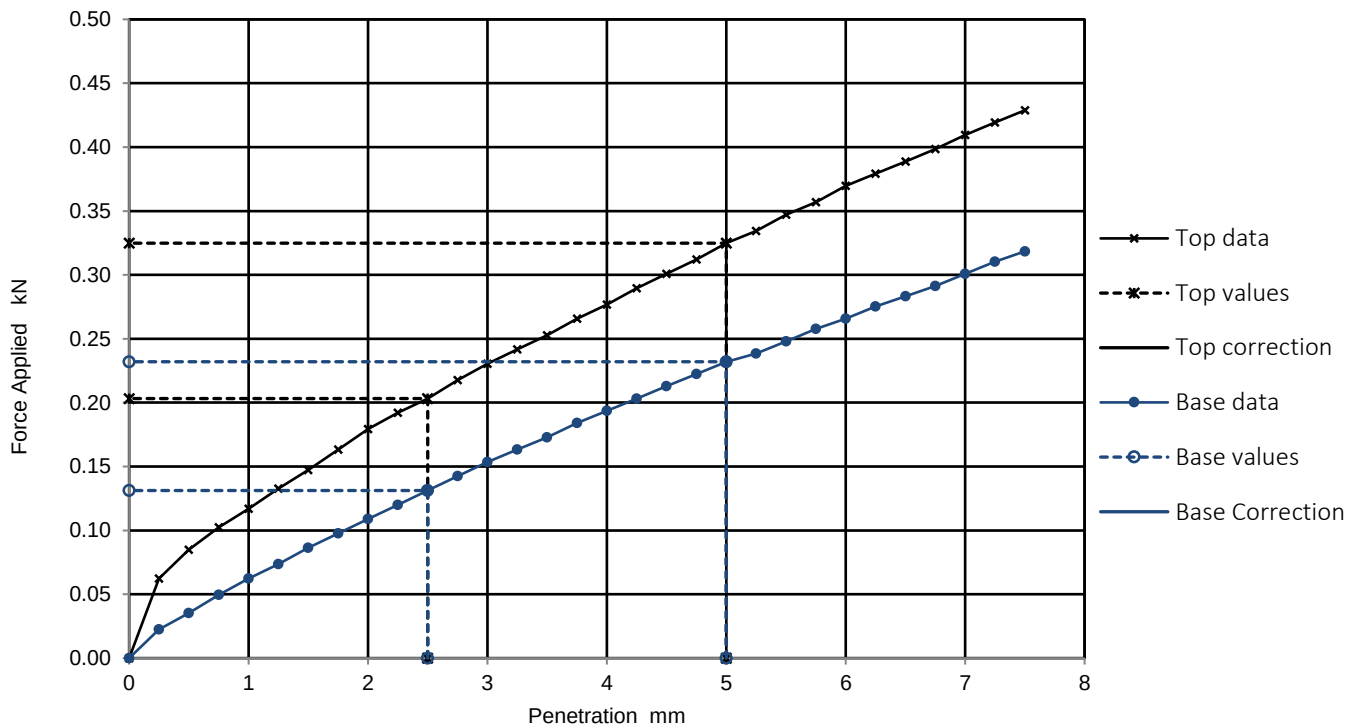
Force v Penetration Plots

Initial Specimen details Bulk density 2.00 Mg/m<sup>3</sup> Surcharge applied 6 kg  
Dry density 1.65 Mg/m<sup>3</sup> 4 kPa  
Moisture content 21 %

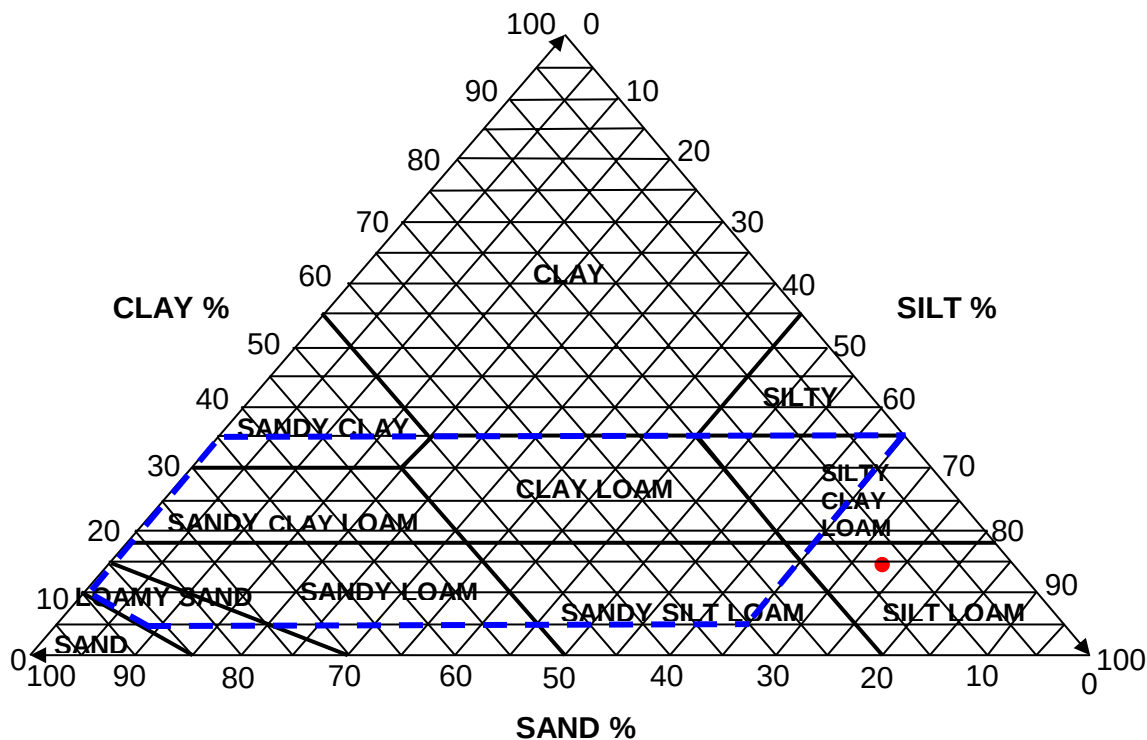
### Soil Texture Triangle

Depth Top [m]: 0.10  
Depth Base [m]: Not Given  
Sample Type: D

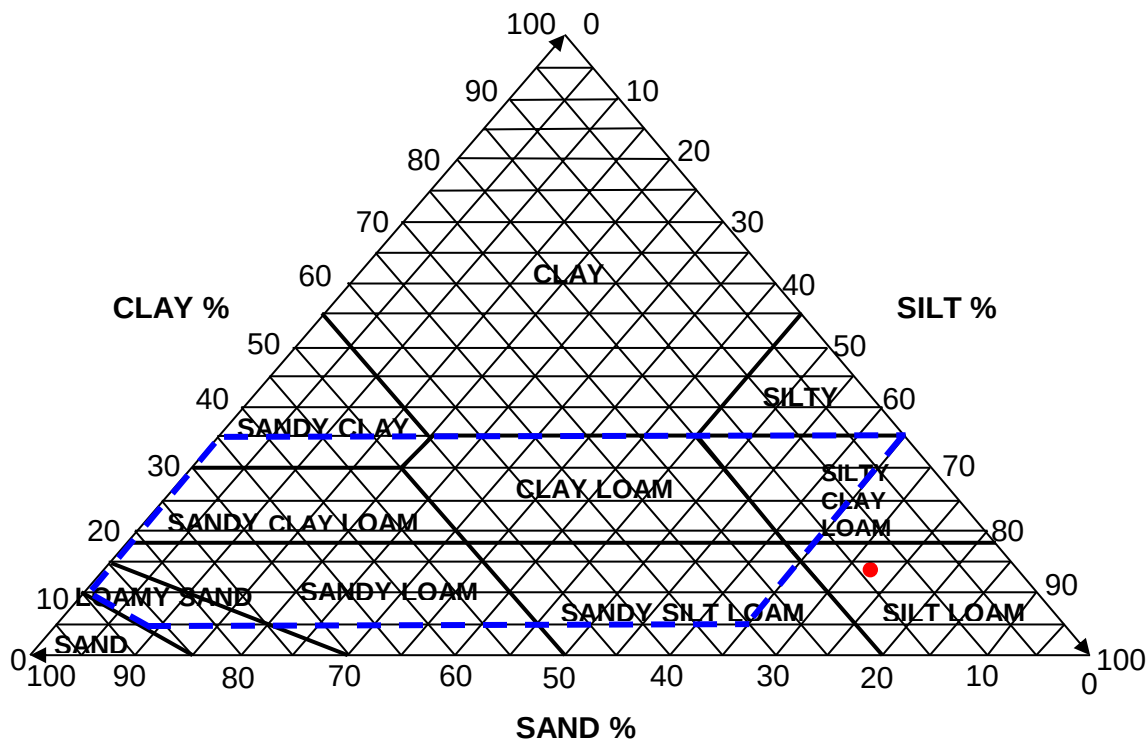
### Soil Texture Triangle

Depth Top [m]: 0.10  
Depth Base [m]: Not Given  
Sample Type: D

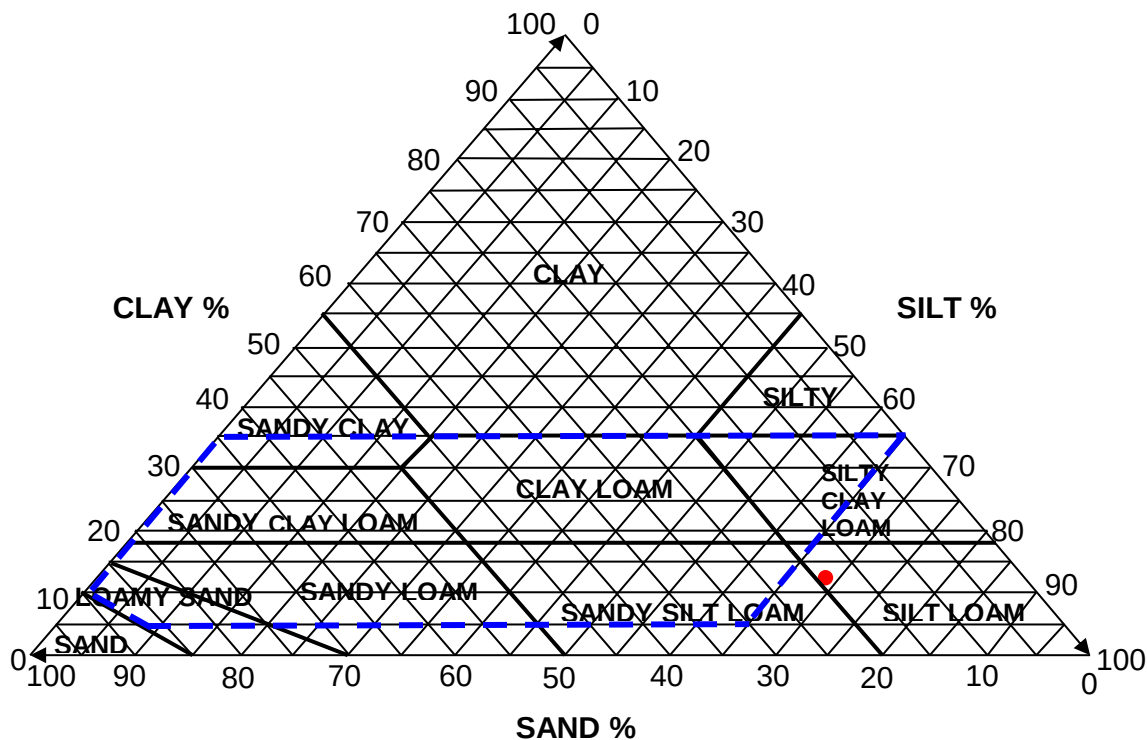
### Soil Texture Triangle

Depth Top [m]: 0.10  
Depth Base [m]: Not Given  
Sample Type: D

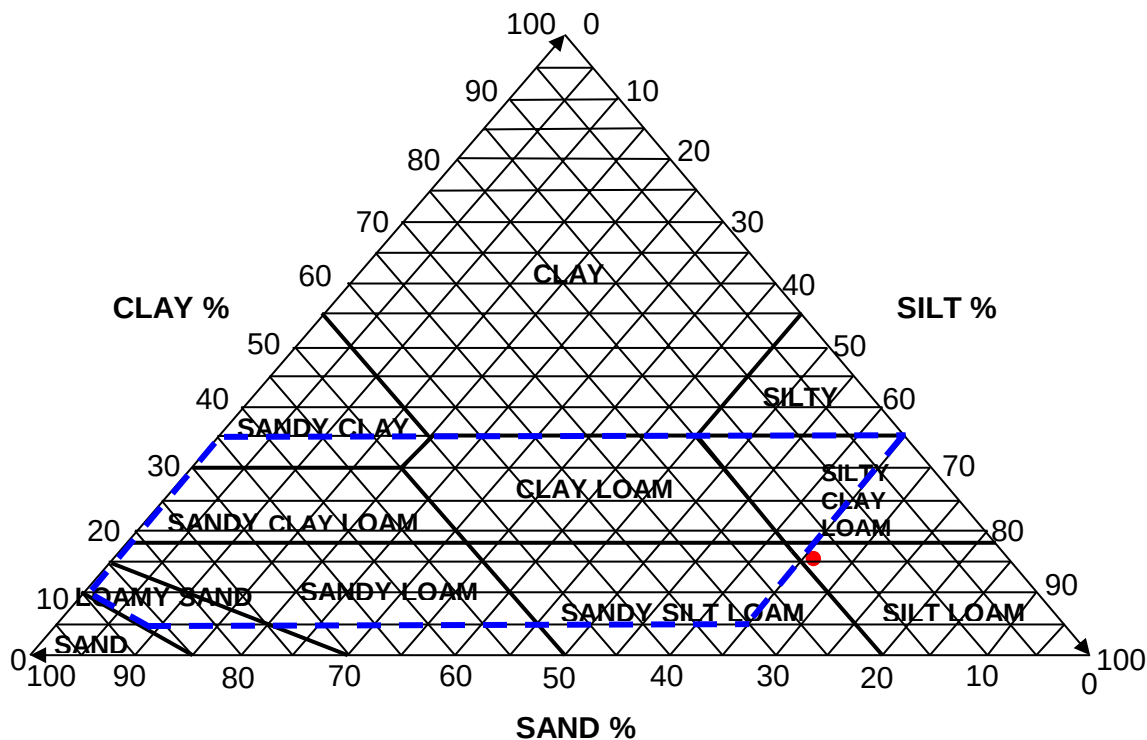
### Soil Texture Triangle

Depth Top [m]: 0.15  
Depth Base [m]: Not Given  
Sample Type: D

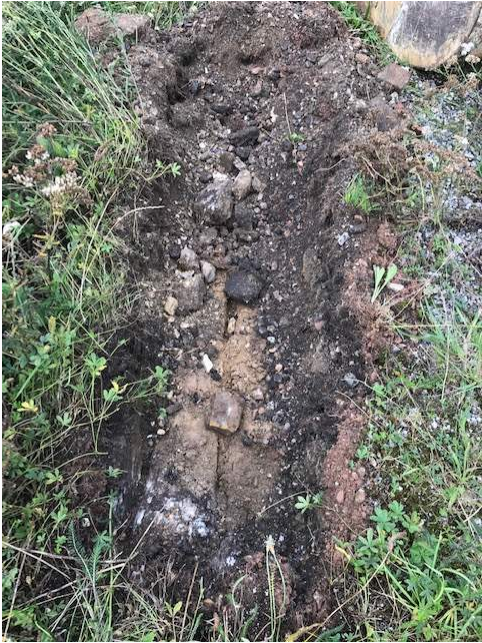
TP1

Photo of Pit

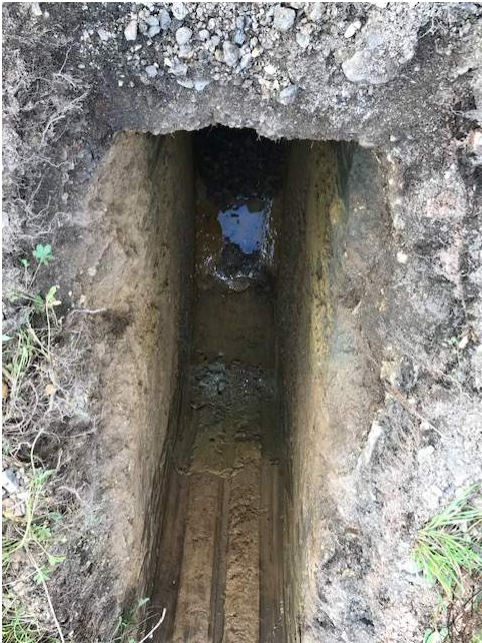
Hole ID TP2

Photo of Pit
