8<sup>th</sup> February 2017  
Our Ref: 17.9377

**Soakage Testing and Groundwater Monitoring – Woodford Farm**

| Project | WOODFORD FARM |

# Soakaway Test Results & Soil Infiltration Rate

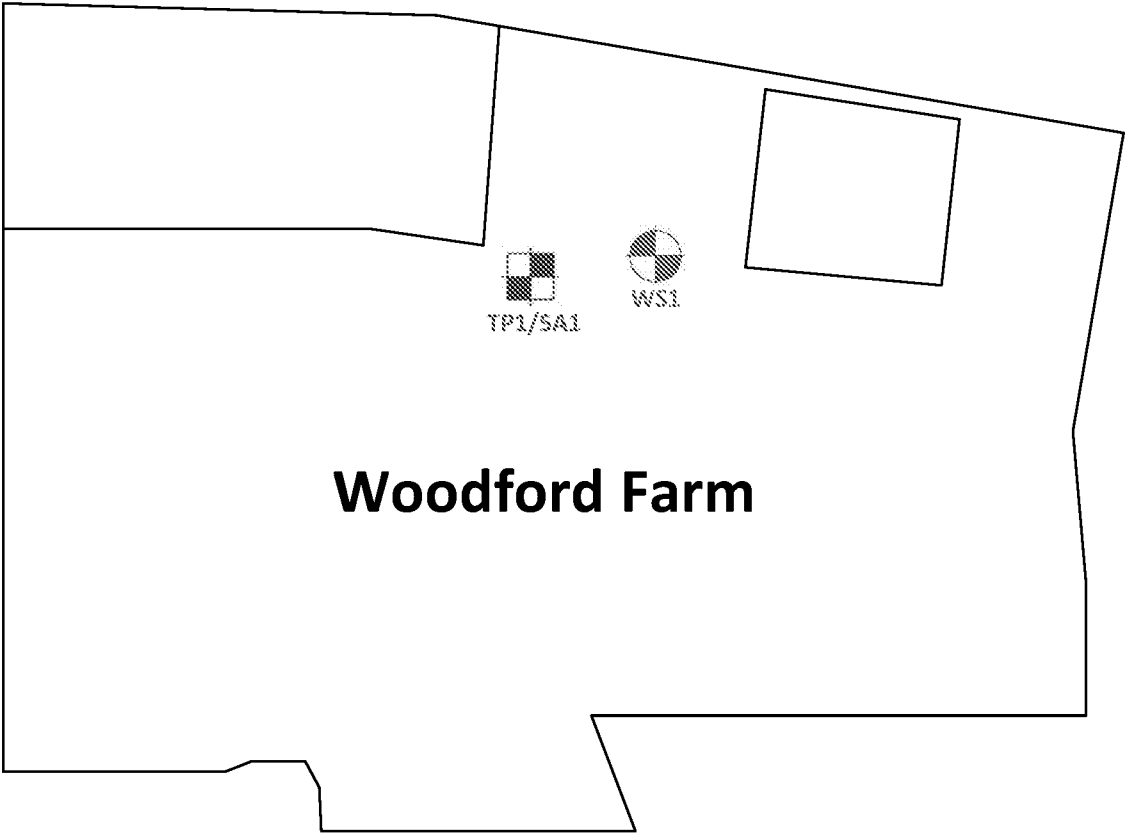
| Drawing | HOLE LOCATION<br>PLAN | Scale | A3 |

A site layout plan indicating positions of the test locations is attached.

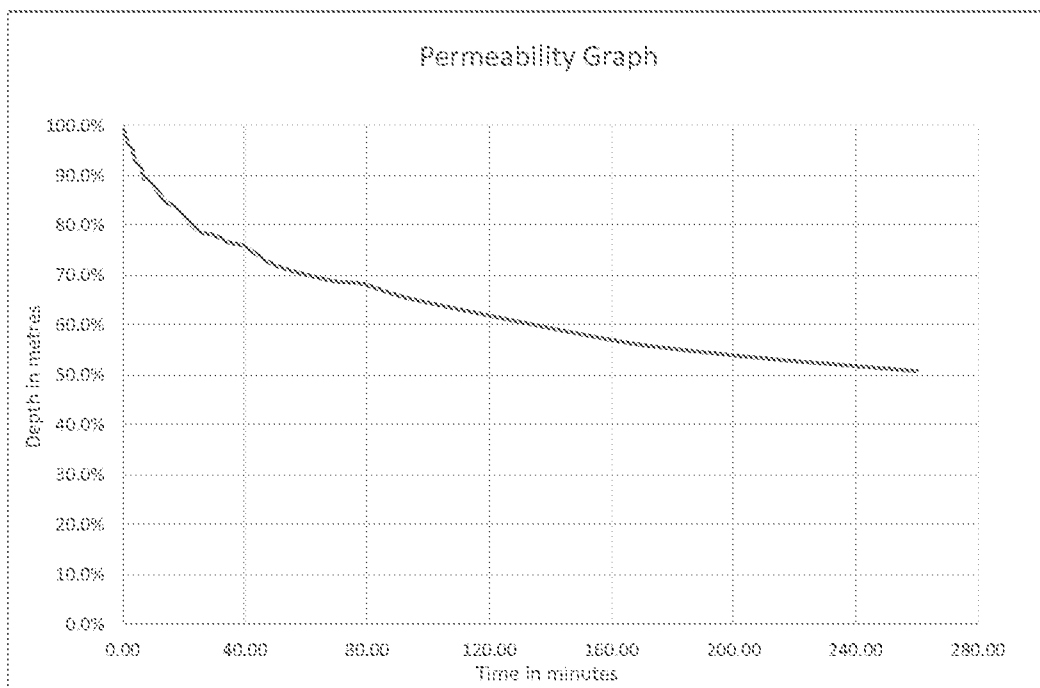
WARNING DOES NOT FALL TO 25% OF START DEPTH-Refer to graph sheet for calculation

invalid 25% and/or 75% times

not valid

| Test | Pit depth | Water Depth at Start (m) | Time at 75% (mins) | Time at 25% (mins) | Infiltration | Drainage Conditions |
|---|---|---|---|---|---|---|
| SA1 – Test 1 | 1.00 | 0.66 | 40 | N/A | † 3.14x10 <sup>-6</sup> | Poor |

† - invalid test, infiltration rate inferred.

The infiltration value was determined using an extrapolation calculation, and as such should be used with a degree of caution. Drainage conditions are derived from Soil Mechanics in Engineering Practice by Karl Terzaghi, Ralph B. Peck and Gholamreza Mesri; Table 14.1 Permeability and drainage characteristics of soils (after Casagrande and Fadum 1940).
