## **DESIGN AND ACCESS STATEMENT & HERITAGE STATEMENT**

Site Address - Aldwick Barn, Aldwick, West Sussex. PO21 3RN

Proposal - Remedial Works & Refurbishment

Date - November 2025

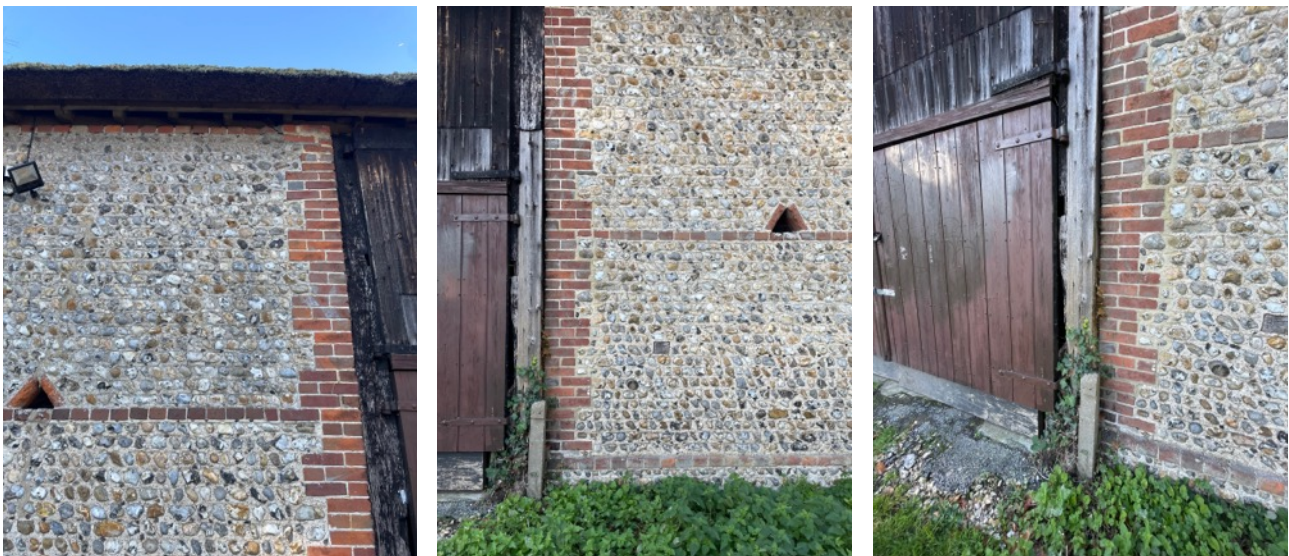
Minor areas of external walling require modest and localised stitching & lime repair works. Where required, reclaimed brick & stone is to be used.

fig 2-4 Localised areas requiring minor repairs.

Newly introduced brick & stone is to be set onto hydraulic-lime bed, and pointed with a soft / textured lime (colour to match existing as close as practically possible).

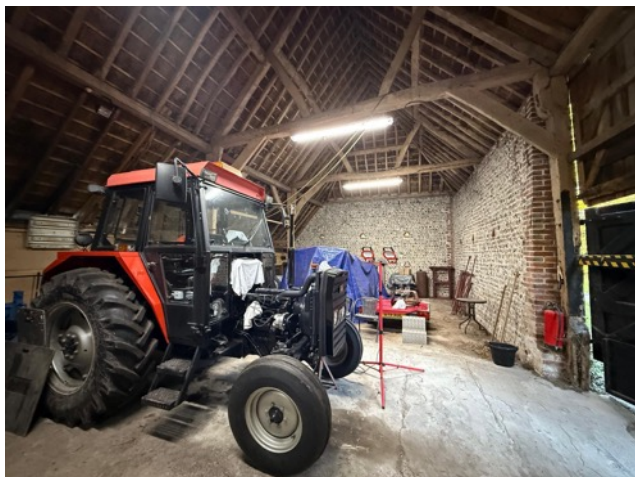
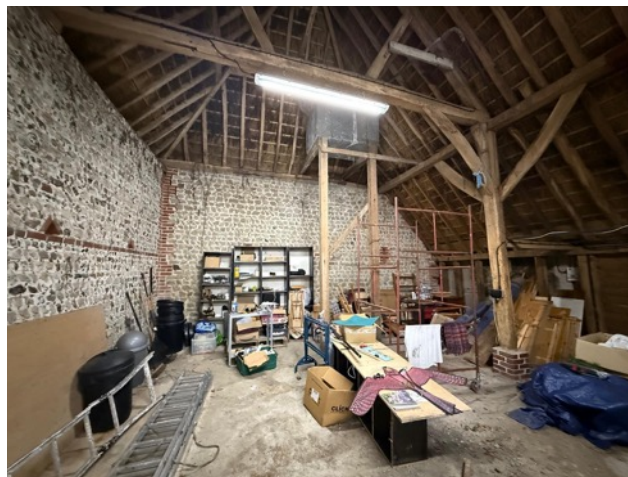
Careful removal of existing concrete floor. Prior to commencement a localised section of the floor at the perimeter will be removed to ascertain thickness and relationship to existing external wall / foundation.

fig 5-6 Barn interior.

A structural engineer will advise as to sequential removal of the floor and any temporary support works required, to avoid undermining, or having an adverse affect on the overall stability of the building. Once confirmed, and in association with, the existing concert floor is be removed leaving level clean, compacted ground as a base for a heated / insulated limecrete floor system.

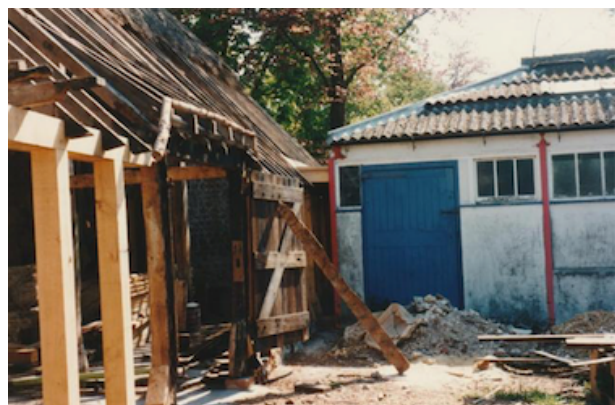
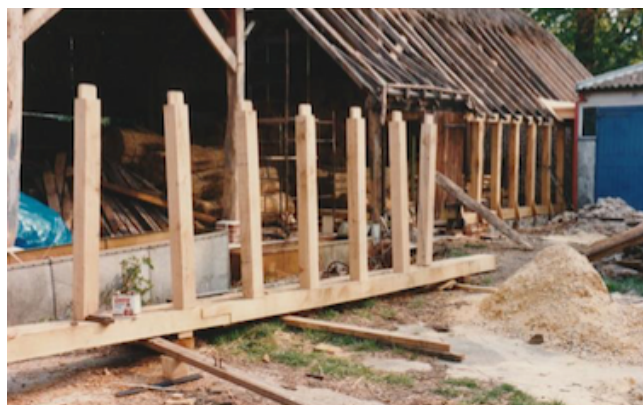
fig 7-8 Previous replacement of rear timber frame wall.

It should be noted that the existing rear timber frame wall element is not considered historic fabric. This element was replaced prior to the applicant's ownership.

As part of the applicants future planned works, the dairy building abutment / flashing connection to the rear / SW corner, is an unsuccessful abutment detail with the barn. In anticipation of this, it is proposed that the replacement thatched roof be introduced with a slightly raised eyebrow detail over this element, in order to afford greater flexibility for a robust dairy building roof to barn link detail element. In order to do this, a small section of the timber frame wall within will need to be removed and re-supported. As non-historic fabric it is considered that this could be justified.

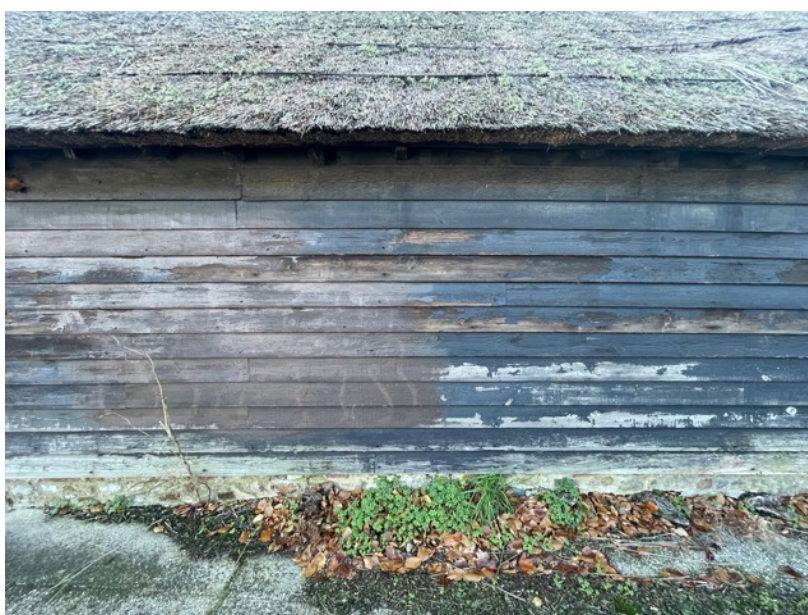
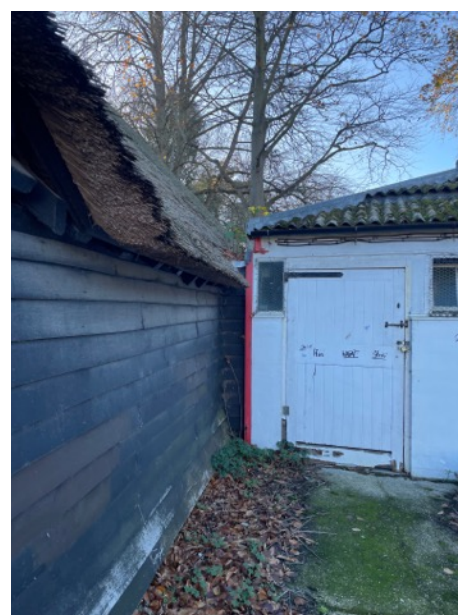
Reiterating the existing rear timber frame wall element is not considered historic fabric, the existing wall is proposed as being insulated with a breathable system and re-plastered internally using lime.

fig 9-10 Existing timber frame wall / weatherboarding.

This is expected to necessitate removal and replacement of the existing timber weatherboarding with new timber boards (sample / details to be provide to the LPA) prior to commencement of works.

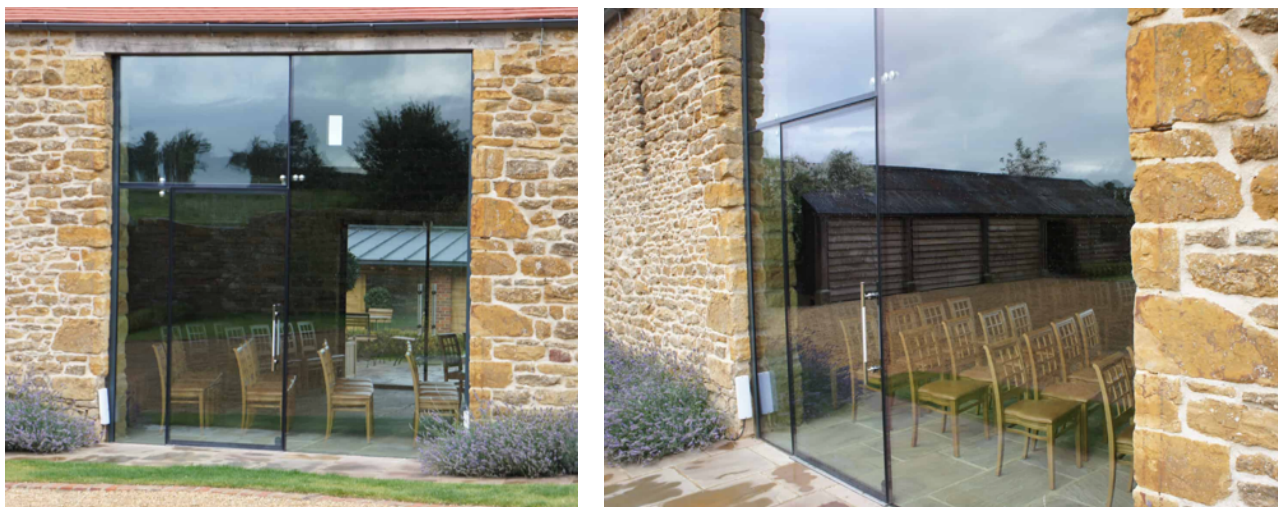
Designed to improved security and thermal performance of the building, glazed doors are proposed as being introduced, set behind and leaving the existing outer timber doors in place.

fig 11-12 Proposed internal doors.

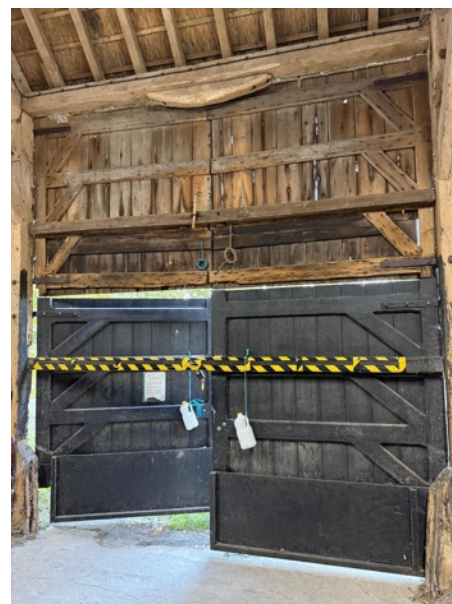
fig 14 Existing barn doors (SE elevation)

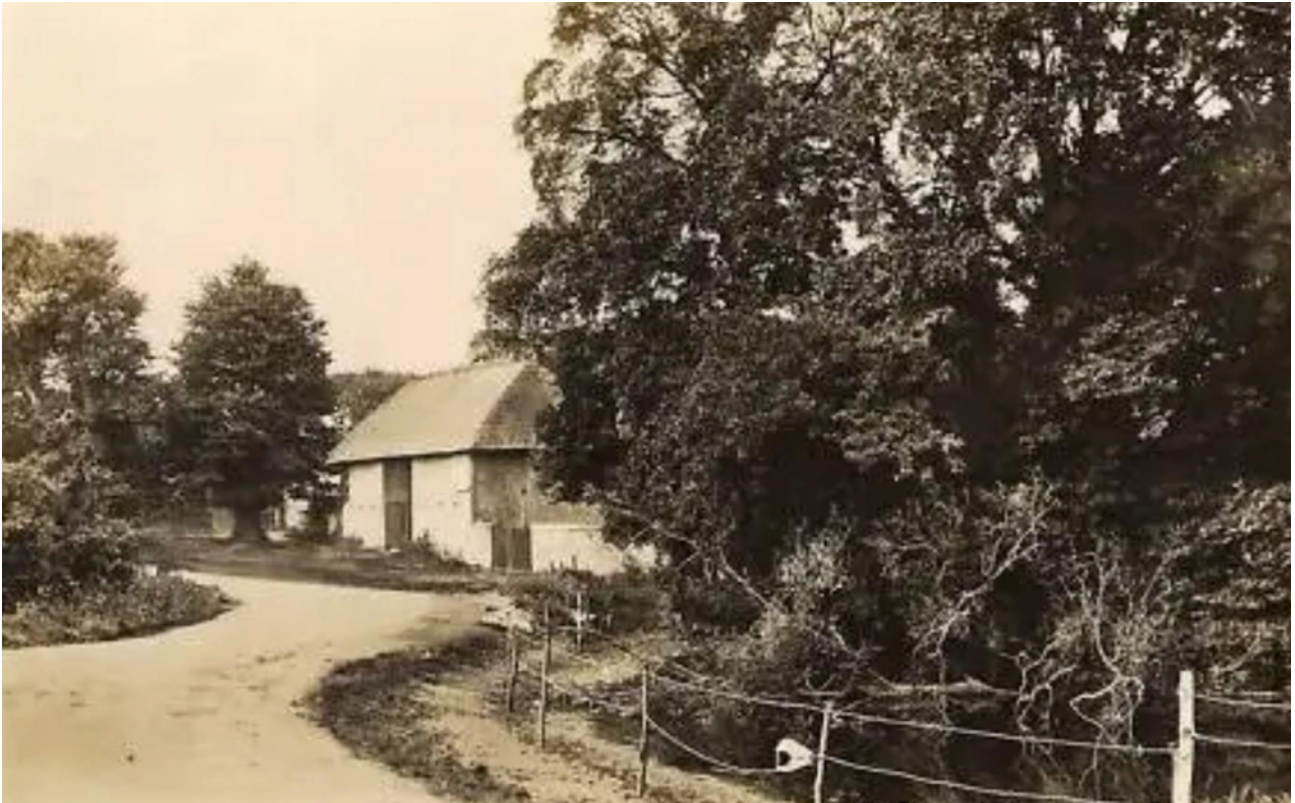
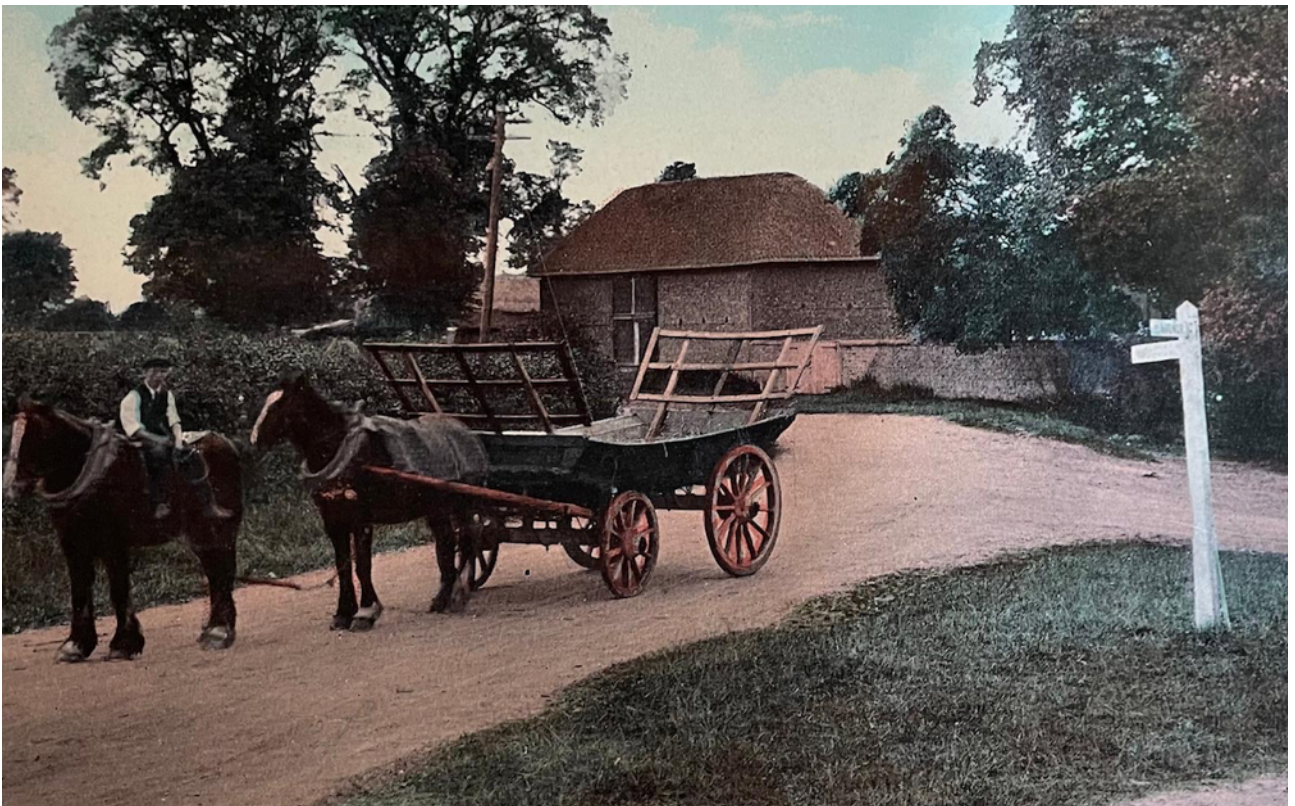
Historic photographs supplied by the applicant; for LPA reference-use regarding historic thatched roof ridge detail.

Replacement thatched roof to master-thatcher specification; to include simplified ridge detail akin to historic photographs.
