# **DESIGN AND ACCESS STATEMENT**

**PREPARED BY SUSSEX BUILDING CONSULTANCY  
LIMITED ON BEHALF OF MR AND MRS HIGHWOOD**

**NEW LIME RENDER WALL COATING  
TO FLANK WALL TO PREVENT DAMP  
INGRESS.**

**SITE AT  
SADDLERS, HIGH STREET, ANGMERING.**

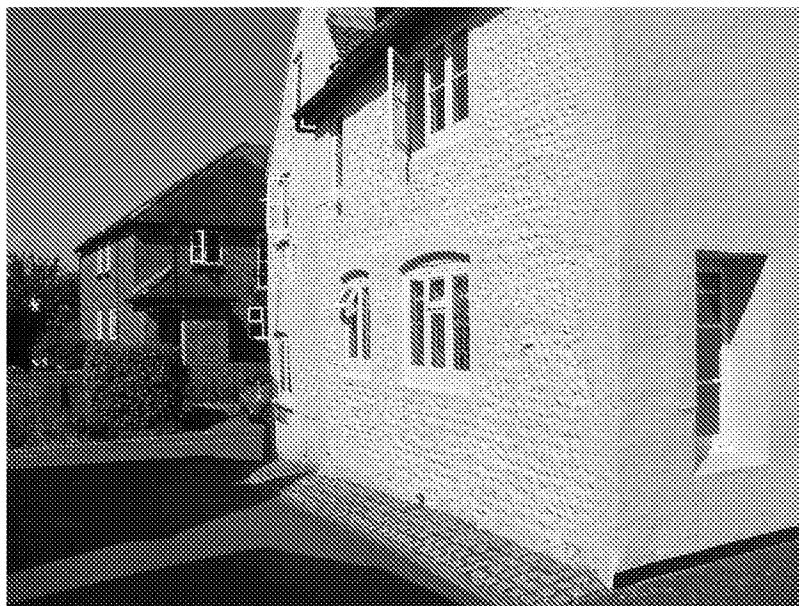
Photo – Side elevation fronting The Cottrells.

1.2 The accommodation is set across three floors with the top floor set within the roof space. The front elevation is an attractive frontage with painted brick and flint walls and a mixture of casement and sliding sash timber windows. To the side fronting The Cottrells, the wall finish is similar and to the rear the walls have been rendered at some point and painted in the same colour. The pitched roofs are plain clay tile covered.

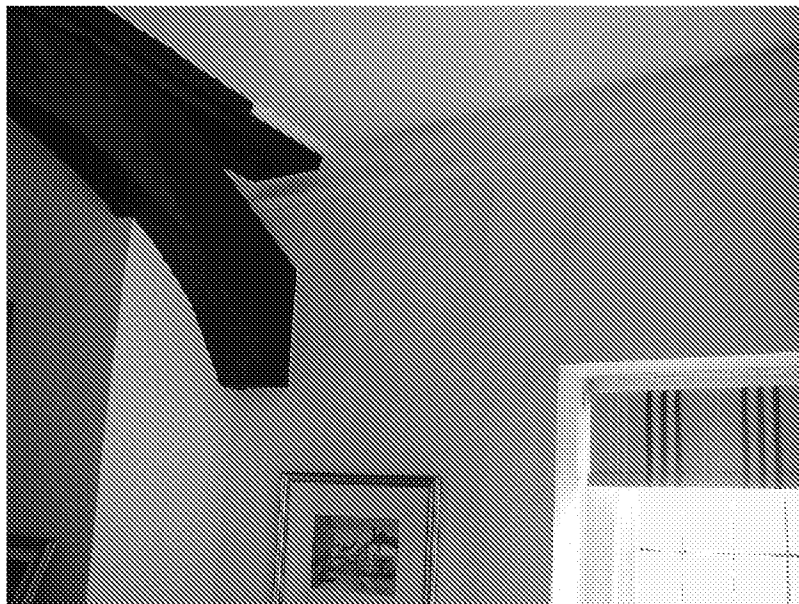
Photo – Damp ingress stains to internal wall (taken July 2015).

3.1 The property has been suffering with damp ingress for a while now and the applicants need to provide measures to prevent this as internal decoration, furniture and clothes have suffered accordingly.

3.2 The walls are solid construction and the external paint has been ineffectual in preventing the passage of damp party due to the fact that parts of the wall are chalk blockwork which has acted as a sponge and exhibits damp even in the dry summer season.

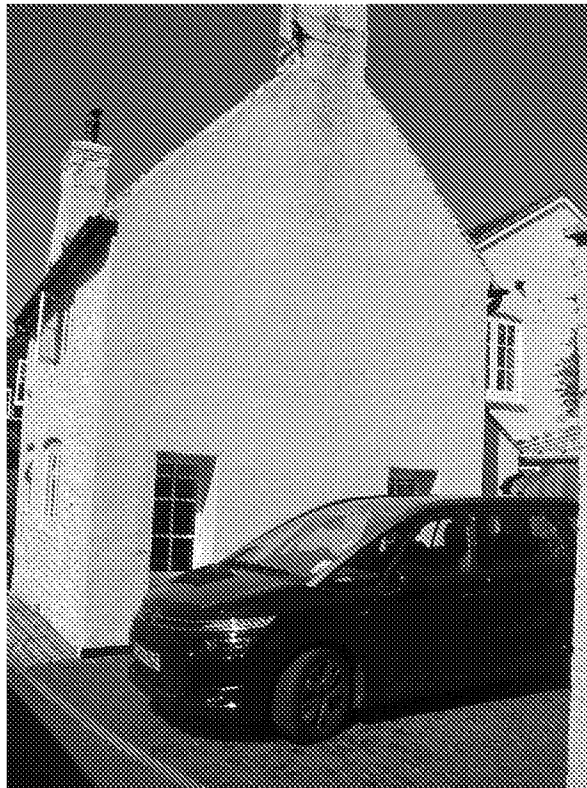
Photo – Rear elevation of 'Saddlers' showing the rendered wall finish.

2.3 The applicants seek to provide a lime rendered coating to the flank wall to match with the rear wall rendered covering, this will provide a weatherproof envelope whilst still allowing the building to breathe and move.

4.1 Many of the walls of other buildings in the local area have similar painted rendered finish. The rear elevation of 'Saddlers' has been treated in the past presumably because of similar weathering reasons and this wall exhibits no damp issues.
