## **Sussex Lime Plastering**

### Method Statement for Church House, Arundel Road, Angmering

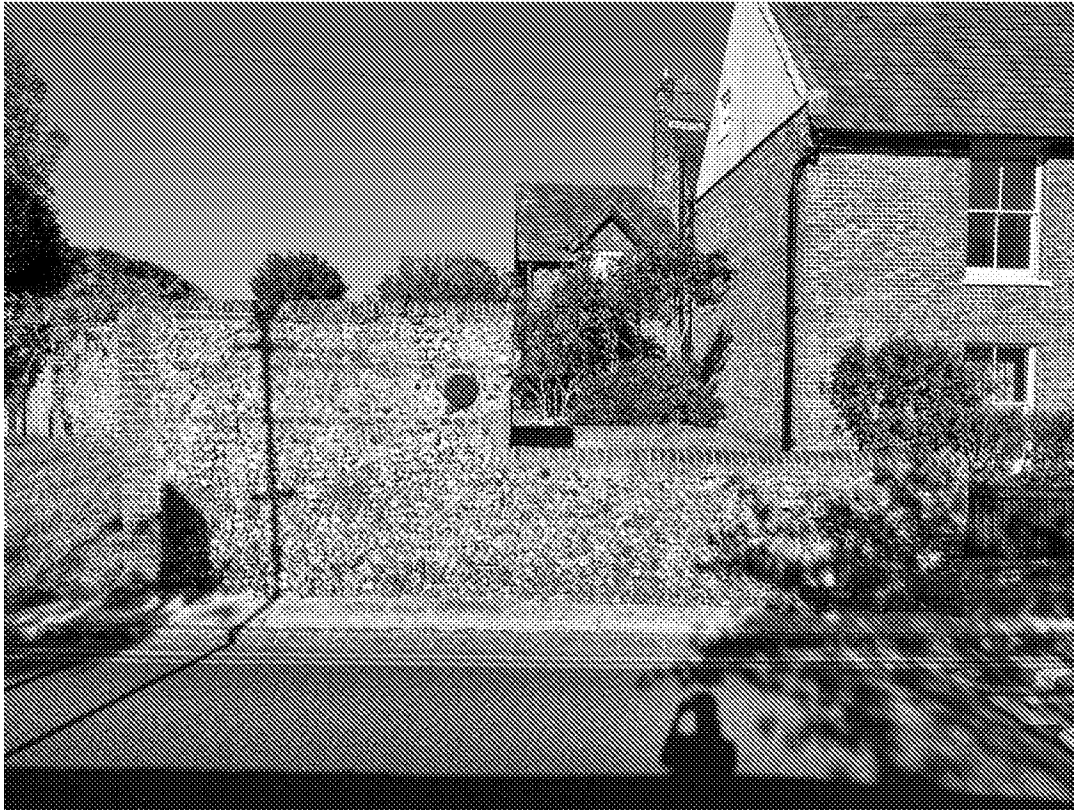
The length of flint wall along the western boundary.

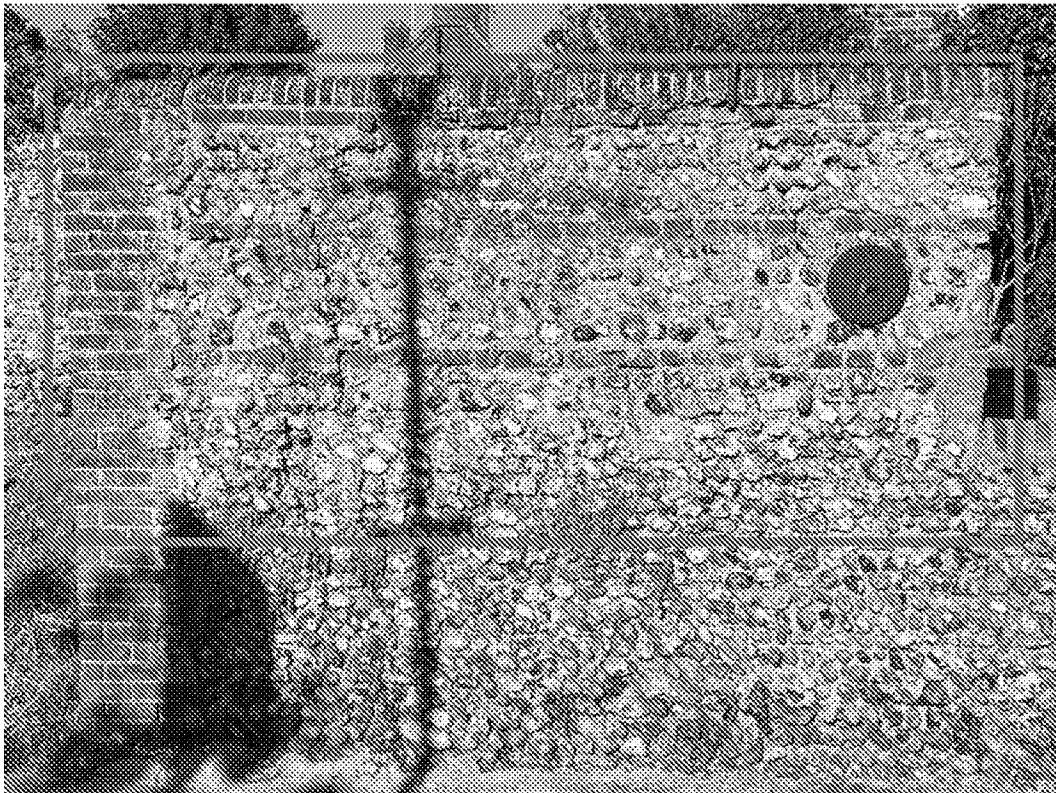
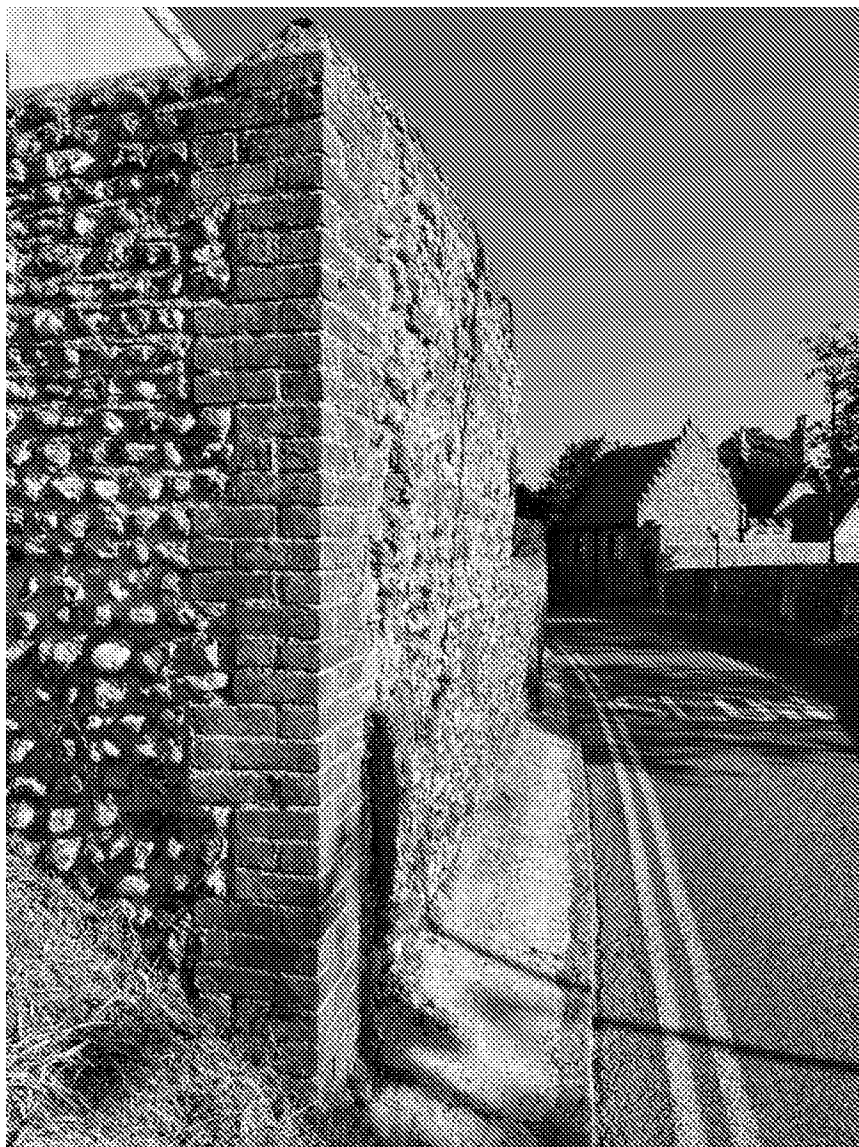
The section of flint wall to be re-built.

Taking down and rebuilding the garden wall which runs along Arundel Road, due to an excessive lean towards the road. This will be done primarily with hand tools but not excluding some power tools. Removal of the capping bricks will be done in such a way that minimal damage is caused to the original brick so they can be used once again. All flints will be cleaned of mortar and kept as to use all original flints in the rebuild.

The wall will be reinstated to the existing height and width, any bricks that need to be replaced will be done so with an appropriate reclaimed brick. The patress plate will also be reinstated in its original position.
