### **Geotechnical Reports**

Our ref: GE9623/JUNE14/GWM/AP1

### **LAND OFF MILL LANE, RUSTINGTON – GROUNDWATER MONITORING**

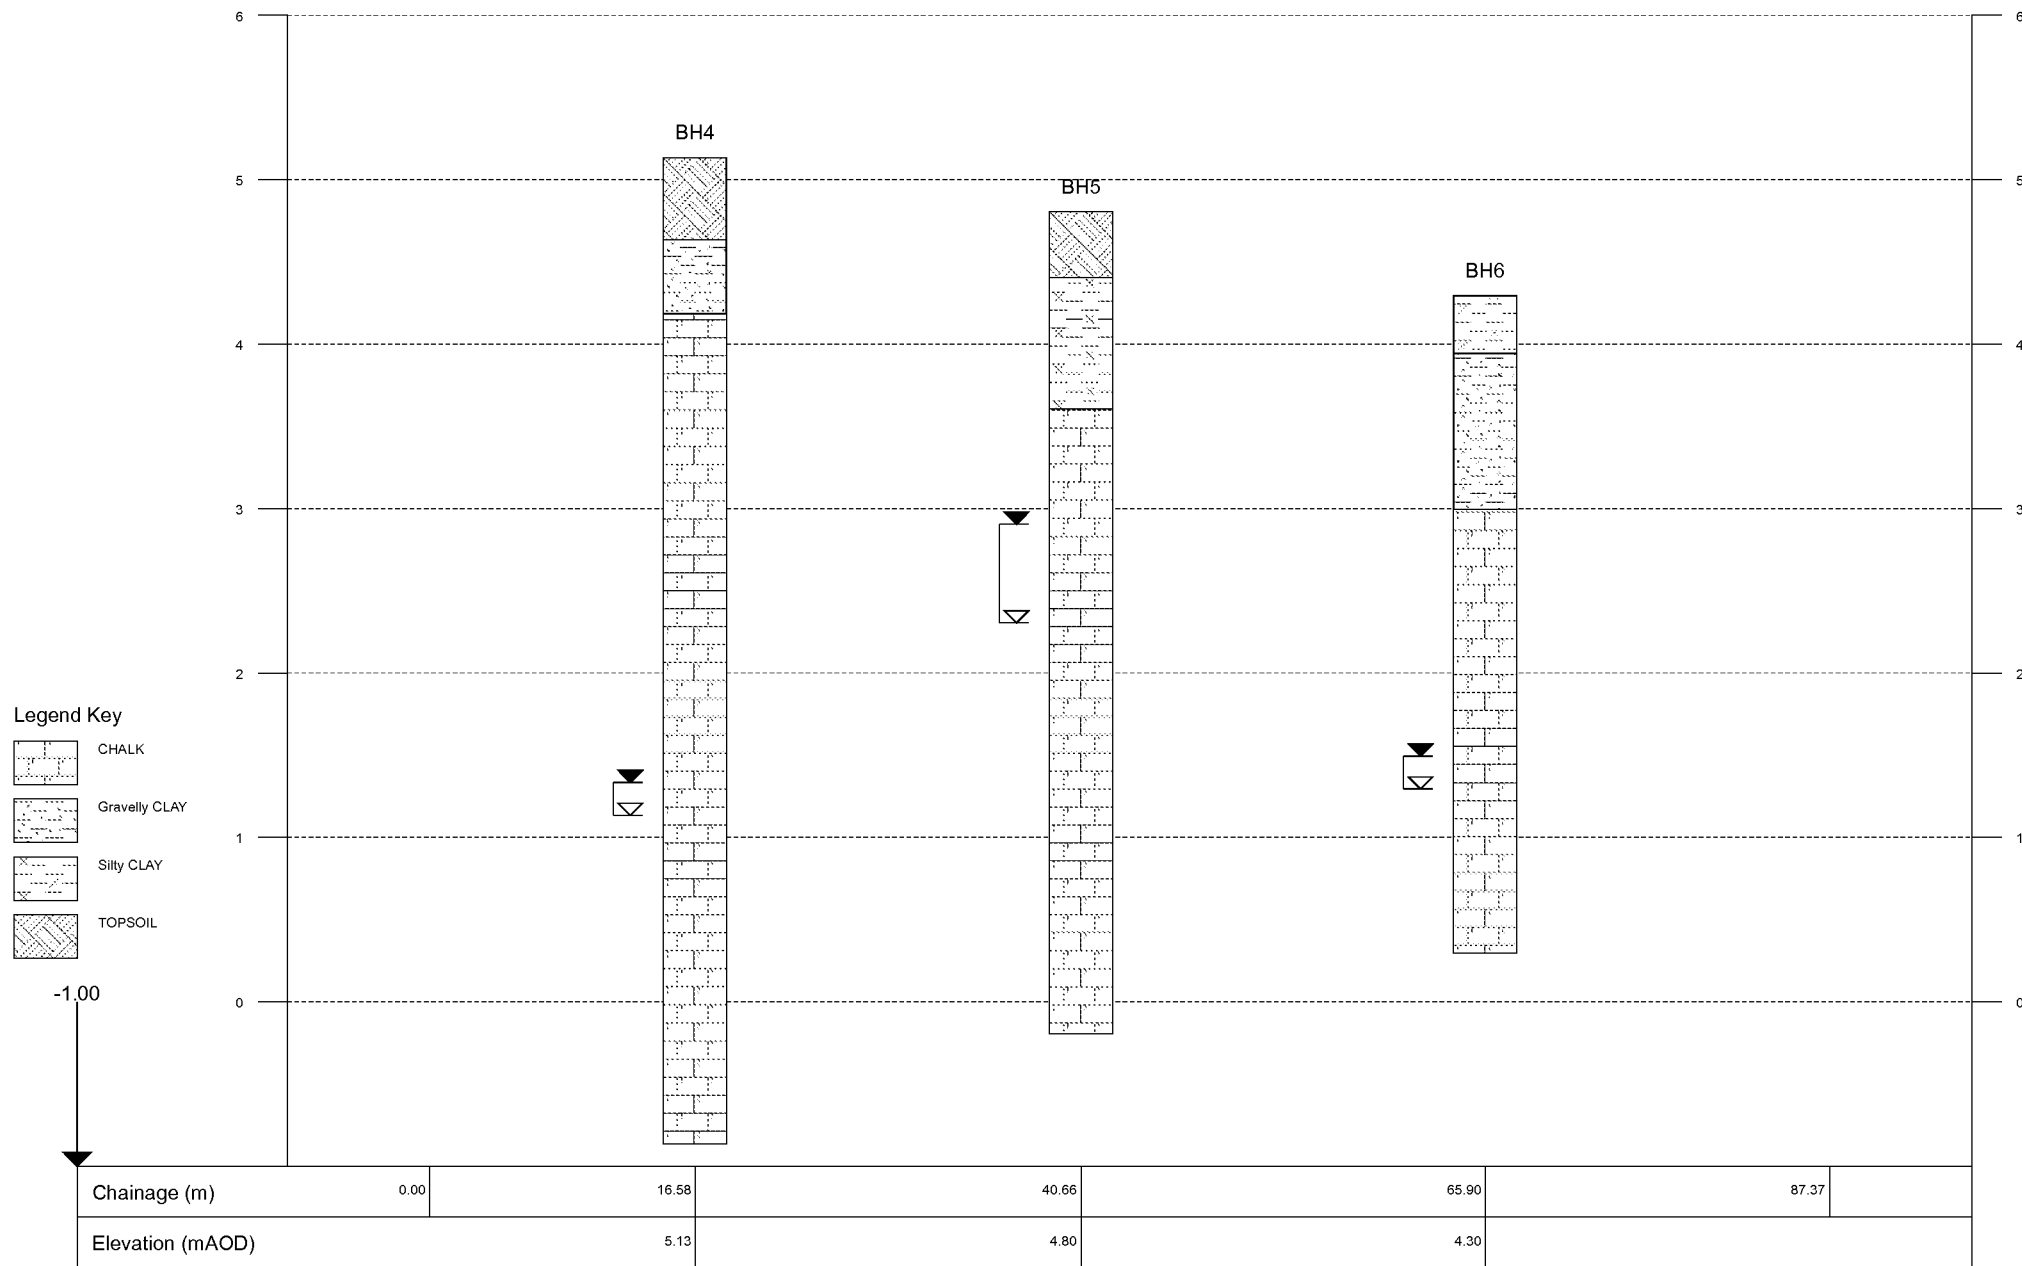
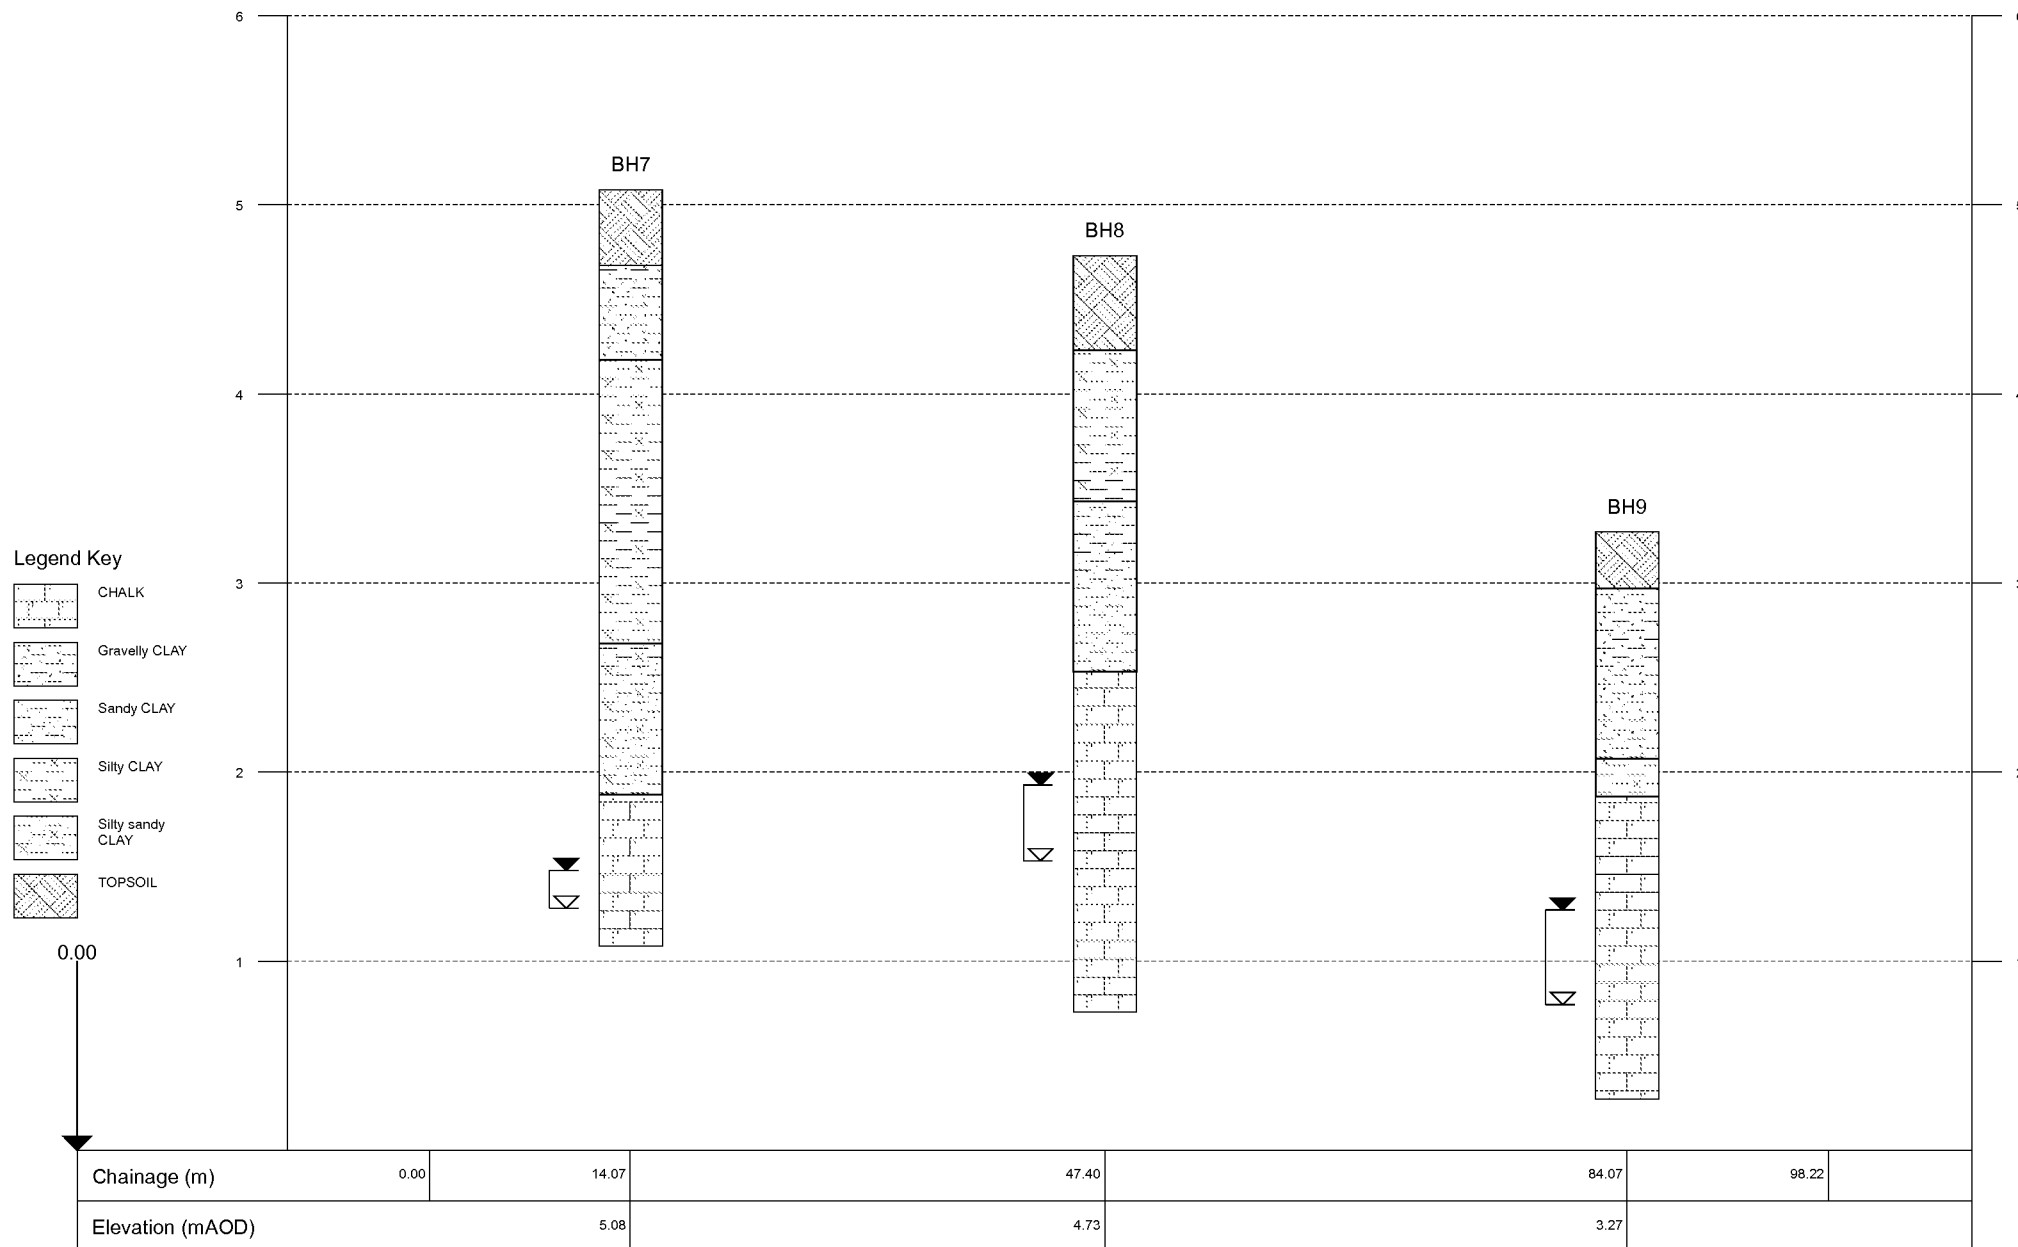
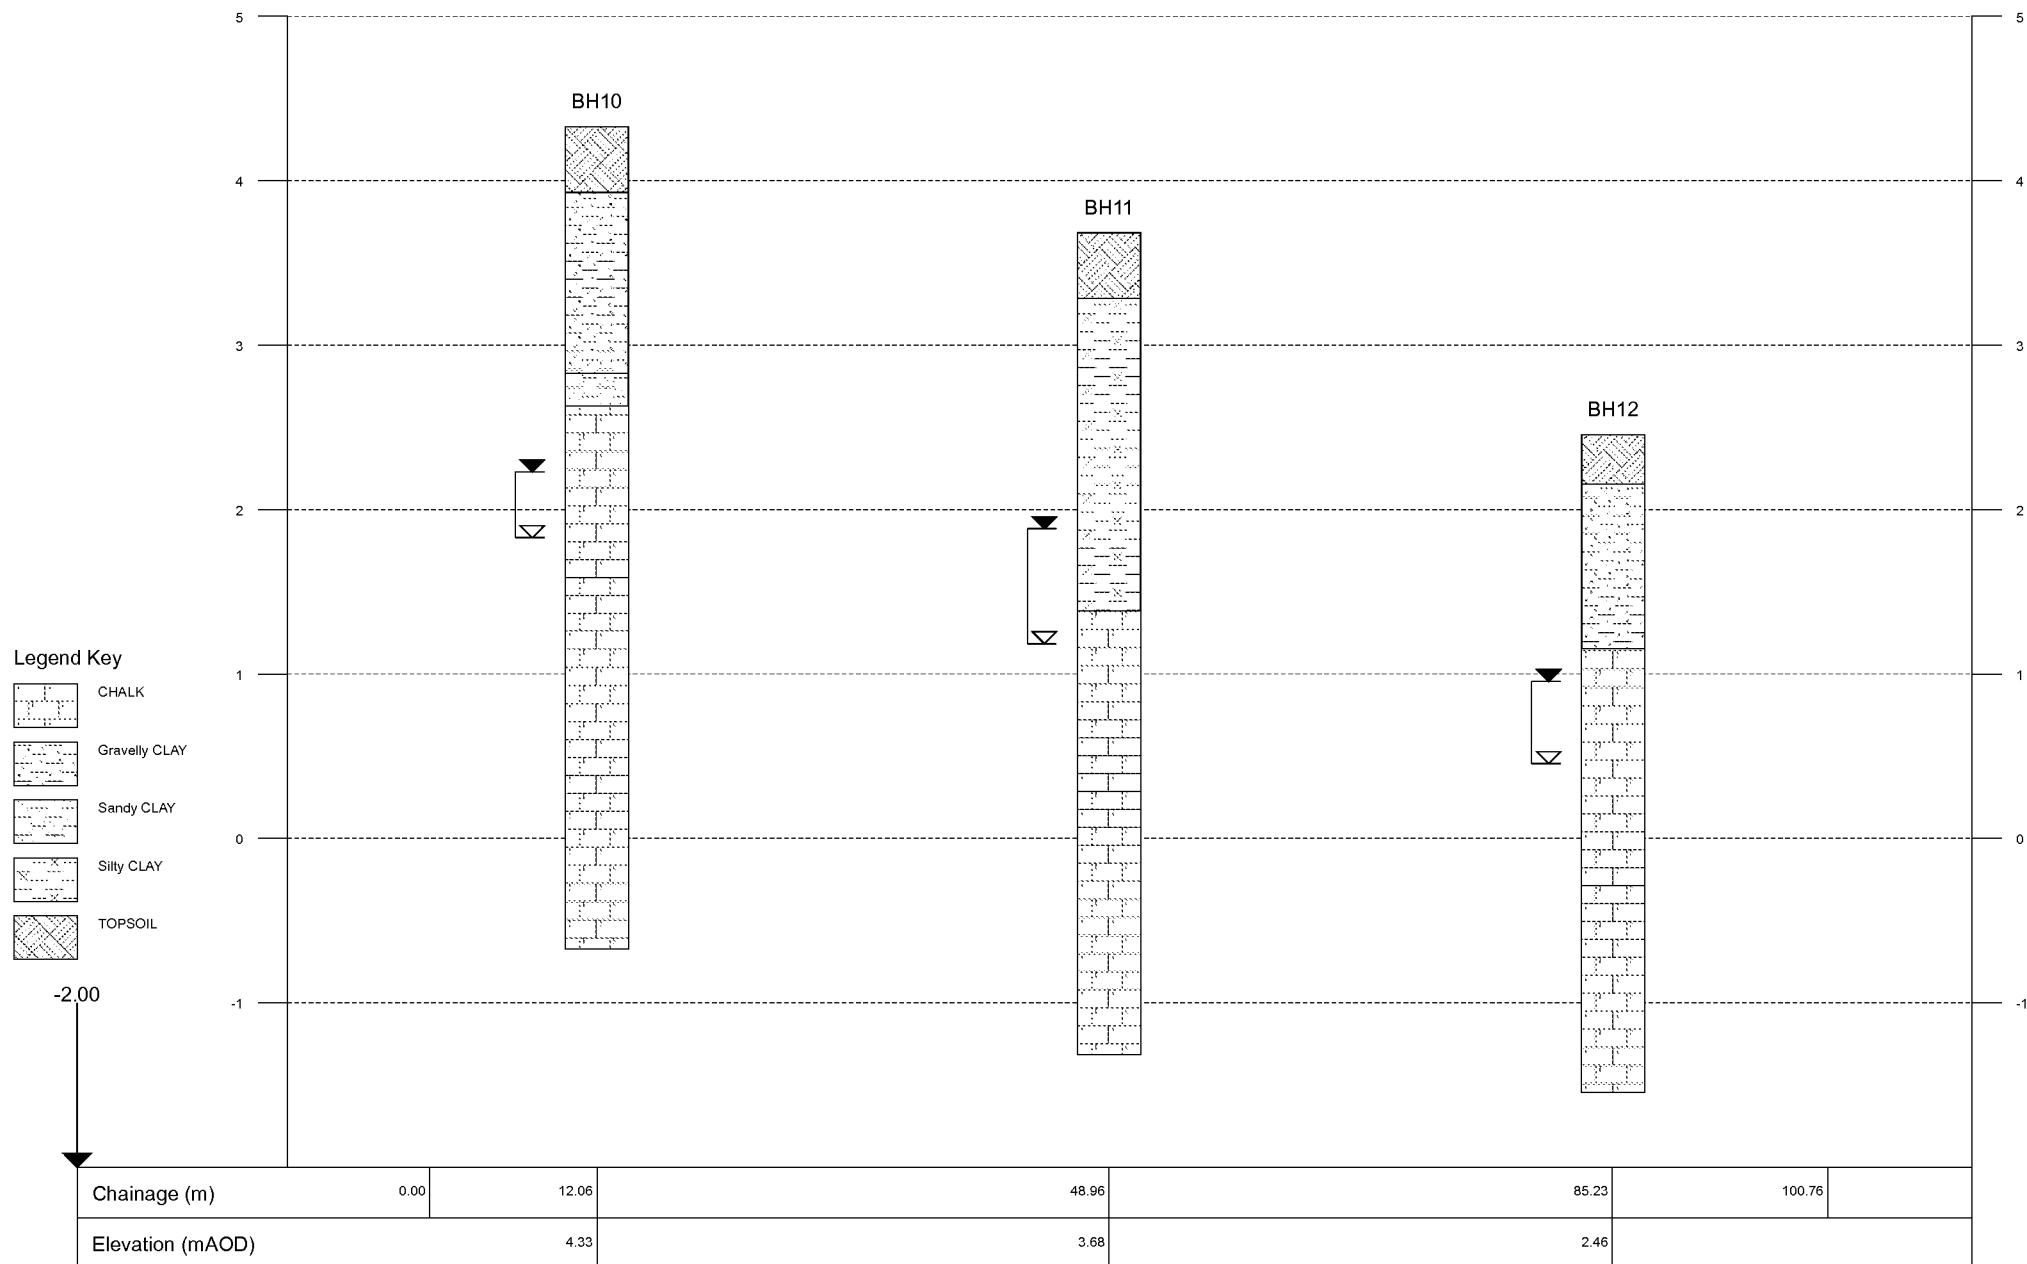
For further details of changes in groundwater levels, a graph of the monthly recordings and section drawings of the boreholes are appended.
