## **Appendix 1**

### **Geotechnical Reports**

### **LAND OFF MILL LANE, RUSTINGTON – GROUNDWATER MONITORING**

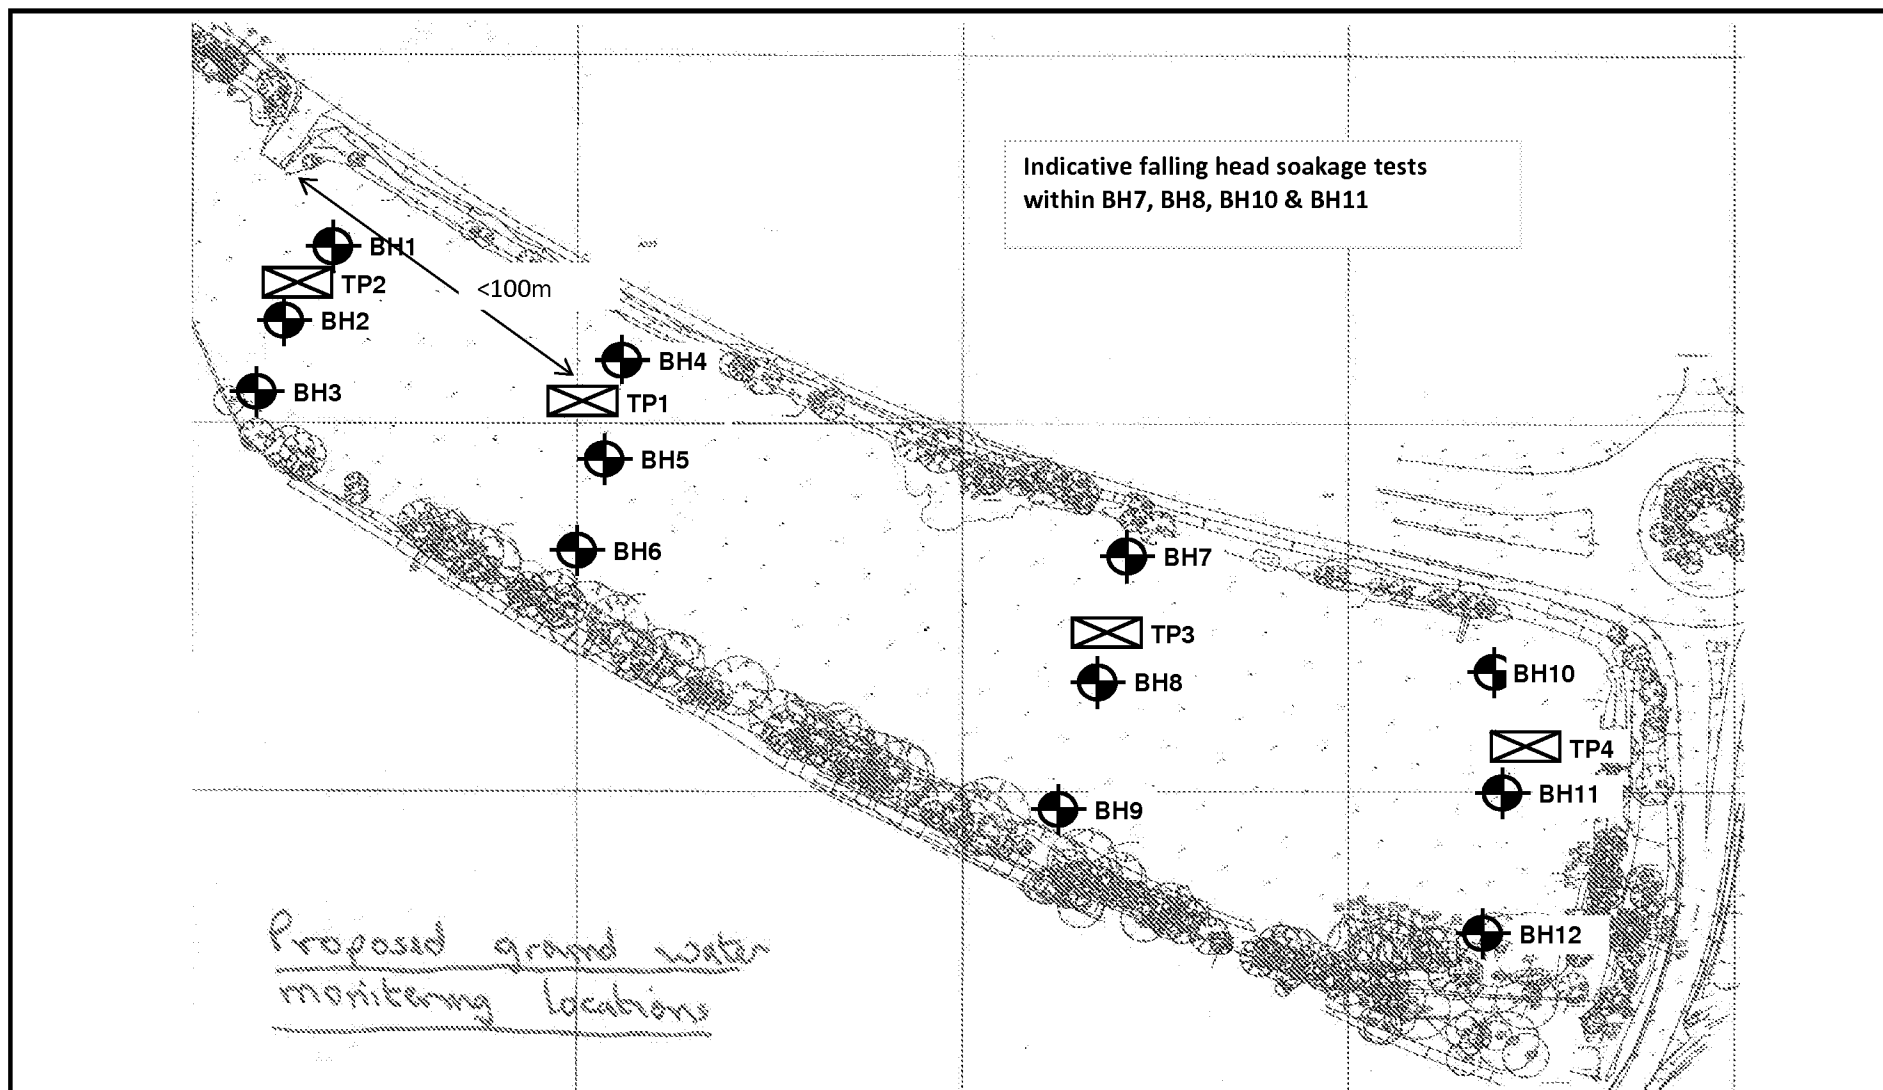
| <b>Figure:</b> 1 | <b>Scale:</b> Not To Scale | | |

Four indicative falling head soakage tests were undertaken within the existing monitoring wells referenced BH7, BH8, BH10 and BH11 in the eastern portion of the site (see figure 1). A total of 25l of water was added to each of the boreholes, however due to high infiltration rate it was not possible to raise the head more than 0.04m above the groundwater level. Water levels in all of the boreholes returned to their original level within 1 minute of water input.

| <b>Project:</b> Mill Lane, Rustington | | <b>Title</b> Monitoring Wells Location Plan | |

Geo-Environmental were requested to attend site and install twelve monitoring wells in predetermined locations at the above named site. The purpose of installing monitoring wells across the site was to determine groundwater depths and flow so that some form of drainage strategy could be designed by the client's engineers. In addition, full scale soakage testing were undertaken within the northern portion of the site, the results of these tests are reported below.

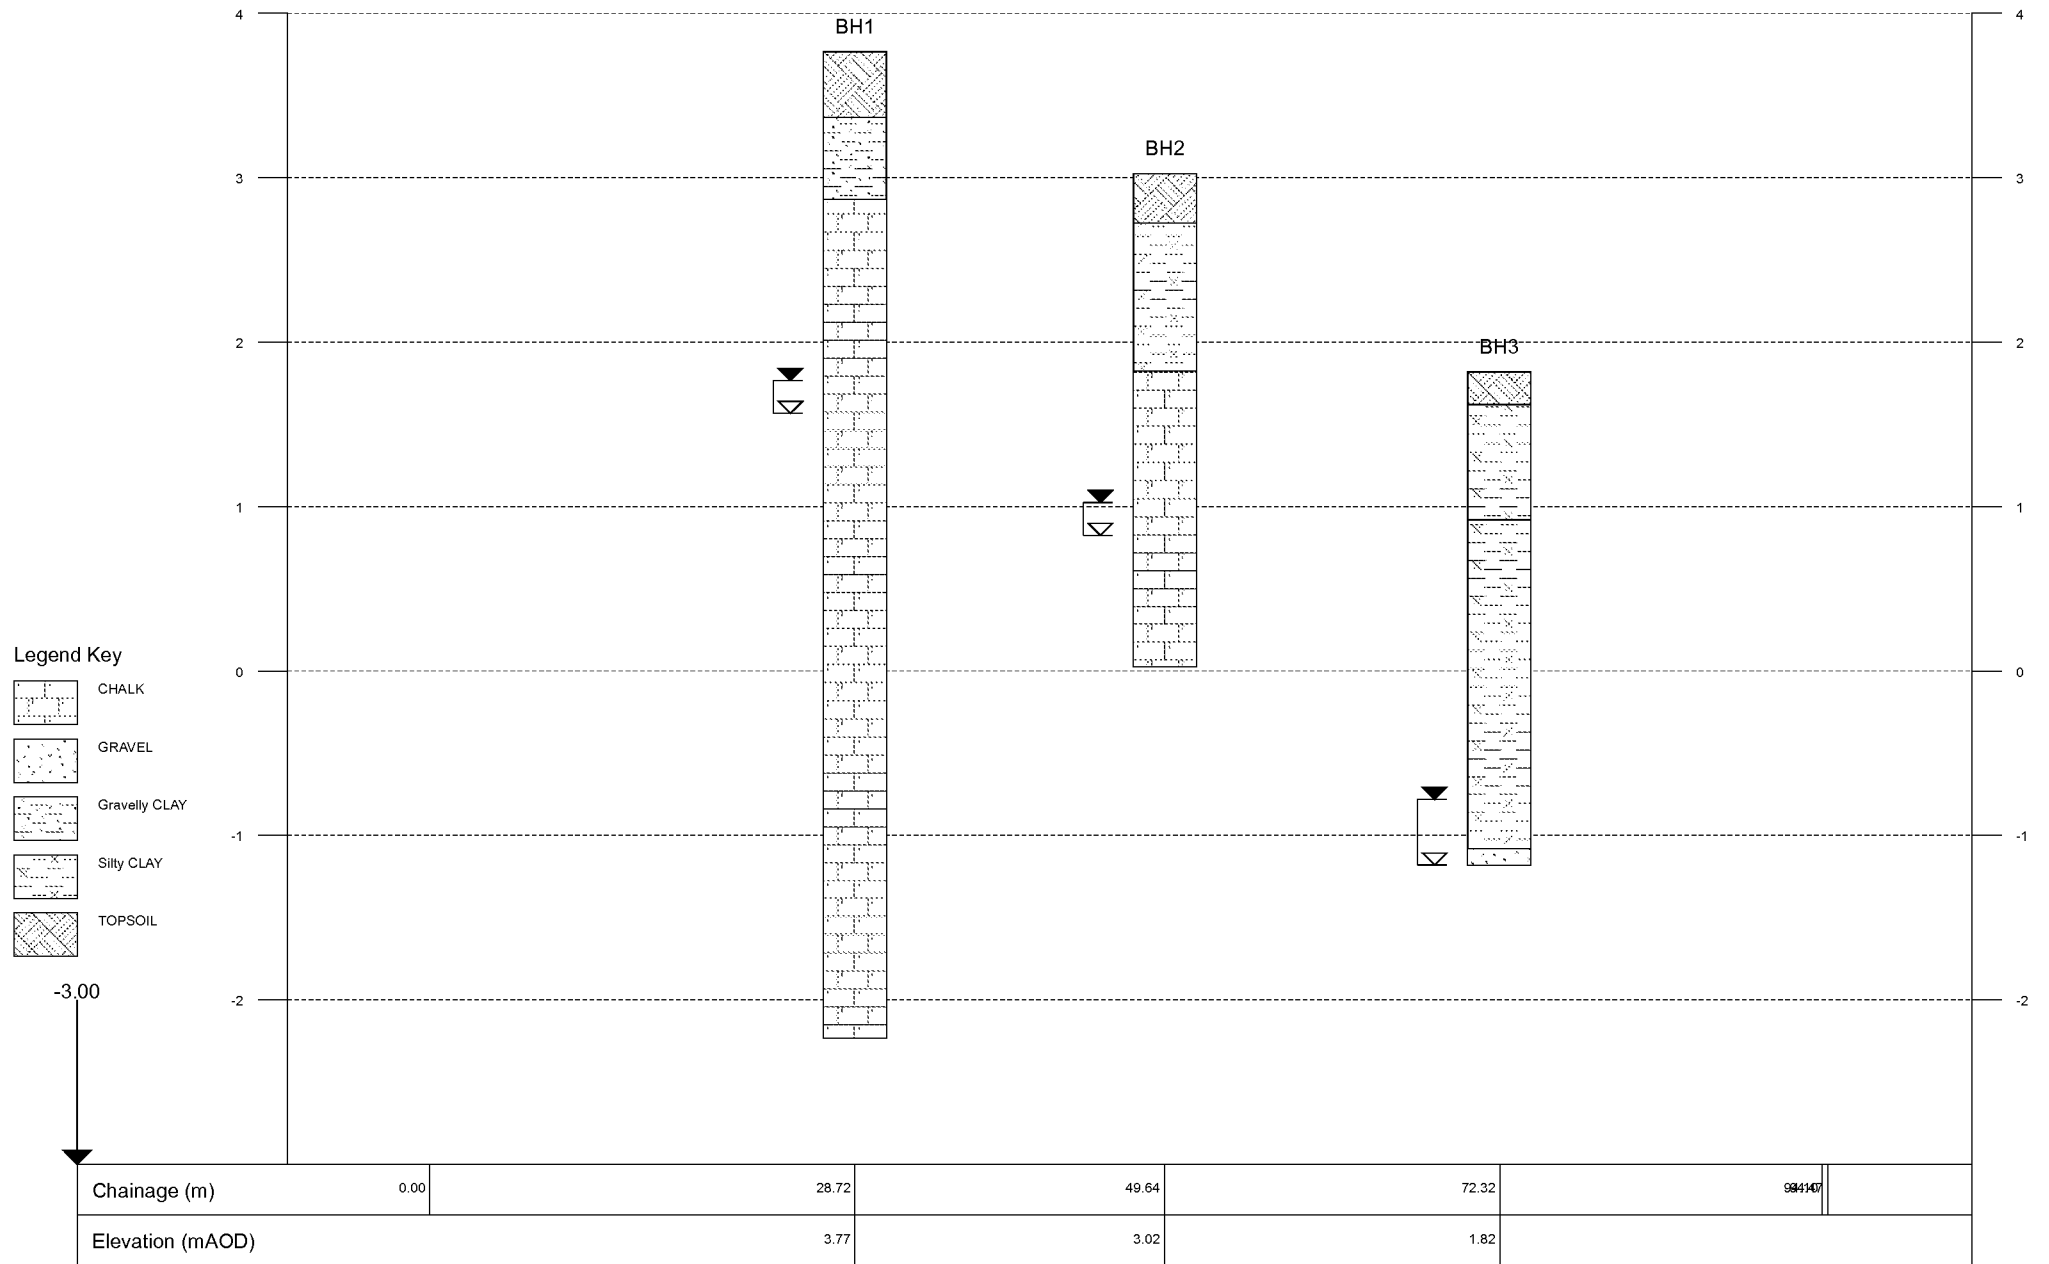
Project No: GE9623  
Location: Rustington  
Client: Store Property Investments Limited

For further details of changes in groundwater levels, a graph of the monthly recordings and section drawings of the boreholes are appended.
