# Proposed Development of Land at A259 New Road / Brook Lane, Rustington

## Phase 1 Ground Condition Assessment

On behalf of **Commercial Development Projects Ltd**

Project Ref: 32447 | Rev: 02 | Date: January 2015

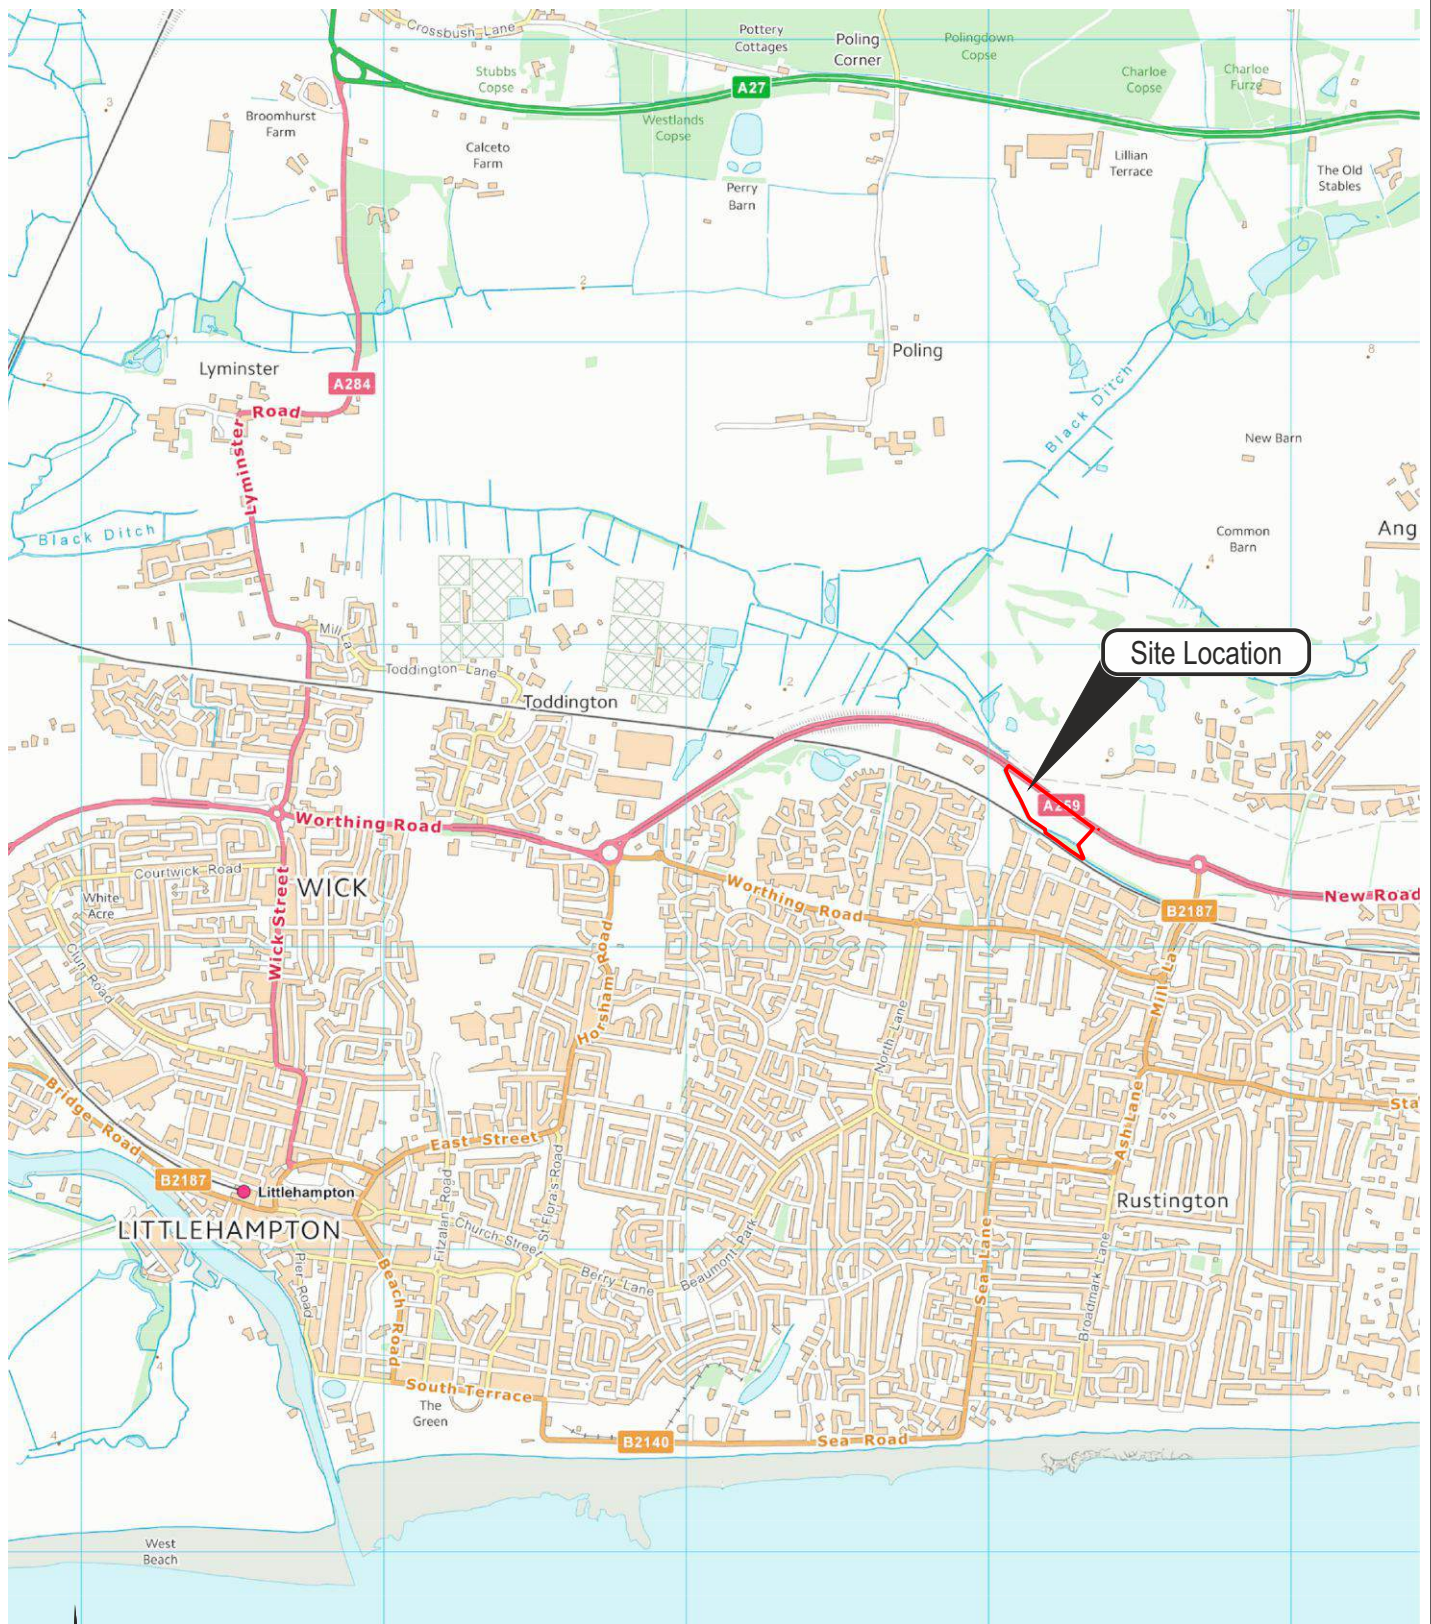
FIGURE 1

Site Location

Approximate Site Boundary  
Site Grid Ref: TQ 052 034

The site is located about 1.5km to the north of Rustington Village Centre and is centred at National Grid Reference (NGR) TQ 05213 03416. A site location plan is presented as **Figure 1**.

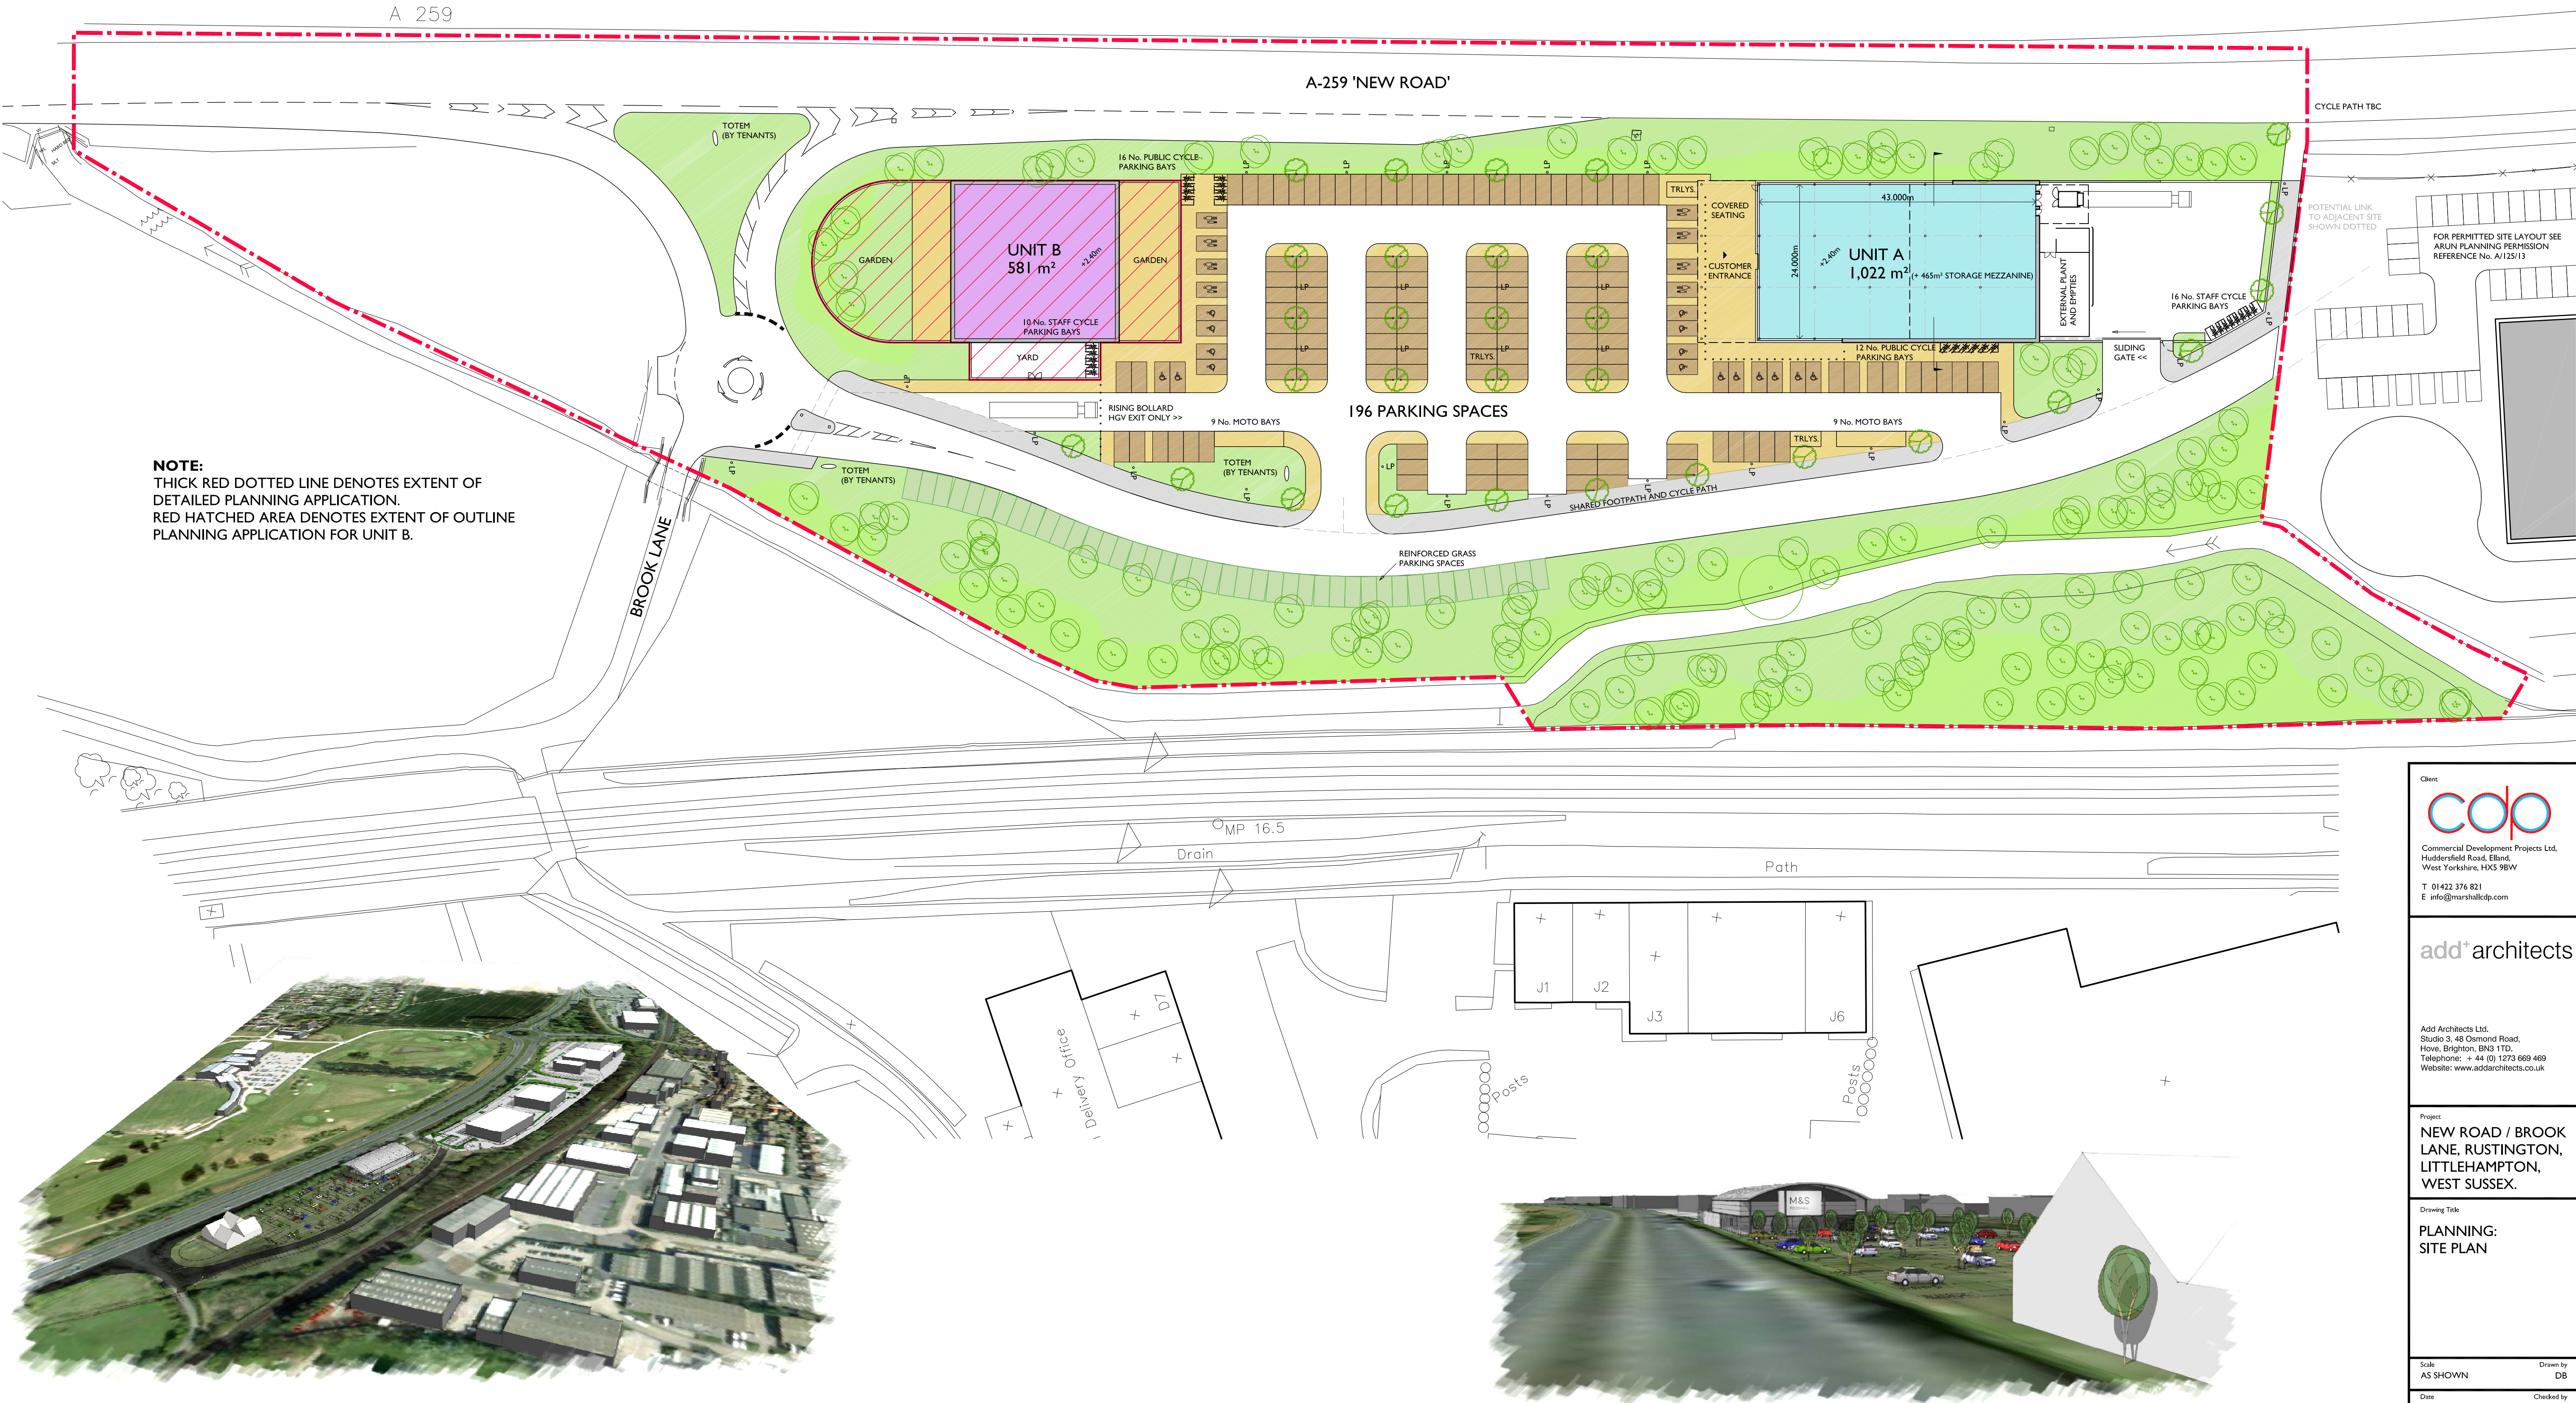
SITE PLAN, I:500@A1, I:1000@A3

AERIAL VIEW FROM THE WEST
