## **Proposed Wheelie Bin Storage**

**Weavers Cottage, Weavers Hill, Angmering,  
West Sussex · BN16 4BP**

### **Heritage Statement & Design and Access Statement**

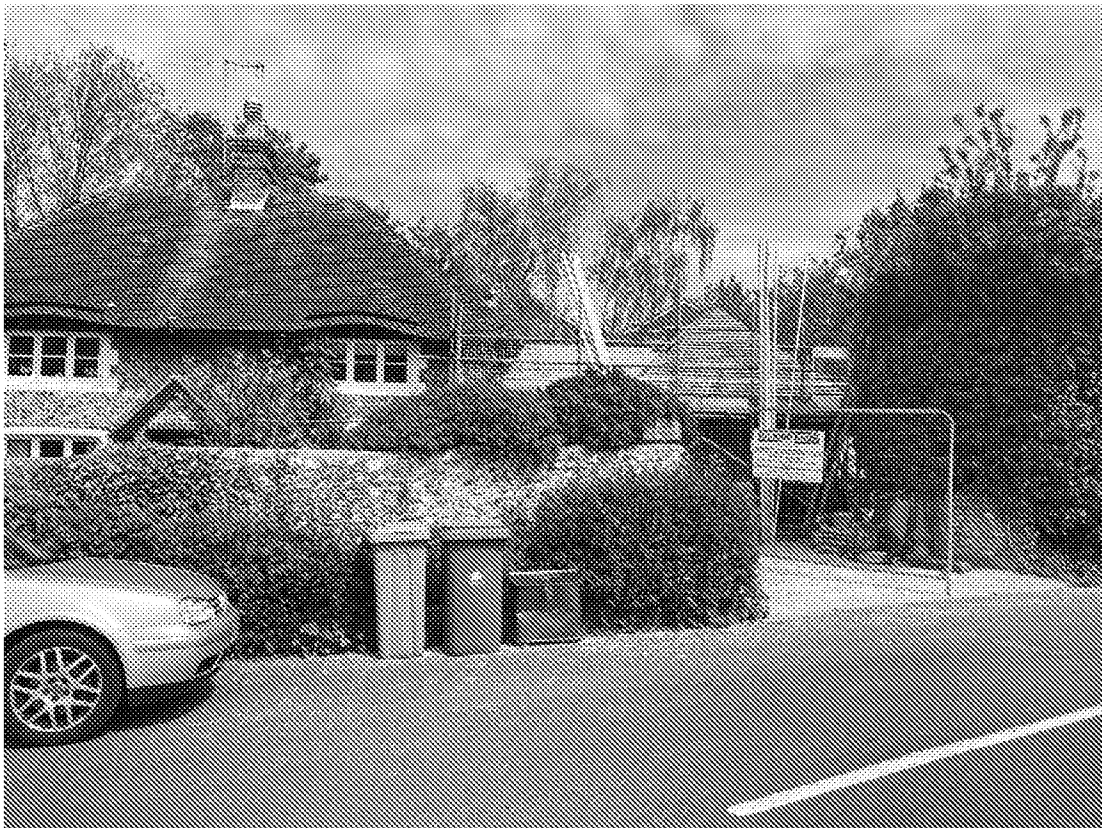
**Figure 1. External Elevation (May 2021).**

The intention is to locate the bin storage within the site boundary. To achieve this the existing flower bed will be partially removed and reformed allowing it to sit flush against the flint garden wall. The existing bushes and other various shrubs will be retained either side to maintain the appearance of its soft boundary.

Due to the addition of the flood gate and steps at the front of the property, it would be problematic to locate the bins inside the garden wall. Equally, the bins cannot be located on the existing driveway as it does not leave sufficient space for parking which is already very restricted. Therefore for ease of access the location is best situated within the existing flower bed sitting flush against the flint garden wall.

The proposed wheelie bin storage is intended to enhance the external appearance of the property through the concealment of the owners bins which are currently placed on the boundary of the driveway. It will be constructed of pressure treated timber and will be painted to match the joinery on the main house.
