Project  
Alterations to:  
Pearl Dental, the Blaber House,  
Angmering

Drawing Title  
Plans and Elevations  
as Proposed

| Scale | 1:50, 1:100@A1 | Drawing Number | 14-136-02 |

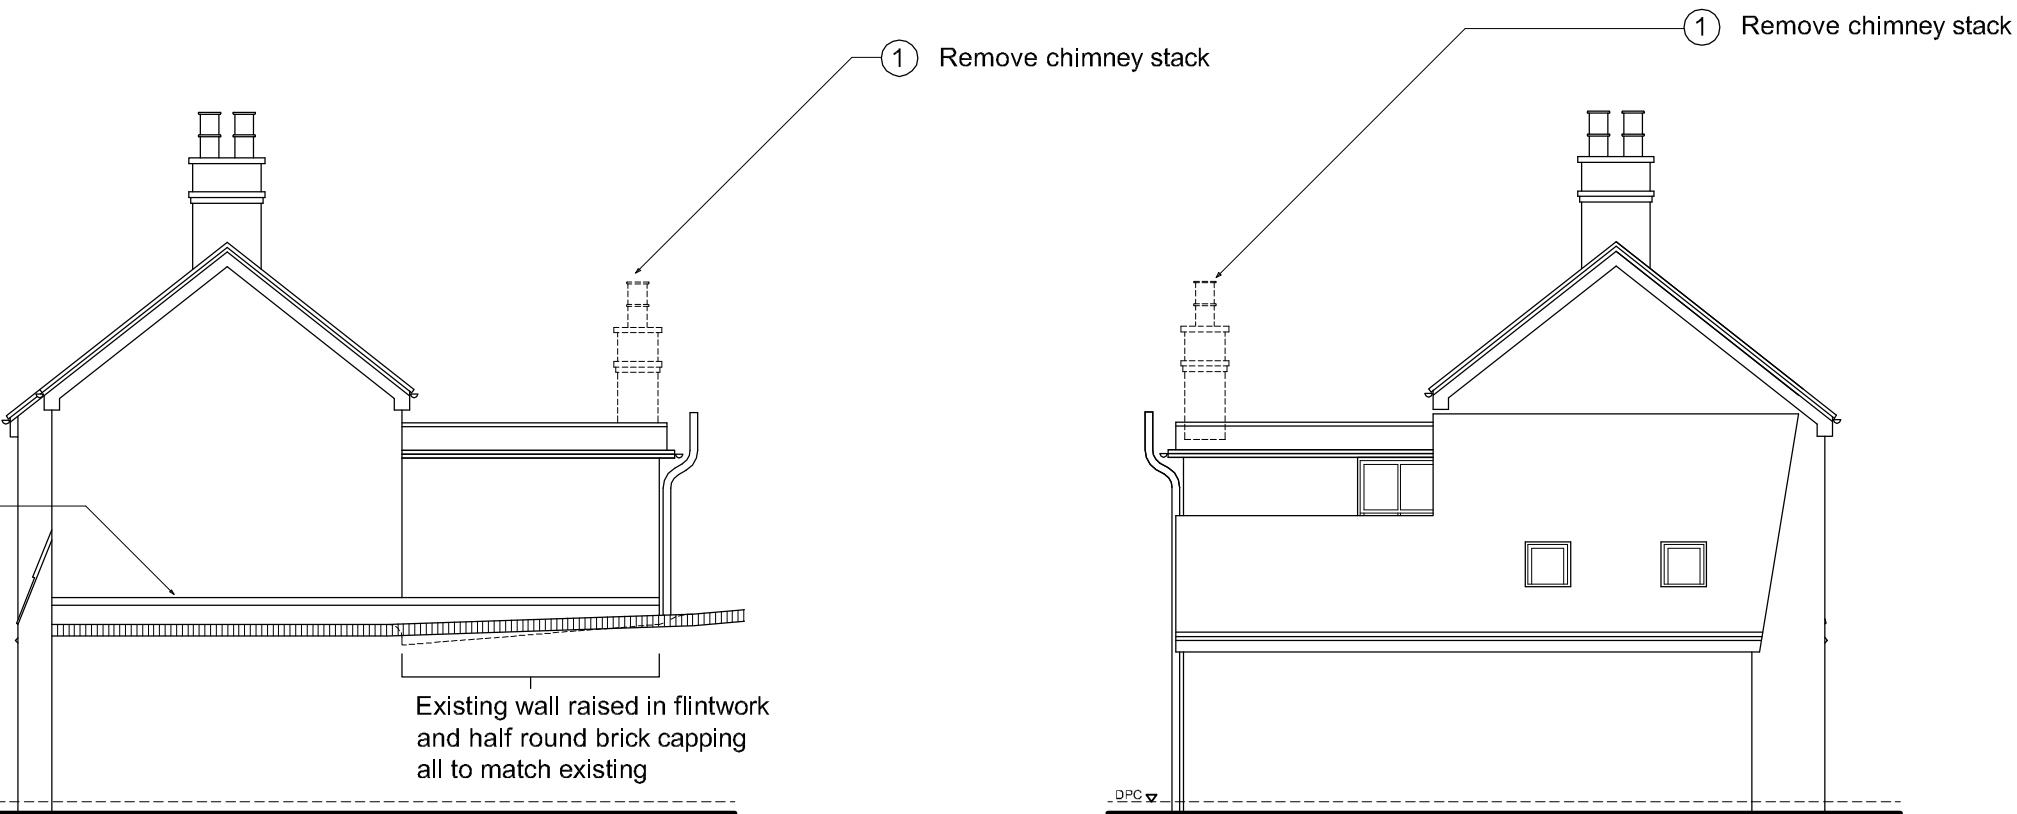
Side Elevation 1:100

- ① Stack is in a poor state of repair and responsible for ingress of water at 1st floor. Stack is located to the rear of the property and only visible from limited public areas. Its removal would not be considered detrimental to the Principal elevation
- ② Proposed new window is to be a direct copy of the adjacent 1st floor window

----- ITEMS SHOWN DASHED TO BE REMOVED

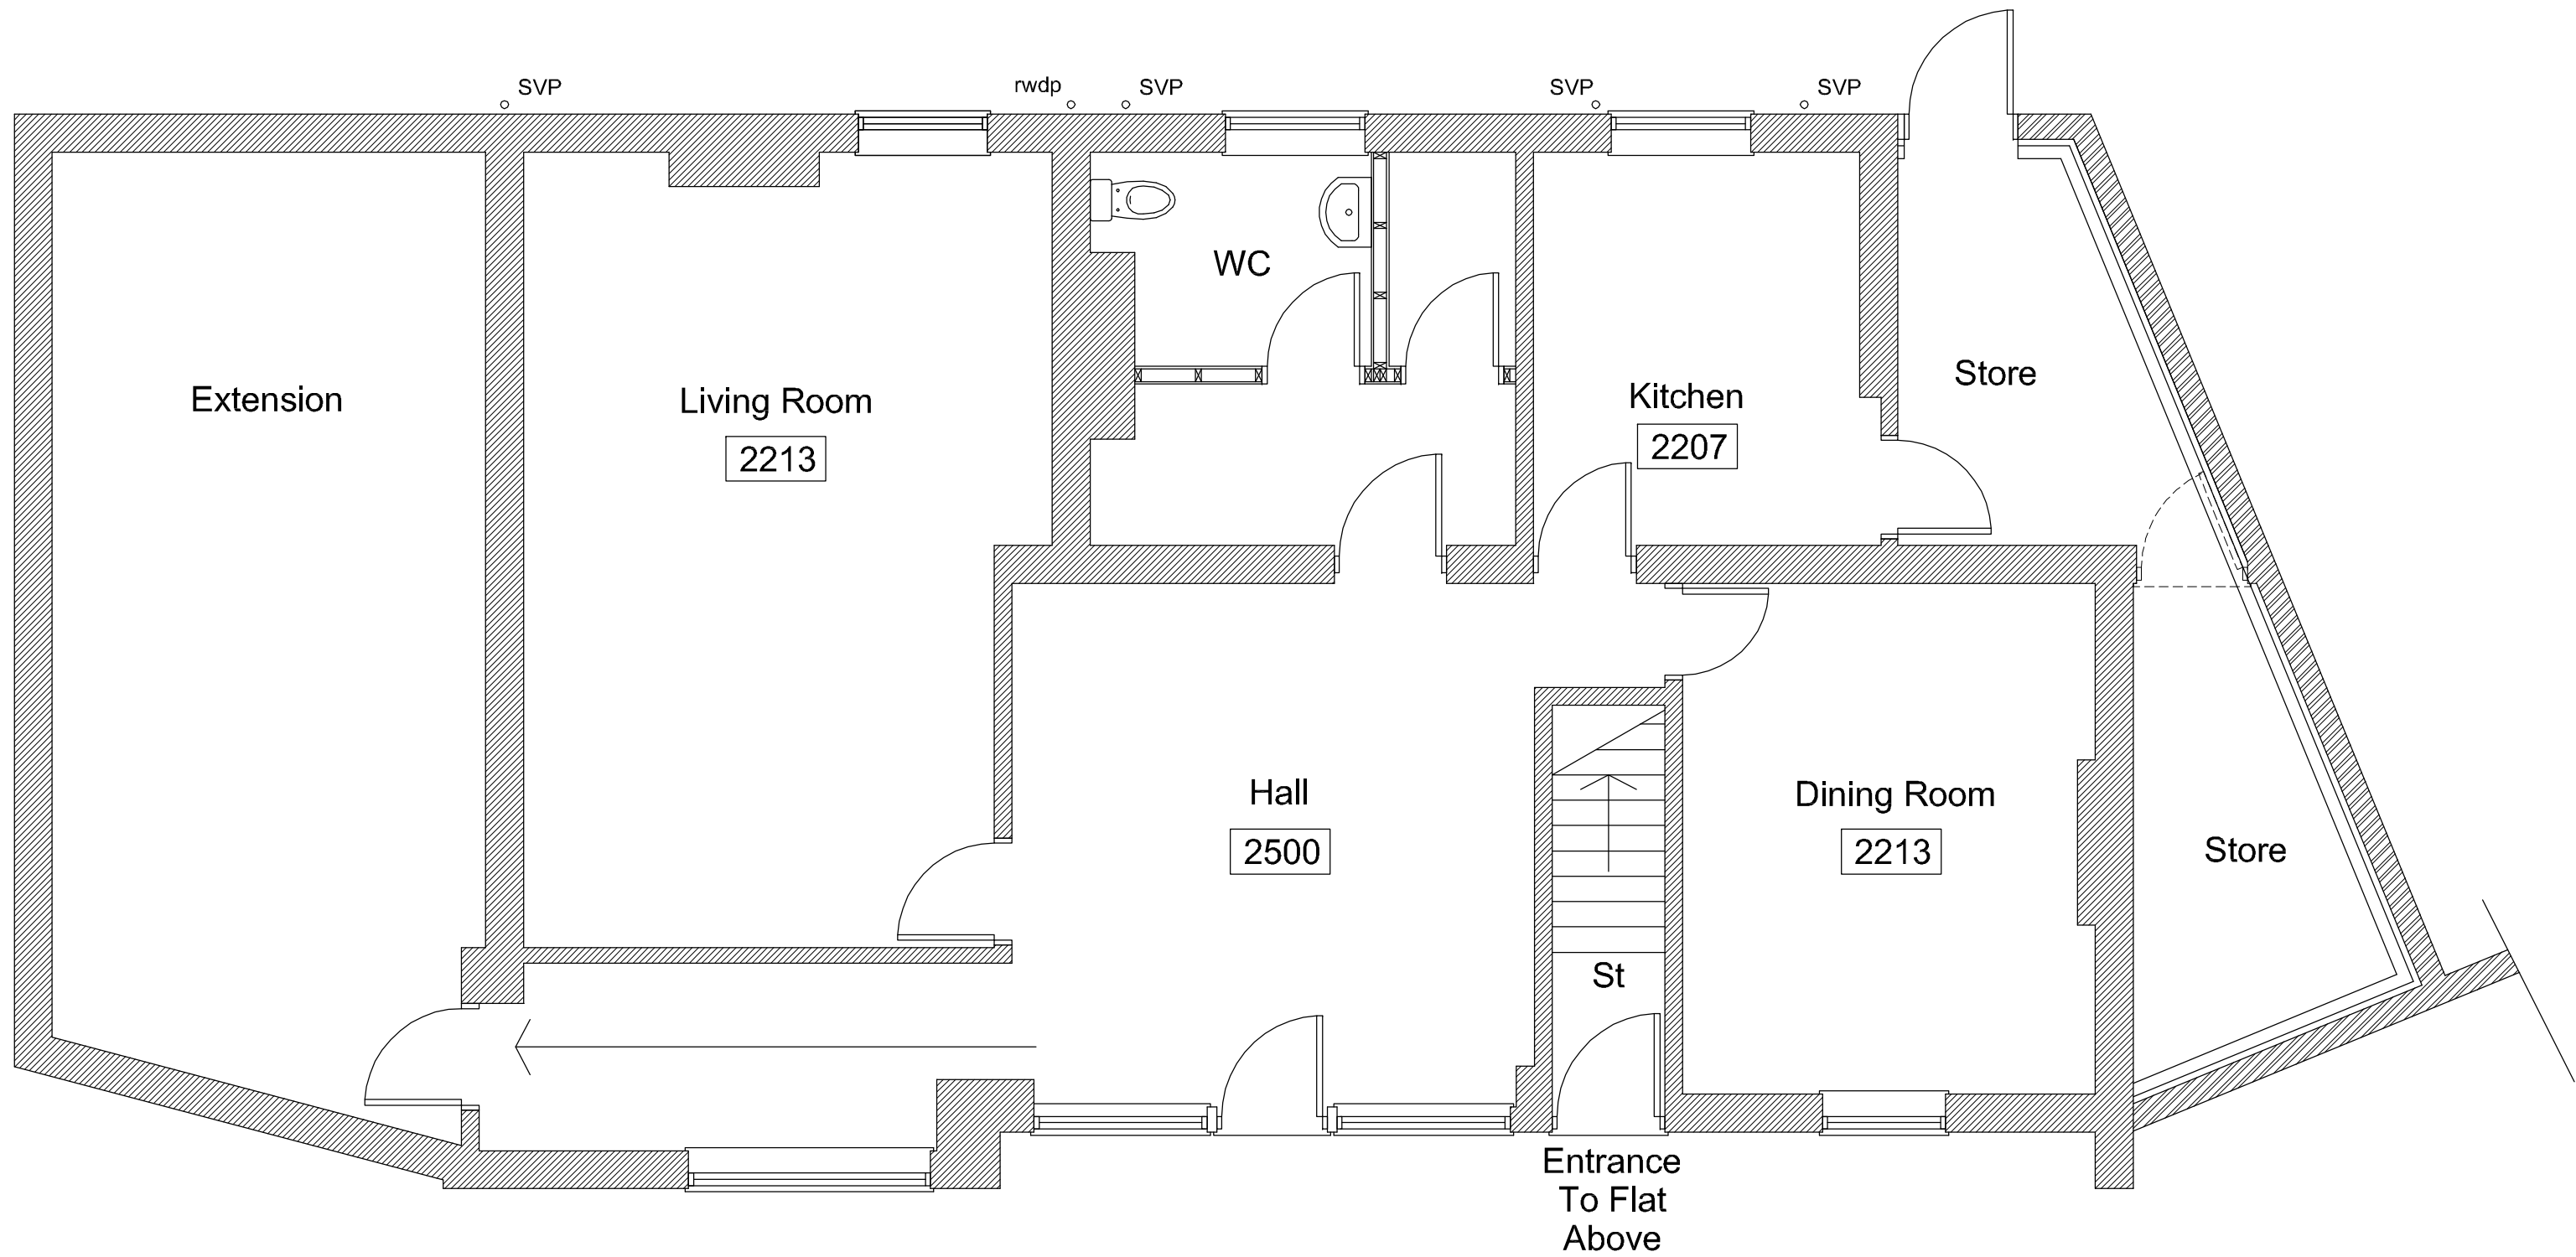
Ground Floor Plan 1:50

2620 Floor to ceiling spot heights
