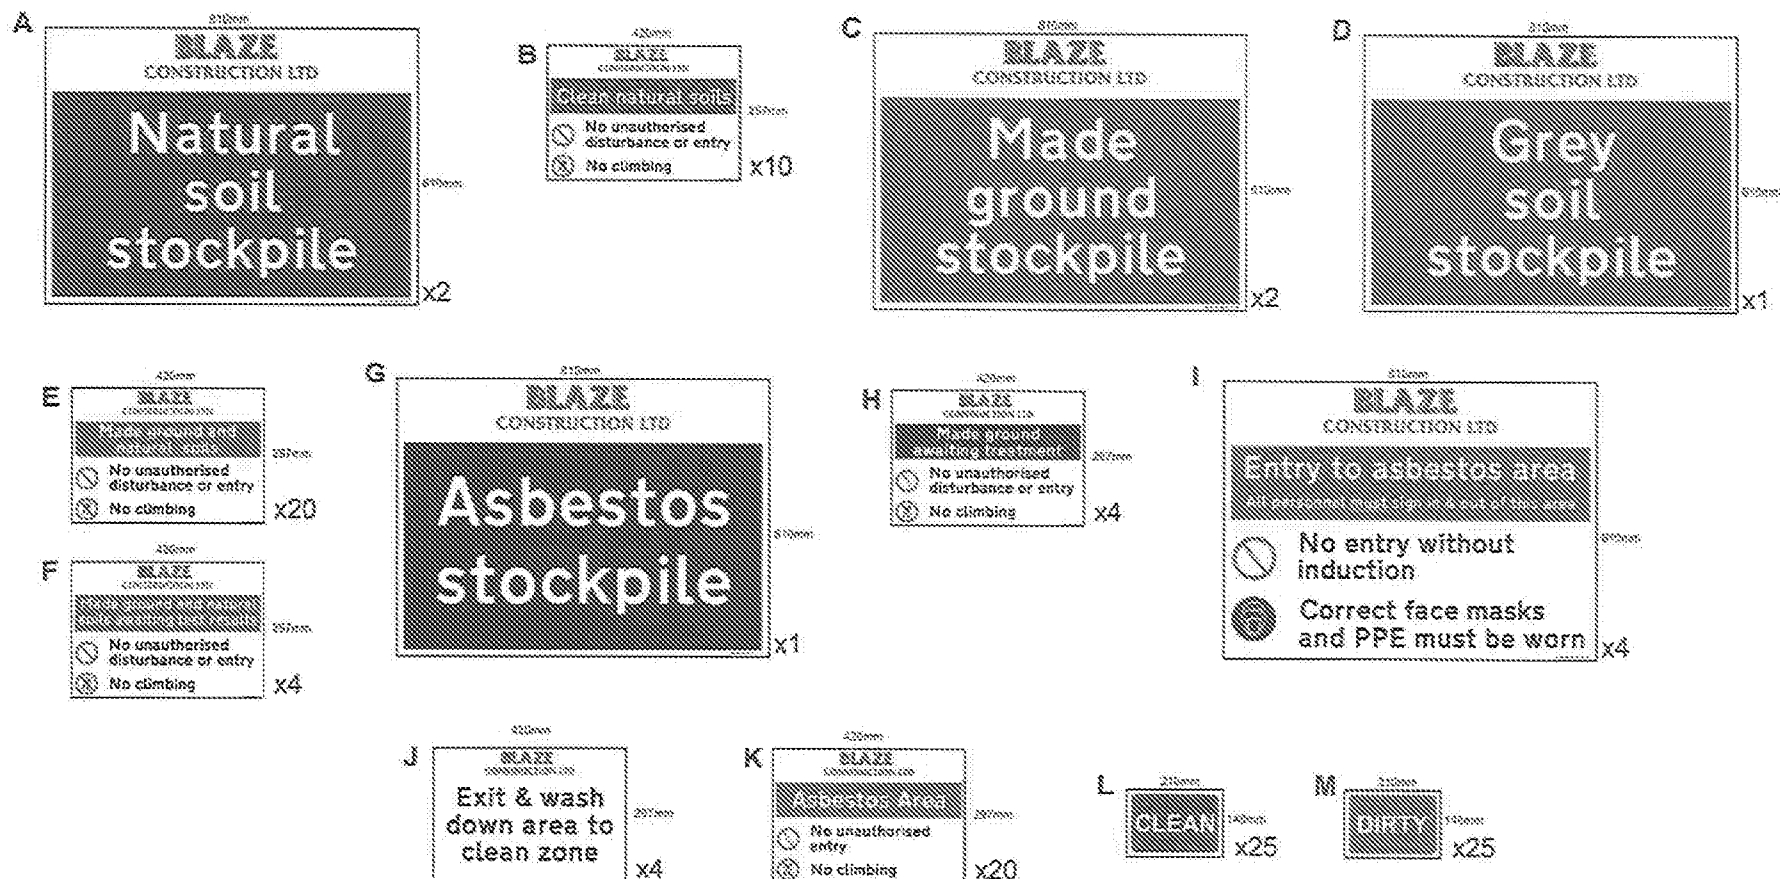
## Appendix 2

Additional signage to be erected on site.

NB – Sign I to be altered to read “Entry to remediation area” instead of “Entry to asbestos area”, and “Correct task specific PPE must be worn” instead of “Correct face masks & PPE must be worn”.

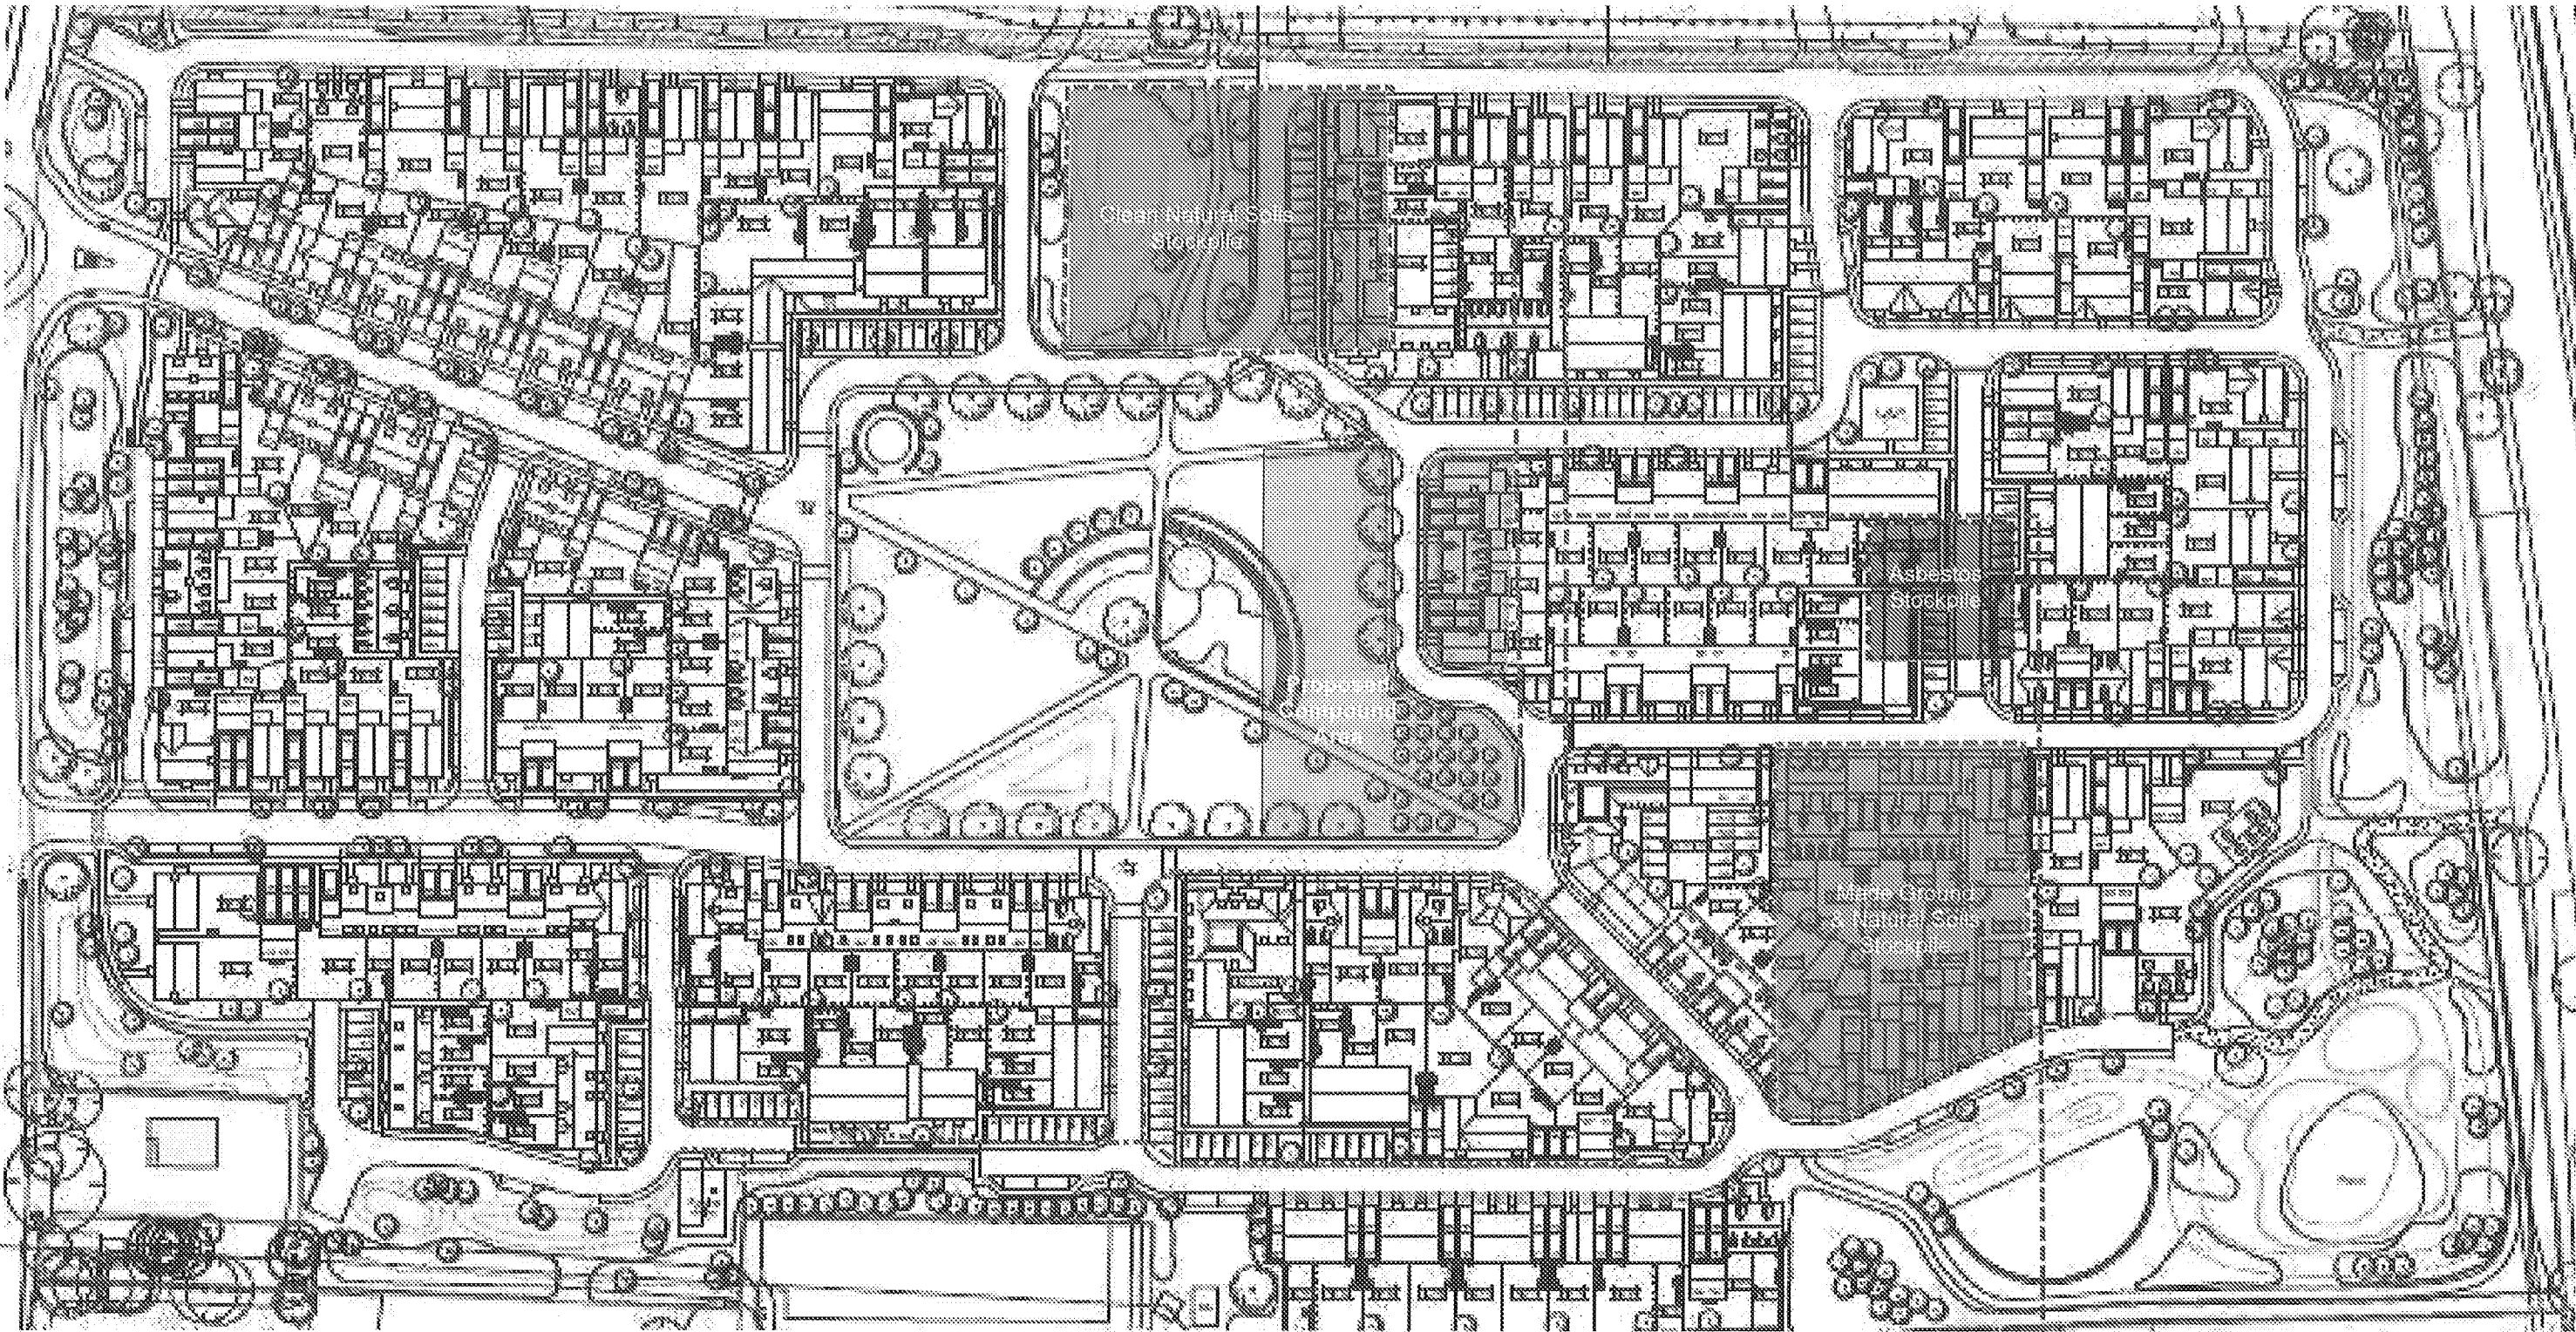
## Appendix 5

Plans showing changes to layout of fencing & designation of routes prior to Stage 2 works commencing.

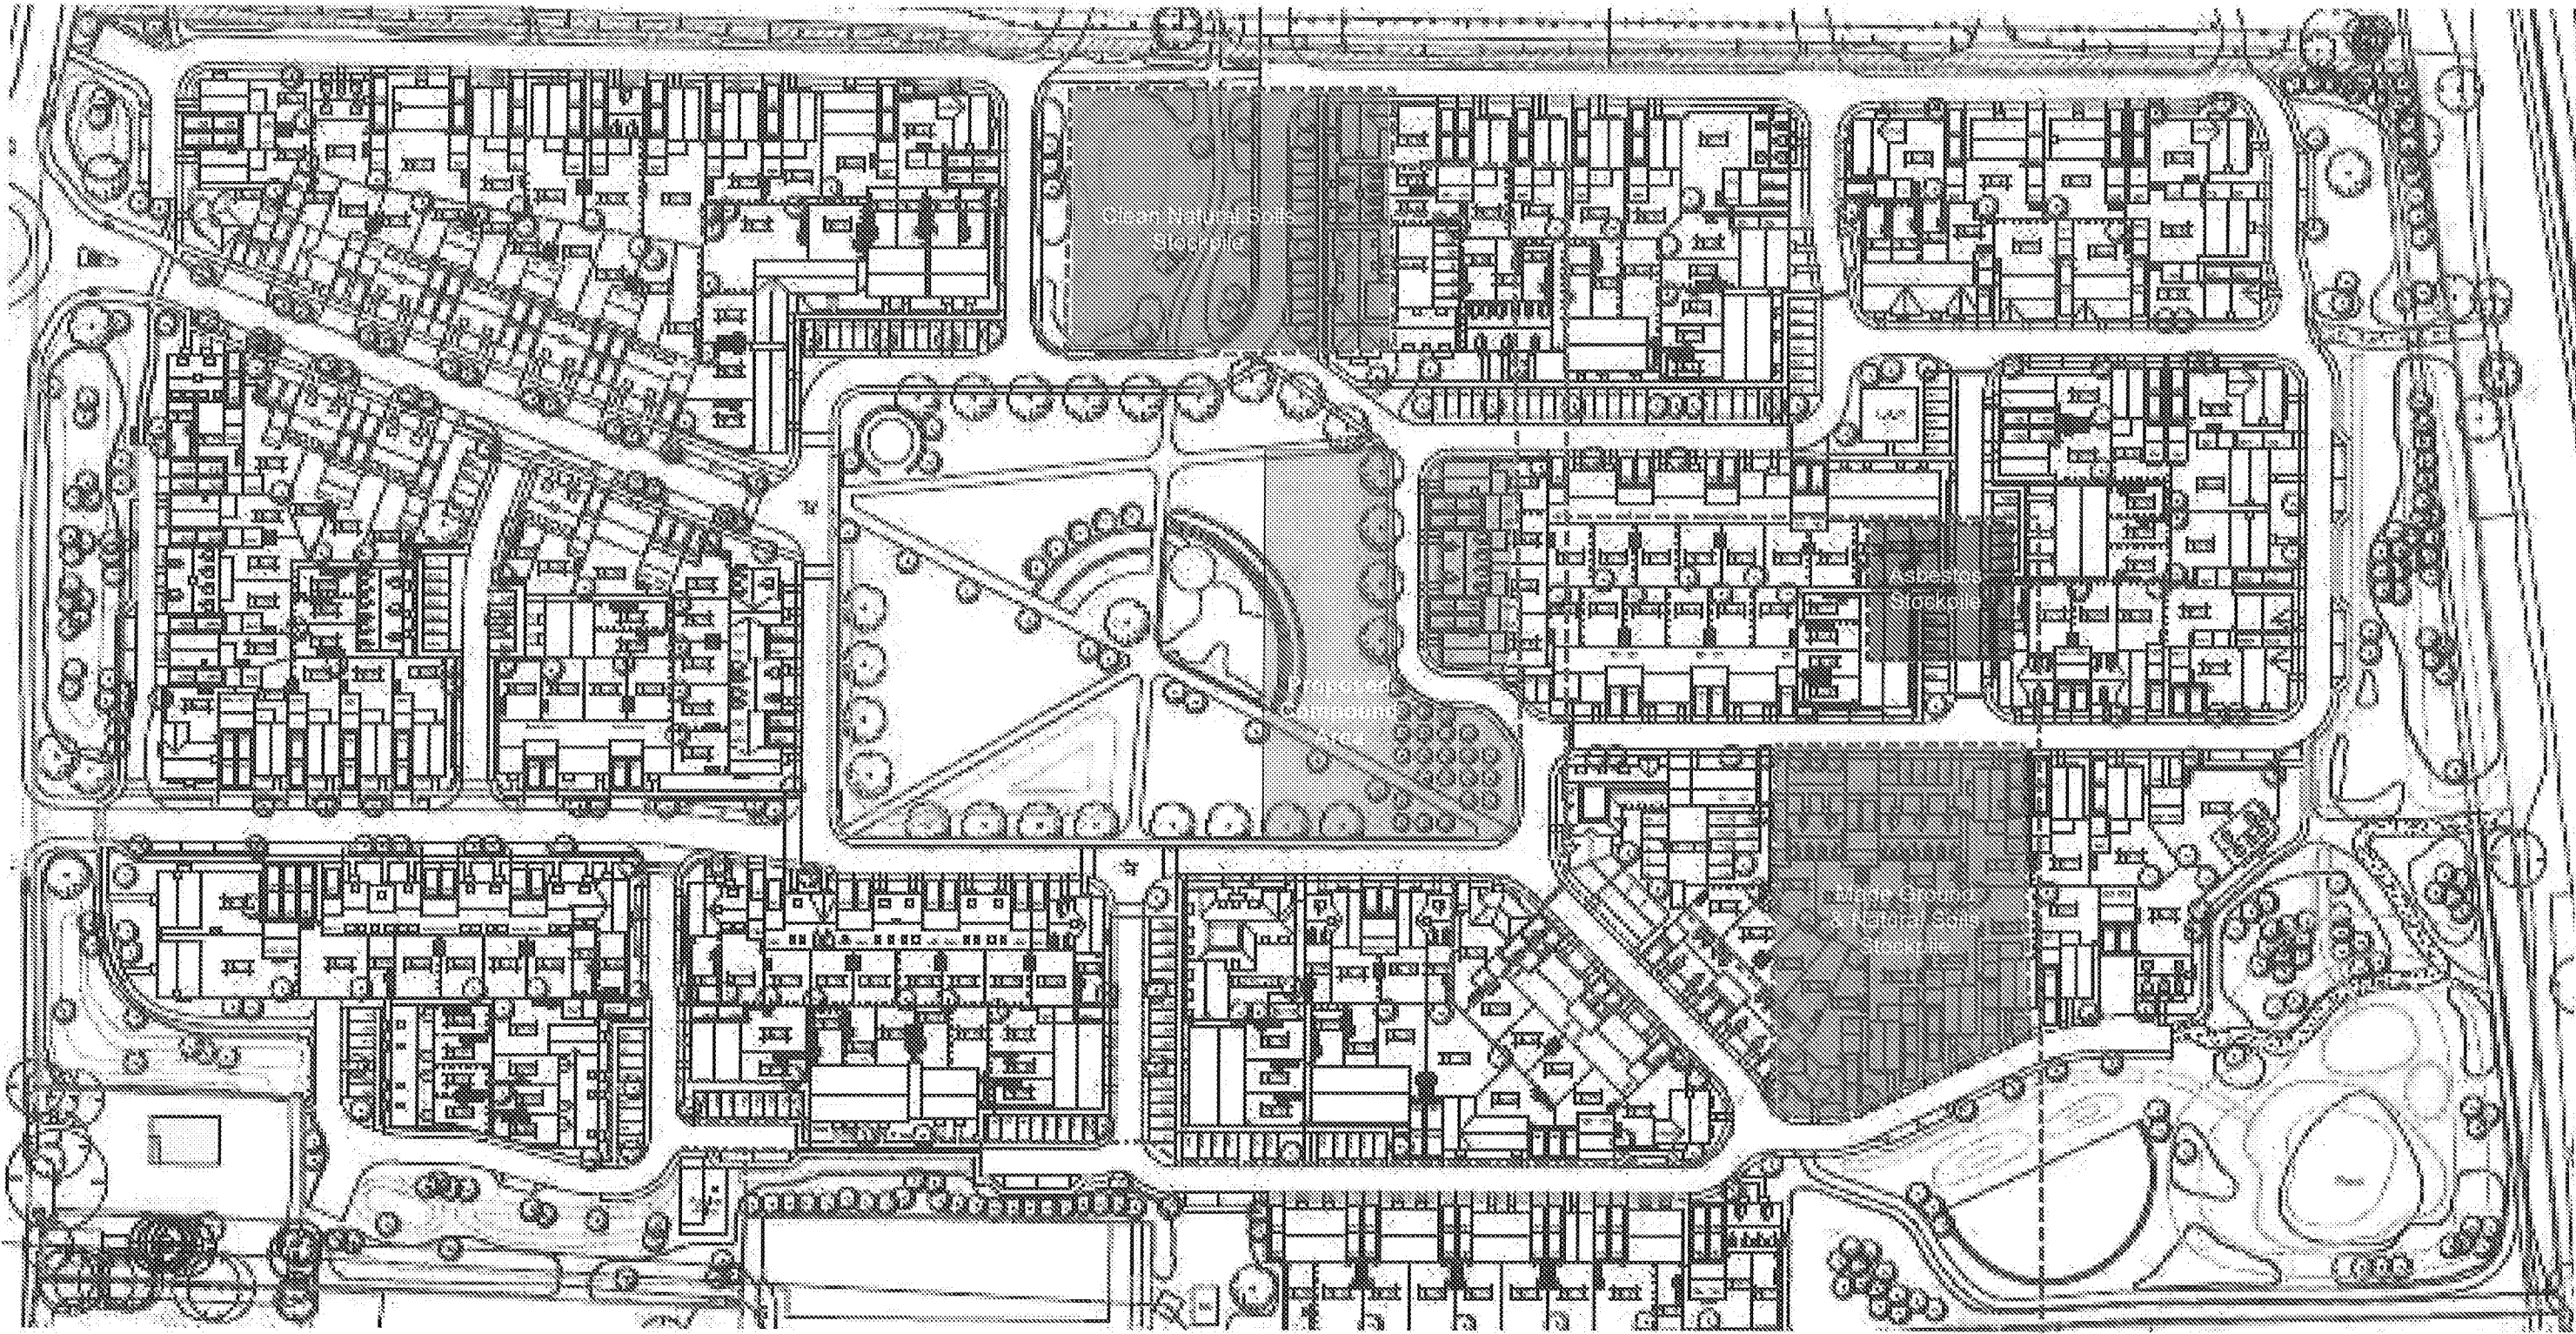
Appendix 6

Plans showing changes to layout of fencing & designation of routes prior to Stage 3 works commencing.

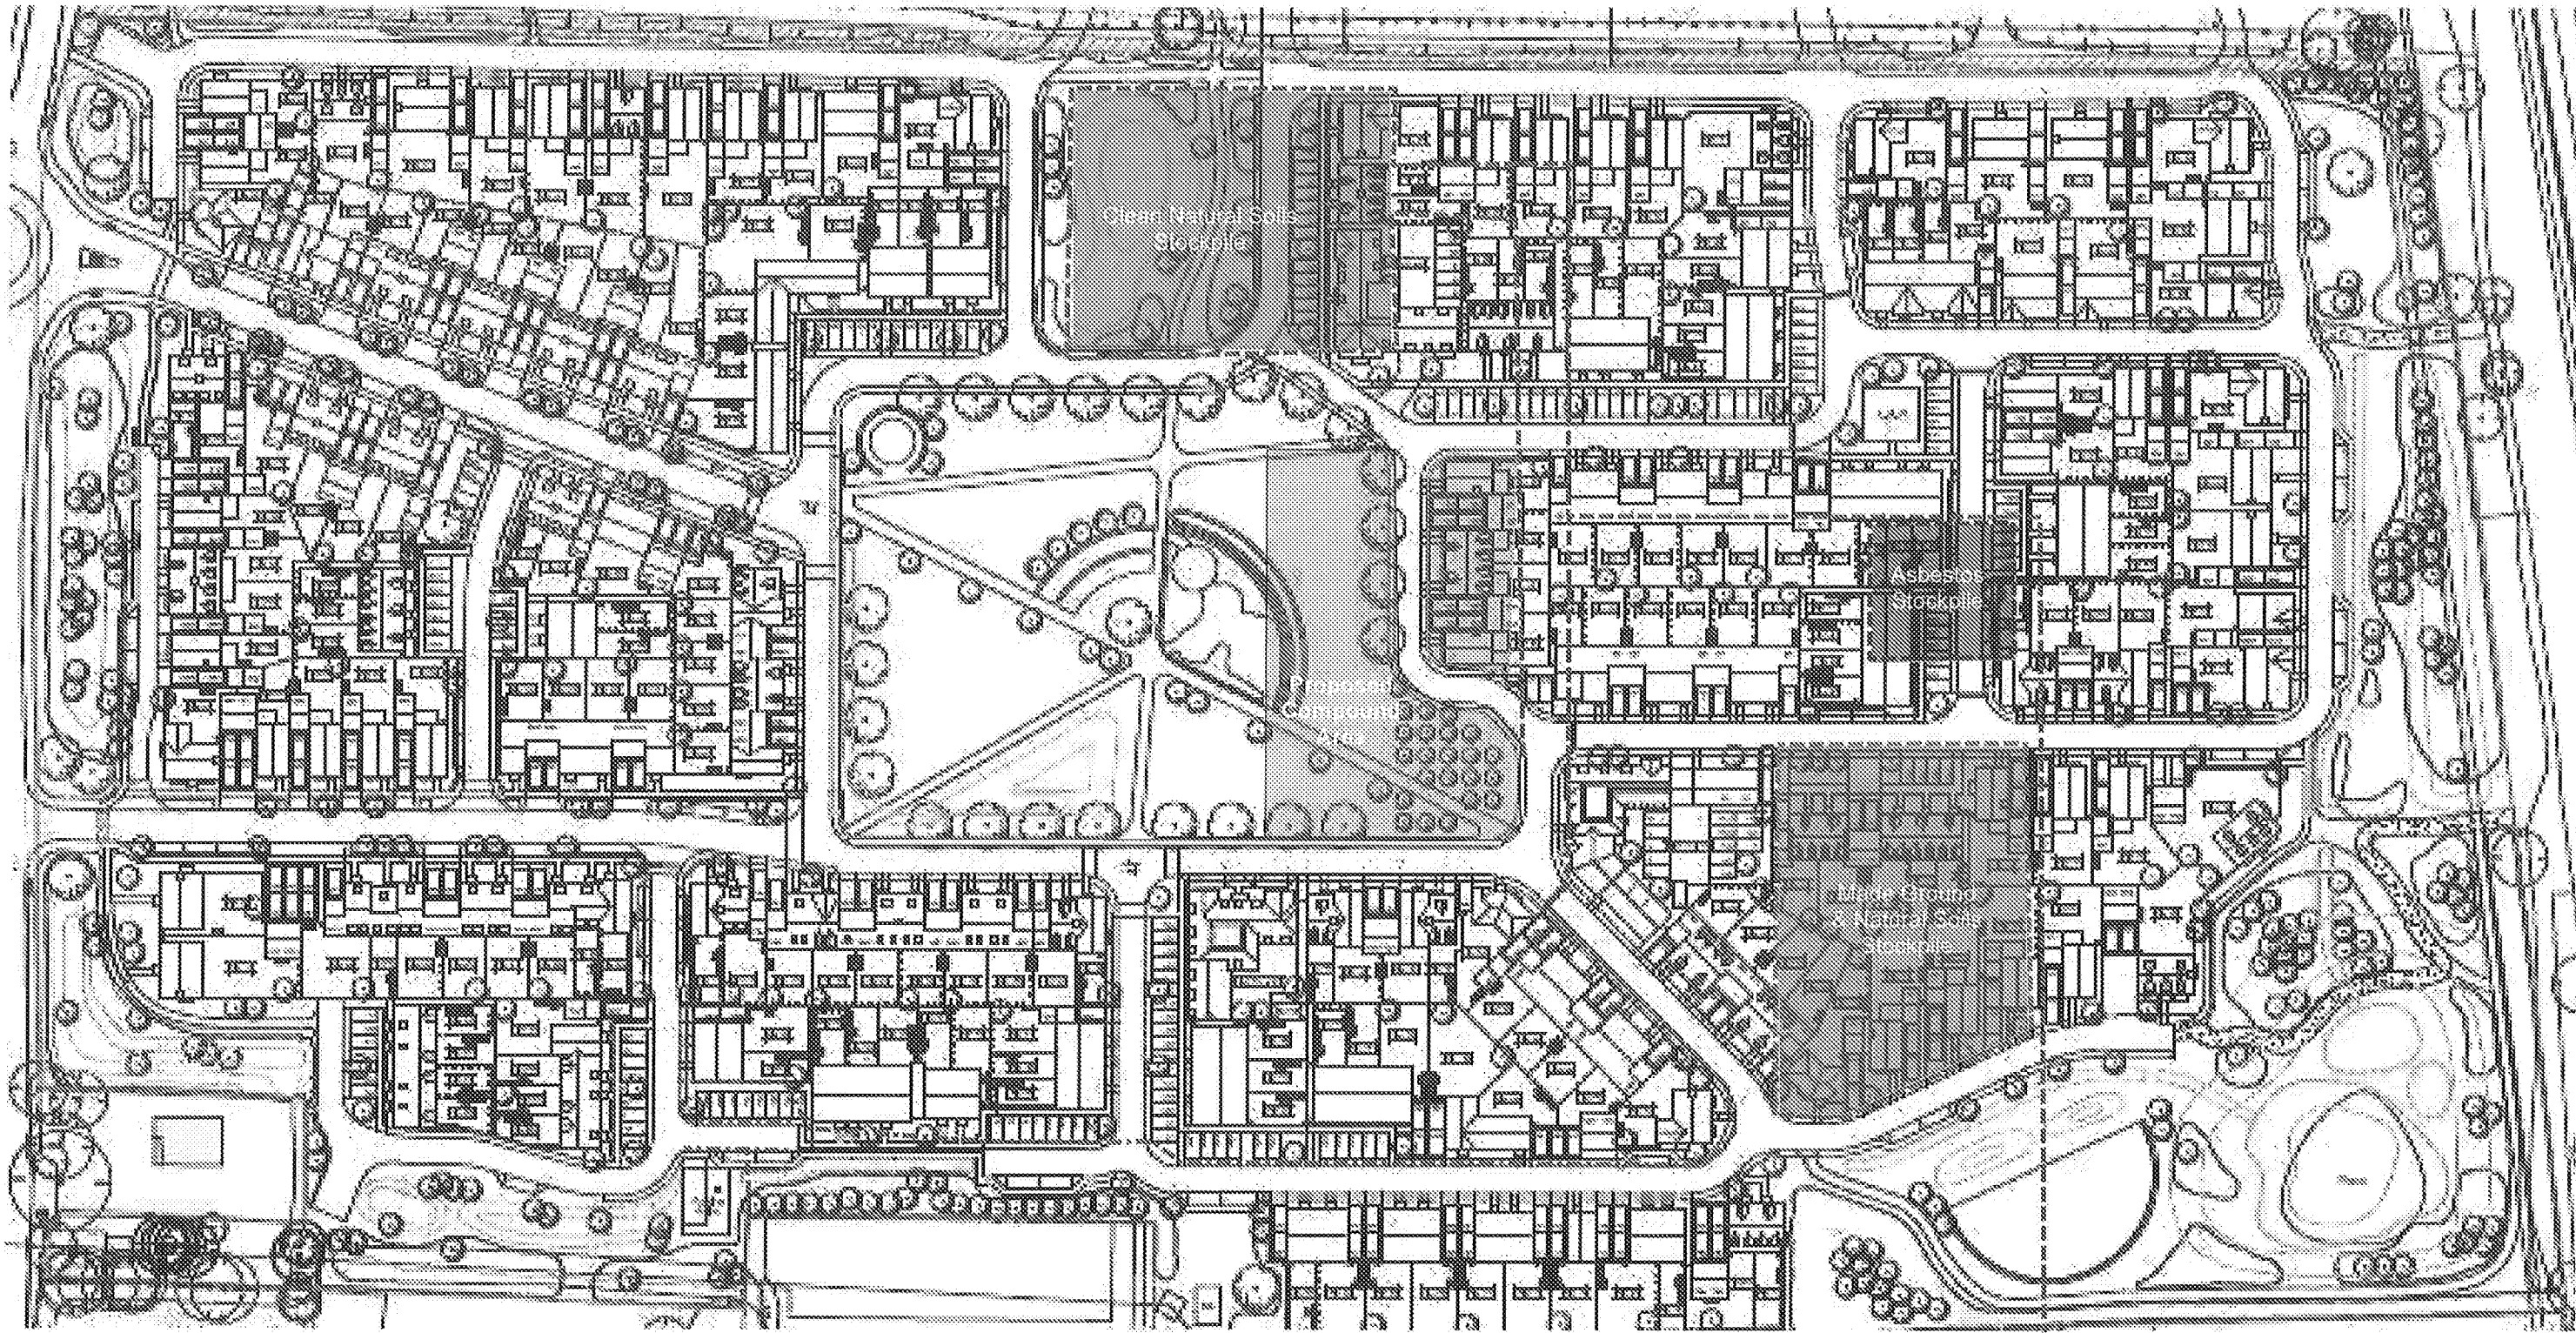
## Appendix 7

Plans showing changes to layout of fencing & designation of routes prior to Stage 4 works commencing.

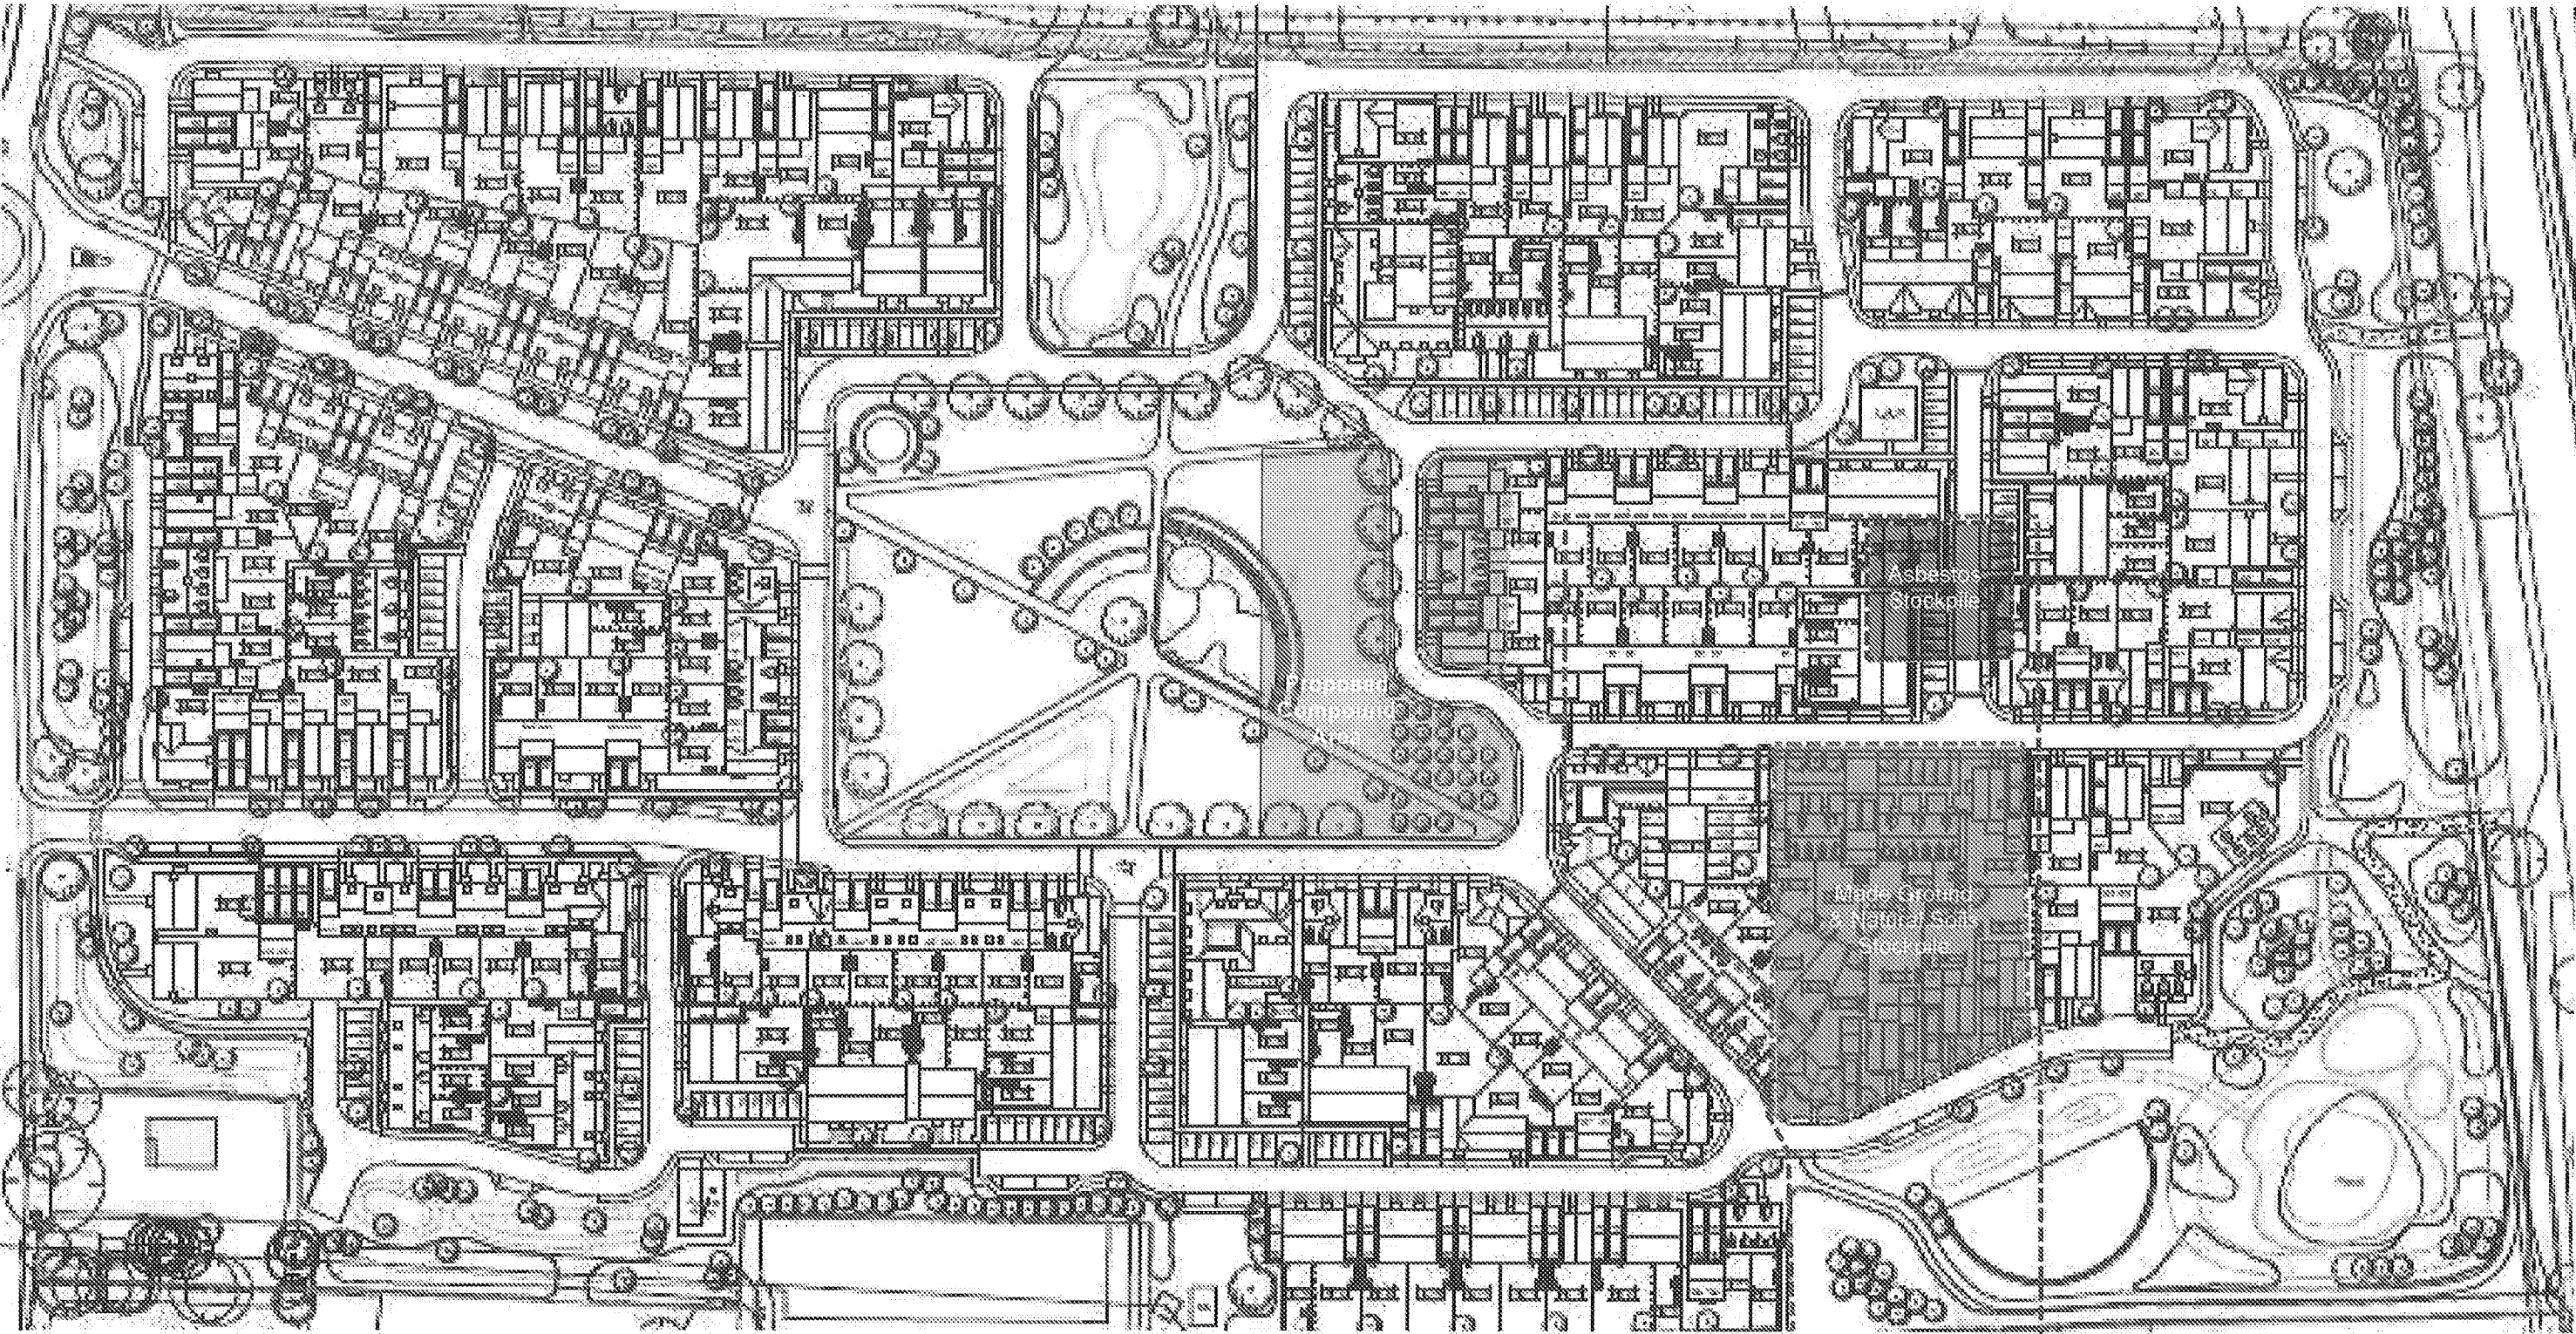
## Appendix 8

Plans showing changes to layout of fencing upon completion of works (leaving only area of stockpiles fenced off).
