**Temporary Car Parking**  
**Caffyns Audi, Worthing**  
**Flood Risk & Drainage Statement**

## Temporary Car Park at Caffyns Audi

### **Audi Worthing – Report on Infiltration Tests**

**RE: Land North of A259, Angmering - Groundwater Monitoring**

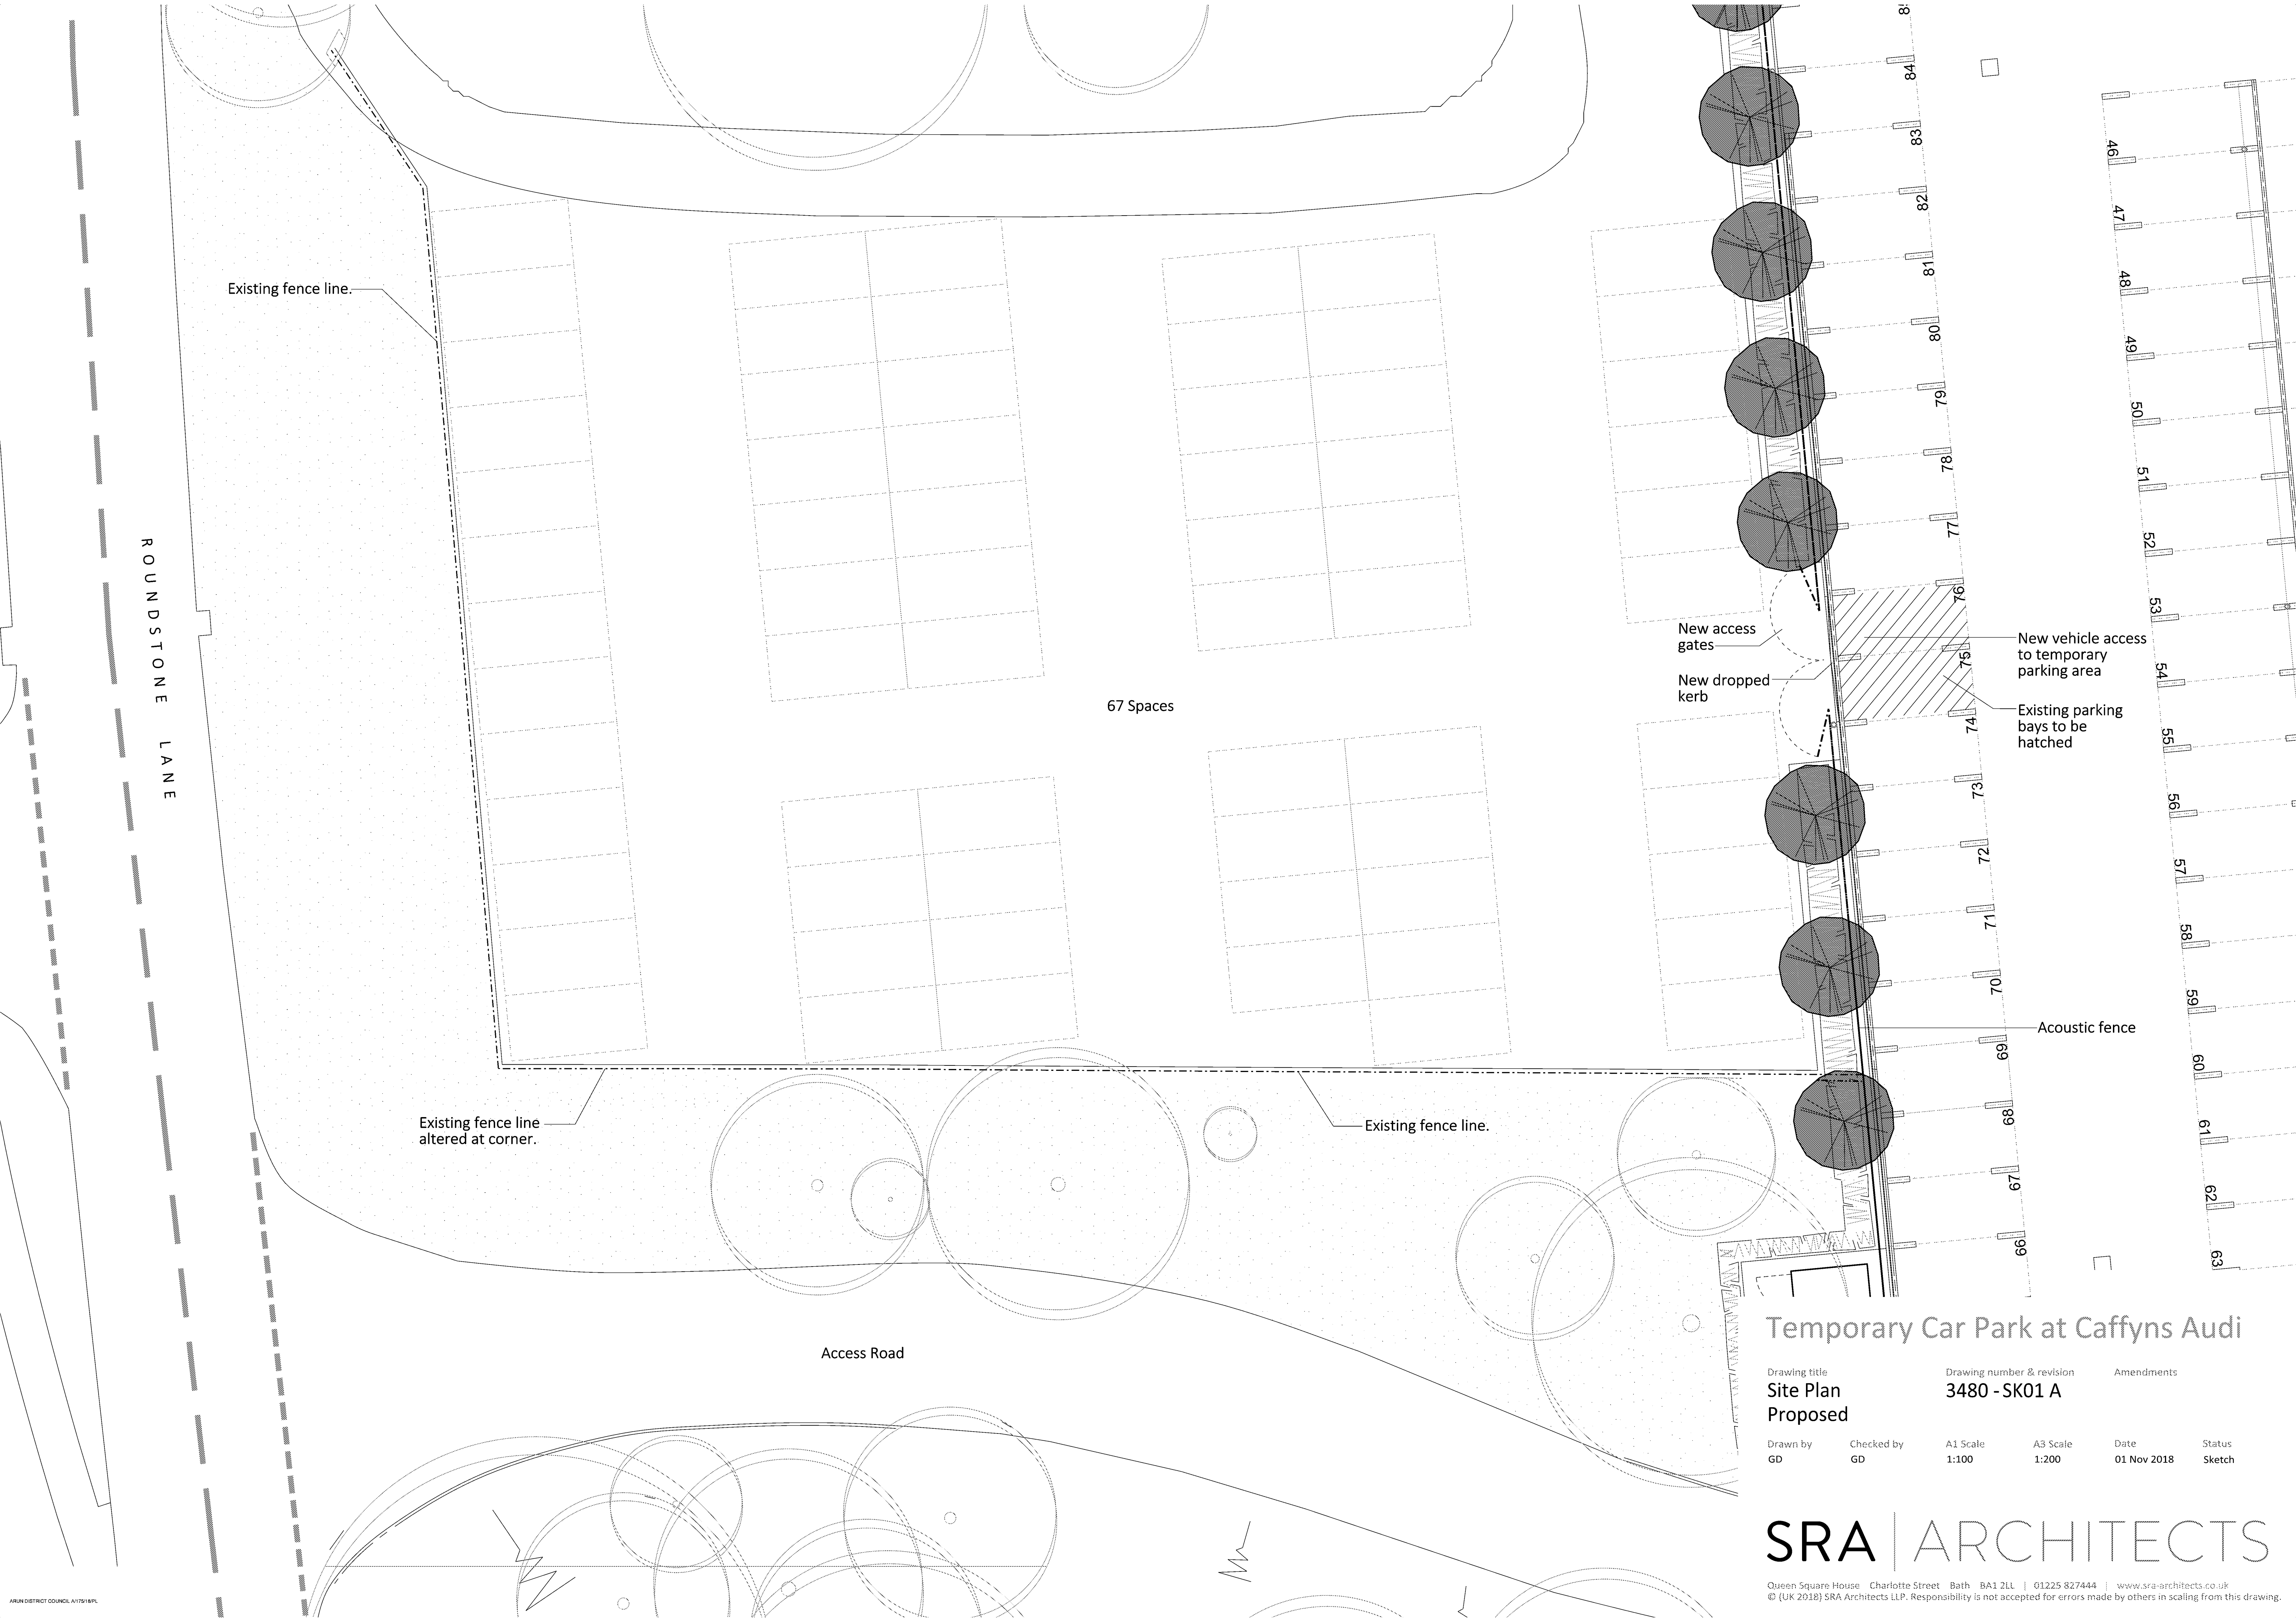
| Drawing title | | Drawing number & revision | | Amendments | |
|---|---|---|---|---|---|
| Site Plan Proposed | | 3480 - SK01 A | | | |

The proposal is to construct a temporary car storage area adjacent to a recently completed car dealership site. The layout is shown on the appended proposed site plan, SRA Architects Drg. No. 3480-SK01A.

The proposed vehicle storage area is to have a permeable surface, and therefore no positive drainage is required.

67 Spaces

New vehicle access to temporary parking area  
Existing parking bays to be hatched

Therefore, the proposed permeable storage area is to be formed using granular material to allow surface water to drain through to the underlying sub-soils. The imported stone will provide a level of treatment to the run-off should any oils be deposited. It should be borne in mind that it is highly unlikely that any significant deposition of oils will occur, as the vast majority of vehicles stored will be new or nearly new, and are consequently well maintained.

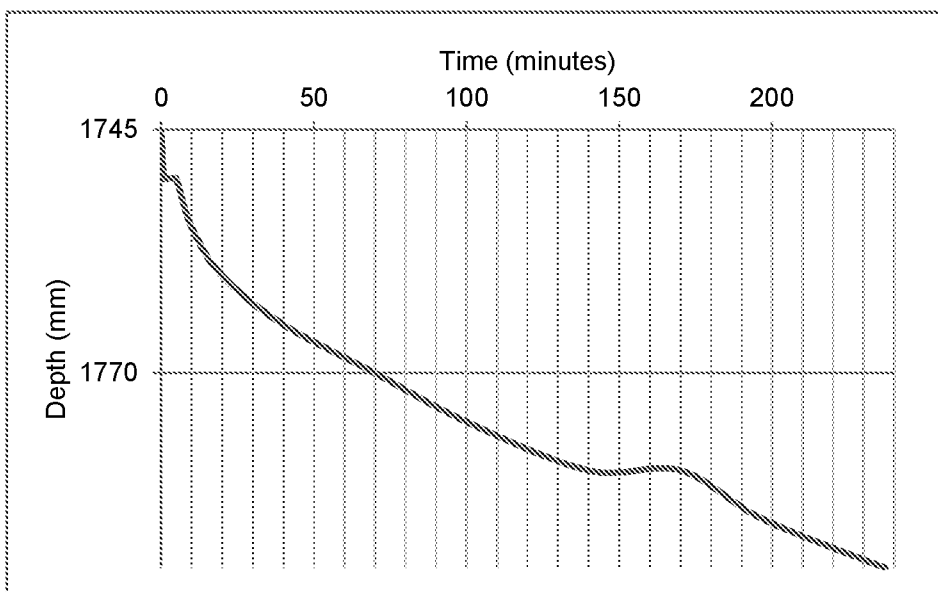
Test No. SA1

**Time (min)                  Depth (mm)**

**Test Pit Log****Depth (m)****Description**

Light brown slightly sandy SILT/CLAY.

**BR365 Soil Infiltration Rate = N/A m/sec**  
**Average Infiltration Rate = 1.3E-06 m/sec**

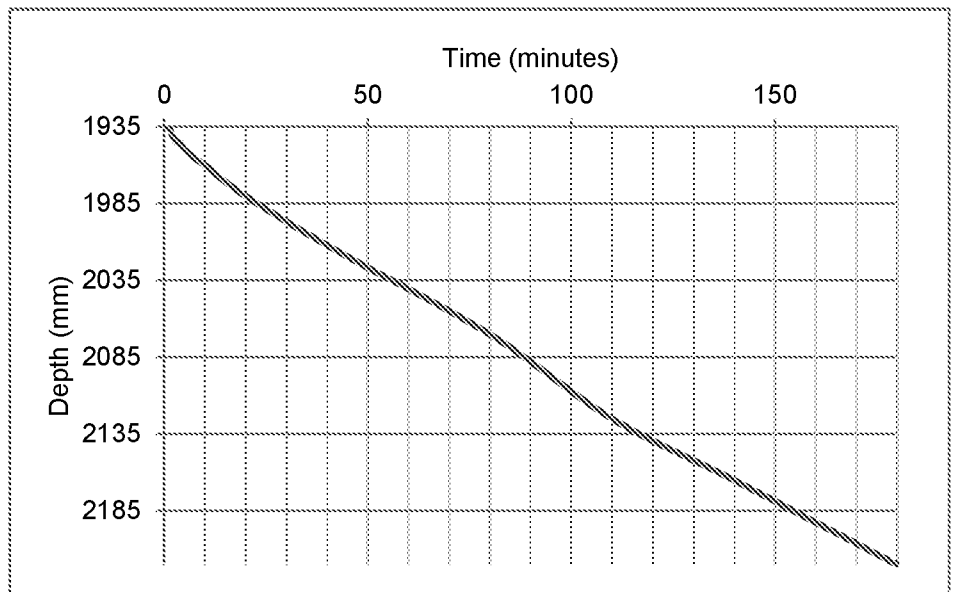
**Test No.** SA2

| Time (min) | Depth (mm) |

**Test Pit Log**

| Depth (m) | Description |
|---|---|
| 0.3-2.4 | Light brown slightly sandy SILT/CLAY. |

**BR365 Soil Infiltration Rate = N/A m/sec**  
**Average Infiltration Rate = 1.4E-05 m/sec**

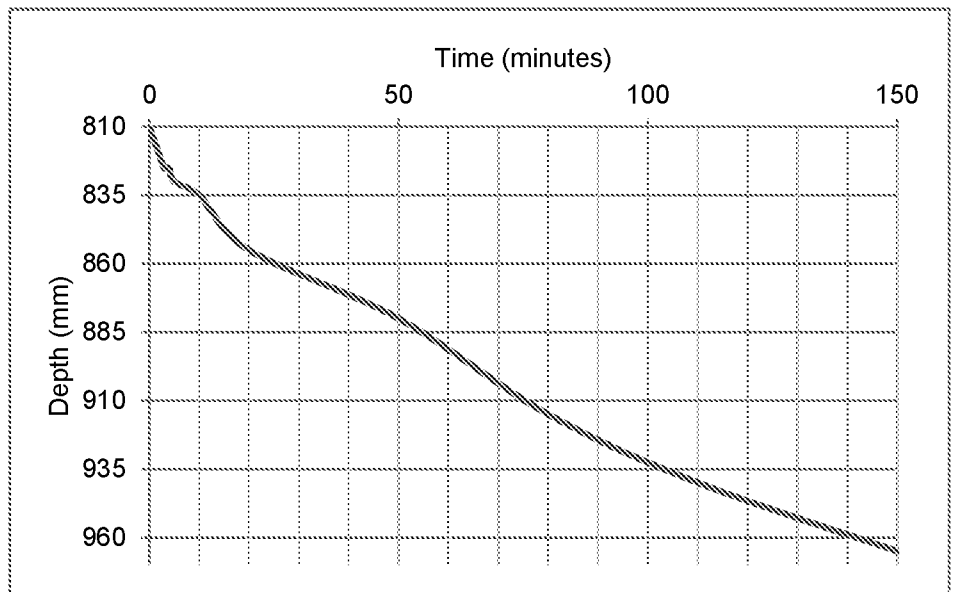
**Test No.** SA3

| Time (min) | Depth (mm) |

**Test Pit Log**

| Depth (m) | Description |
|---|---|
| 0.25-1.25 | Light brown slightly sandy SILT/CLAY. |

**BR365 Soil Infiltration Rate = N/A m/sec**  
**Average Infiltration Rate = 7.8E-06 m/sec**

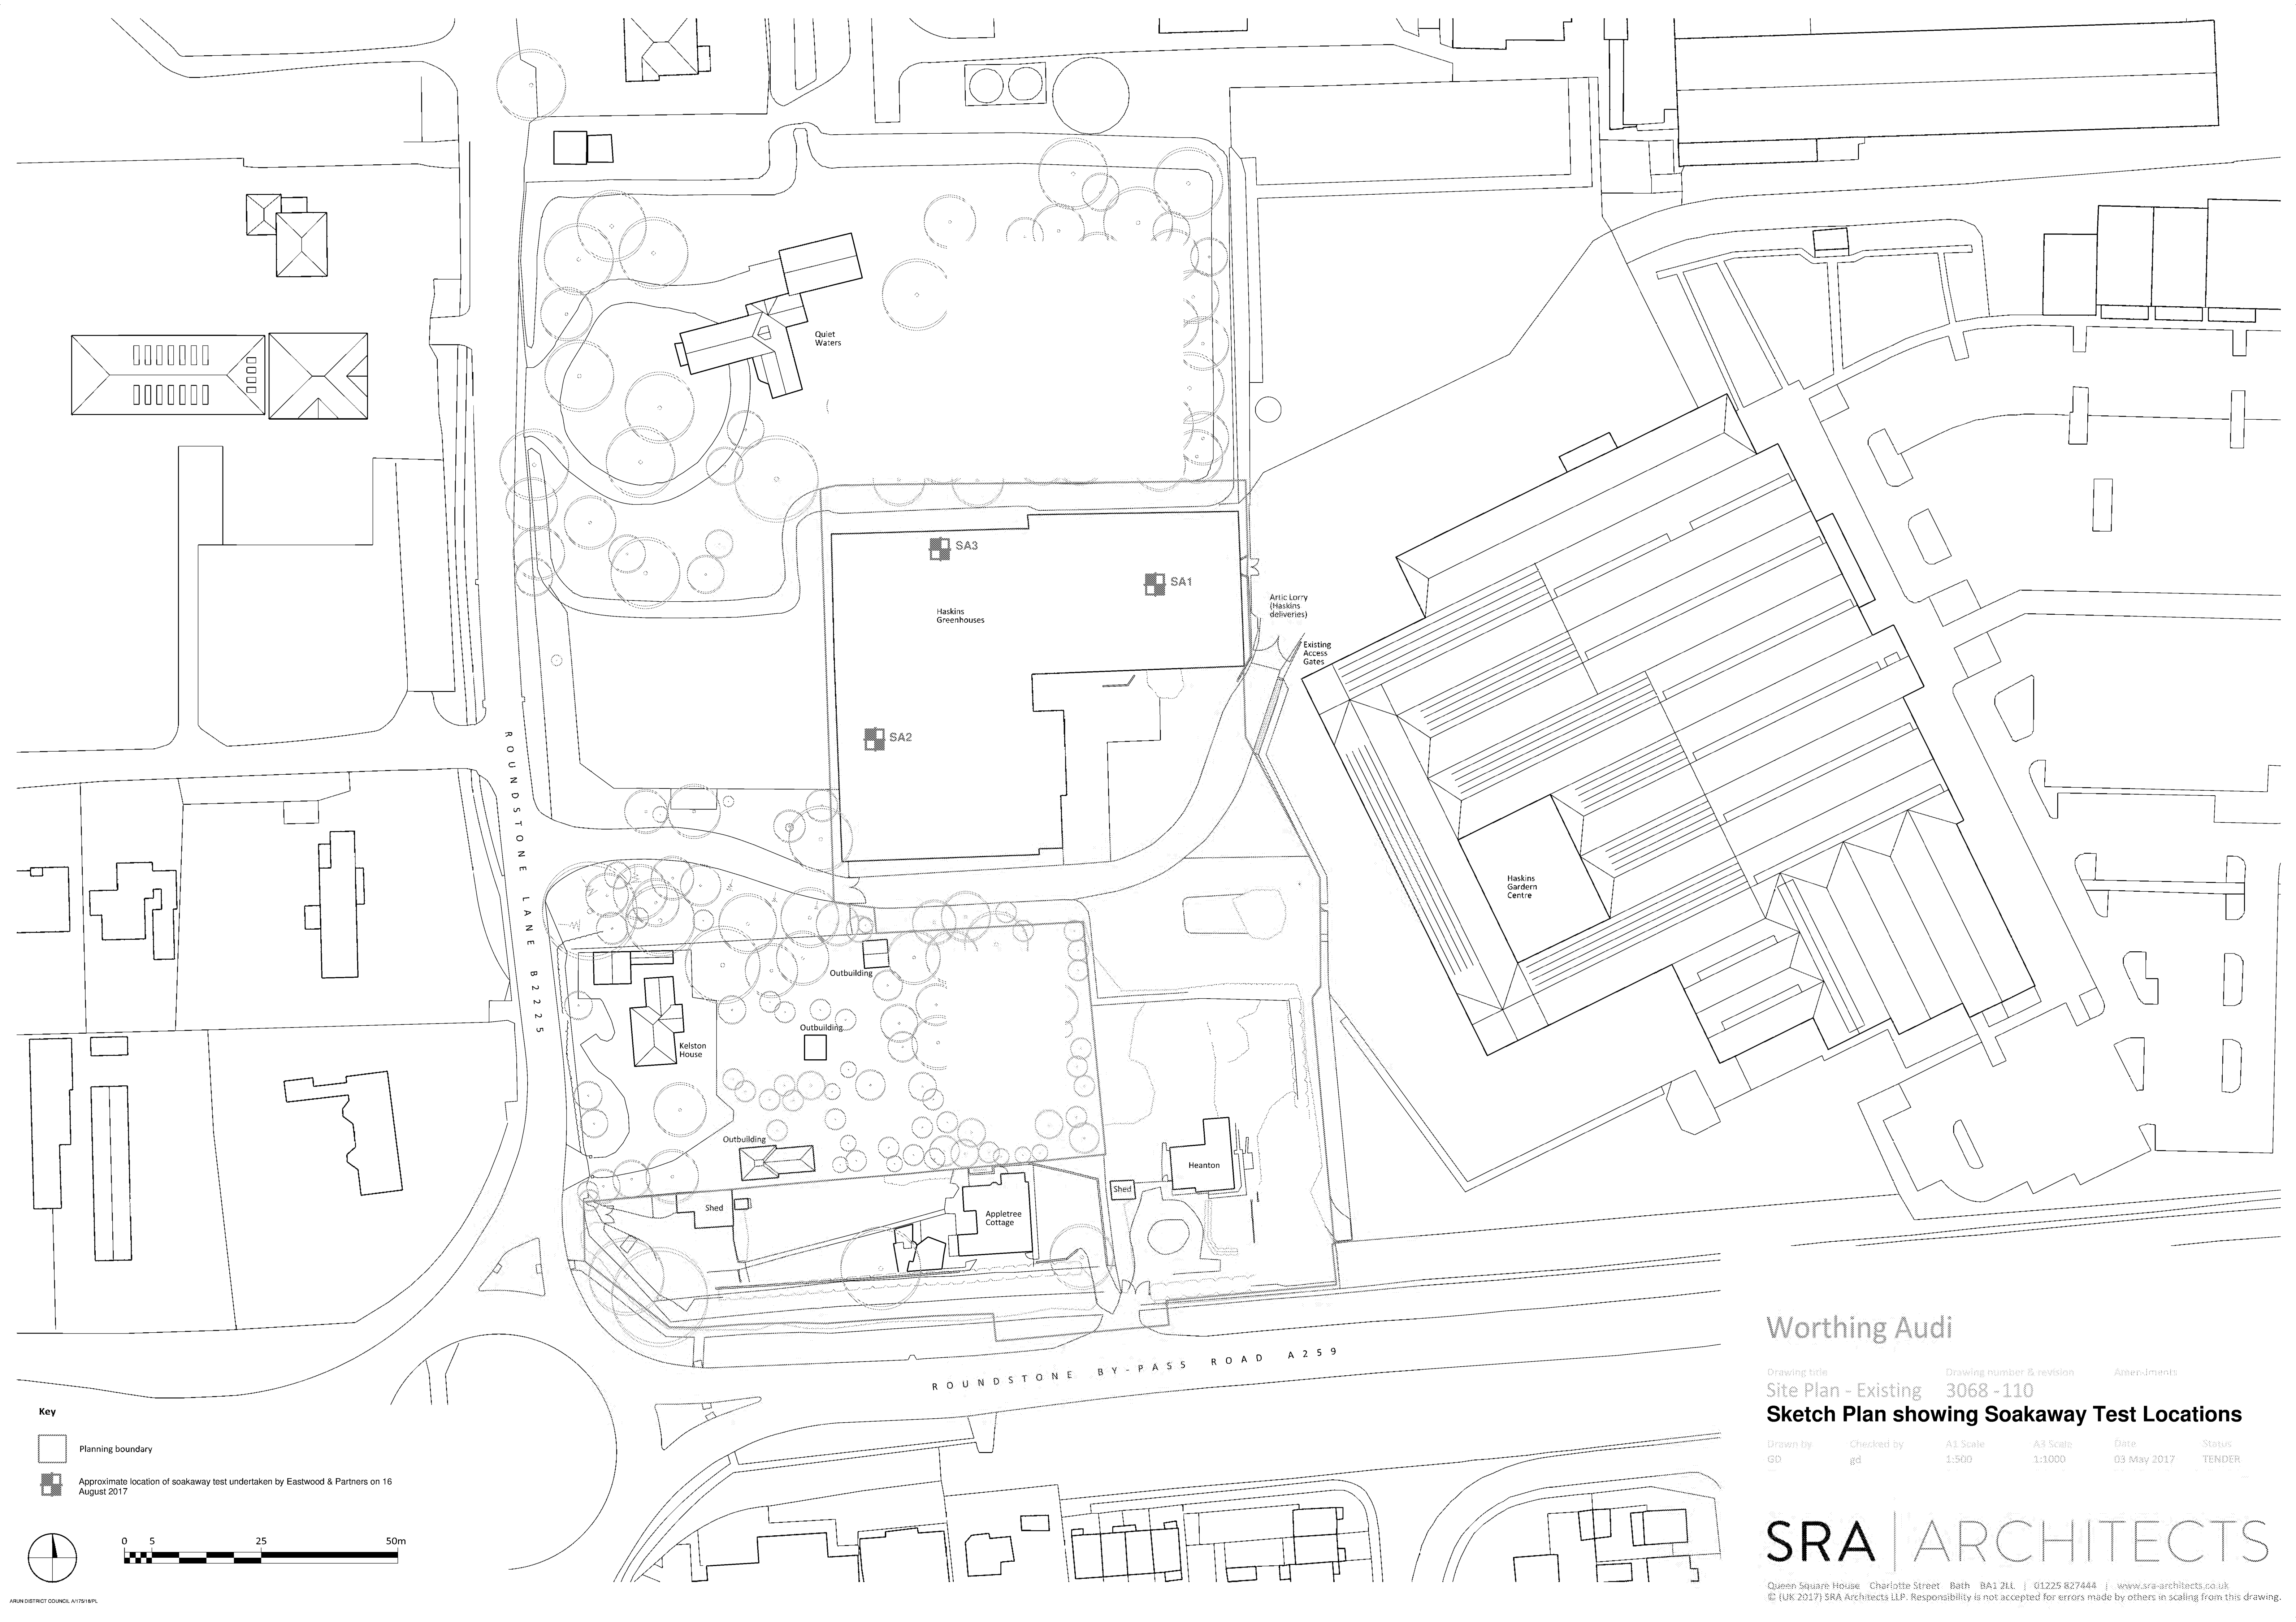
| <b>Sketch Plan showing Soakaway Test Locations</b> | | |

Approximate location of soakaway test undertaken by Eastwood & Partners on 16 August 2017

Eastwood & Partners visited site on 16 August 2017 and excavated three pits (SA1 to SA3) in the area of the former greenhouses in the north of the site. A sketch plan showing the location of the pits is enclosed. The pits reached depths of between 1.25 m and 2.4 m bgl. Each pit was filled with approximately 500 mm depth of water and monitored over a period of several hours.

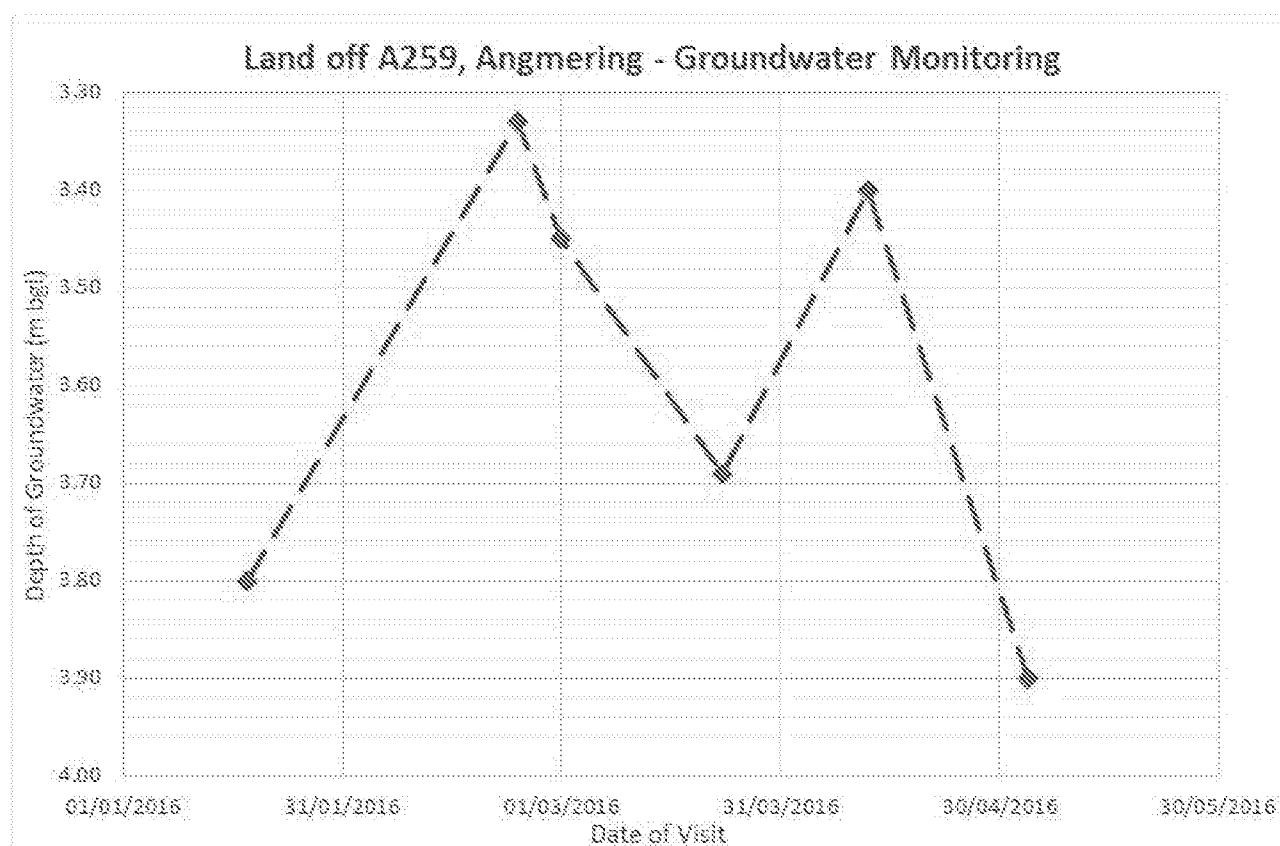
**Graph 1 Groundwater Monitoring Within Borehole BHI**

The groundwater reading for 18<sup>th</sup> January was recorded during the drilling of the borehole. The graph showed the increase in groundwater depth between January and April. It must be noticed that every single reading has its own importance for the definition of the highest groundwater depth. The readings, however, also showed the natural oscillatory behaviour of groundwater level, with influence from a number of factors including precipitation and site characteristics.

Graph 1 shows that, as anticipated, groundwater was rising from the annual minimum, which typically occurs around November, to the annual maximum, usually occurring around March.

Groundwater monitoring was undertaken by Soils limited on four occasions over a period of three months. Monitoring was undertaken by means of manual dipping of the wells. Groundwater monitoring results have been presented in Table 1 and are displayed in Graph 1.

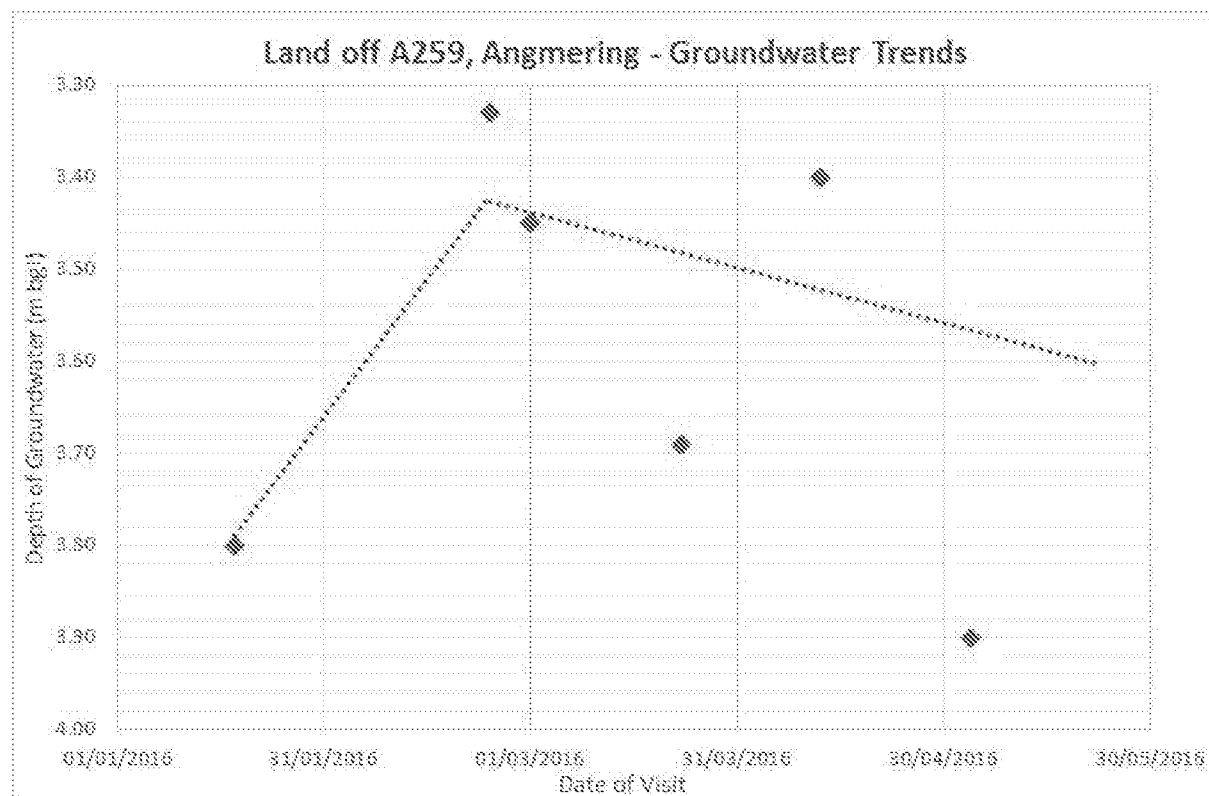
**Graph 2 Expected Groundwater Trends**

The highest measured groundwater level was 3.33m bgl and was attained on 24<sup>th</sup> February 2016 and thereafter the readings varied between 3.45m and 3.40m bgl, with an intermediate reduction at 3.69m bgl. Notwithstanding the single readings, well-defined trends could be identified and showed how the average of groundwater depth was reducing after the peak conditions identified between February and March 2016. Those trends were reported in Graph 2.

The readings oscillated around the trendline and, as a consequence, it could not be excluded that in the following months the groundwater level, for example after intense periods of rainfall and also depending on the general site conditions, could occasionally rise again to values higher than the ones represented by the trendline or alternatively change or invert the trend. All of these must be considered as a part of the natural oscillations of groundwater.
