## **Compiled Ground Investigation Report**

**Land North of Mayflower Way, Angmering, Littlehampton,  
West Sussex BN16 4AY**

**Reference: 17403/CGIR**

**February 2019**

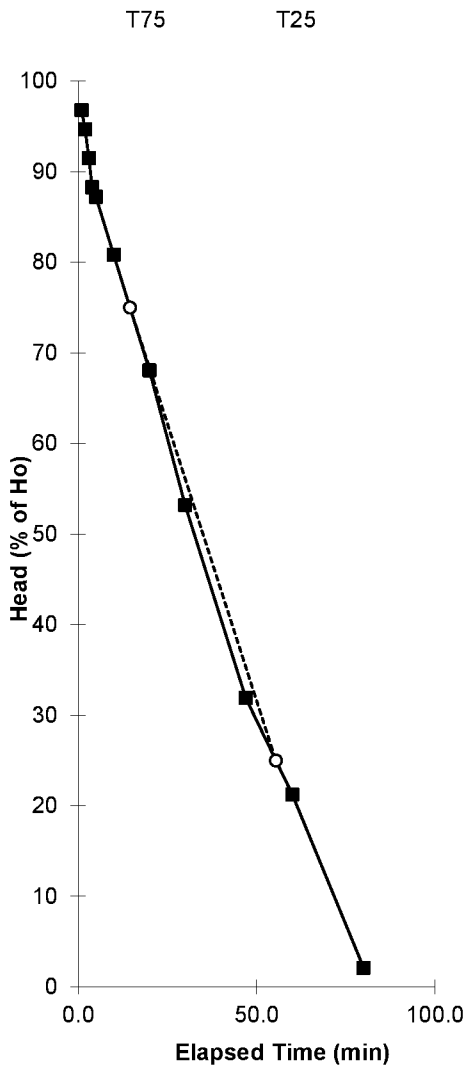
## Soakaway Calculations

| Seahway Test No. | TP1 Test1 |

| <i>Depth to</i> | <i>EIapsed</i> | <i>Head of</i> | <i>Head of</i> |
|---|---|---|---|
| T25 | 55.450 | 25 | |
| T75-25 | 40.867 | Derived from Best Fit | |

A single test was completed within TP1, ending once 75% of the water had drained away. A test was carried out in both TP2 and TP3, which did not complete within the monitoring period. The data from the incomplete tests were extrapolated to give an indicative infiltration rate.

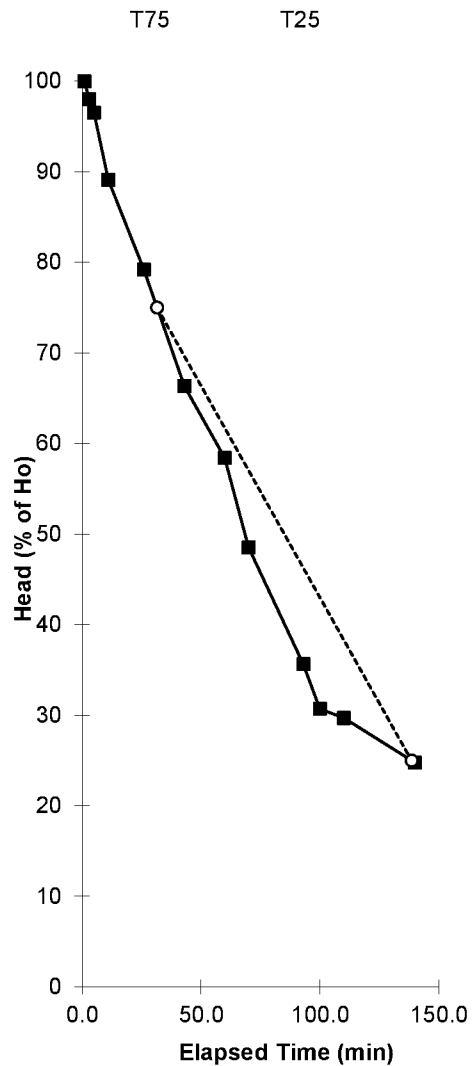
| T25 | 138.500 | 25 |
| T75-25 | 106.942 | Derived from Best Fit |

Extrapolated past 110 mins

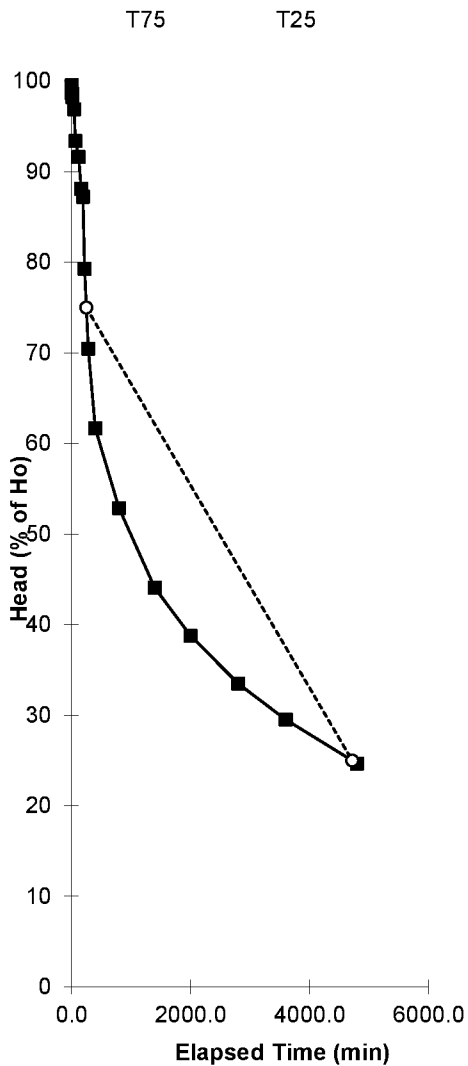
| T25 | 4718.182 | 25 |
| T75-25 | 4468.932 | Derived from Best Fit |
