## APPENDIX B. PIA Data

# **Chalcraft Lane – W Bersted – I-Transport**

Collision report 01/05/2015 – 30/04/2020

**Chalcraft Lane, West Bersted**  
**Collision Dates 01/05/2015 - 30/04/2020**  
**i-Transport**

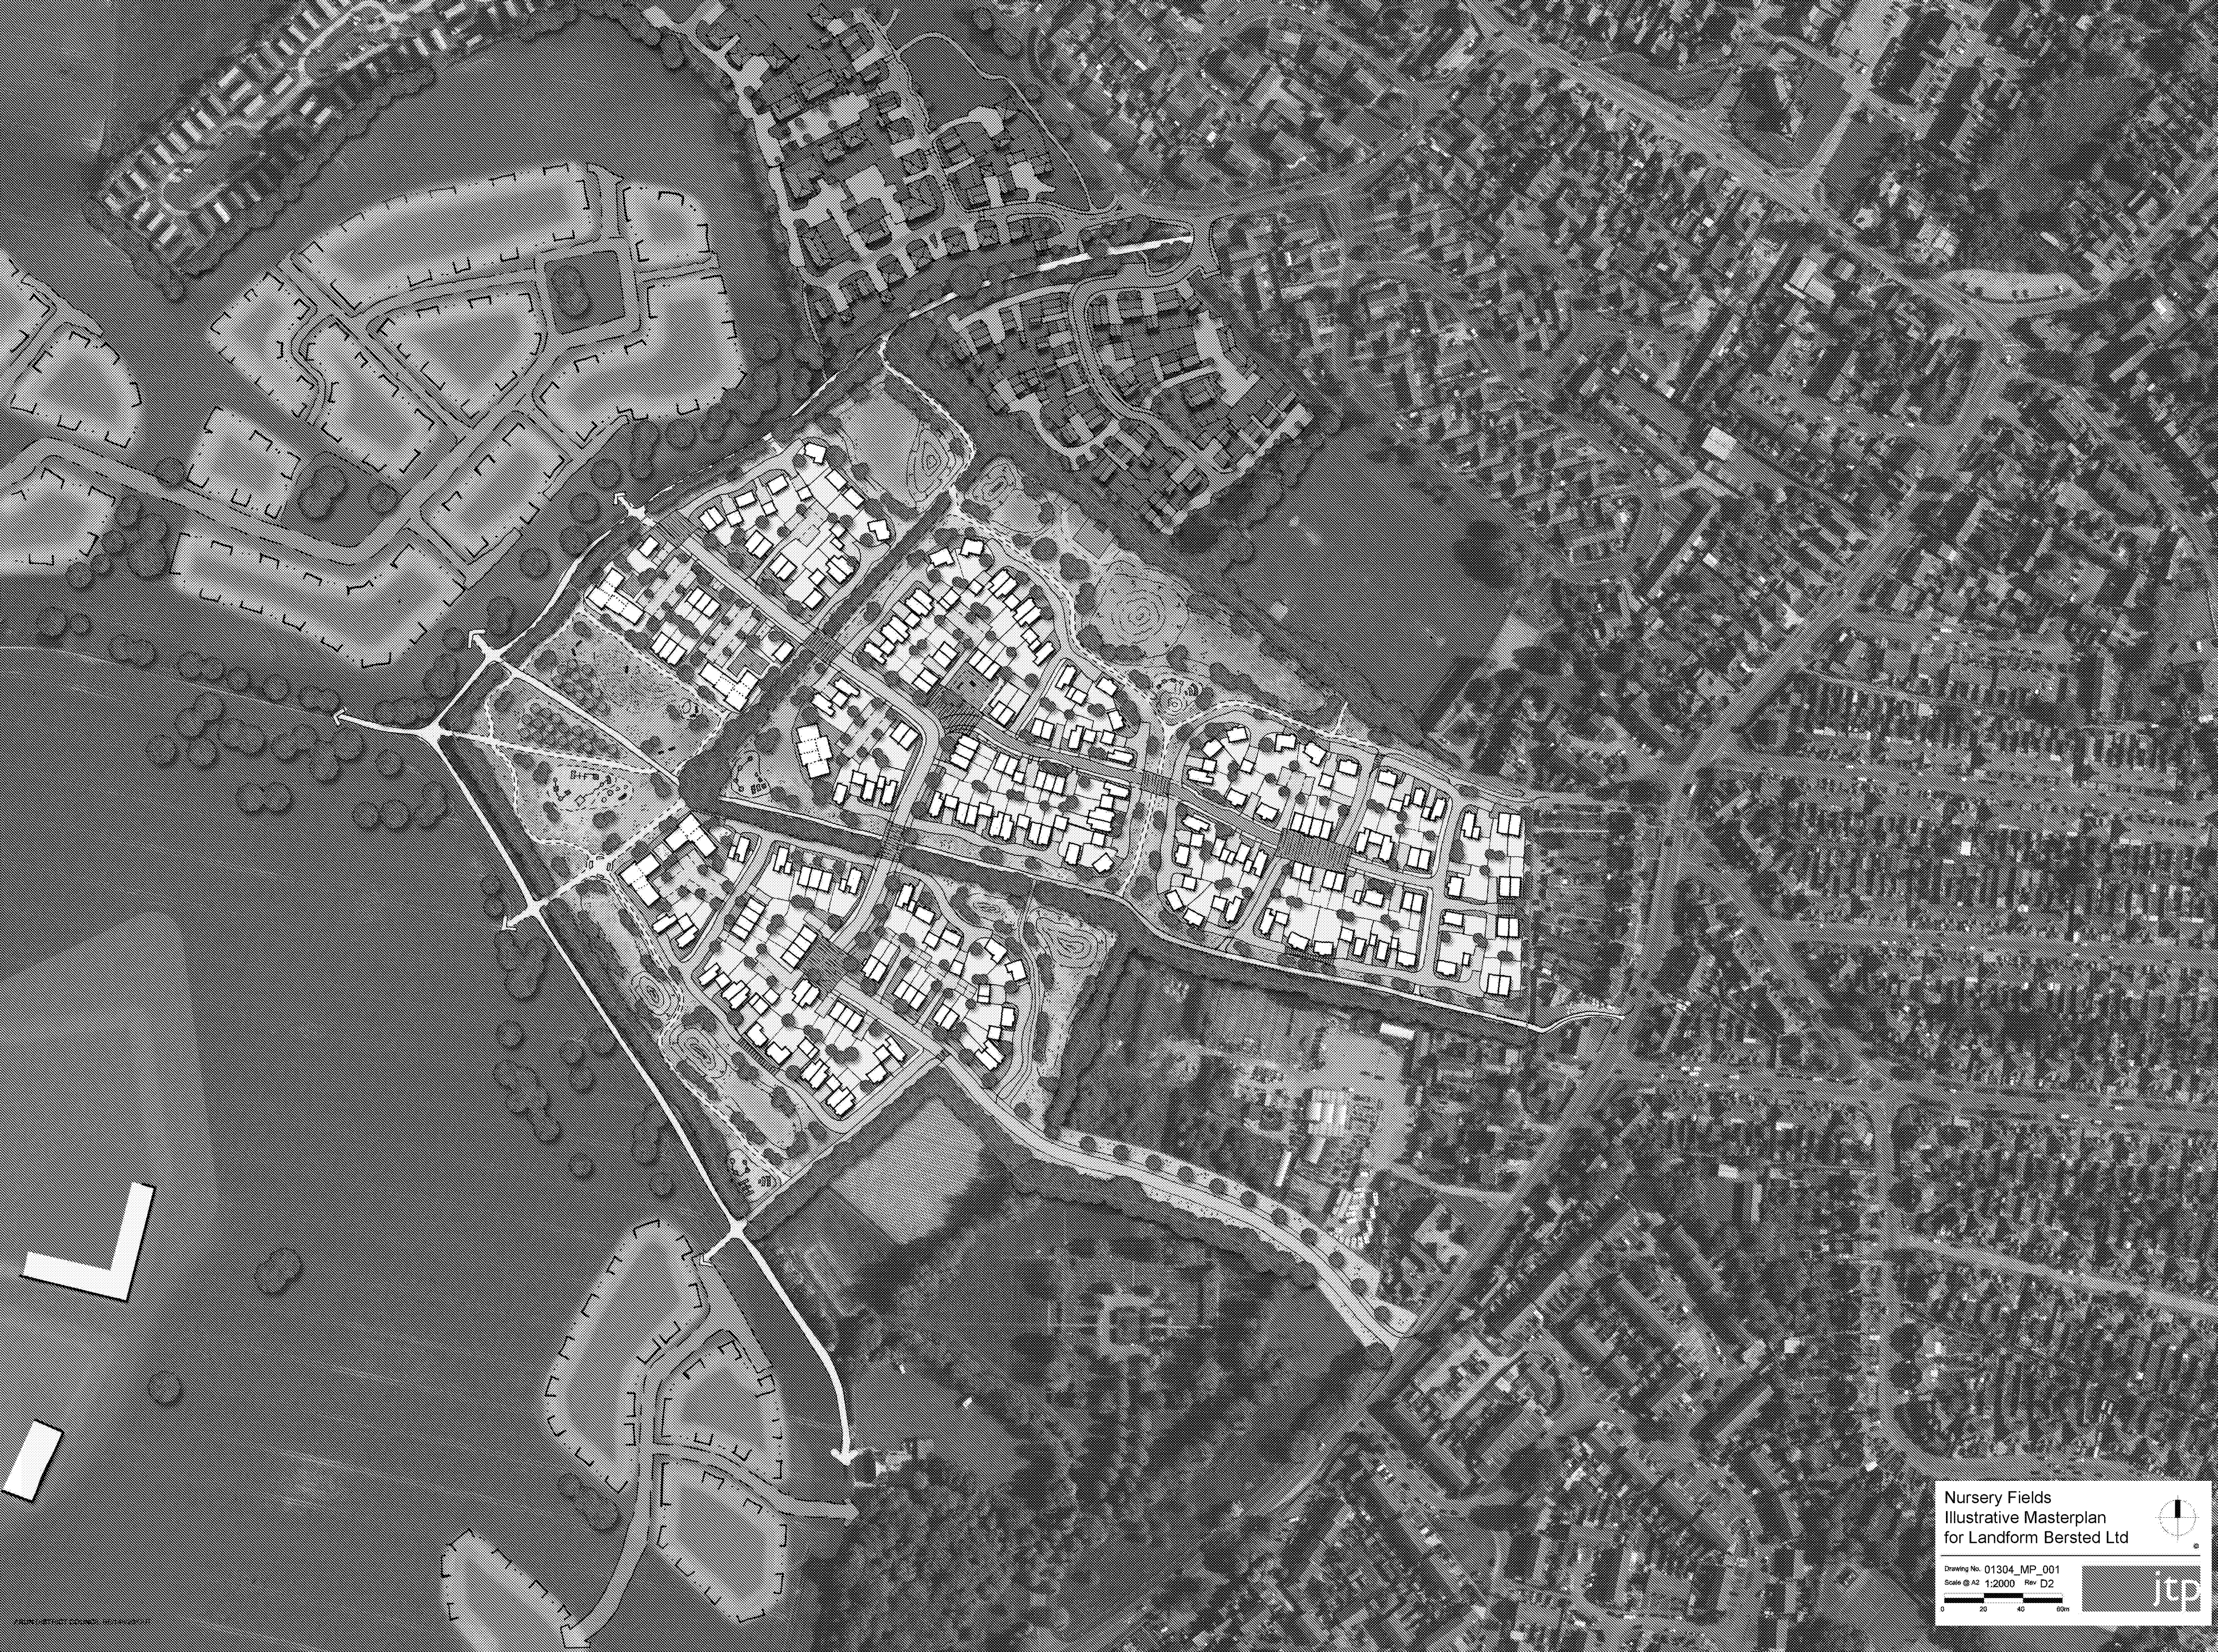
## APPENDIX C. Illustrative Site Layout

Nursery Fields  
Illustrative Masterplan  
for Landform Bersted Ltd
